**Linden Lea, Church Lane,
Manby, Lincs.**

Archaeological Watching Brief

LAS Report No. 406

March 2000

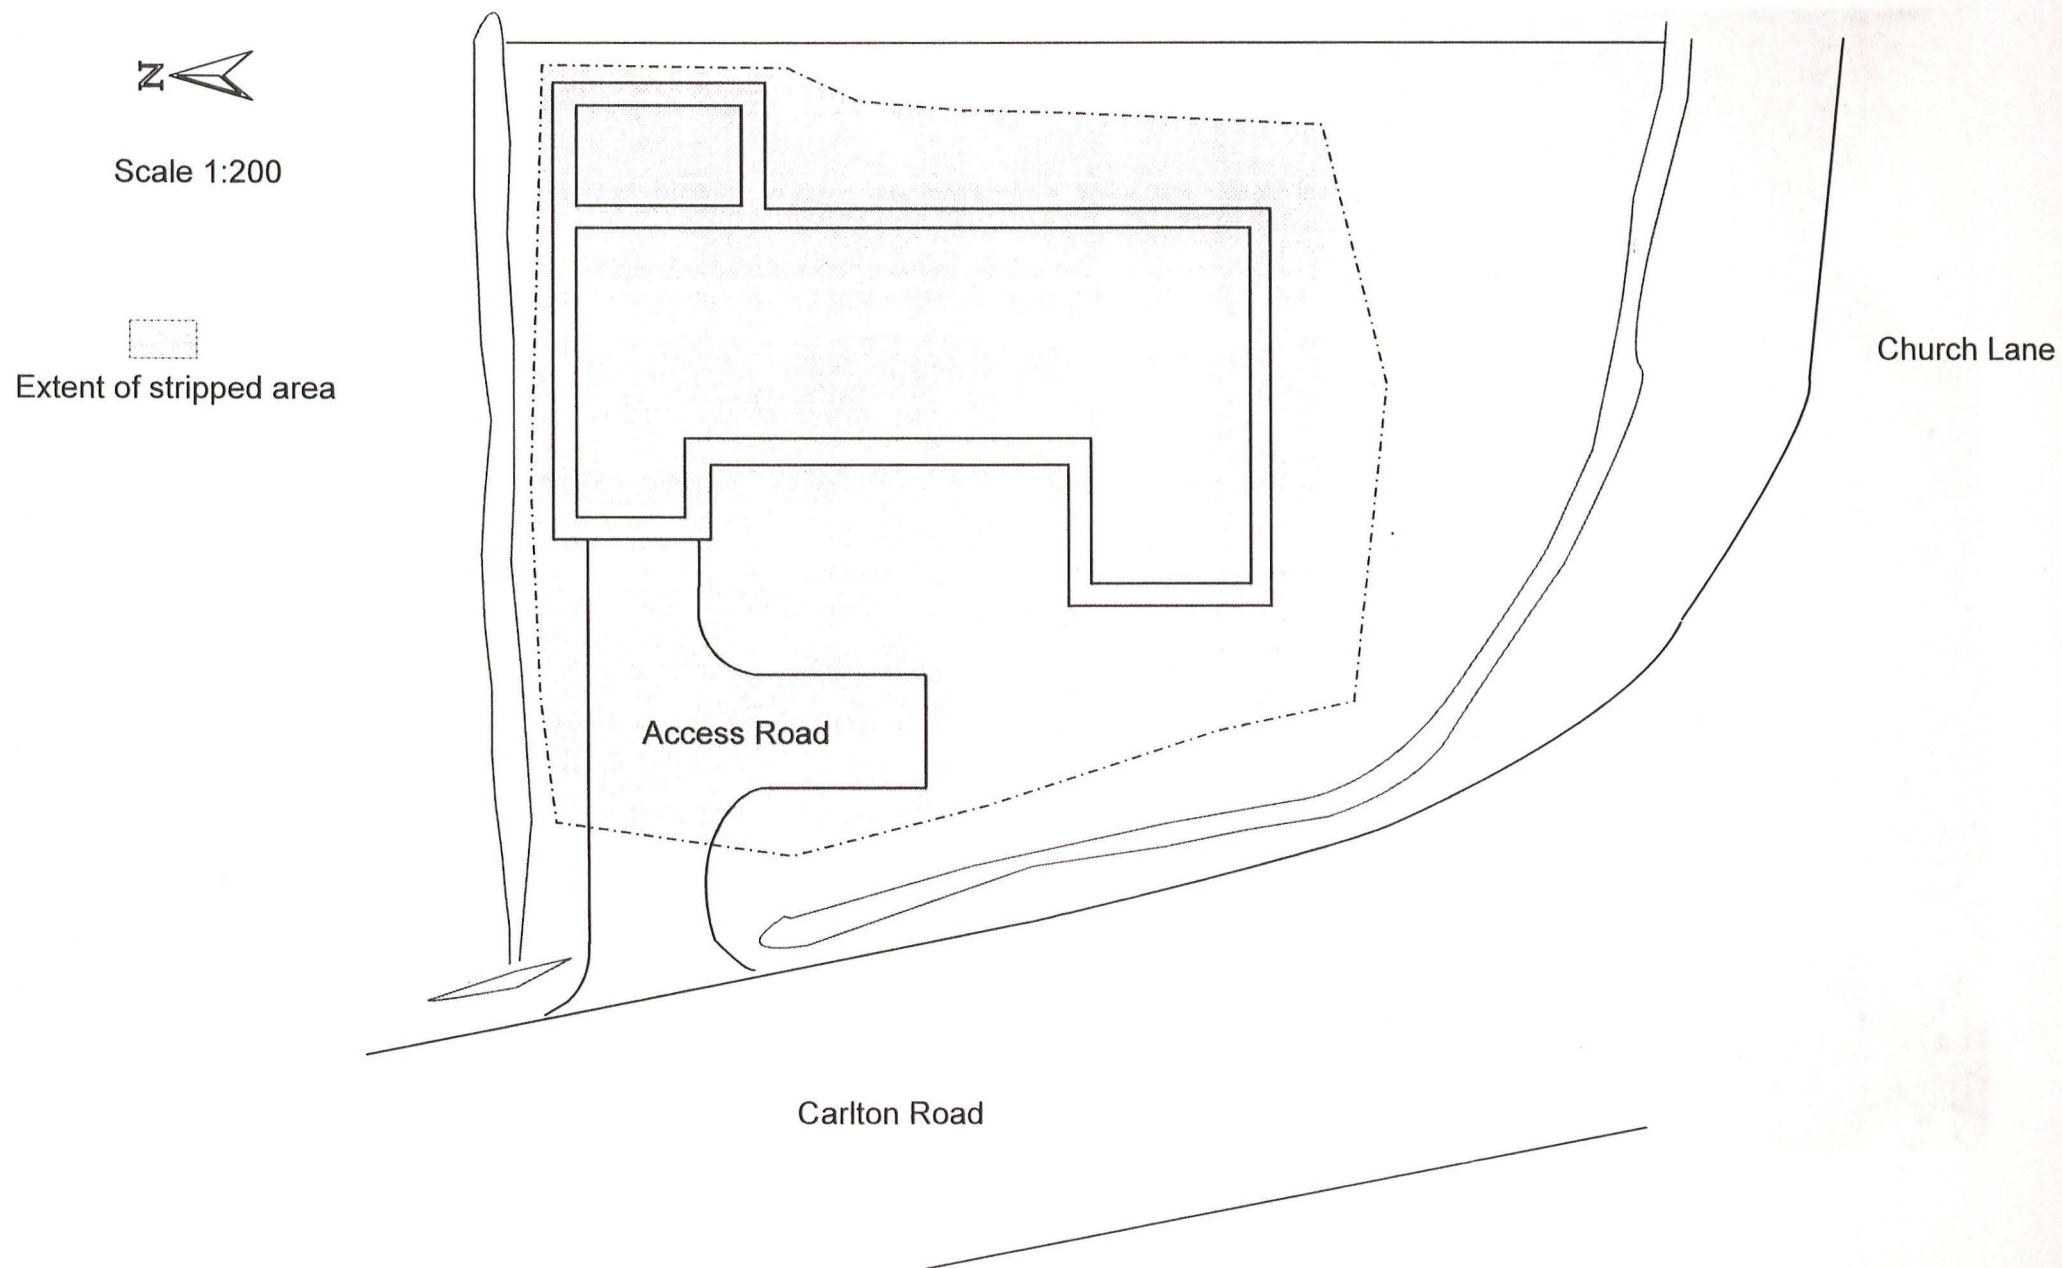
Figure 2: 1:200 Plan of the development site showing the location of the foundation trenches

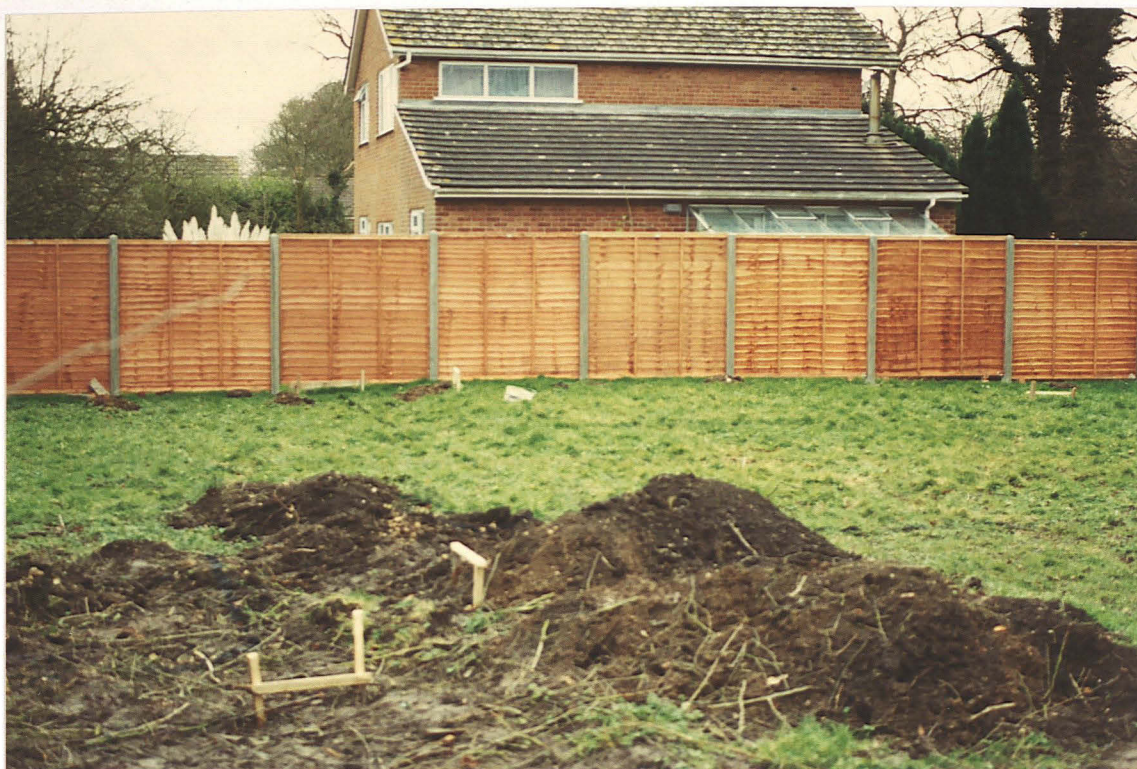
Plate 1: Development site, looking east

The plot measures approximately 45m by 35m and was previously part of the garden of Linden Lea (Pl. 1). Trees and hedges form three of the boundaries around the site.

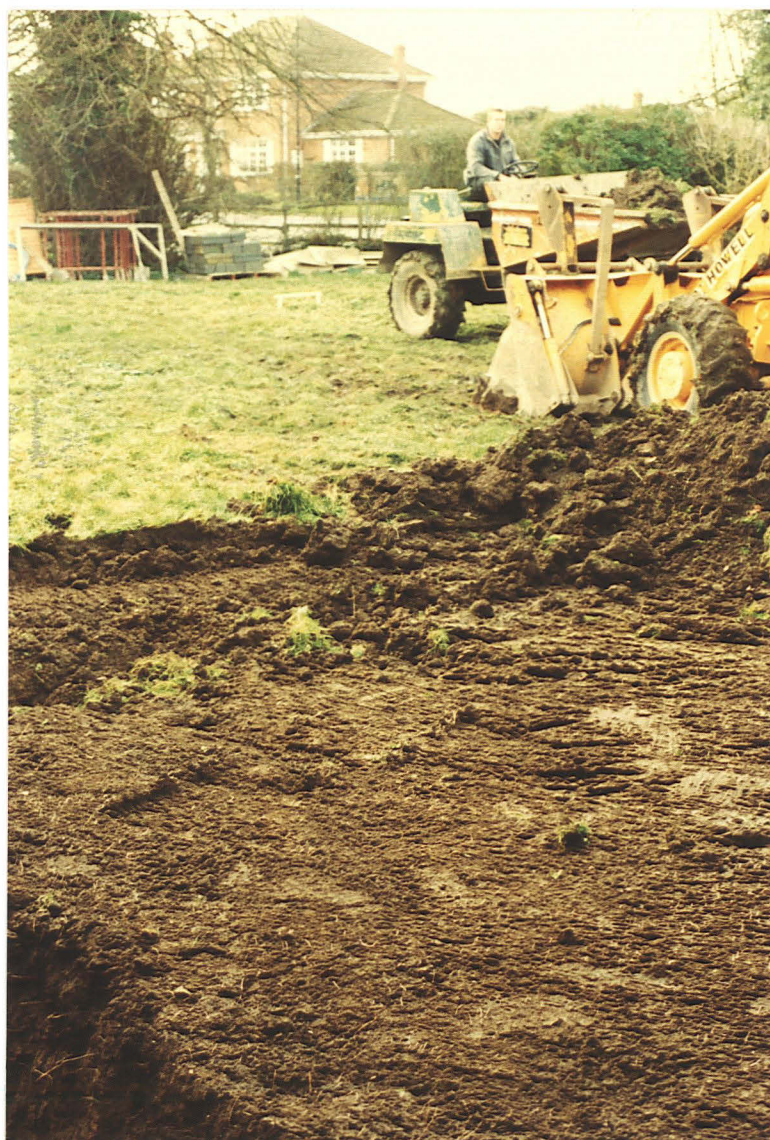
Plate 2: Stripping the development site

The topsoil was removed from the house plot using a back-acting machine with a 1.8m toothless ditching bucket under archaeological supervision (Pl. 2). The foundation trenches were also machine-excavated under archaeological supervision using a 0.8m toothed ditching bucket to depths of 1m and 1.2m. Sections within the foundation trenches were cleaned and recorded. The location of the foundation trenches was planned (Fig. 2) and a series of record photographs taken. The deposits recorded in the foundation trenches were assigned context numbers by L.A.S. for recording purposes. These context numbers are referred to in the following report.

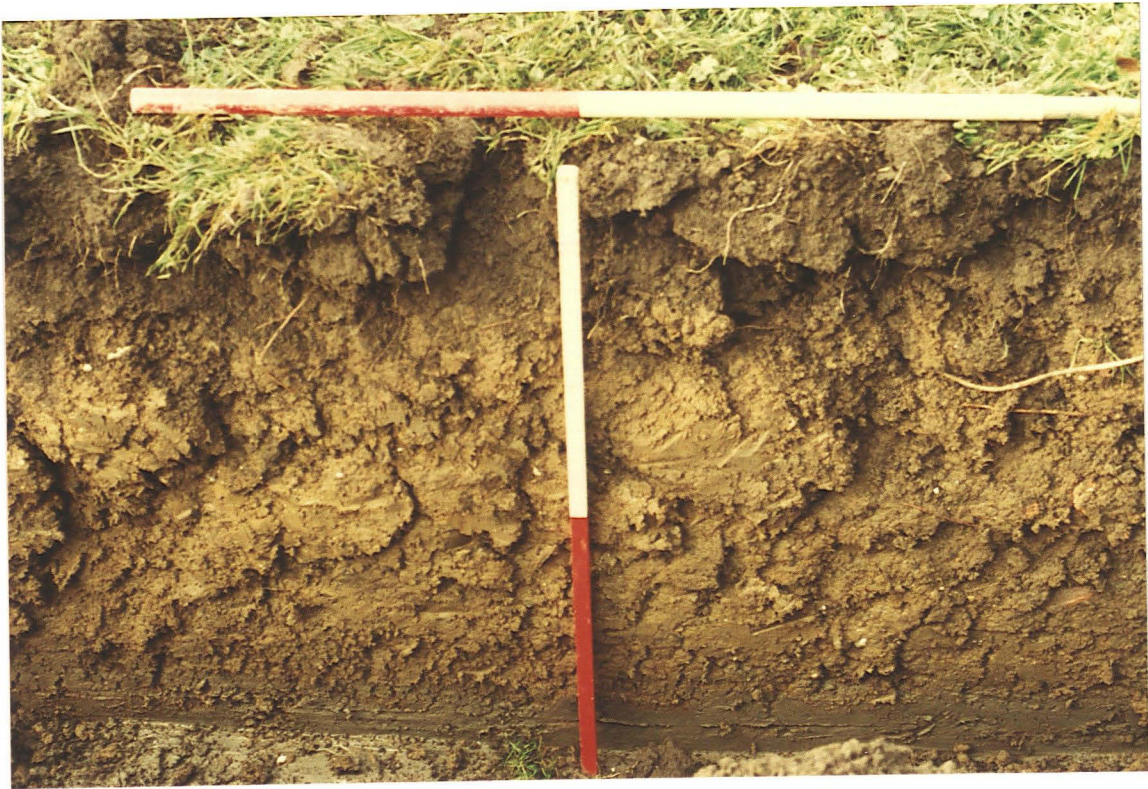
The topsoil (100) was a grey-brown clayey silty loam, containing occasional flint and chalk fragments. The topsoil varied in depth from 0.26m to 0.30m. The removal of the topsoil revealed a yellow-brown silty clay subsoil (101), measuring approximately 0.50m in depth (Pl. 3).

Below this was a darker yellow-brown silty clay layer (102). This contained occasional fragments of natural flint and chalk, but no artefactual evidence. The material appears to have built up gradually as it is a clean deposit and does not appear to have been disturbed by human activity. This is thought to be a fluvial-glacial deposit or possibly weathered boulder clay, laid down on top of the boulder clay (103). Layer 102 varies in depth between 0.50 and 0.65m.

Plate 3: Section in foundation trench, showing deposits 100, 101, 102 and 103
