<sup>NKDC</sup>  
**Thorpe on the Hill, Main Street**  
**Westcliffe Court, House Plots 8, 11 and 12**

**Archaeological Watching Brief**

**LAS Report No. 397**

**May 2000**

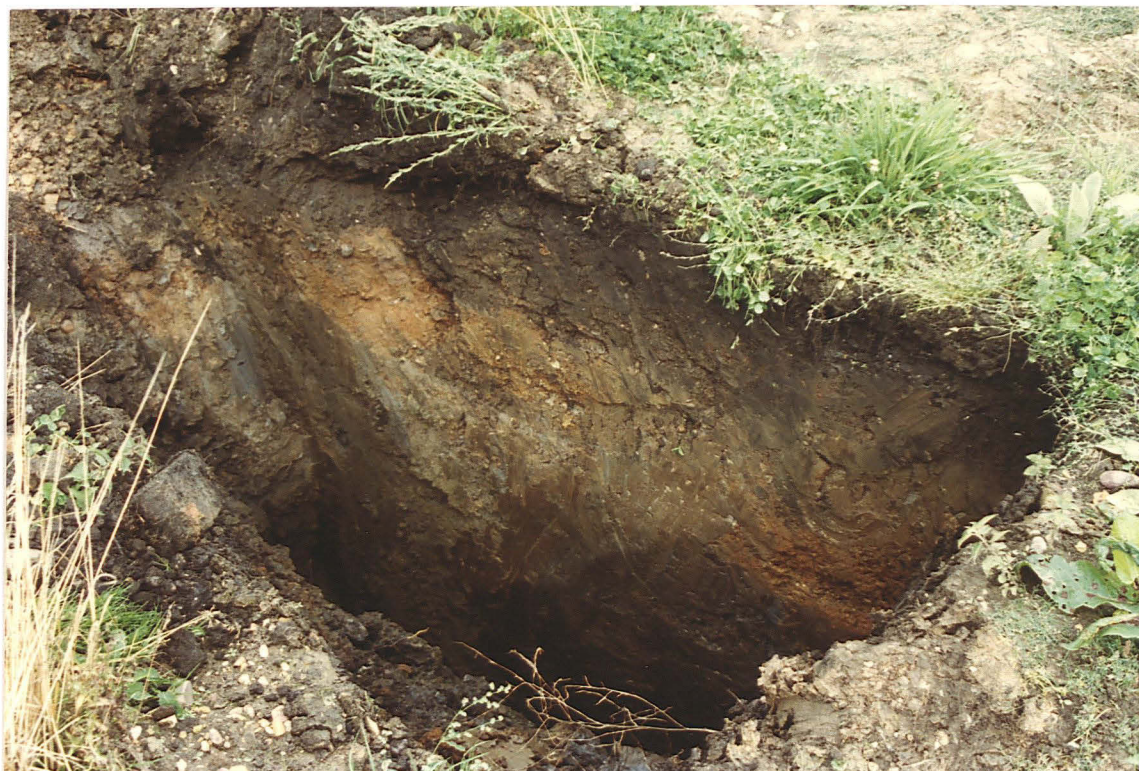
**Pl. 1 Geotechnical Test Pit 1.**

This trench was positioned SW of the existing farm buildings. The ground surface was covered by an uneven spread of demolition rubble from previously cleared farm outbuildings. Beneath the

rubble was the modern topsoil layer, with mixed clay deposits below (Pl. 1).

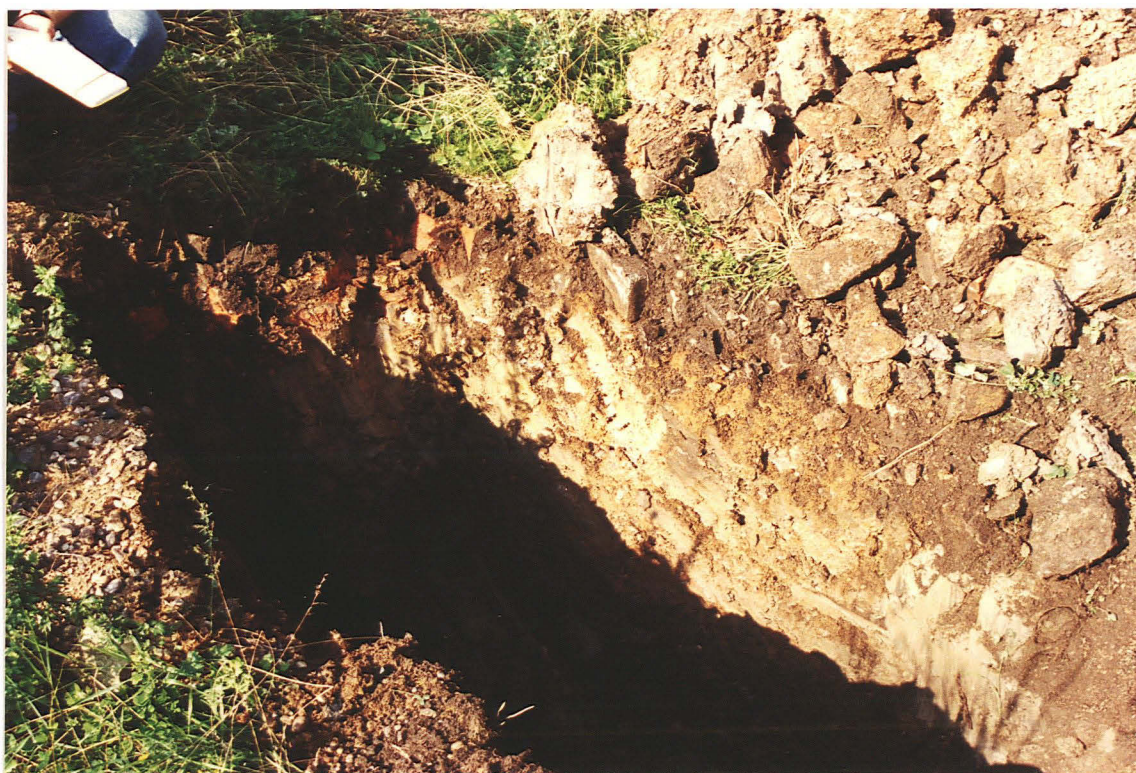
**Pl. 2 Geotechnical Test Pit 2a, showing brick foundation.**

This trench was positioned to the NW of the existing farm buildings, within the area of the field access. This located brick foundations immediately below the ground surface, with rectangular cut stone setts laid in a surface external to the foundations (Pl. 2). This was thought to be a paved yard outside a cattle byre or similar building. The bricks appeared to be of late eighteenth century or early nineteenth century date.

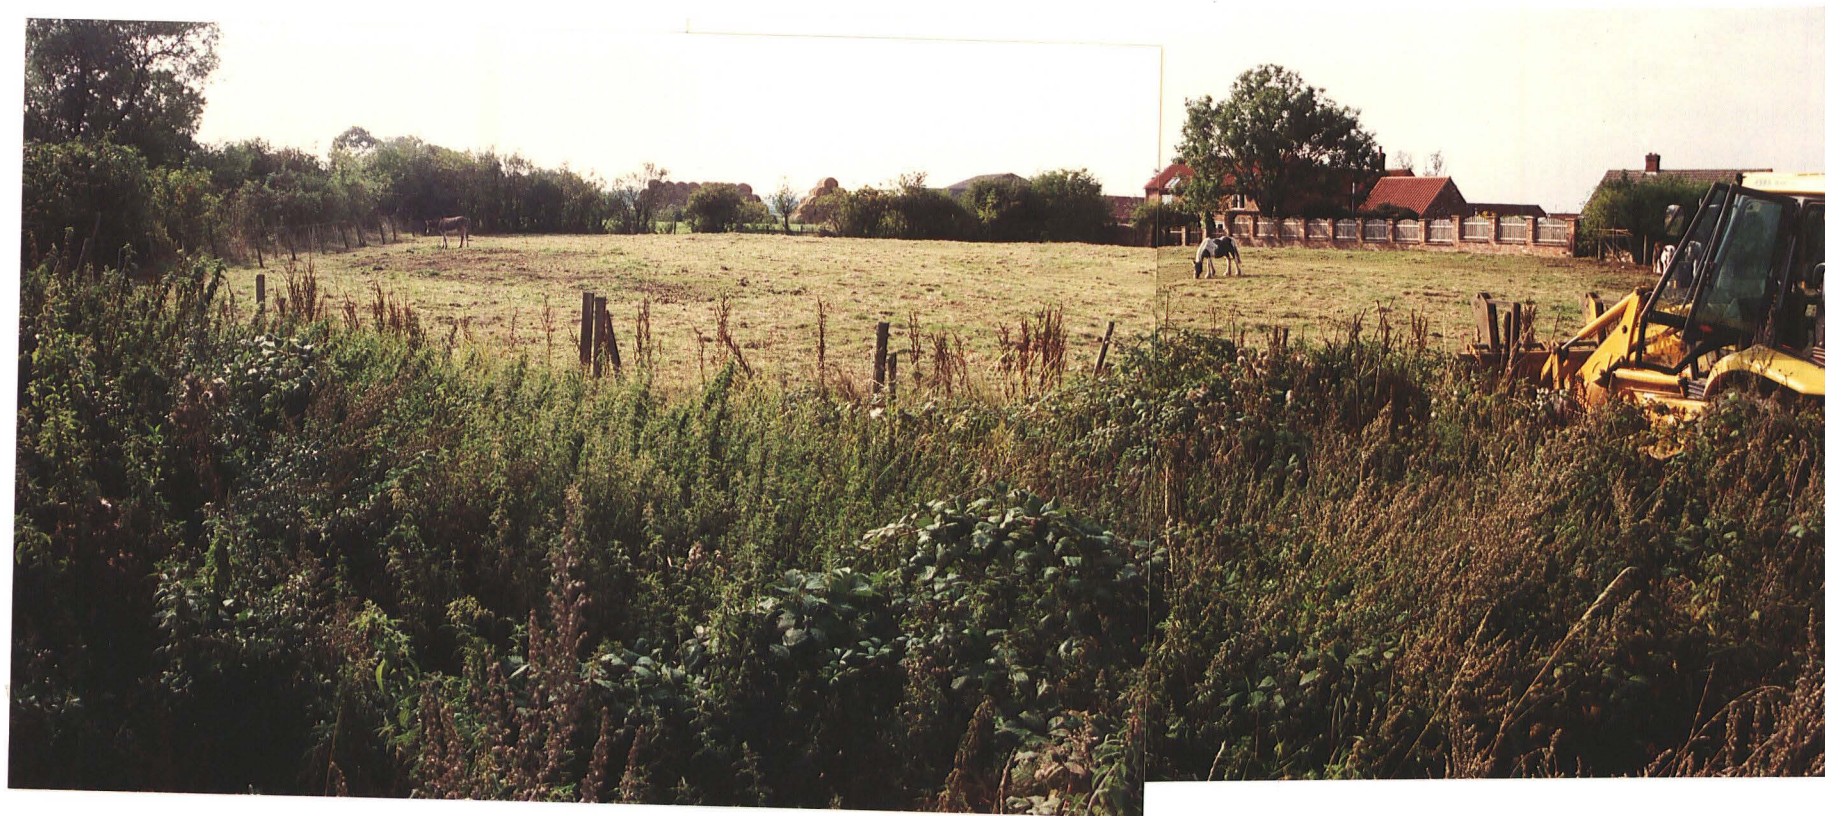
**Pl. 3** Possible earthworks in the pasture field beyond the development site, west of Test Pit 1.

In the NW corner of House Plot 10, the trench was excavated through 0.25m topsoil and 0.15m of gravel within a grey/brown sandy loam matrix, into bands of clay and hoggin. The lowest deposit exposed was a grey clay. The paddock to the west appears to contain slight earthworks, possibly of medieval date (Pl. 3).

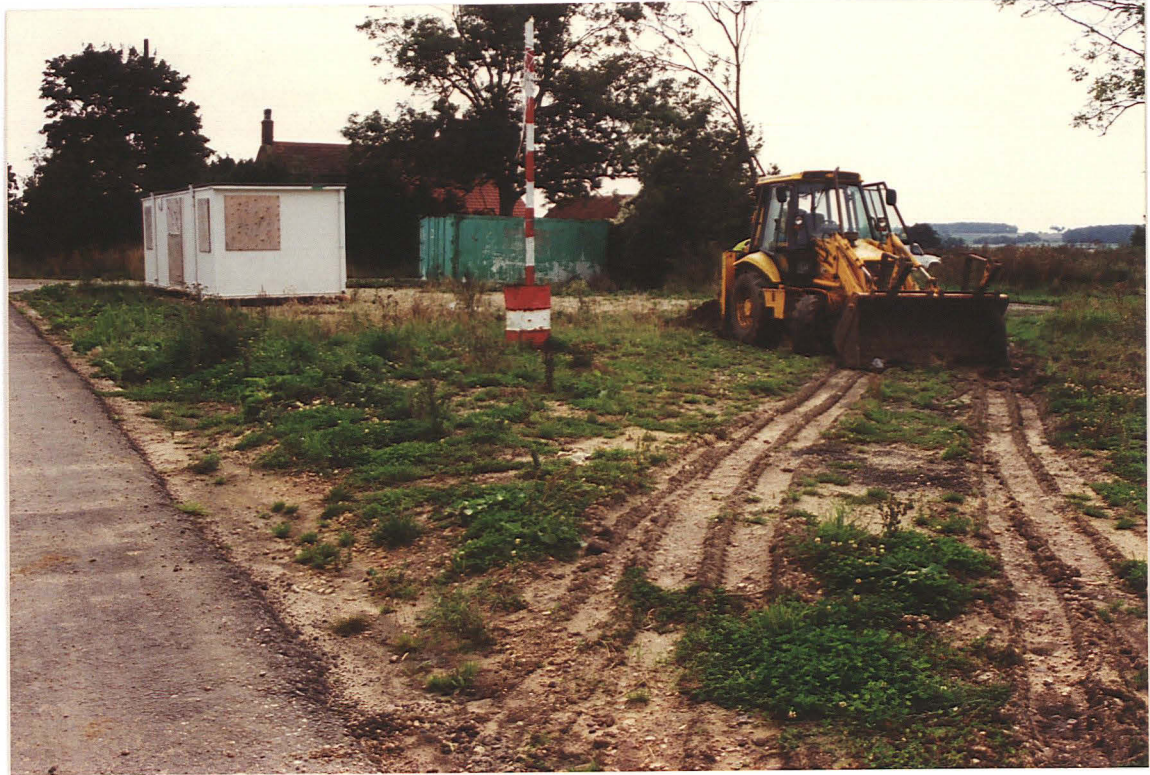
Pl. 4 Location of Geotechnical Test Pit 5 (looking south to The Farm).

Within House Plot 7, east of the existing farm access track and east of the former hedge boundary, the topsoil covered a very mixed layer with clay and brick rubble (Pls. 4 and 5). A number of pebbles and other stones were below this layer but these were apparently naturally present within the yellow clay subsoil and weathered clay. The underlying red/brown clay covered grey clay at the trench base.

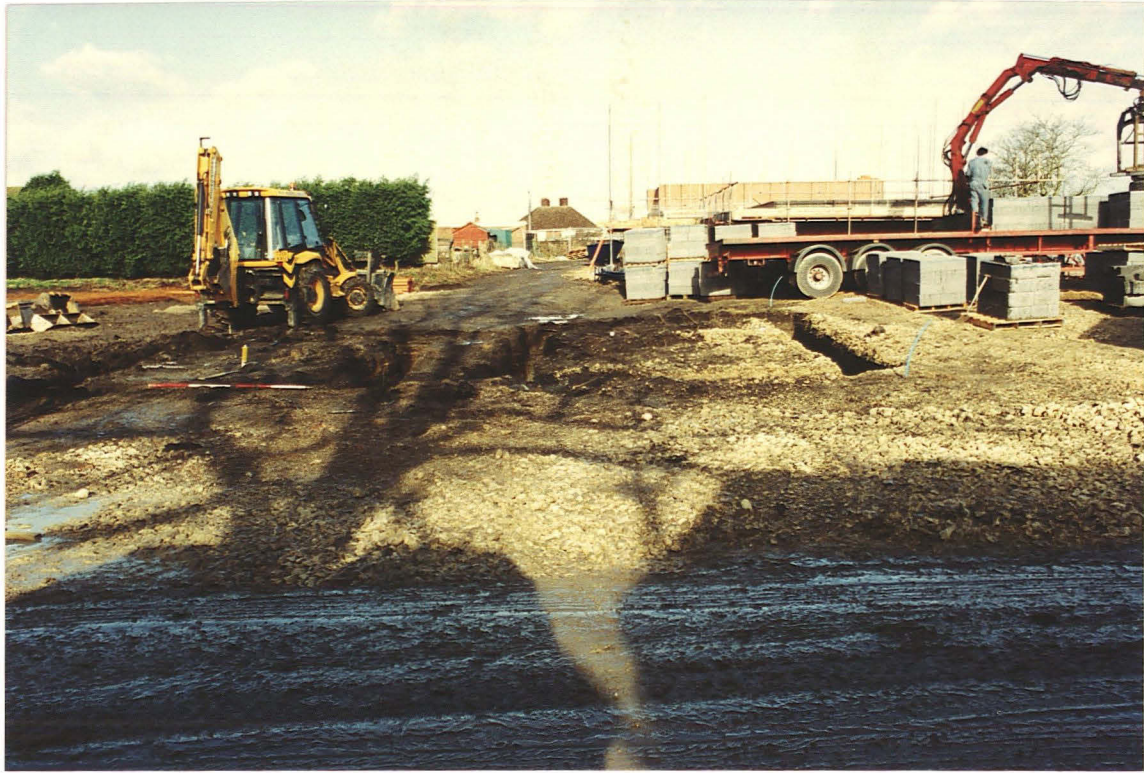
**Pl. 6** Position of House Plot 8, showing the line of the original farm access track (looking north).

These trenches were also 0.6m wide, with an average depth of 1.3m. The siting of this house plot straddled the north-south route of the original access track to the farmhouse on the southern edge of the site, and the east-west orientated sections of foundation trench cut across both this track and associated ditch and tree root disturbance from a removed hedgeline (PIs. 6 and 7). At the eastern extremity of the house plot, the foundation trenches cut across features identified during the 1998 watching brief (PI. 8). The southernmost of these east-west foundation trenches was recorded, as it was the closest to the trench where these features had previously been observed and offered a continuous section through both the modern and archaeological features present. The majority of the section was photographed, but only the eastern three metres were recorded in detail as this was the position of the exposed archaeological features.
