**Land adjacent to 27 Gainsborough Road,
Lea, Lincs.**

**Site Code: LGB00
NGR: SK 8290 8670
LCNCC Accn.: 2000.111**

Archaeological Watching Brief

**LAS Report No: 421
June 2000**

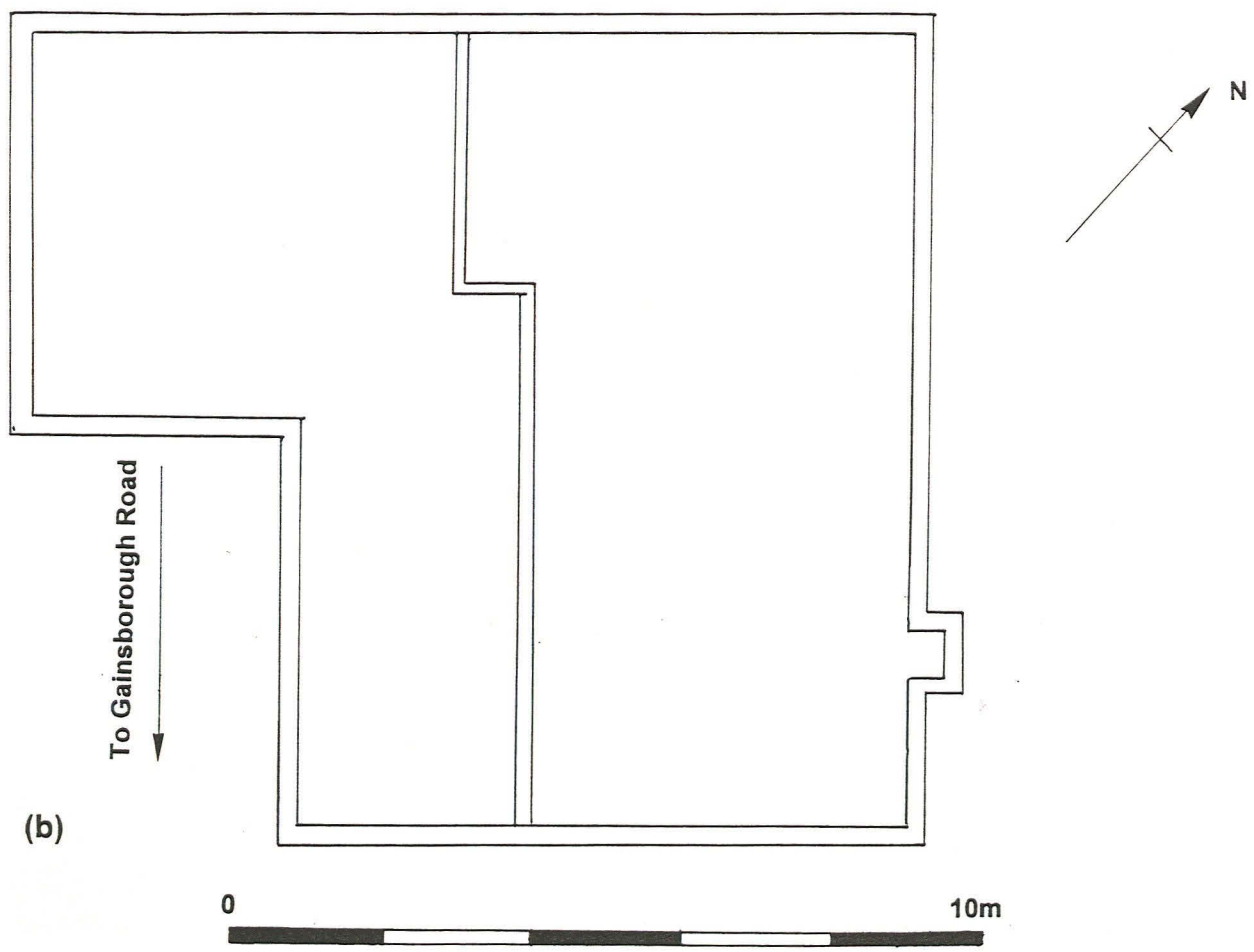
Fig.2 (a) Location of foundation trenches within plot
 (b) Plan of excavated foundation trenches

The foundation trenches for a single bungalow and garage were machine-excavated using a JCB under archaeological supervision (Fig. 2). The foundation trenches measured 0.60m wide and varied in depth between 0.70m and 1m.

A representative section of the foundation trenches was cleaned by hand and recorded using colour photographs, written records and a sketch section. A plan of the excavated foundation trenches was made based on a plan provided by the developer. A full photographic record was made of the works on site.

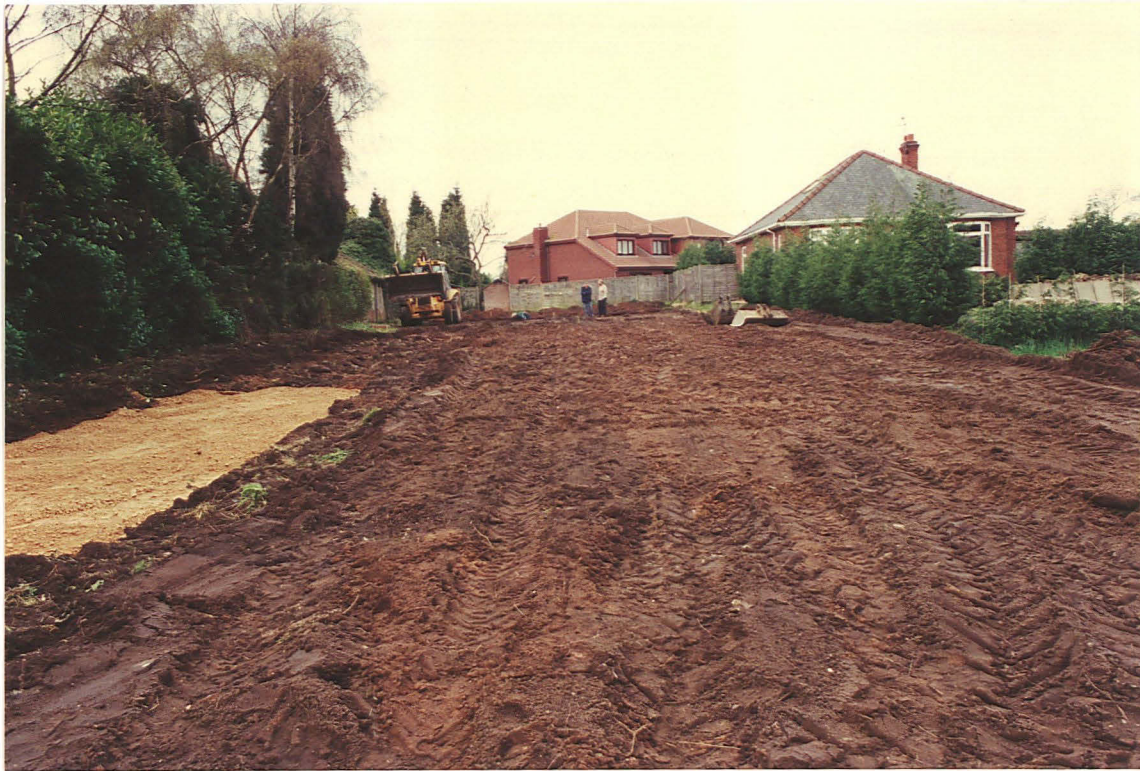
Pl. 1 The development site, looking west: the foundation trenches are located at the rear of the plot

Lea is located on the edge of the Trent Valley 3km south of Gainsborough. The plot is located on the west side of Gainsborough Road between nos. 25 and 27, in the former garden of no. 27 (Fig. 1; Pl. 1). The area measures approximately 60m in length and 15.60m in width. Until 15-20 years ago, this land had been used as a market garden. The land is almost flat, sloping slightly downwards towards Gainsborough Road.

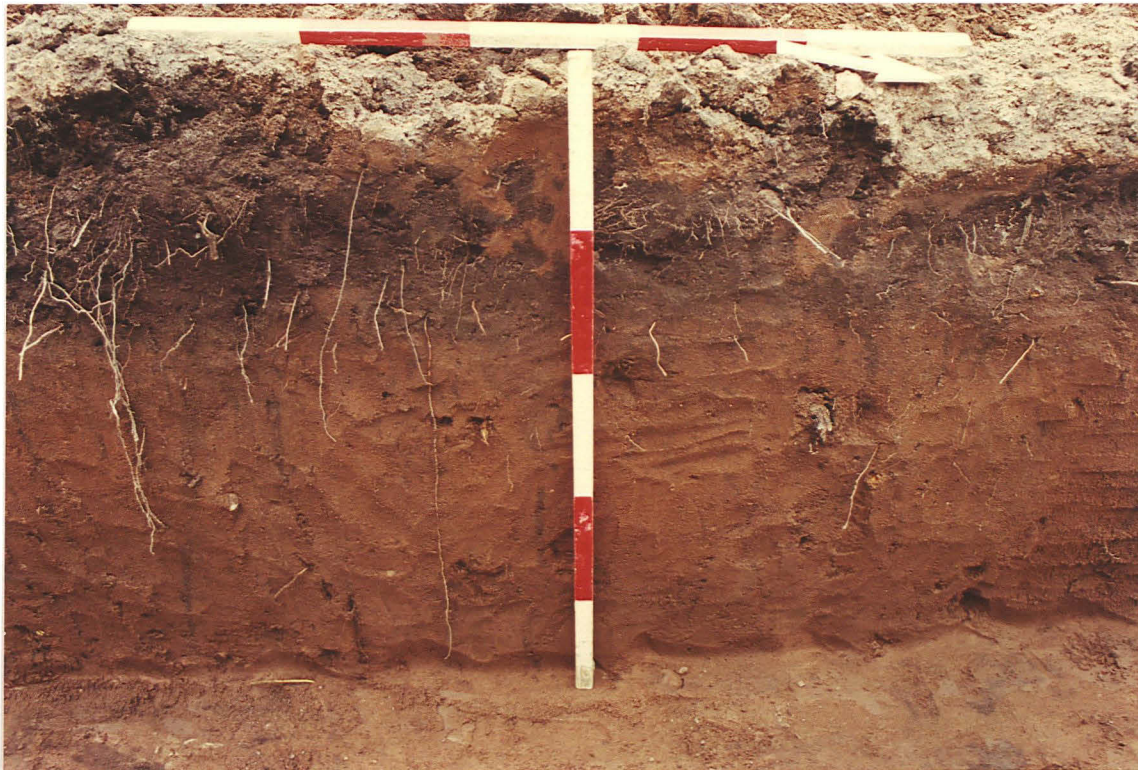
The topsoil (**100**) consisted of a grey/brown sandy silt, containing occasional sub rounded and sub angular stones and modern brick fragments. This varied between 0.08m and 0.20m in depth.

The removal of the topsoil revealed an orange/brown windblown sand (**101**), visible to the base of the foundation trenches. At a depth of 0.95m in one trench light orange sand was visible (**102**) (Pl. 2).

Pl. 2 East facing section of foundation trench, showing deposits 100, 101 and 102
