**The New Veterinary Hospital, Newport,
Lincoln**

Archaeological Watching Brief

Report No.: 423

Site Code: VET99
LCCM Accession No.: 292.99
Planning Application No.: 99/484/F
NGR: SK 9763 7273

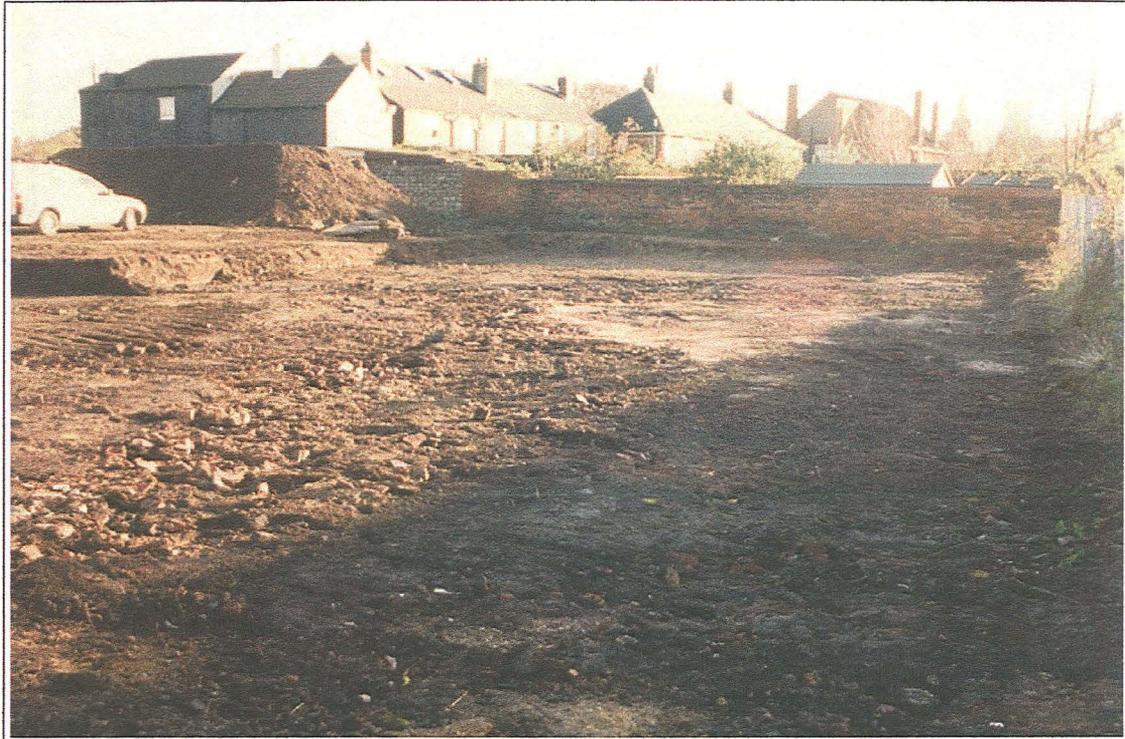
Plate 1 - Completed excavations within the footprint of the Veterinary Hospital (looking SSE)

Ground reduction within the footprint of the new Veterinary Hospital building was almost wholly contained within the depth of non-archaeological overburden and produced no evidence with regard to archaeologically significant deposits (see Fig.2 & Plate 1).

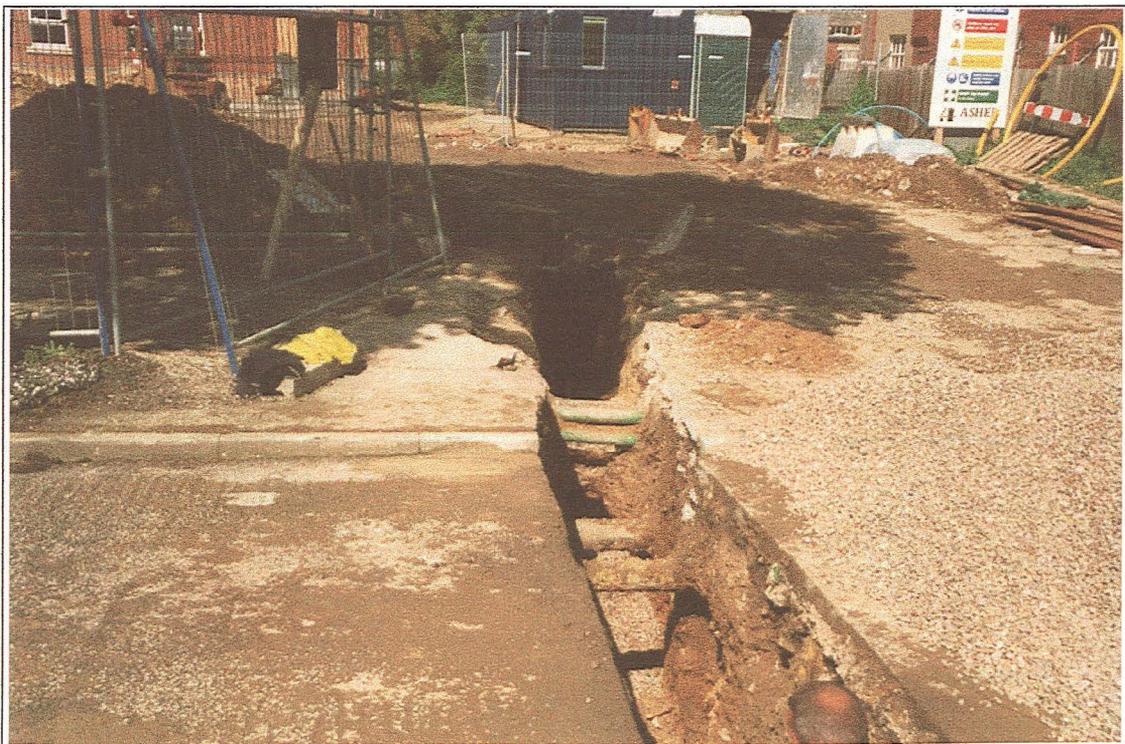
Plate 2 - Excavations in progress along Combined Services Trench into Newport (looking W)

Inspection of the combined services trench, at a point, immediately inside the eastern site boundary revealed a natural pale yellow-grey sand (003) at c.1.36m below the top of the concrete slab forming existing ground level. It was sealed by a natural brash (002), c.0.45m thick, comprising 50% flat limestone fragments to c.100mm in size and 50% loose reddish brown silty sand. The latest deposit (001), extending to just below the c.100mm thick concrete slab, was a loose to moderately compact, dark grey-brown silty sand containing frequent small limestone fragments.

Deposits within the remainder of the trench, extending west to the new Veterinary Hospital building, consisted of apparently recent accumulations of soil interspersed with much evidence of modern truncation for services. The extent of modern disturbance could account for an absence of evidence for burials associated with the church of St John the Baptist.

Any earlier stratigraphy in the combined services trench, running east from the site boundary to a point c.2.5m from its connection with the north-south mains towards the centre of the road, had been almost entirely removed by a series of north-south service trenches, running both under the pavement and along the kerb side of the road (see Fig.2, context 004). Less severely truncated stratigraphy was present in the trench further to the east up to the point of the connection (see Fig.2 & Plate 2). Here, a limestone brash (008) at c.0.75m below existing ground level formed the uppermost natural deposit. A c.0.35m dip to the west, forming a hollow or cut within the natural strata, contained a loose, dark grey silty sand with frequent limestone fragments (007) representing a possible archaeological layer or fill of indeterminate date. It was sealed by an undated c.150mm thick layer of loose to moderately compact, mid brown silty sand with frequent stone (006). The existing road surface and its cement and stone base (005) comprised the uppermost 600mm of stratigraphy visible in the trench side.
