ARCHAEOLOGICAL WATCHING BRIEF REPORT
USSELBY AREA WATER MAIN REPLACEMENT SCHEME

Site Code: UARS99
NGR: TF 0890 8935 (central ref.)
Acc. No.: 226.99

Report prepared for Anglian Water Services Ltd
by Colin Palmer-Brown

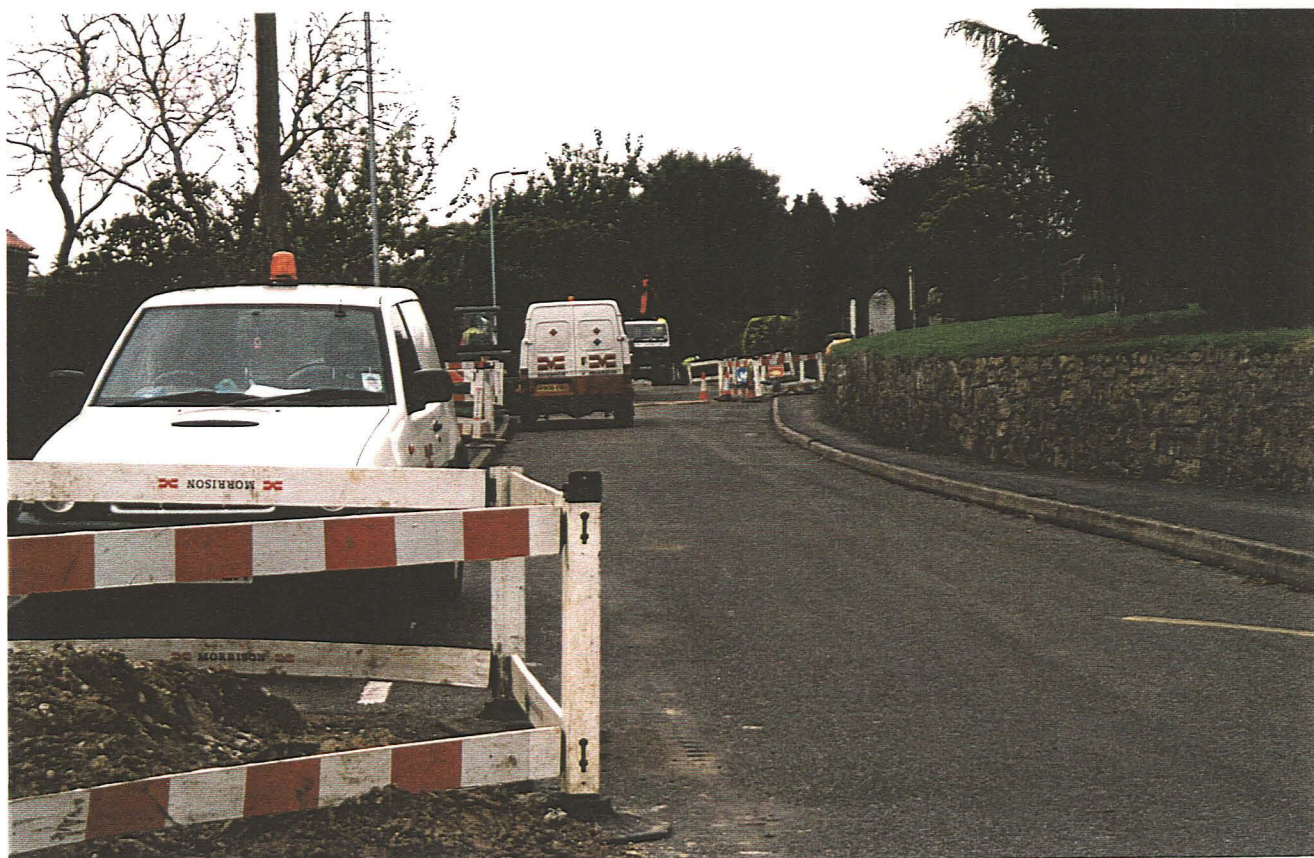
P1. Access pits on Church Street, looking west

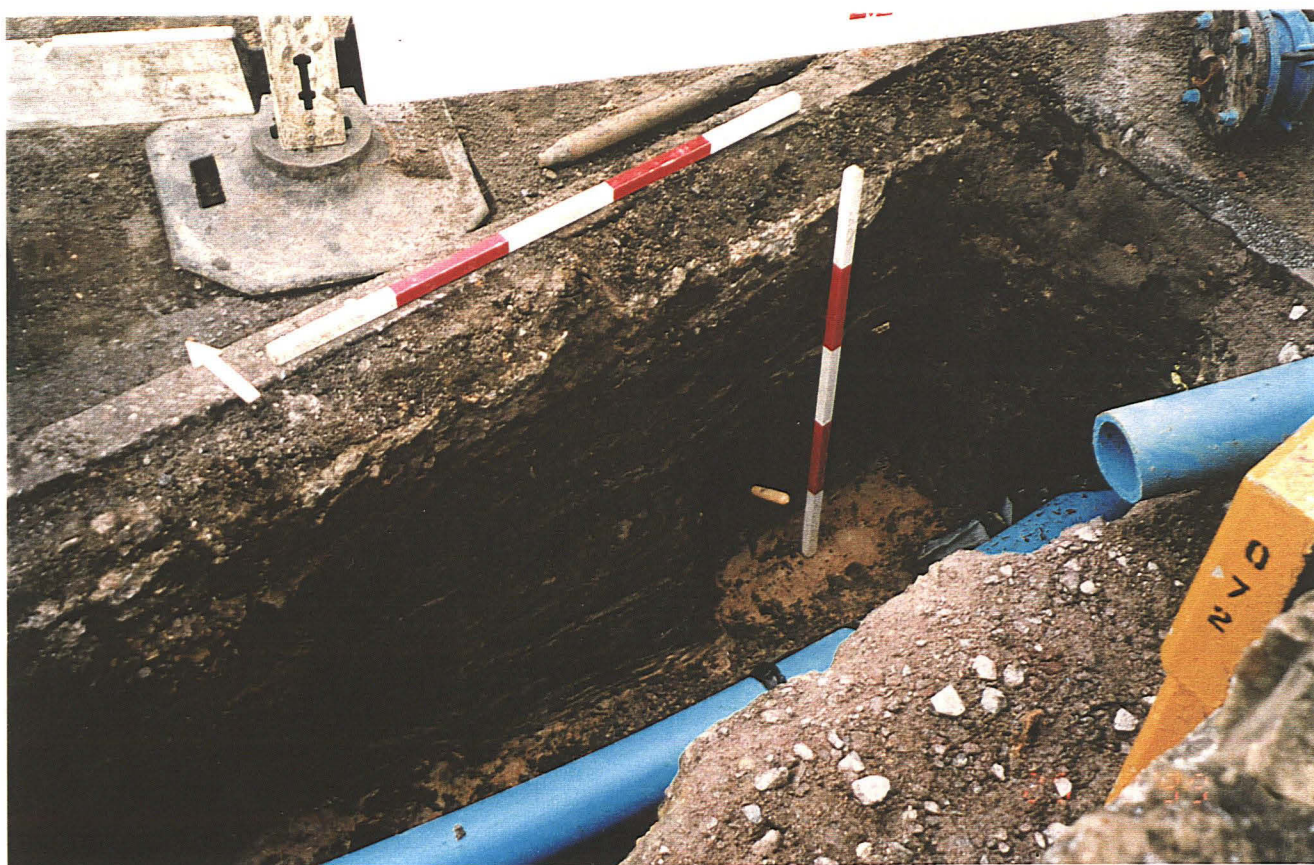
P2. Access pit in pavement on immediate south side of churchyard showing ?longitudinally sectioned ditch [001] (trowel in section = location of medieval pottery sherd)

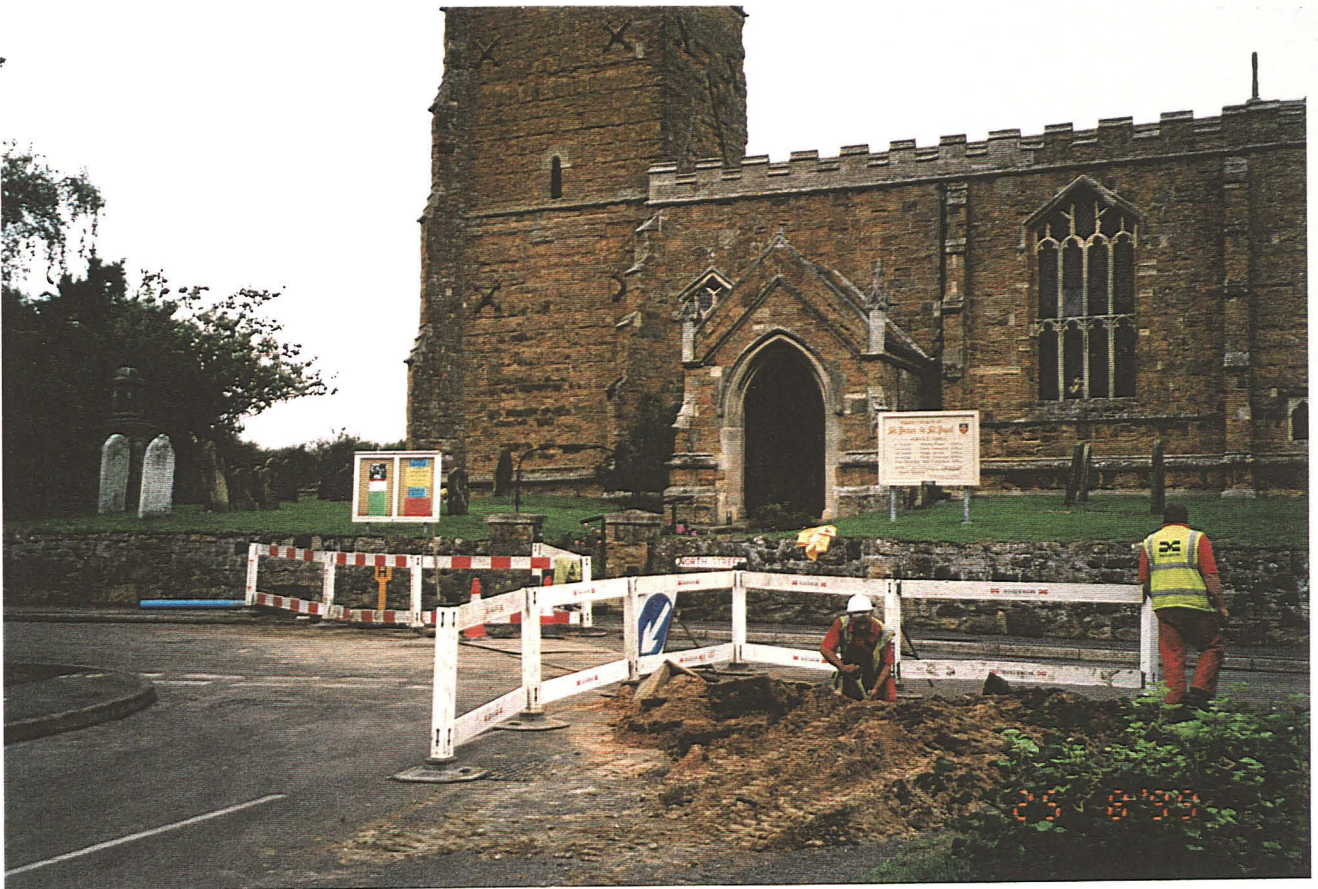
P3. Access pits to south of St Peter's Church, looking north from North Street

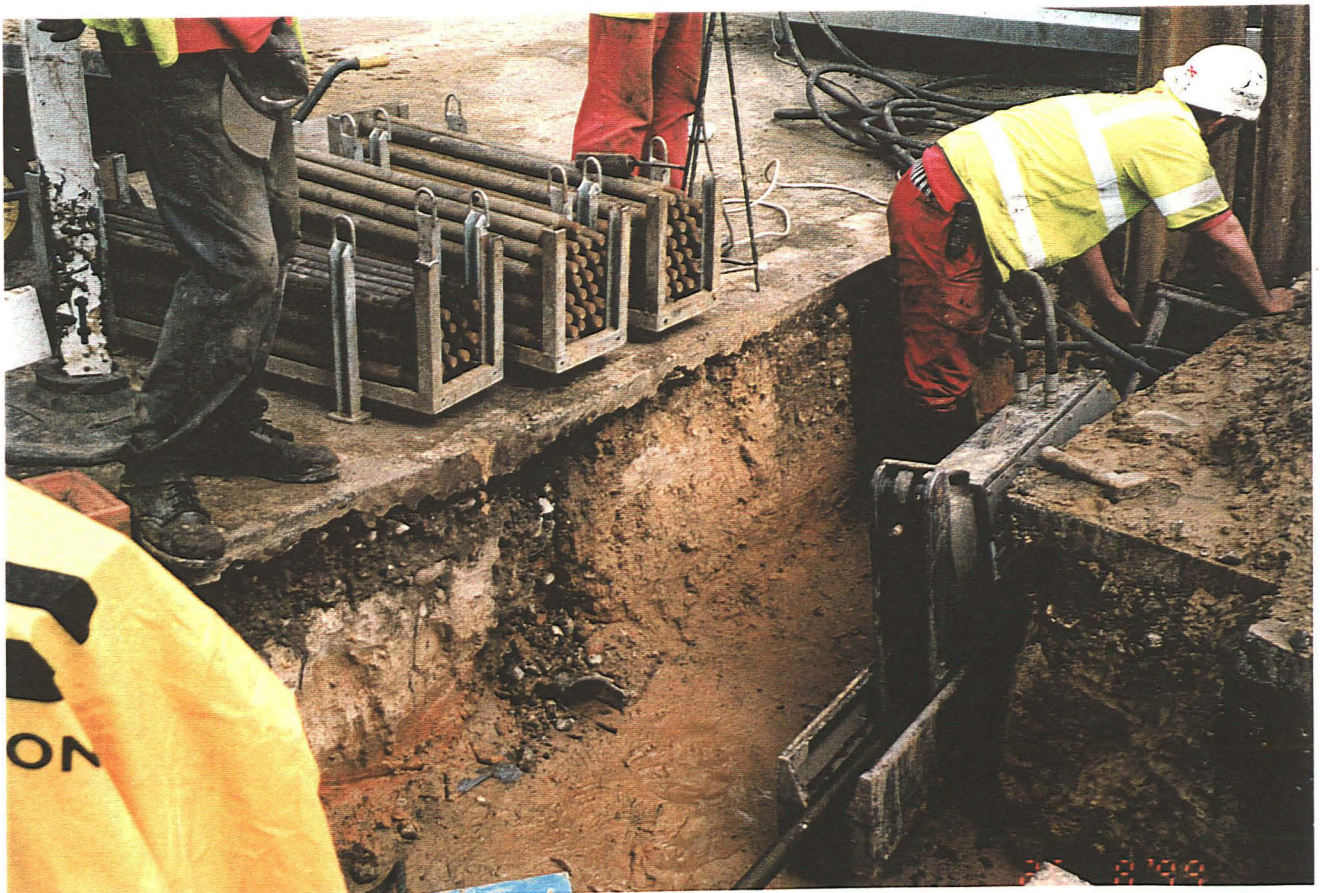
Pits 1 and 3 - 7 were archaeologically sterile, excluding layers of relatively recent origin: tarmac and associated foundation deposits. These road and/or path deposits overlay natural, relatively clean, soft sand, truncated only by recent drains and service trenches (eg see photo. 4). No artefacts were recovered from access pit upcast, excluding post-medieval brick fragments, tile and pottery sherds of very recent origin.

P4. Access trench at junction of North Street/Church Street
