**ARCHAEOLOGICAL WATCHING BRIEF  
REPORT  
BINBROOK ROAD, WELTON-LE-WOLD,  
LINCOLNSHIRE**

Site Code: WLW 00  
Acc. No: 2000.127  
NGR: TF 2748 8752

Report prepared for Mr and Mrs G.P. Ingamells  
by Jim Rylatt  
July 2000

Pre-Construct Archaeology (Lincoln)  
61 High Street  
Newton-on-Trent  
Lincolnshire  
LN1 2JP  
Telephone and fax 01777 228155

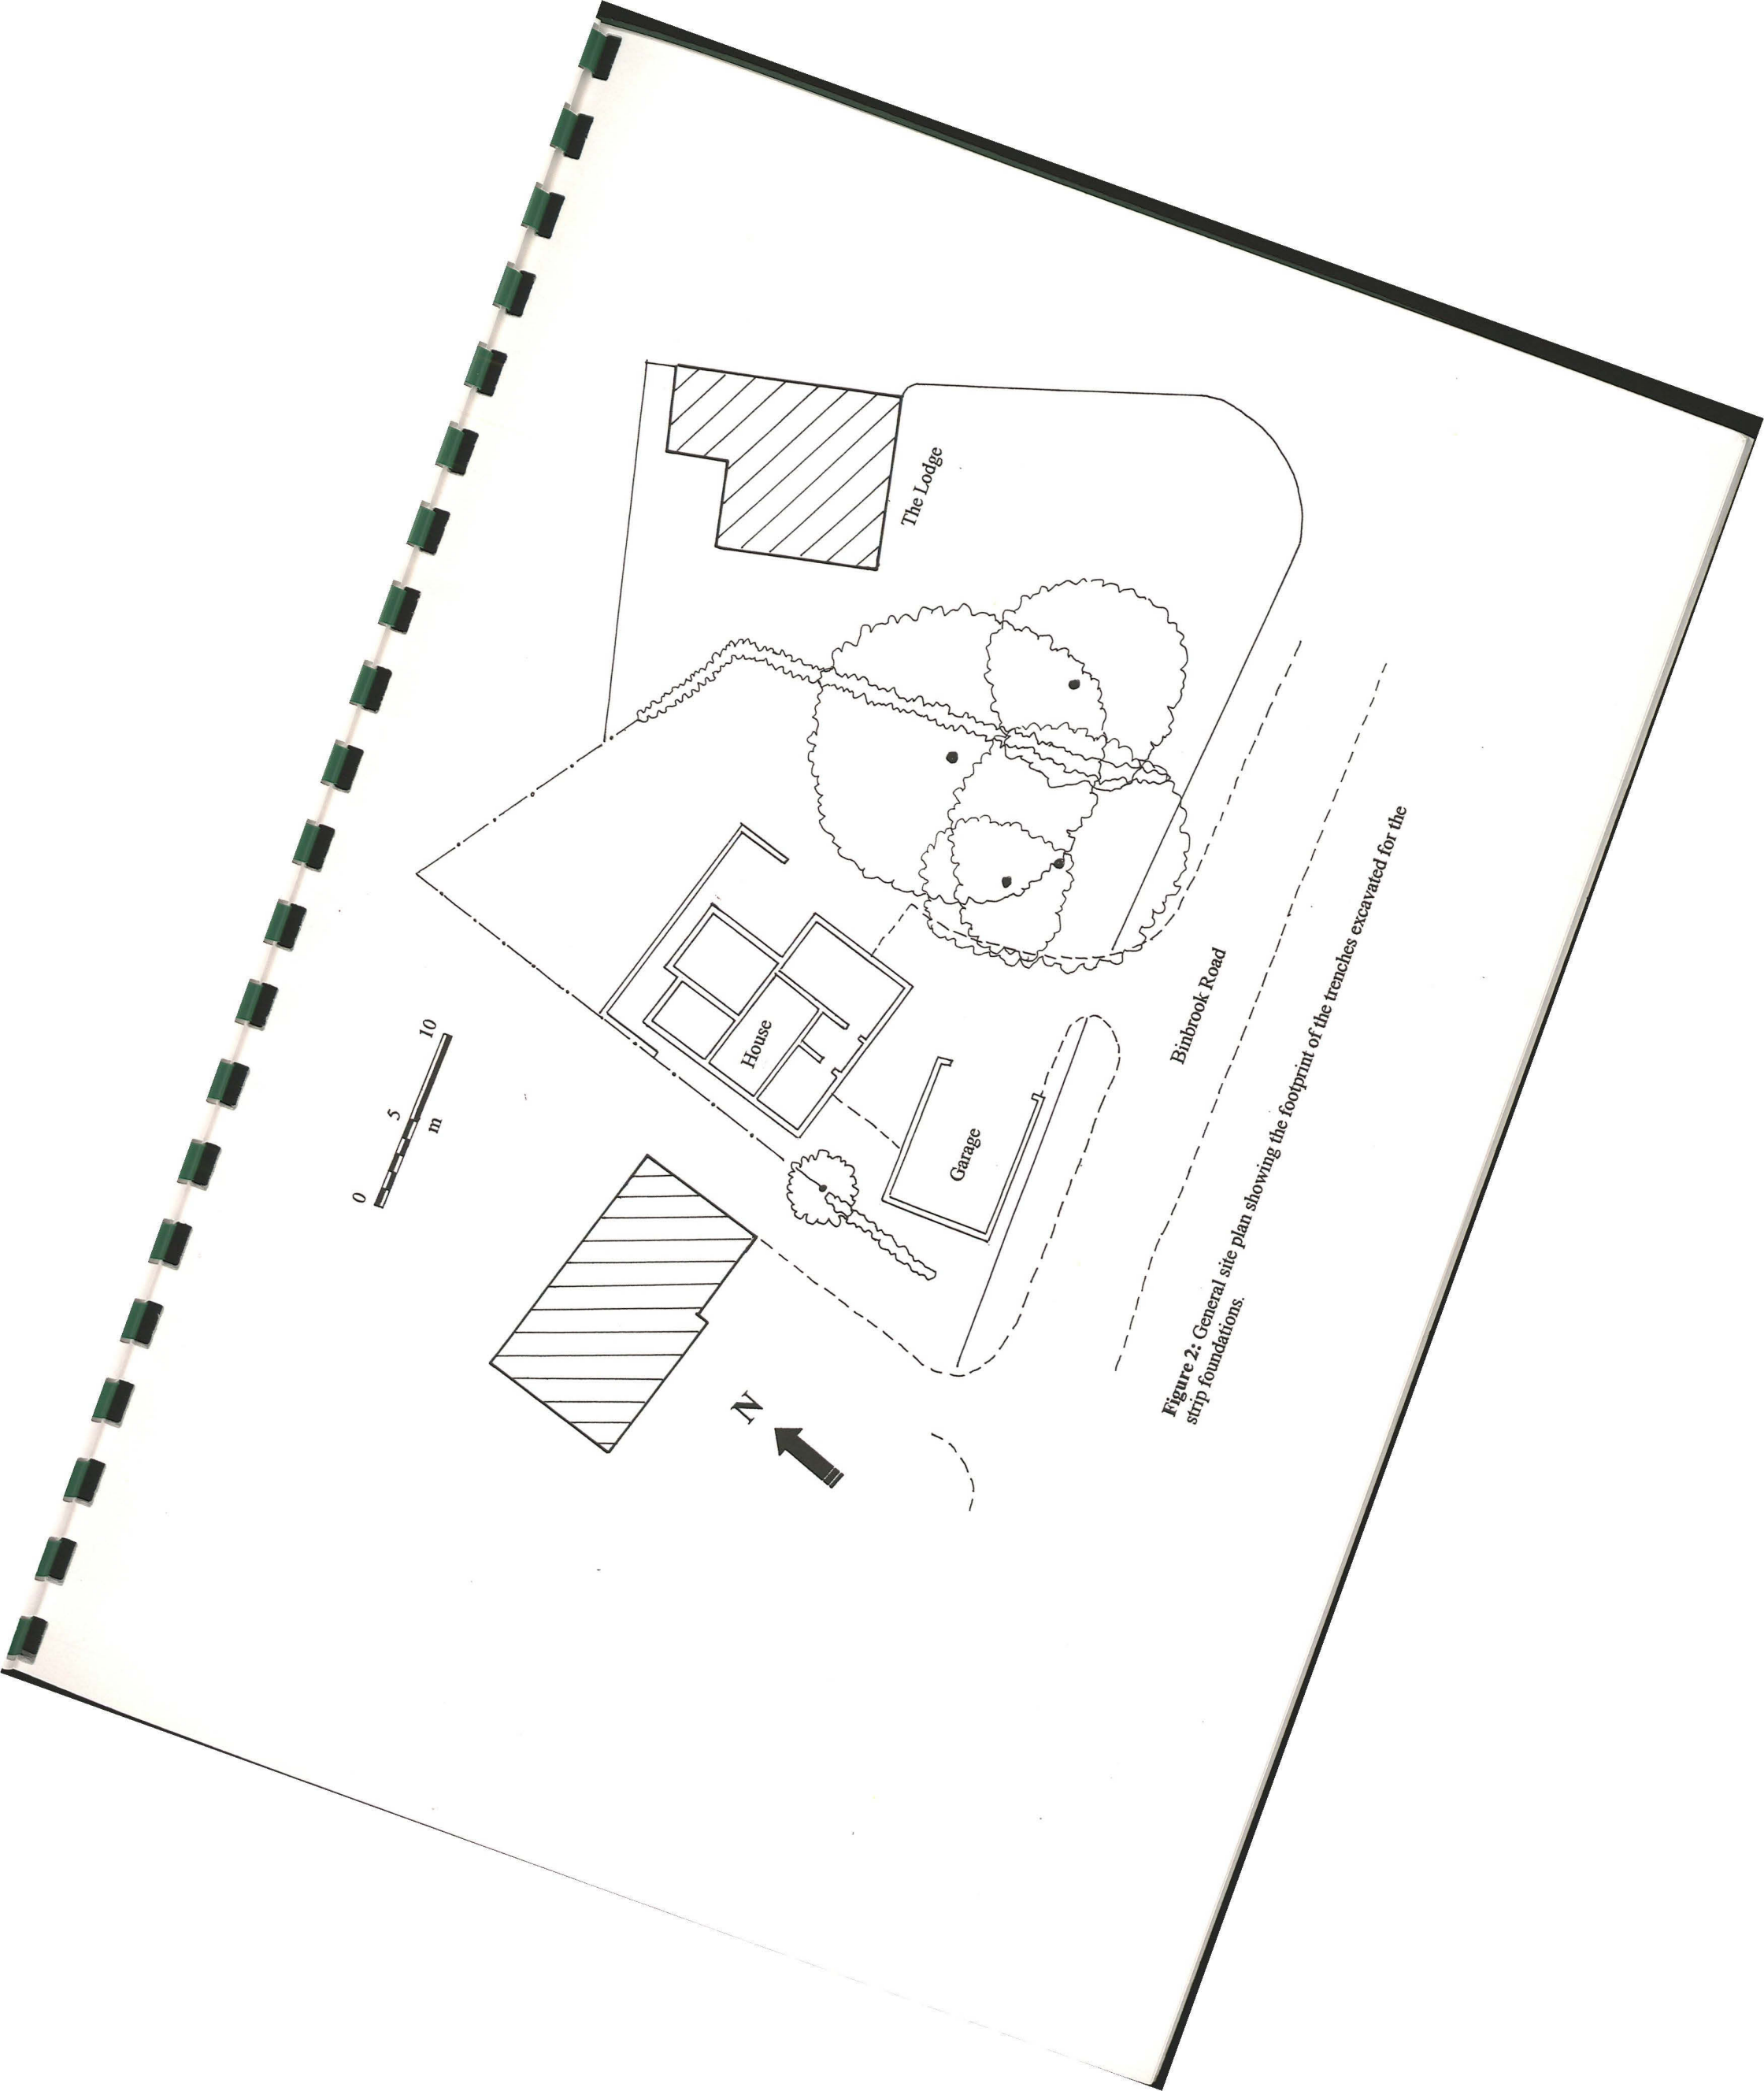
Figure 2: General site plan showing the footprint of the trenches excavated for the strip foundations.

A JCB using a back-actor equipped with a 0.75m wide toothed bucket removed the slope deposits to create the terrace. Subsequently it excavated the trenches for the strip foundations (fig. 2). The northern edge of the terrace extended c. 1.55m below ground level, this gradually tapering off to the existing ground surface at the front (southern) edge. The trenches for the strip foundations were generally c. 0.85m wide, extending c. 0.90m beneath the level of the terrace.

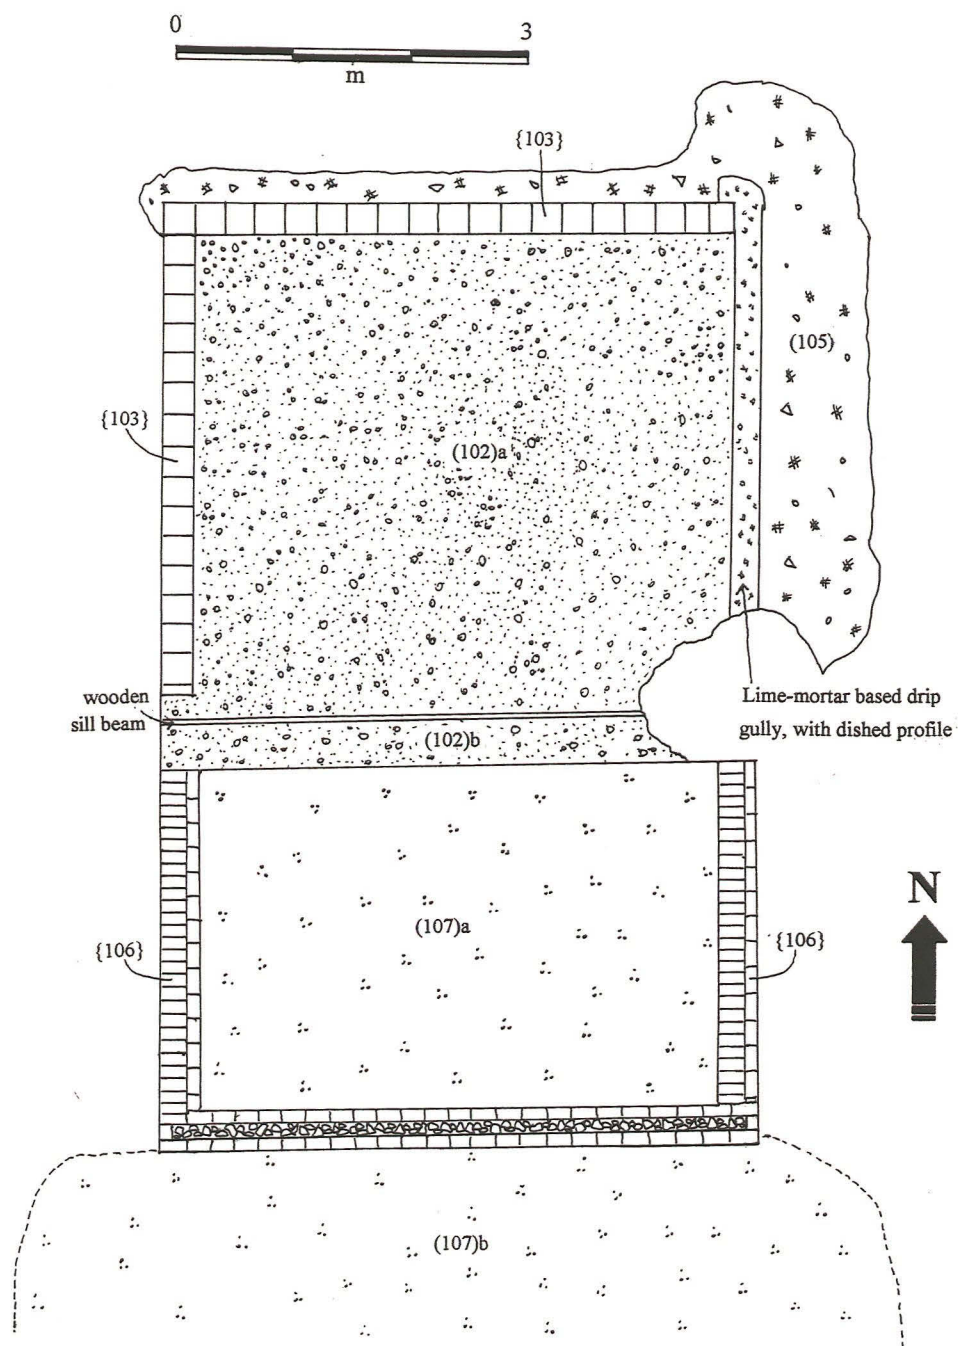
Figure 4: The remains of the Wesleyan chapel as exposed during the groundworks.

The following archaeological features were identified (fig. 4):

(102) A floor slab of grey concrete, which was composed of a hard, modern cement matrix binding sub-angular gravel. It could be divided into two distinct components. (102)a – was contained within the surviving remains of the chapel walls. It extended c. 4.60m east-west and c. 3.40m north-south. (102)b – situated immediately to the south of (102)a was a narrow strip of concrete measuring c. 4.80m east-west and c. 0.40m north-south. The decaying remains of a wooden sill-beam of c. 0.08m square-section separated these two components. This sill beam had been placed into a protective shroud of blue plastic prior to the pouring of the concrete; examination of this damp-proof membrane demonstrated that it was formed from a number of 'ICI fertiliser' sacks, indicating that floor slab (102) was constructed in the 1970s.

{103} The surviving elements of the chapel walls, consisting of an 'L'-shaped section of foundation in red brick; the northern wall was c. 4.60m long, while the western component extended c. 4.20m. Four courses of brick remained *in-situ*, the lower three courses being composed of a double skin of stretchers, each brick having dimensions c. 0.23 x 0.115 x 0.065m (fig. 5). The uppermost surviving course was more unusual, being entirely made up of slab-like 'double bricks', each being 0.23 x 0.23 x 0.07m. All of these bricks were unfrogged, relatively hard and well fired, and of fairly equal dimensions. However, it was also apparent that they were hand made, as most had slightly rolled edges and some showed signs of lipping over the edge of moulds. Lime mortar was utilised for all bonding.

(105) This was a very mixed deposit running along the outer edge of the northern wall, (103), and the eastern edge of the concrete slab, (102). Its position relative to the remains of the chapel suggested that it was the fill of a construction trench and this proposal was supported by the partial survival of the brickwork forming the northern wall (i.e. it had not been robbed). However, the nature of the coarse components within the silty clayey sand matrix challenges this premise. This material included a considerable quantity of coke clinker and ash, fragments of painted lime plaster and mortar, part of a toilet bowl, brick, pantile and wood fragments, and 19<sup>th</sup> and 20<sup>th</sup> century pottery. These objects are more redolent of a destruction deposit.

{106} A wall situated on the south side of the chapel enclosing a small yard. The eastern and western arms were 3.20m long and abutted the chapel at one end, being connected at the other end via a third length c. 5.10m long. The walls orientated north-south were c 0.35m wide and were formed by a series of headers laid in parallel with a row of stretchers. The longer southern wall was constructed differently, the outer faces being formed by parallel rows of stretchers enclosing a rubble core. The surviving sections of wall were quite roughly built and some of the bricks appeared to be seconds, as they were poorly fired and had degraded to a compact, oxidised clay. A yellowish lime mortar bonded all elements.

(107) A loose, degraded tarmac surface, now largely composed of disaggregated grits. It could be divided into two distinct components. (107)a – was the surface of the yard contained by walls {106}, and covering c. 2.90m north-south by 4.50m east-west. (107)b – lay to the south of this yard, extending c. 11.0m north-south and 8.40m east-west. Close examination demonstrated that this surface had been replaced on one

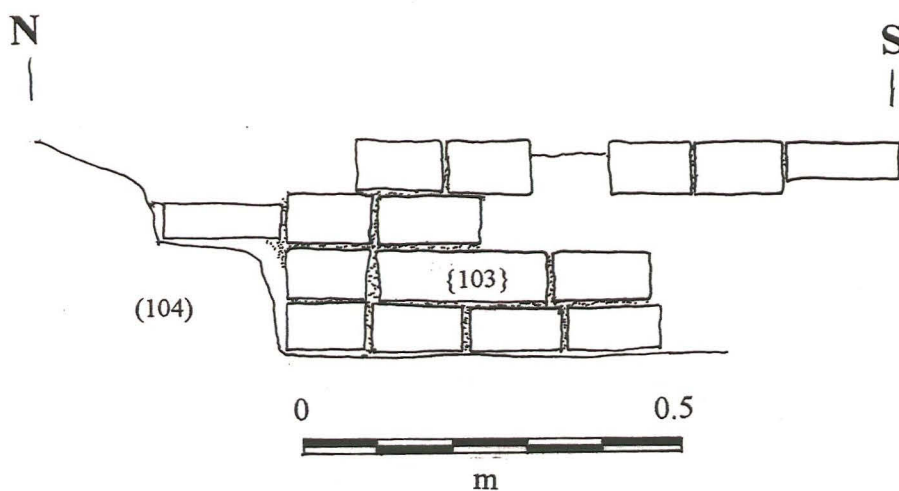
Figure 5: Detail of the north-west corner of the chapel. Mortar is shown stippled.

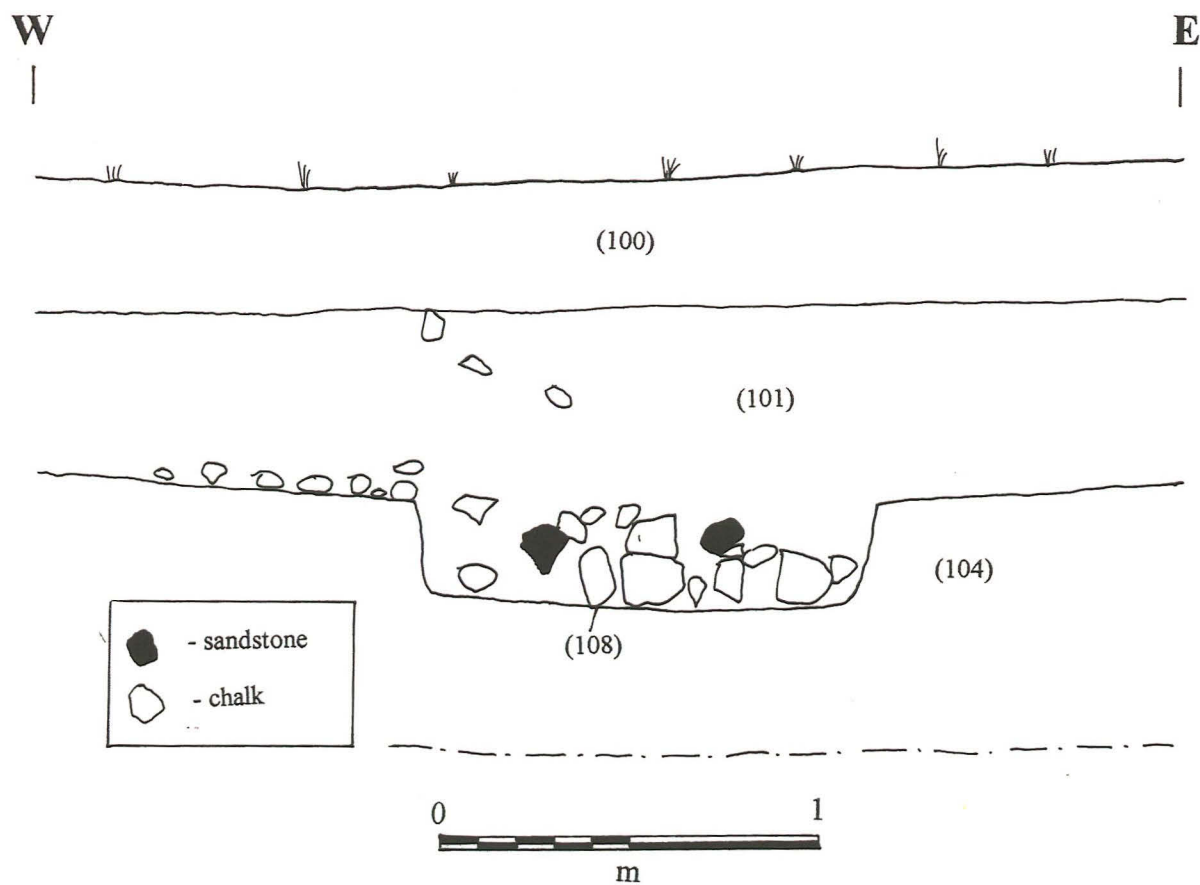
Figure 6: South-facing section showing wall {108} at the northern edge of the terrace excavated for the development.

{108} This feature represented the remains of a wall running northwards from the north-east corner of the chapel. Its destination was never established as it continued beyond the area that was subject to terracing (fig. 6). The components of {108} contrasted with the other walls found on the site, as they consisted of unmortared chalk and sandstone rubble, situated within a matrix of subsoil, (101). However, this material only survived to a depth of c. 0.25m, which, combined with a width of c. 1.20m, raises the possibility that it was only a hardcore footing for a more substantial brick or stone wall; there were no loose fragments of brick or mortar within or above {108}, which implies that any superstructure was of drystone construction.

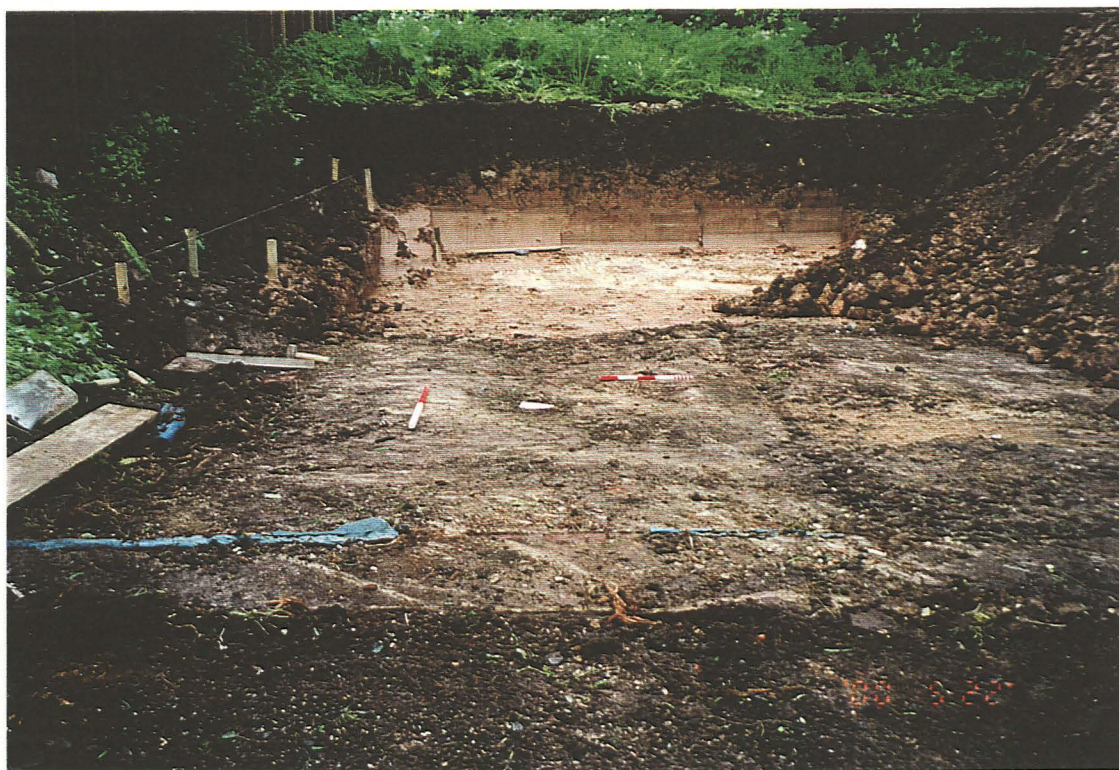
**Plate 2:** Concrete floor slab (102), with wooden sill beam in blue plastic fertiliser sacks in foreground. Note that pinky brown natural (104) is exposed immediately behind chapel, indicating that it was also terraced into the hillside, looking north.

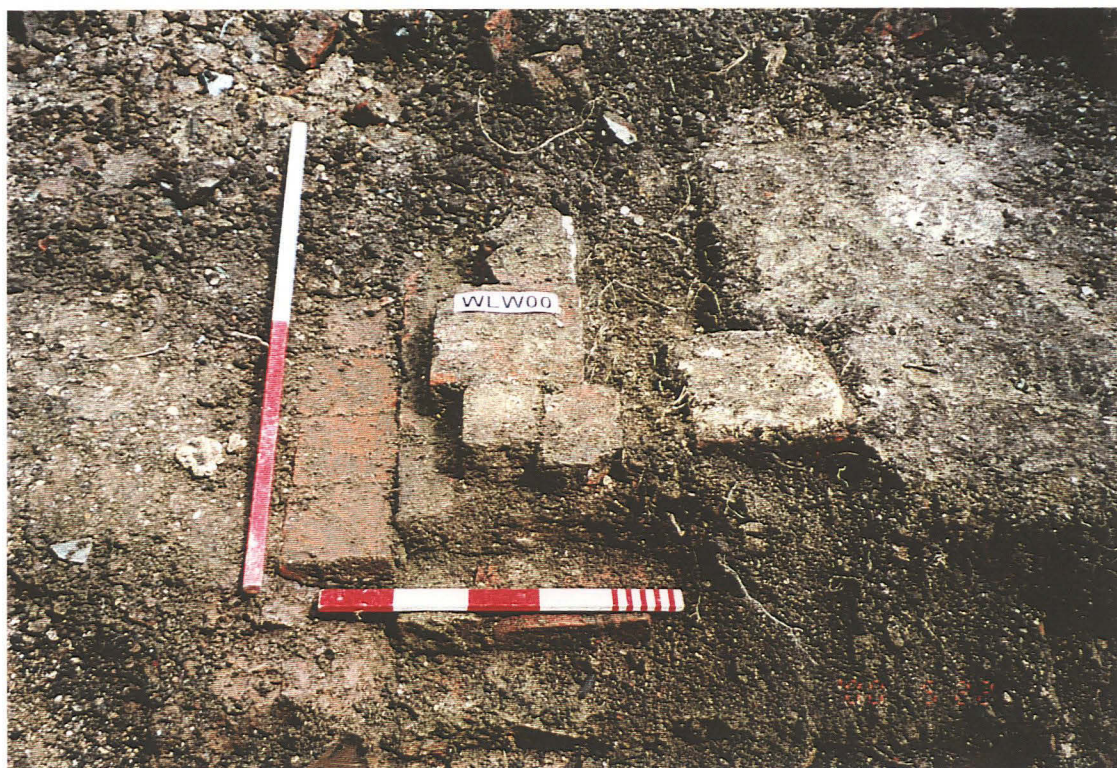
**Plate 3:** The north-west corner of chapel foundation {103}, looking east.

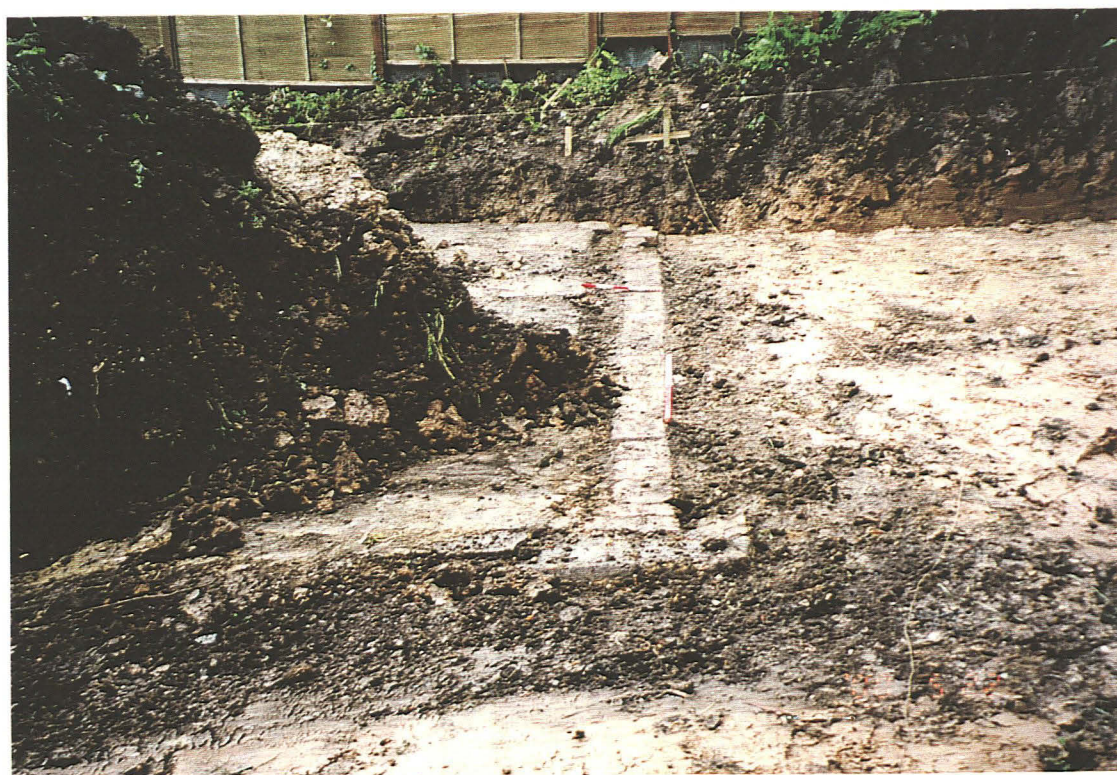
**Plate 4:** Northern wall of chapel, with dark demolition deposit (105) in the foreground. Note also the northern corner of the concrete drip gully that appears to define the eastern end of the chapel, looking west.
