**99 Nettleham Road,
Lincoln**

Archaeological Watching Brief

**LAS Report No. 454
August 2000**

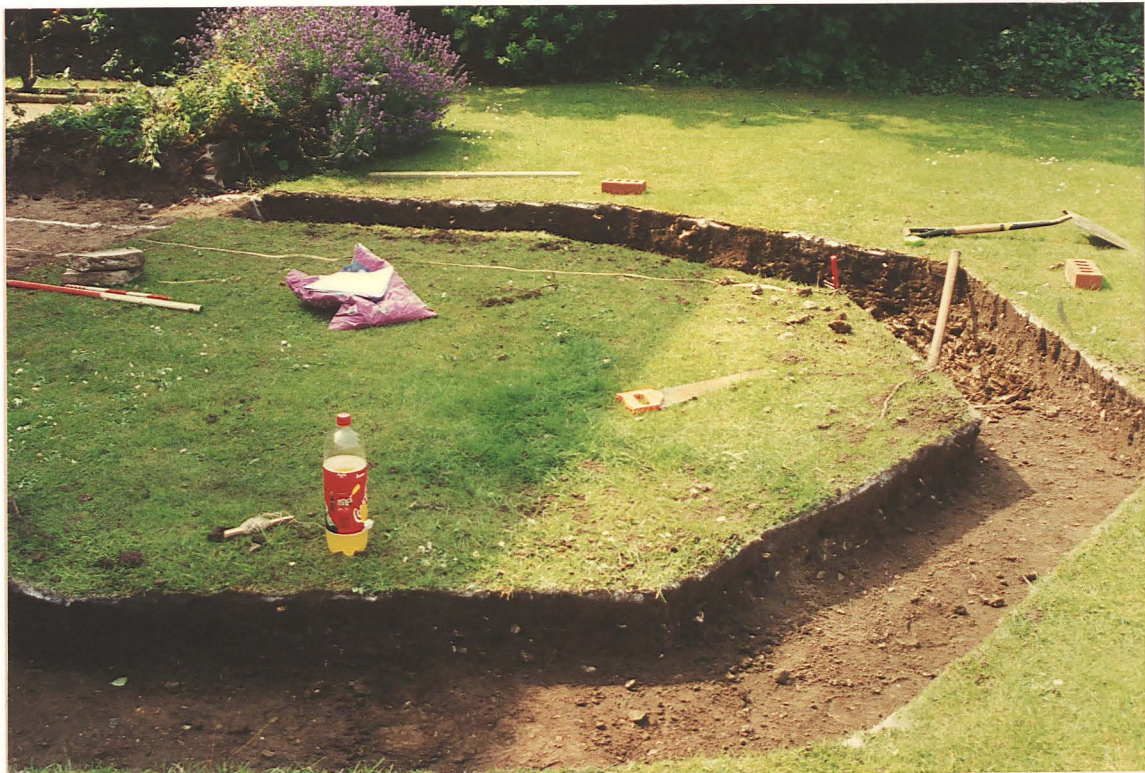
Pl. 2 Partially excavated foundation trenches for the conservatory, looking south

The foundation trenches were dug by hand under archaeological supervision to a depth of 0.70m (Pl. 2).

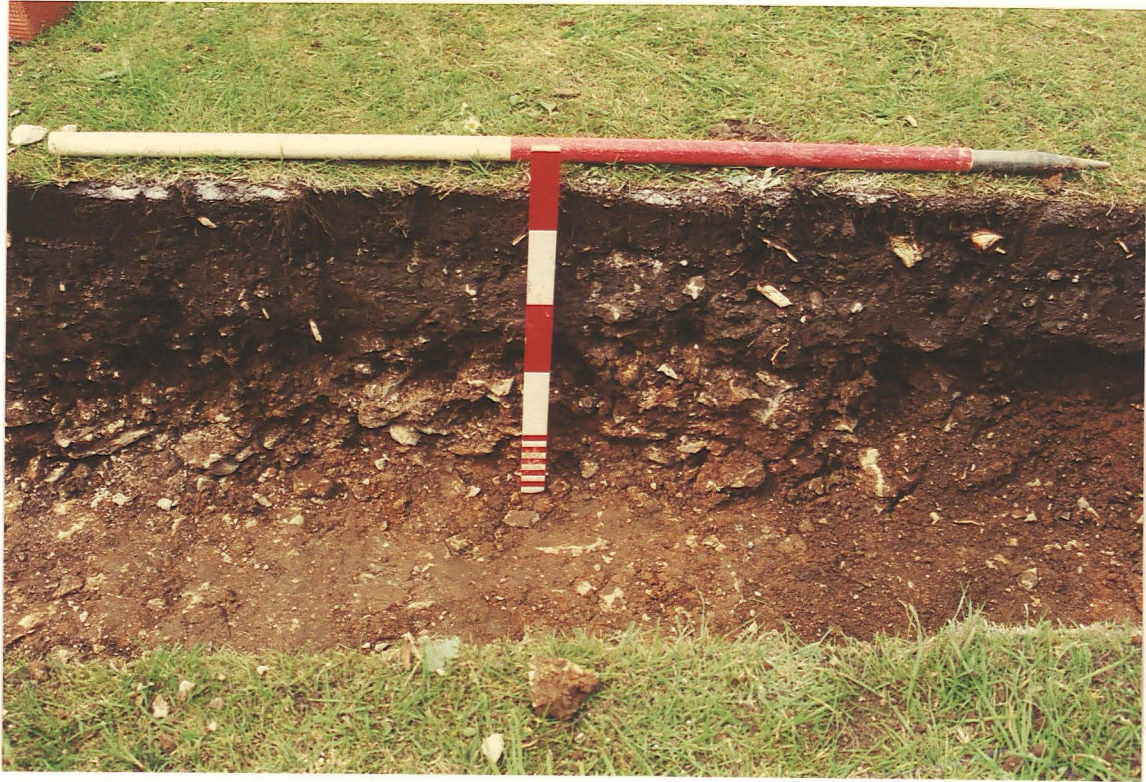
The topsoil consisted of a grey-brown silty loam containing frequent limestone fragments and a small quantity of post-medieval pottery and tile (100). This measured approximately 0.30m in depth and its removal revealed limestone brash (101), which was visible to the base of the foundation trenches (Pl. 3). No archaeological features were located within the trenches.

Pl. 3 Section through excavated foundation trench, looking west (0.50m vertical scale and 1m horizontal scale)
