**Whitehouse Farm, Delph Road,
Branston Booths, Lincolnshire**

Archaeological Watching Brief

**Report for
Mr P. Gregory**

**LAS Report No. 453
August 2000**

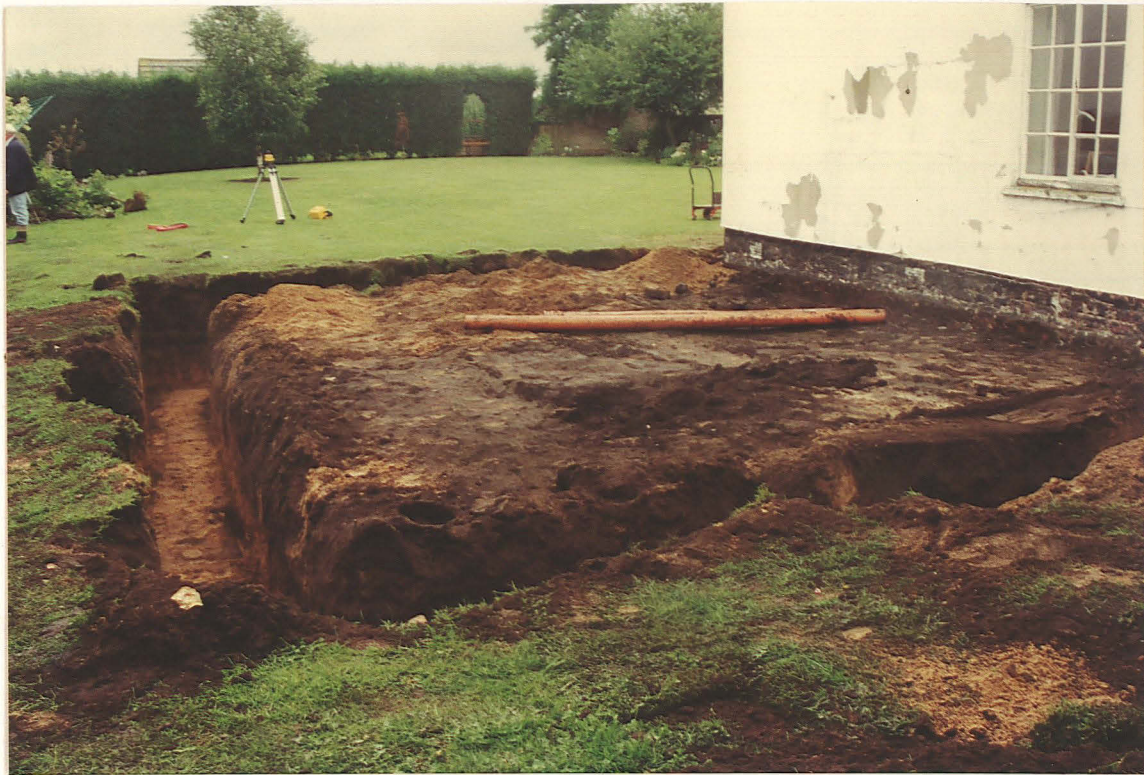
Pl. 1 Foundation trenches for the two-storey extension adjacent to the existing farmhouse, looking south

Branston Booths lies on the fen edge 7km east of Lincoln. Whitehouse Farm is located on the corner of Bardney Road and Delph Road (Fig. 1). The existing building is being extended onto the lawn at the east (Pl. 1), and onto the patio at the front of the building (Pl. 2; Fig. 2).

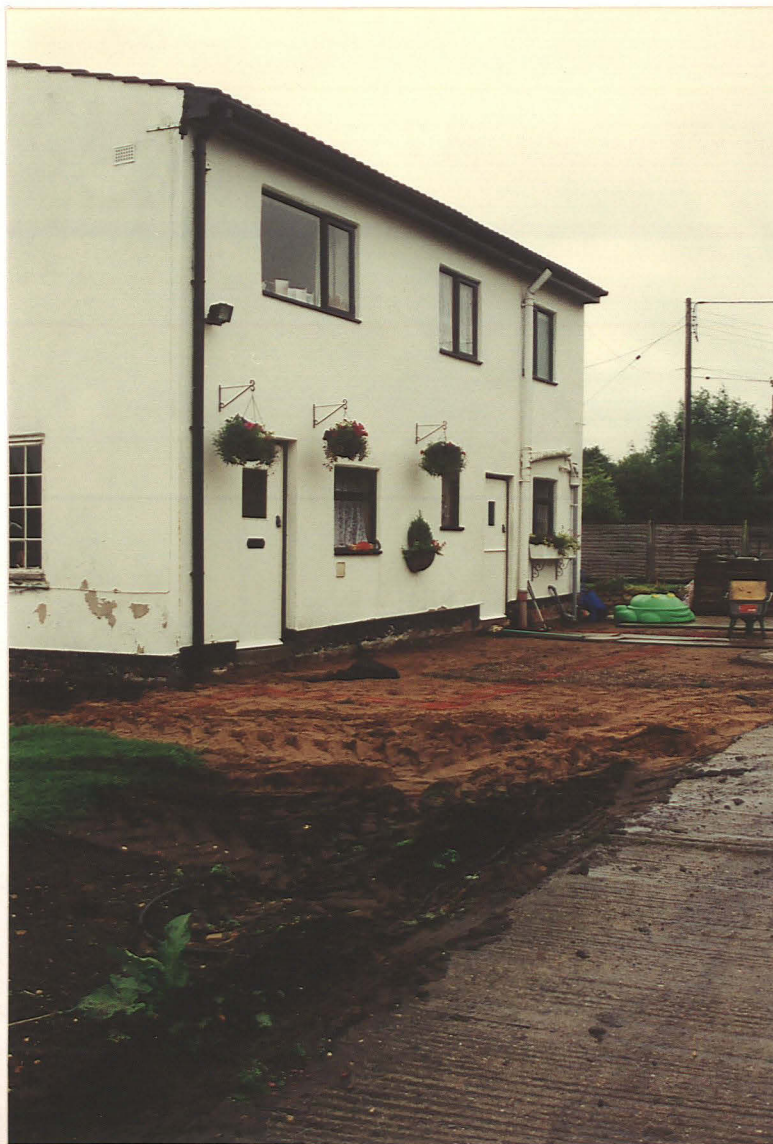
Pl. 2 Location of the one-storey porch extension in front of the farmhouse, looking south

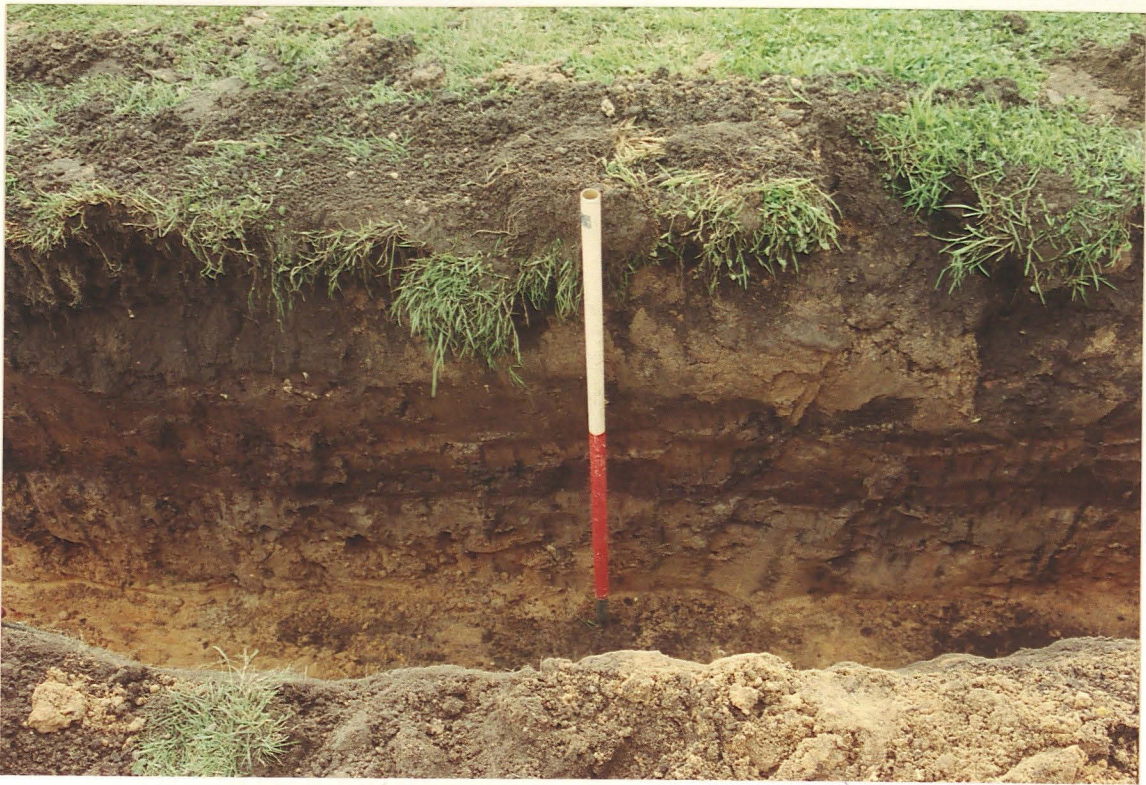
At the side of the house, the removal of the turf revealed a dark grey/black silty loam topsoil (**100**) containing fragments of broken brick and tiles, presumably from one of the other farm buildings. Immediately below this, a subsoil of grey/brown sandy silt (**101**) approximately 0.25m was revealed. This was visible in the trenches both next to and in front of the existing building. A possible buried soil (**102**) measuring 0.10 to 0.15m in depth was visible below this. This was a dark grey/brown sandy silt, no artefacts were recovered from this layer, so its date remains unknown. Layer **102** overlay a mixed light grey/brown sandy deposit measuring 0.15 to 0.20m in depth. Immediately below this lay the natural orange sand (**104**) (Pl. 3).

Pl. 3 Section through the deposits, with 1m scale

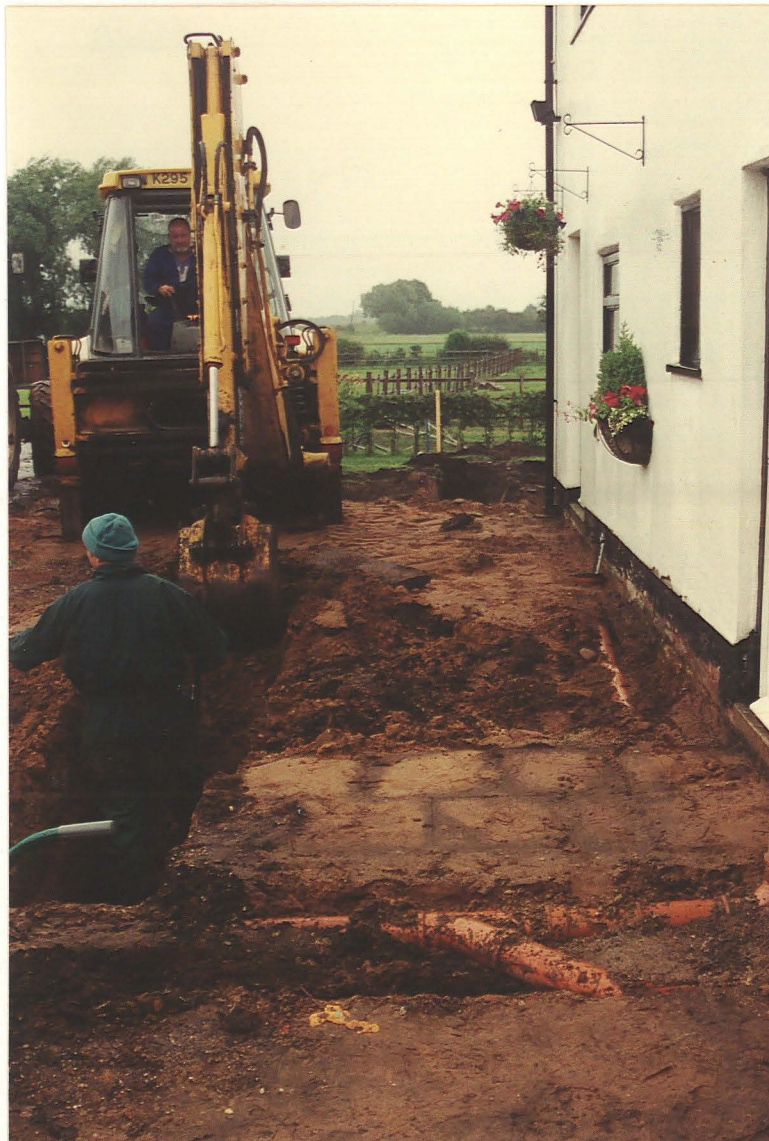
In front of the house a modern make-up layer was recorded, varying between 0.20m and 0.40m in depth. This was a combination of grey/black silty loam with a large percentage of gravel, brick and stone fragments (**106**). Above this was a layer of builders' sand used as bedding for the patio. The most westerly trench in front of the house had been dug previously for the insertion of a waste pipe (Pl. 4).

Pl. 4 Disturbed ground and waste pipe in the foundation trenches in front of the existing farmhouse
