**LAND OFF POST OFFICE LANE, SPILSBY:
ARCHAEOLOGICAL WATCHING BRIEF REPORT**

Site Code: PLSOO
NGR: TF 4005 6616
Acc. No.: 2000.130

Report prepared for Mr P Presswell
by Andrew Hardwick

September 2000

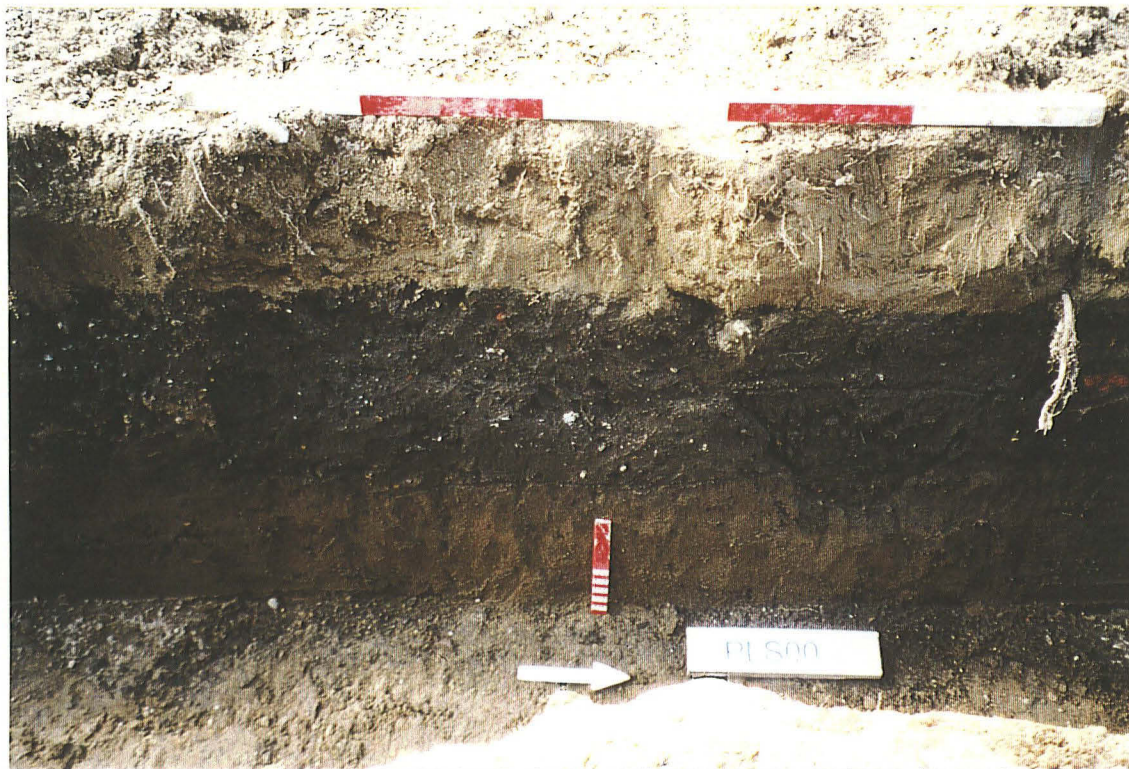
P3. Post hole 02 and ground raising dumps in section, looking west

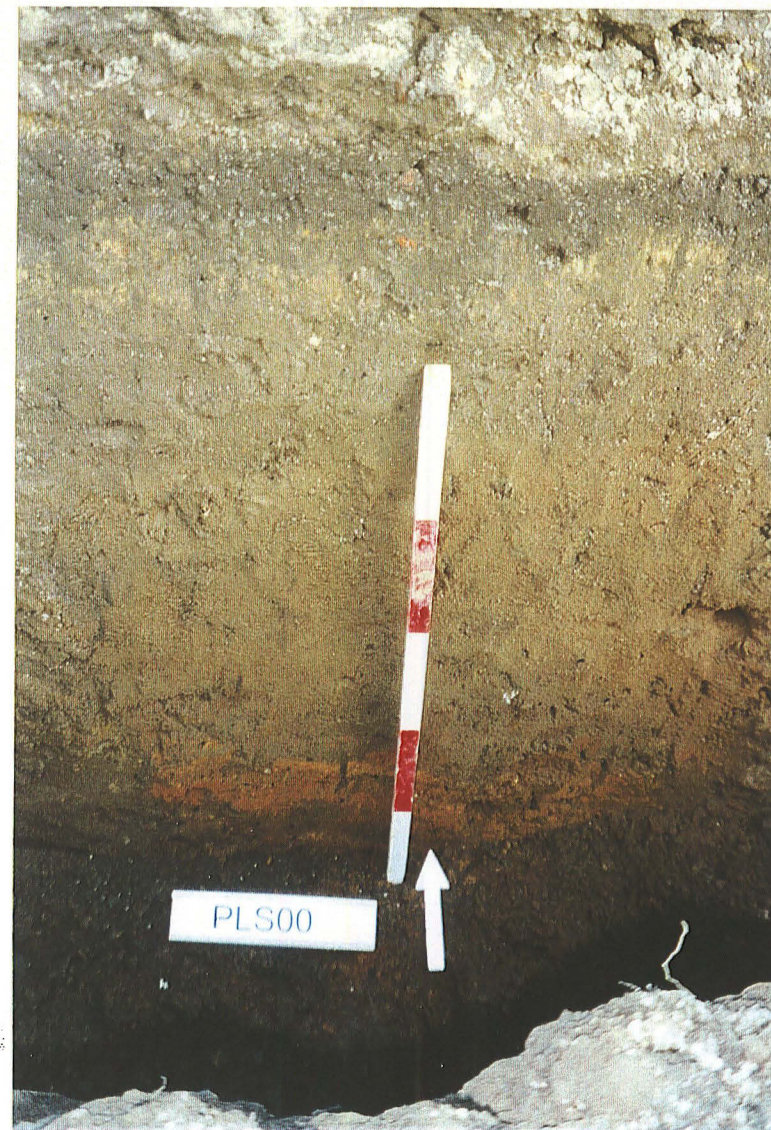
P4. ?Industrial residue within pit 01, looking north
