# **Birch Court, Freiston Road, Boston**

# **Archaeological Watching Brief**

LAS Report No. 468

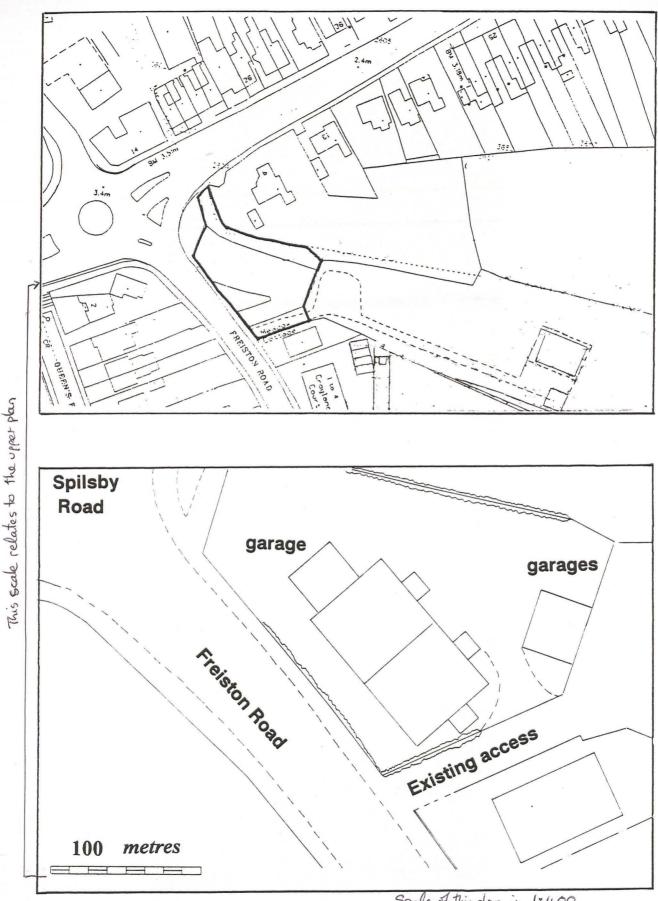
Fig. 2 The monitored development site (based on reduced scale copies of plans supplied by the client, MLG dwg no. 14052.04). Inset a © Crown Copyright, reproduced with permission of the Controller of HMSO. LAS Licence No. AL 50424A).

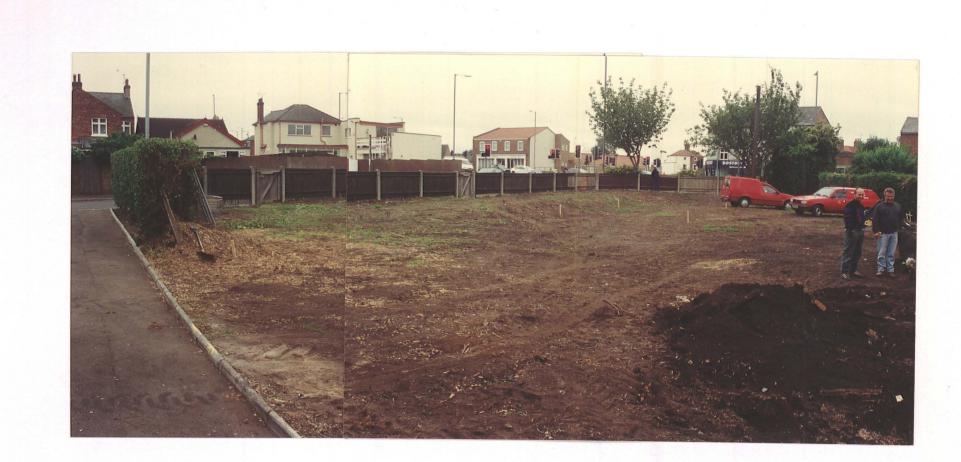
PI. 1 The development site, with pegs marking the position of the flats. Looking west, with Freiston Road (top left).

The development site lies to the NE of Freiston Road, close to the junction with Spilsby Road, approximately 150m away from the centre of Boston (Figs. 1 and 2). Prior to the development the site was disused and overgrown with several large trees and bushes. A low, flat-topped bank was within the site, alongside the Freiston Road boundary (Pl. 1).

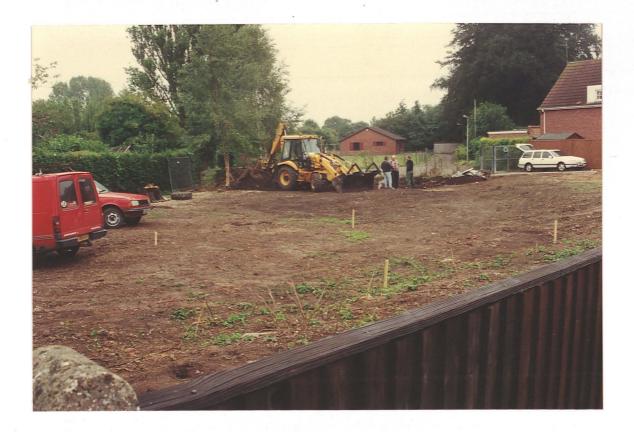
- PI. 2 Location of the new garage, with the former meadow land beyond (looking NE).
- Pl. 3 Twentieth century brick foundations exposed in the garage footing trench, above dark brown topsoil (looking north).

To the NE of the site is an open drainage ditch, aligned west-east beside low-lying meadow (Pl. 2).

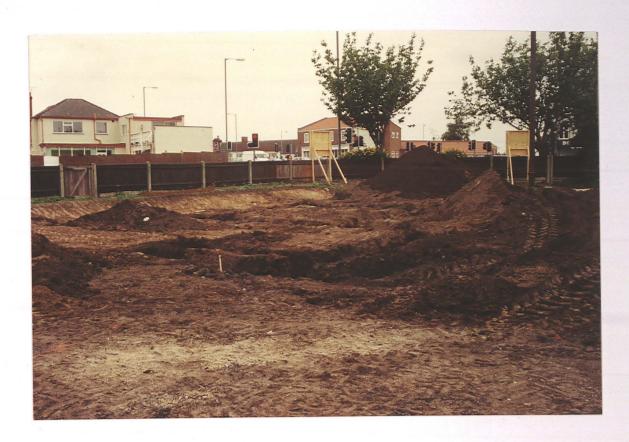
PI. 4 Excavation of footings for the new flats (looking west).

The foundation trenches for the block of flats were machine-excavated using a 0.6m wide, toothed bucket to depths of 0.9m (in the SW) and 1.3m (in the NE) below the existing ground level (PI. 4). The site was covered by a layer of dark grey/brown sandy silt topsoil **100**, containing brick rubble. This varied in depth across the site between 0.1m and 0.3m. The low bank beside Freiston Road proved to be of very recent construction, and appeared to be from road realignment and associated landscaping for the Spilsby Road junction to the NW.

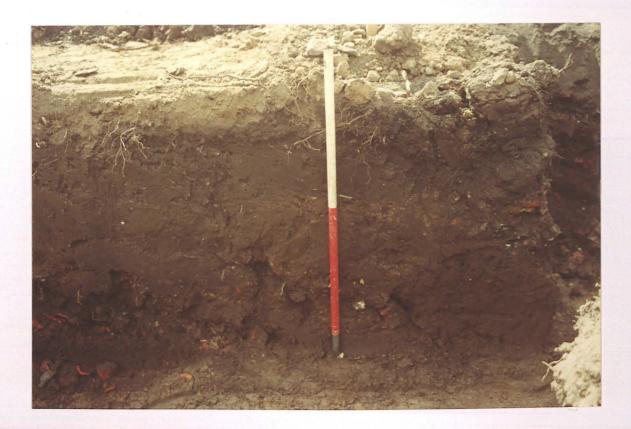
PI. 5 Trench excavated through topsoil 100, and levelling deposits 101 and 102 (with brick rubble). Below is silt layer 103. Scale divisions 0.5m.

Removal of the topsoil **100** revealed layer **101** at the SW of the site, and layer **102** in the NE. Layer **101** seemed to be buried late post-medieval topsoil, incorporating brick rubble (PI. 5). A large metal sheet was visible in one section, and occasional charcoal flecks were evident. This deposit measured between 0.3m and 0.4m in depth.

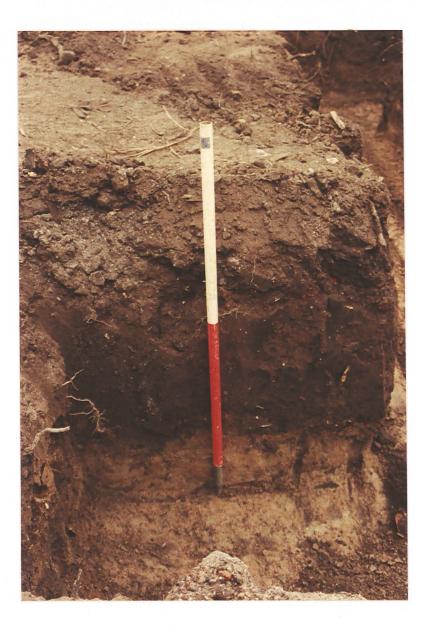
PI. 6 Silt layer 103 at base of trench, below post-medieval levelling deposits (scale divisions 0.5m).

Below this lay a light grey silt with frequent iron panning **103**, thought to be an alluvial flood deposit (PI. 6). Four small sherds of pottery, dating to the late medieval to early post-medieval period were recovered from within this silt (Appendix 2). The depth at which this silt occurs varies across the site, indicating that the land formerly dipped towards the SW.
