**Development at Church Lane,  
Mareham-le-Fen, Lincolnshire**

**Archaeological Watching Brief**

Report No.: 419

Site Code: MCL99  
LCCM Accession No.: 143.99  
Planning Application No.: S/114/2004/98  
NGR: TF 2777/6121

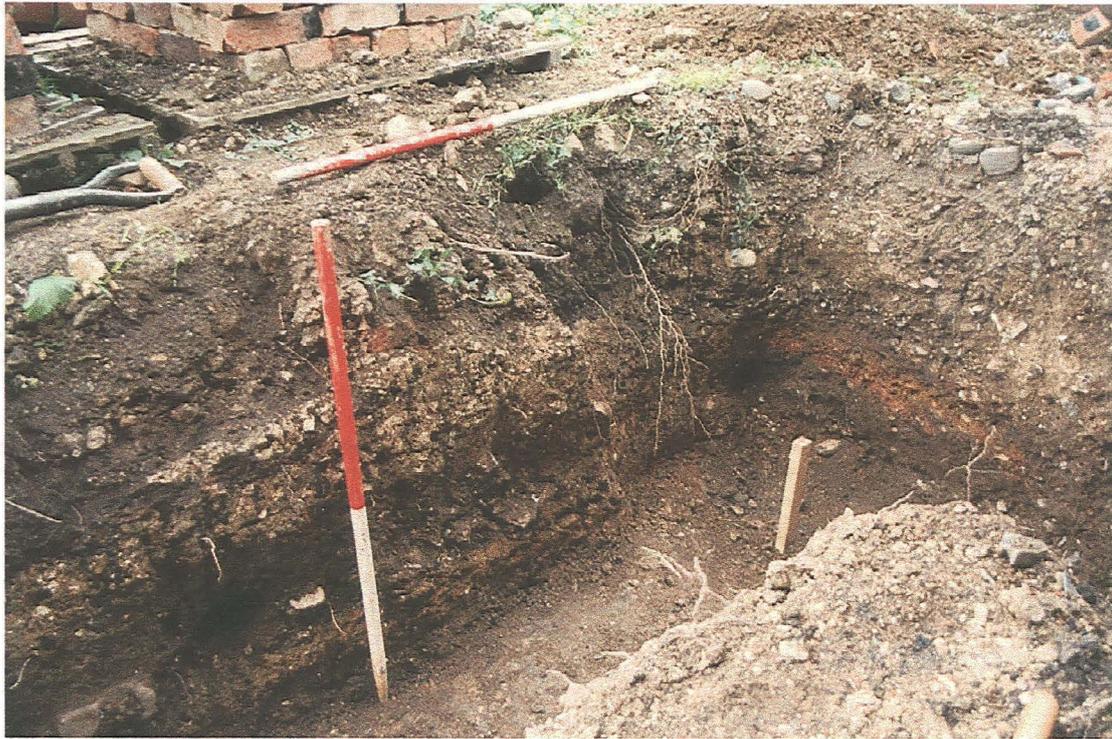
*Plate 1: General view of possible occupation deposits, Trench 1 - looking north-west*

All of these deposits and features possibly represent the remains of floor layers, or other occupation deposits, dating to between the 13<sup>th</sup> and 15<sup>th</sup> centuries.

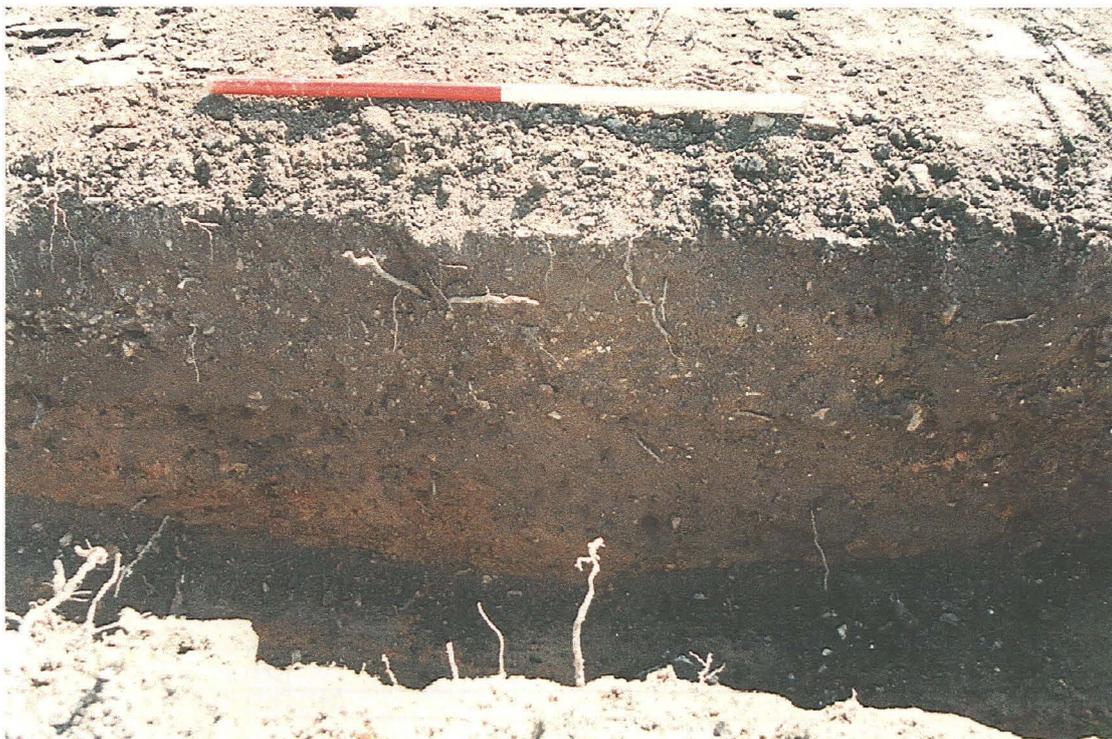
*Plate 2: Overall view of (indistinct) cut features [150] & [155], Trench 4 - looking south*

[155] appeared at the north-west corner of the foundation network, and comprised a 600mm deep cut with multiple fill deposits. The feature was only visible in the north-facing section, and its east-west extent could not be fully determined owing to truncation by a further cut feature to the west.

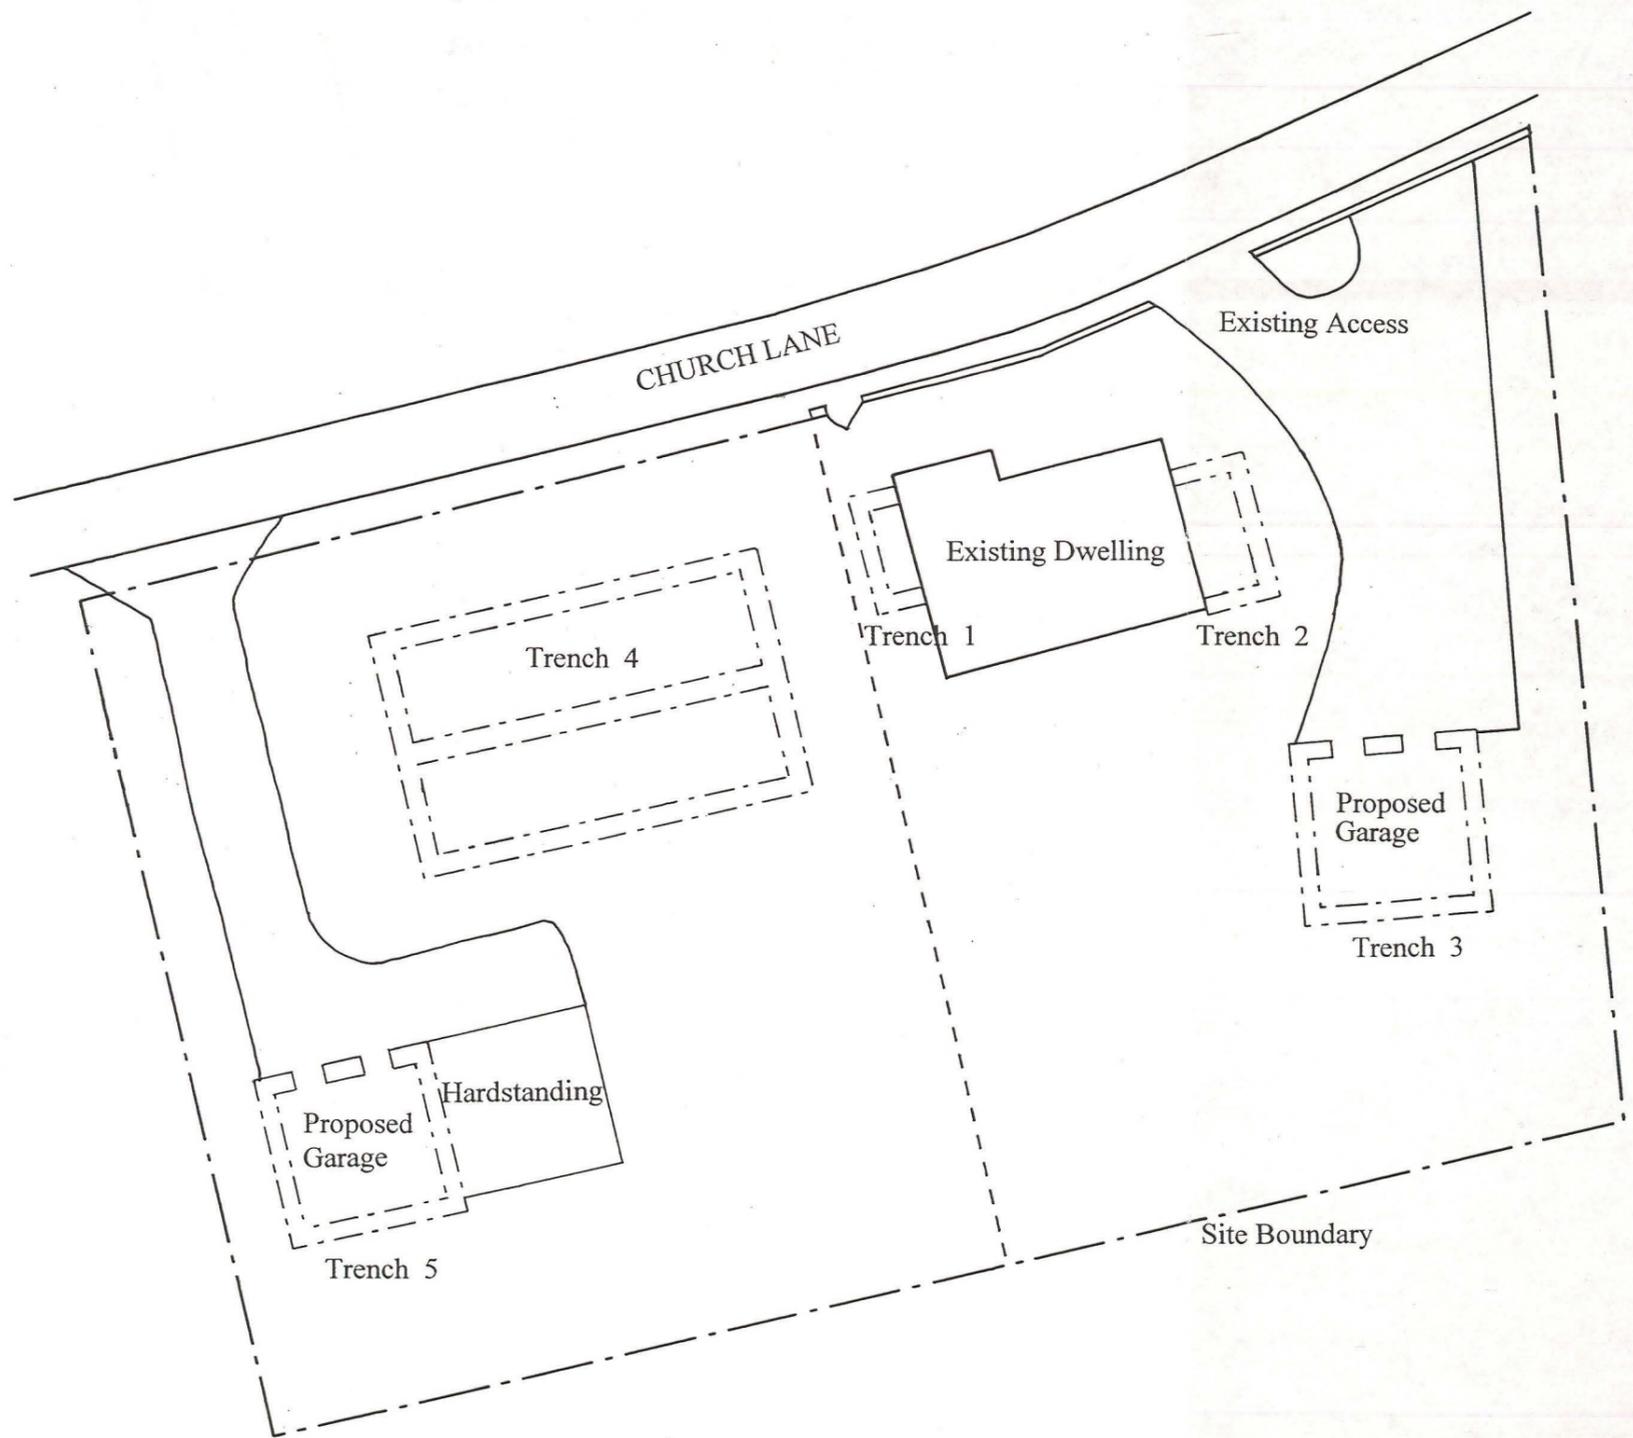
CITY OF LINCOLN ARCHAEOLOGY UNIT		
SITE CODE: MCL99	PLAN/ELEV/SECTION NO:	
CLIENT: Ellerby Homes Ltd		
DESCRIPTION:	Plan of Excavated Areas	
SCALE: 1:250	ARCHIVE NO:	
DRAWN BY:	CHECKED:	DATE:
MUSEUM ACCESSION NO: 143.99

KEY  
----- Foundation Trench

Based upon Ryland Design drawing Nos. 2843/02 and 3005/02.

The development of this site comprised five discrete areas of excavation, relating to the foundation requirements of the extensions to the existing property, the new bungalow, and the two double garages. Each of these areas was identified as follows (see Fig.2):

- **Trench 1** - extension for new kitchen porch, north-west corner of existing house (Plot 1);
- **Trench 2** - extension for new entrance hall/w.c., east side of existing house (Plot 1);
- **Trench 3** - double garage for existing house (Plot 1);
- **Trench 4** - foundation network for new bungalow (Plot 2);
- **Trench 5** - double garage for new bungalow (Plot 2)

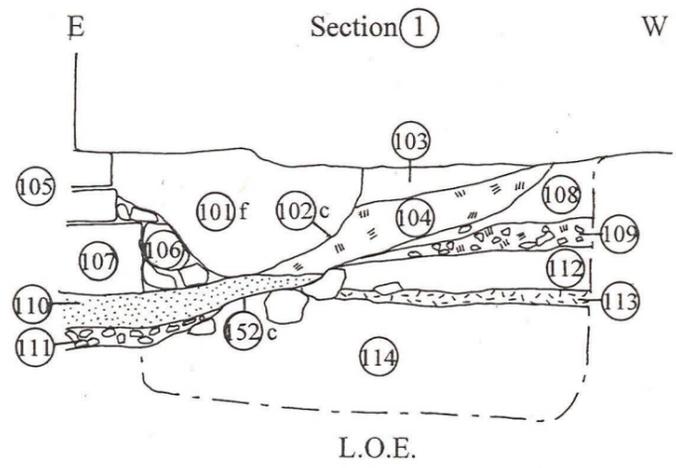
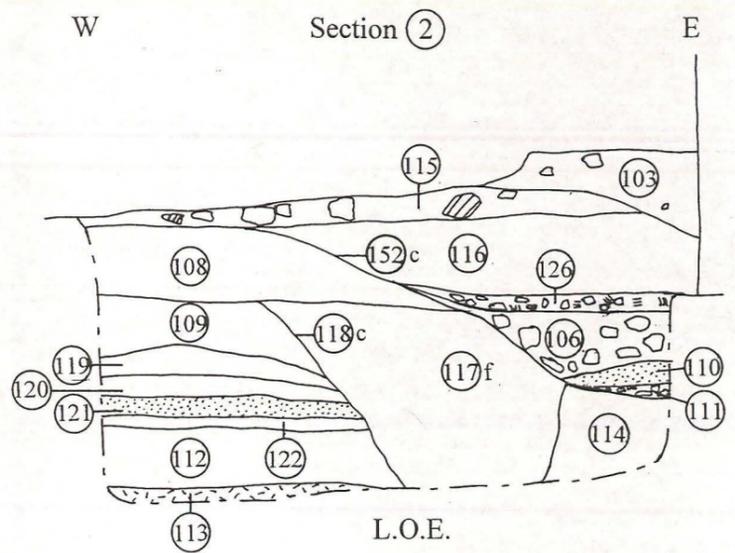
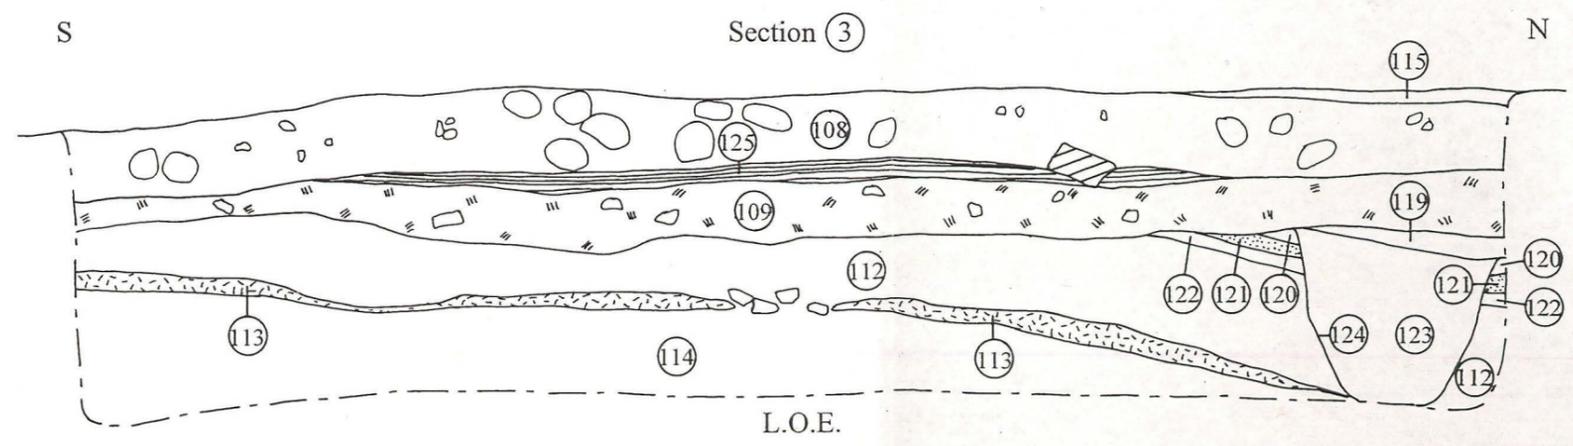
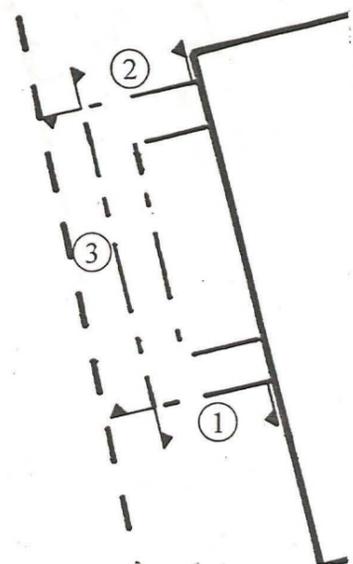
Fig.3

CITY OF LINCOLN ARCHAEOLOGY UNIT		
SITE CODE: MCL99	PLANE/ELEV/SECTION NO:	
CLIENT: Ellerby Homes Ltd		
DESCRIPTION: Sections ① - ③ Trench 1		
SCALE: 1:20	ARCHIVE NO:	
DRAWN BY: K.W	CHECKED:	DATE: 29/06/99
MUSEUM ACCESSION NO:		143.99

#### 3.1 Trench 1 (see Figs.2 & 3)

This area comprised a 'C'-shaped foundation trench measuring approximately 4m (N-S) x 1.5m (E-W), located immediately adjacent to the north-west corner of the existing house.

The earliest deposit comprised a fine-grained mid grey-brown sandy silt layer [114], containing only very occasional small flint pieces and charcoal flecks.

This was *c.* 300mm thick to the limit of excavation (L.O.E.), and was overlain by [113], a thin lense of off-white/yellow-brown lime mortar containing small pieces of stone.

Overlying [113] was a 200mm thick layer of mid brown sandy silt [112], containing pebble, shell, and charcoal inclusions.

At the north-east corner of the trench, [112] was then sealed by a series of three thin layers. The first of these, [122] comprised a *c.* 40mm thick friable red/pink clayey silt, with the colour possibly indicating the presence of degraded roof tile. Above this, was [121], a lense of friable mid orange sand & gravel, and [120], a red-brown sandy silt/ash containing approximately 30% charcoal inclusions. A single sherd of 13<sup>th</sup>-15<sup>th</sup> century pottery was also recovered from this deposit.

These layers were then cut by a small pit feature, [124], which was in turn filled by [123], a moderately compacted mid-brown clayey, sandy silt containing only occasional small flint pieces.

This fill deposit was overlain by a further thin lense/layer, [119], a mid-brown sandy silt containing *c.* 40%-50% small pebble and flint inclusions, and a single fragment of a 13<sup>th</sup> century jug.

This phase of activity was then sealed by a 150mm-200mm thick layer of mixed yellow-brown clay and mid grey-brown silt, [109], which was recorded throughout the trench. It contained frequent flint fragments and possible

mortar inclusions, and also a fragment of a bowl dating to the late 15<sup>th</sup>-16<sup>th</sup> centuries.

In the centre of the south-facing trench section, layer [109] was cut by a possible pit feature, [118]. This was at least 600mm deep to L.O.E., and was infilled with a mid-light brown slightly clayey sandy silt, [117].

Along the east-facing section of the trench, [109] was sealed by [125], which possibly represents the remains of a clay floor. This deposit comprised a series of alternating lenses (each  $\leq 10$ mm in thickness) of well compacted dark orange/red-brown ?burnt? clayey silt and mid-dark grey silty clay.

[125] was then overlain by a 200mm thick layer of mid brown-grey sandy silt topsoil, [108]. This was present across the majority of the site to the west of the existing house, and contained various modern inclusions. Two fragments of medieval roofing tile were also recovered from this context, probably dating to between the 13<sup>th</sup> and 15<sup>th</sup> centuries, although they are undoubtedly disturbed from earlier underlying deposits.

The remaining contexts recorded in this trench were primarily associated with the construction of the existing house.

These included the foundation trench ([152]), sand & gravel bedding layers ([111] & [110]), limestone foundations ([107]), and brick superstructure ([105]). The backfill of the construction trench was then represented by deposits [103]-[104], [106], [115]-[116] and [126].

A further small pit feature was present at the southern end of the trench, immediately adjacent to the upstanding wall. This comprised cut [102] and fill [101], and was obviously modern in origin.

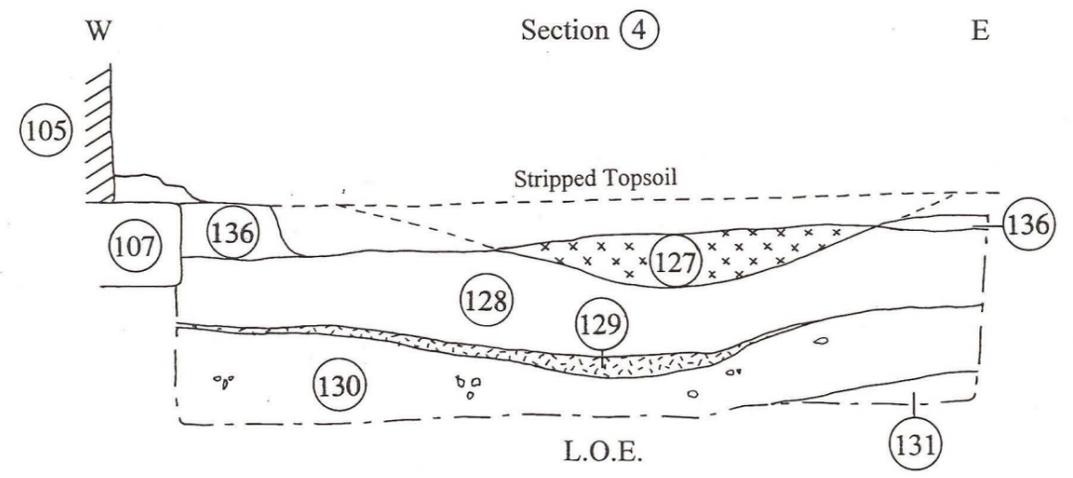
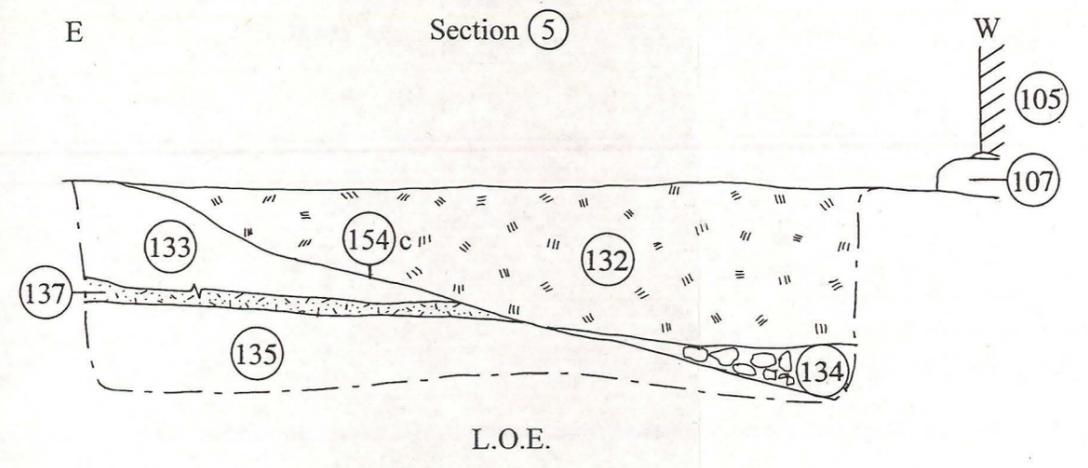
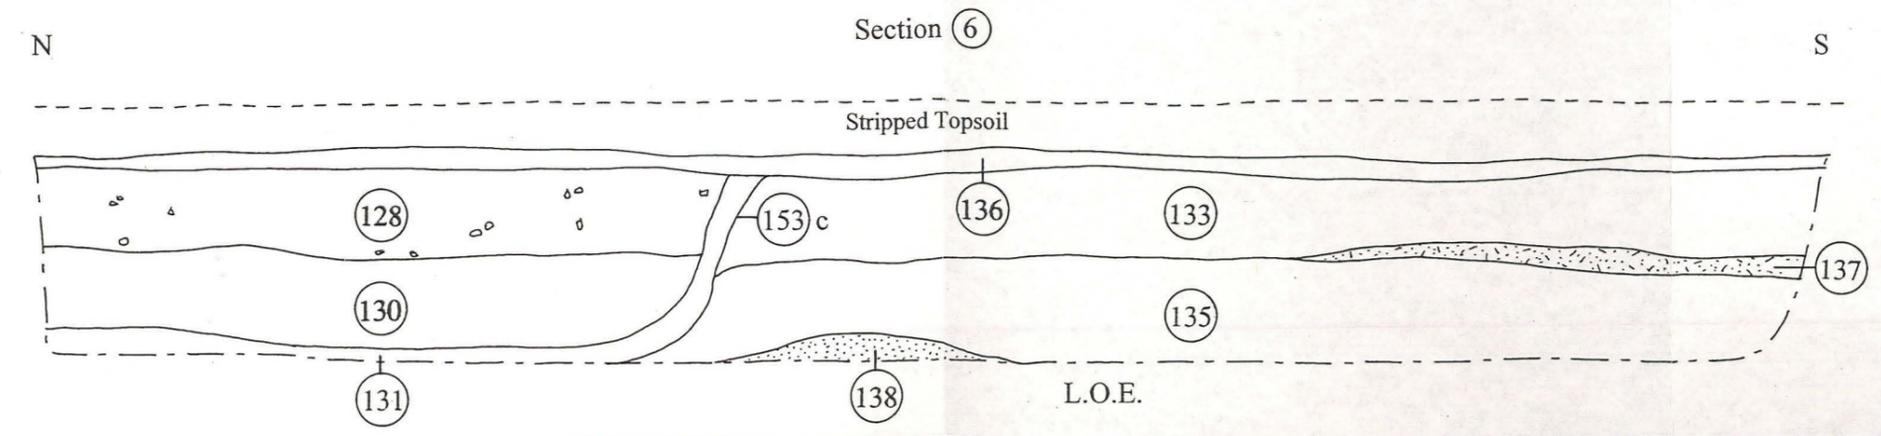
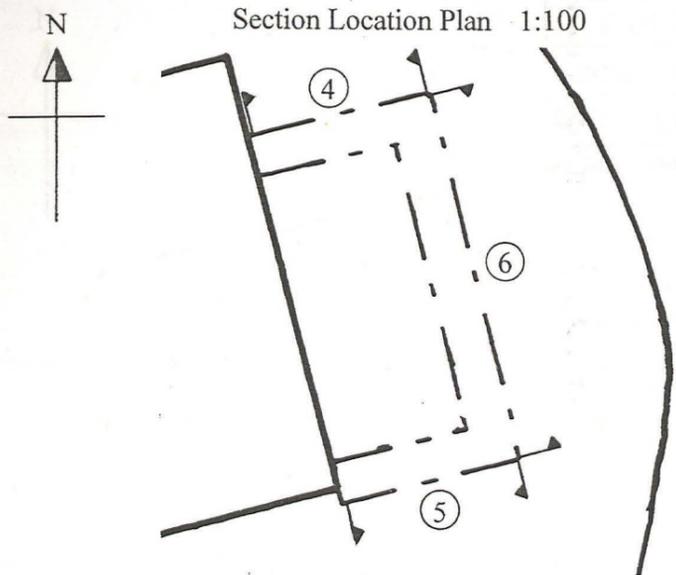
Fig.4

CITY OF LINCOLN ARCHAEOLOGY UNIT		
SITE CODE: MCL99	PLAN/ELEV/SECTION NO:	
CLIENT: Ellerby Homes Ltd		
DESCRIPTION: Sections ④ - ⑥ Trench 2		
SCALE: 1:20	ARCHIVE NO:	
DRAWN BY: K.W.	CHECKED:	DATE: 29/06/99
MUSEUM ACCESSION NO:		143.99

### 3.2 Trench 2 (see Figs.2 & 4)

Trench 2 was situated along the eastern side of the existing house, again comprising a 'C'-shaped trench, but measuring 5m (N-S) x 2.5m.

The stratigraphic sequence encountered in this trench was considerably different from that seen in Trench 1. There was little or no evidence for actual occupation or structures,

and the majority of the contexts appear to represent dumping deposits.

The earliest layer uncovered was [138], a moderately compacted friable orange sand. This contained no obvious inclusions, and probably represents the prevailing 'natural' (*i.e.*, geological) deposit for the site.

[138] was only revealed at the L.O.E. and was sealed by [135], a 300mm thick mid brown sandy silt containing frequent flint and pebble inclusions. A single sherd of late 13<sup>th</sup>-14<sup>th</sup> century pottery was also recovered from this context.

This layer was then overlain by [137], a thin (*c.* 50mm-100mm) lense of mid-light yellow-brown sandy lime mortar, which was in turn sealed by [133], a more substantial (up to 300mm thick) layer of slightly clayey, mid-brown sandy silt.

Towards the northern end of the trench [133] was truncated by a large cut feature, [153], which measured at least 2m (N-S) x 2.5m (E-W). This feature was 'lined' by a thin (*c.* 100mm) layer of mid yellow-brown sandy, clayey silt [131], which was in turn sealed by a 200mm-300mm thick layer of mid grey-brown sandy silt, [130]. Other than frequent charcoal flecks appearing in [130], both of these deposits contained only pebble and flint inclusions.

In the south-facing section of the trench, [130] was overlain by a 50mm-75mm thick intermittent lense of coarse yellow-brown lime mortar and stone pieces, [129]. This extended across an area measuring approximately 2m (E-W), and was itself overlain by [128].

[128] formed the uppermost fill deposit of cut [153], and comprised a moderately compacted mid-brown clayey silt containing only occasional small pebble and flint inclusions.

Unfortunately, no dating evidence was present within this feature, and therefore its age, and indeed its purpose, remain a mystery. It is possible, however that it is associated with the construction of the existing structure, and therefore dates from the 19<sup>th</sup> century at the earliest.

At the southern end of the trench, a cut feature was revealed in the north-facing section cutting into [133]. This feature, [154], was

definitely associated with the existing building, and was very similar in appearance to context [152] seen in Trench 1.

[154] was filled firstly by [134], a dump of cobbles mixed with mid-brown silt, and finally by [132], a mid-light yellow-brown clay containing limestone and flint inclusions.

The limestone foundations, [107], and the base of the existing brick superstructure [105], were also revealed within this cut.

Both [132] and the aforementioned [128] were then sealed by the topsoil deposit for this part of the site. This comprised a 200mm-250mm thick layer of moderately compacted mid-grey sandy, slightly clayey silt [136].

The topsoil was mixed with various modern rubbish, as in other areas of the site, and was sealed at the northern end of Trench 2 by a dump of mid-dark grey ash/clinker.

Other than the single sherd of pottery recovered from layer [135], no datable finds were produced from this trench.

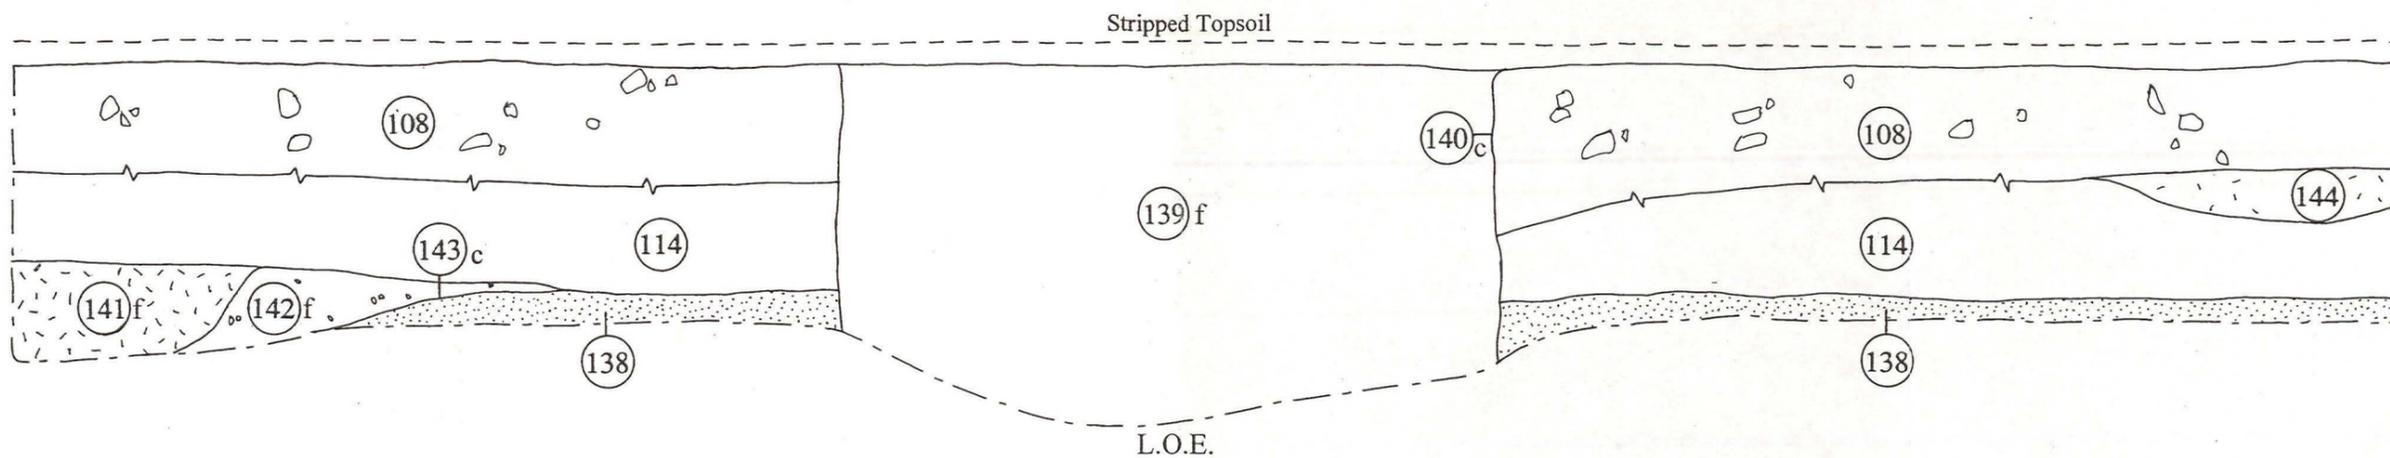
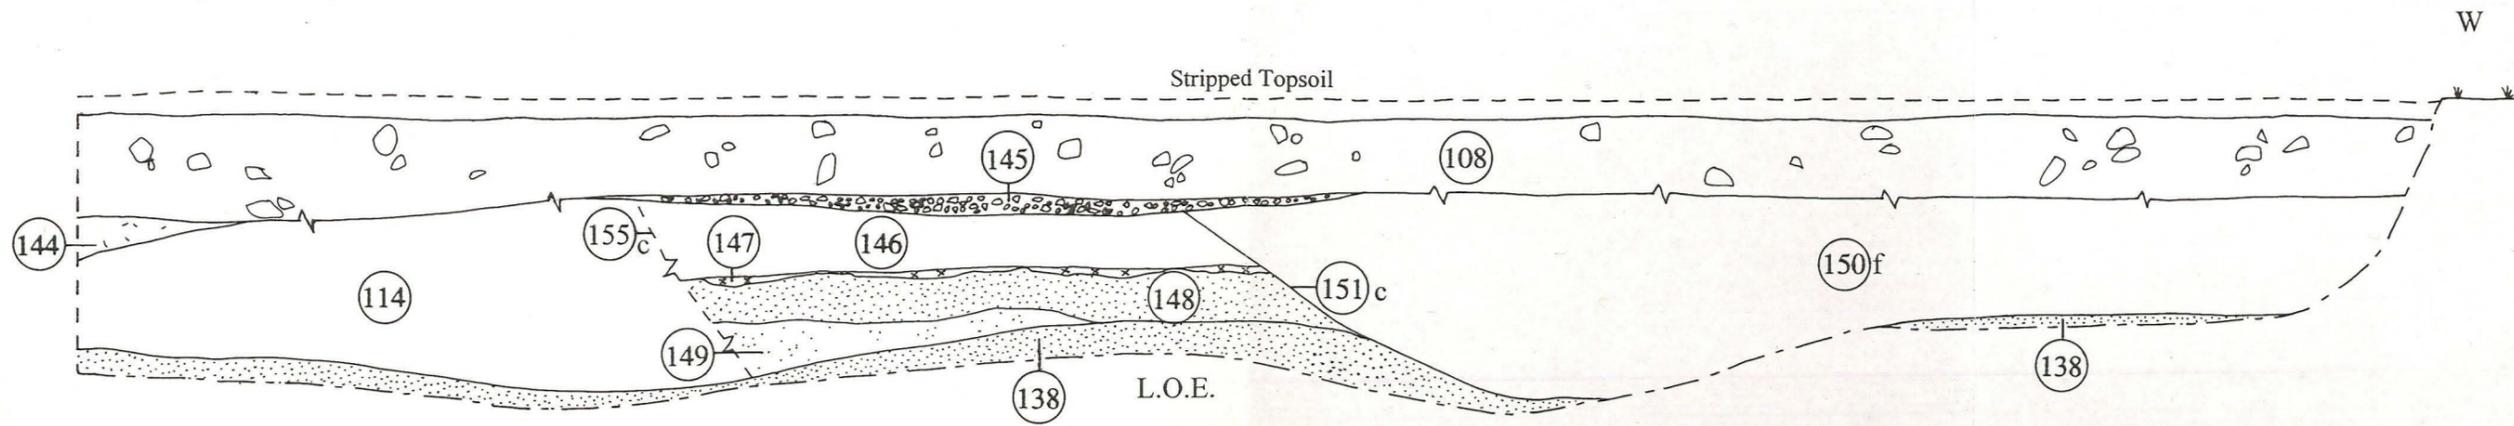
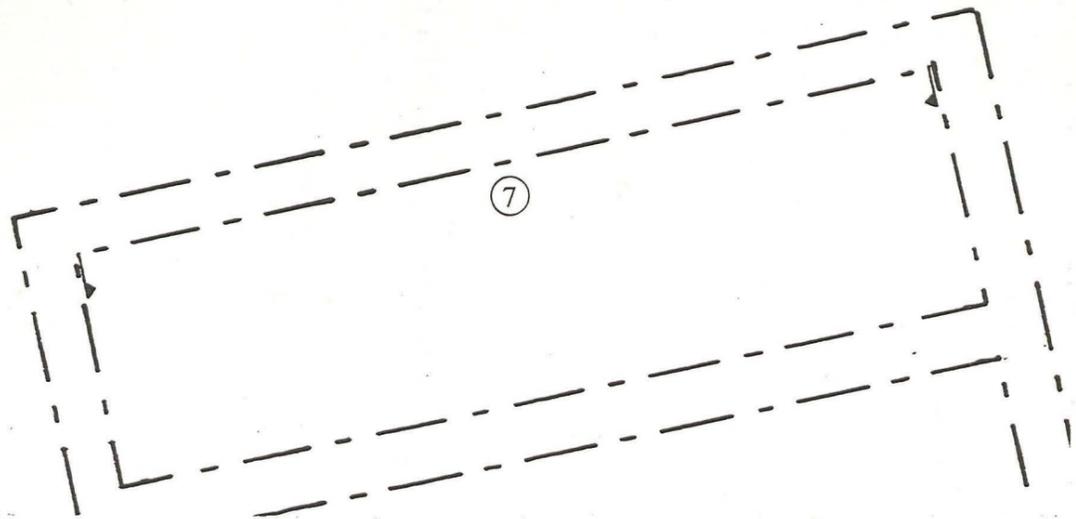
Fig.5

CITY OF LINCOLN ARCHAEOLOGY UNIT		
SITE CODE: MCL99	PLAN/ELEV/SECTION NO:	
CLIENT: Ellerby Homes Ltd		
DESCRIPTION: Section ⑦ Trench 4		
SCALE: 1:20	ARCHIVE NO:	
DRAWN BY: K.W.	CHECKED:	DATE: 04/10/99
MUSEUM ACCESSION NO:		143.99

### **3.4 Trench 4 (see Figs.2 & 5)**

Trench 4 comprised a rectangular network of foundation trenches measuring approximately 9m (N-S) x 15m (E-W). It was situated towards the north side of Plot 2, adjacent to the Church Lane frontage.

The stratigraphic sequence encountered in this trench was more complicated along the northern edge of the network, and it was in this

area that the main emphasis of the recording was focused.

As with Trench 2, the earliest deposit revealed was the natural sand layer [138], which was just present at L.O.E.

It was cut at the north-eastern corner of the network by a shallow feature [143], which was itself filled by two further deposits. Of these, the earliest, [142], comprised a mid-dark grey-brown sandy silt containing small pebble inclusions, with [141] made up of friable off-white/yellow-brown lime mortar. Above [141] was [114], as seen in Trench 1.

[114] was subsequently sealed by a thin lense of off-white/yellow-brown lime mortar, [144], and truncated by a cut feature, [155].

The fills contained within the cut comprised the following, from earliest to latest: [149], a 200mm thick mottled mid grey-brown sandy silt/light brown sand; [148], a 200mm thick friable, mid-light brown sand containing infrequent small charcoal flecks; a thin lense of charcoal or ash, [147]; and [146], a mid grey-brown sandy silt, very similar to the aforementioned [114].

Immediately to the west, this sequence of fills was cut by a further feature, [151].

This comprised a large, fairly irregular, cut measuring at least 3.5m E-W (the feature continued into the east-facing section, and therefore its full extent was not revealed). It was infilled with a single deposit, [150], a mid grey-brown sandy silt, again very similar to [114].

On its eastern edge this fill deposit was overlain by a thin lense of gravel, [145], which extended for over 2m E-W.

[108], the topsoil deposit first recorded in Trench 1, was then present, overlying [145].

The only remaining feature in Trench 4 comprised a large, vertically-sided cut, of

obviously modern origin, [140]. This was filled by [139], a mixed clayey, sandy silt. This deposit contained occasional modern inclusions, together with buried turf, flint and pebbles. It was initially thought that this was the remains of one of the 1997 evaluation trenches, but it does not seem to coincide with any of the recorded trenches, and therefore its purpose and origin remain unknown.

No dating evidence was uncovered in this trench.
