Greestone Centre, De Montfort University, Lindum Road, Lincoln: Landscaping & External Works

Archaeological Evaluation

Report No.: 444

Site Code: LRB00

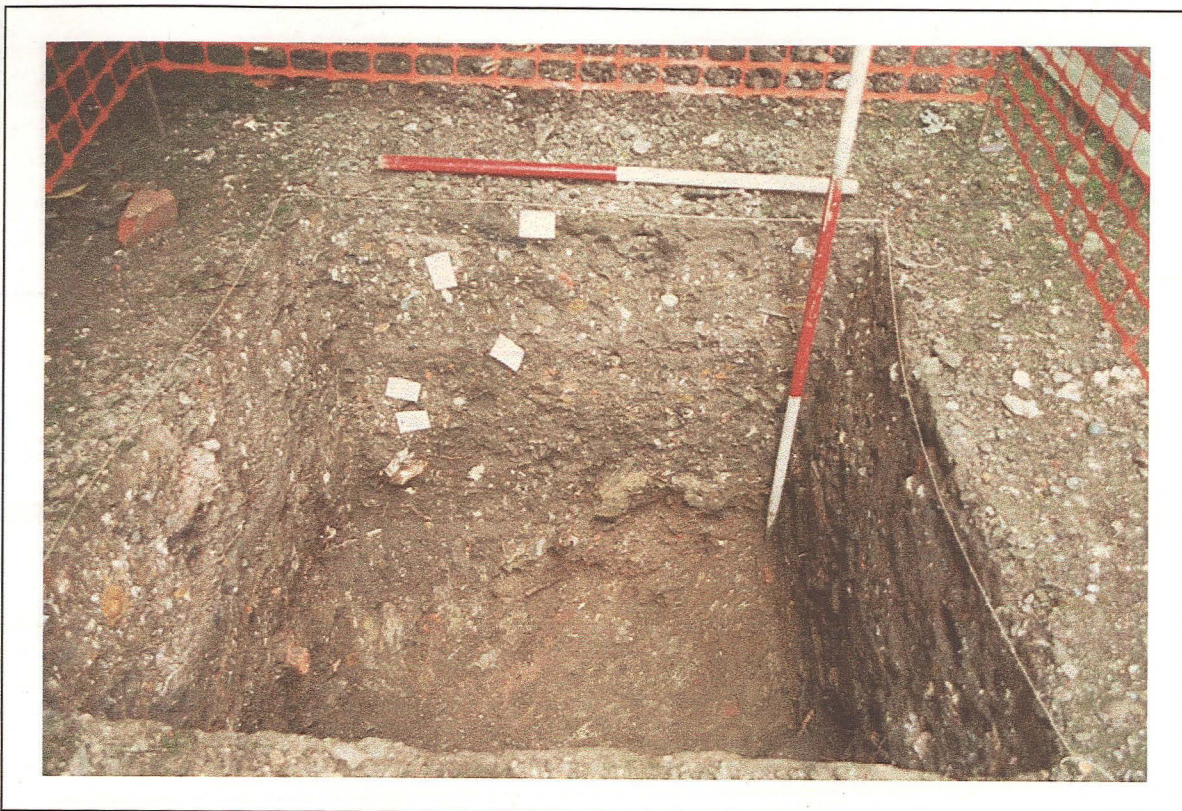
Plate 1: General view of east-facing section, T.P.1 - looking west

The earliest deposit comprised [111], a well compacted mid grey/yellow-brown clay layer containing modern brick and bitumen inclusions. This layer was up to 600mm thick to the limit of excavation (L.O.E.), and probably represents redeposited natural clay displaced during the construction of the existing structure.

[111] was overlain by a series of three deposits, comprising (from earliest to latest): [110], a 450mm thick layer of mid grey-brown sandy, clayey silt; [109], a 100mm thick mixed light-mid yellow-brown clay and sandy silt; and [108], a 50mm-75mm thick mid-brown silty sand layer.

All of these deposits contained limestone and modern brick inclusions, and appeared to form 'tip' deposits behind the existing lower retaining /terrace wall.

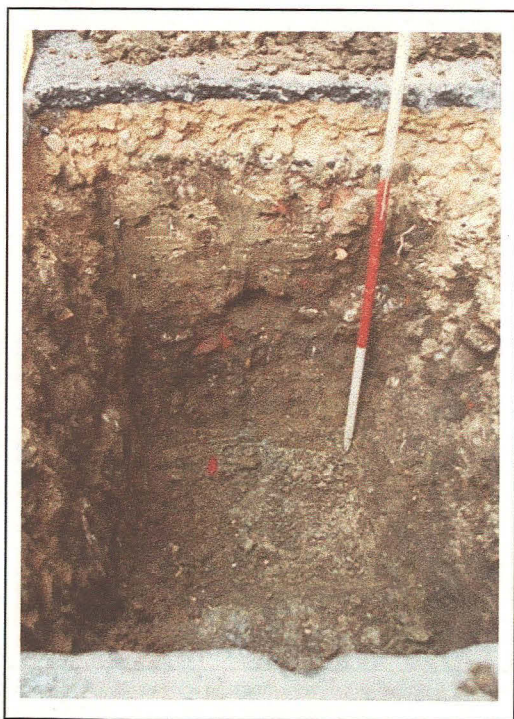
Plate 2: Overall view of south-east facing section, T.P.2 - looking north-west

The earliest deposit was a well compacted mid-light yellow-brown clay, [123], which was 300mm thick to the L.O.E., and contained no obvious inclusions. In contrast to the redeposited clay encountered in T.P.1, this deposit appears to represent the undisturbed natural strata.

[123] was sealed beneath a 300mm thick layer of friable mid-grey clayey silt containing modern brick, slate and limestone inclusions. This deposit, [122], was then itself overlain by [121], a 500mm thick layer of well compacted mid-light yellow-brown clay, containing brick and stone inclusions.

The final layers revealed in this trench were then associated with the existing modern surface of the access road. This comprised a *c.* 50mm thick layer of tarmac founded on a *c.* 100mm layer of limestone hardcore, context [120].

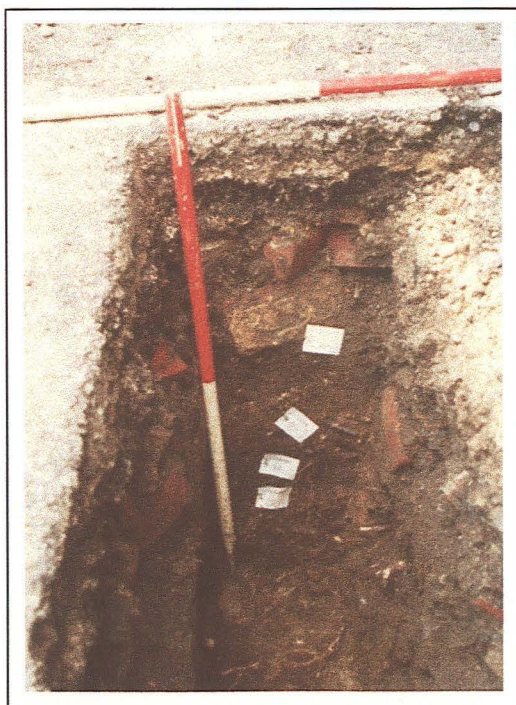
Plate 4: General view of south-west facing section, T.P.4 - looking north-east

The earliest deposit was revealed just above the L.O.E. (at a depth of c. 900mm below the existing ground level), and comprised a mid-light grey-brown clay, [124]. This was well compacted and contained occasional small pieces of irregularly shaped limestone and a single sherd of late 9th-10th century pottery.

[124] was then sealed by three further layers, all producing late 9th-10th century pottery. These comprised (from earliest to latest): [119], a mid grey-brown silty clay layer which also contained a piece of kiln furniture, and tile dating from between the 13th and 15th centuries (although the latter might be intrusive material); [118], a mid-brown sandy clayey silt with more fragments of kiln furniture, together with shell and limestone flecks; and [117], a mid-light brown clayey silt containing limestone and charcoal flecks. The majority of the pottery recovered from these deposits (and from several other contexts across the site) appears to be kiln waste (*i.e.*, pottery damaged during the firing process).

The latest of these layers, [117], was present c. 400mm below the existing ground level, and was overlain by [116], a very mixed mid grey-brown sandy silt, containing large quantities of modern bricks and rubble. This dump deposit, [116], is probably contemporary with the construction of the existing building, and lay immediately beneath the tarmac surface [120], as recorded in T.P.3.
