ARCHAEOLOGICAL WATCHING BRIEF REPORT ERMINE STREET, NAVENBY, LINCOLNSHIRE.

CENTRAL LINCS TRUNK MAIN REHABILITATION, PHASE I

NGR: SK 9940 5720 - SK 9928 5812 LCCM ACC. NO. 2000.141

> Report Prepared for Anglian Water Services Ltd. by Jim Rylatt October 2000

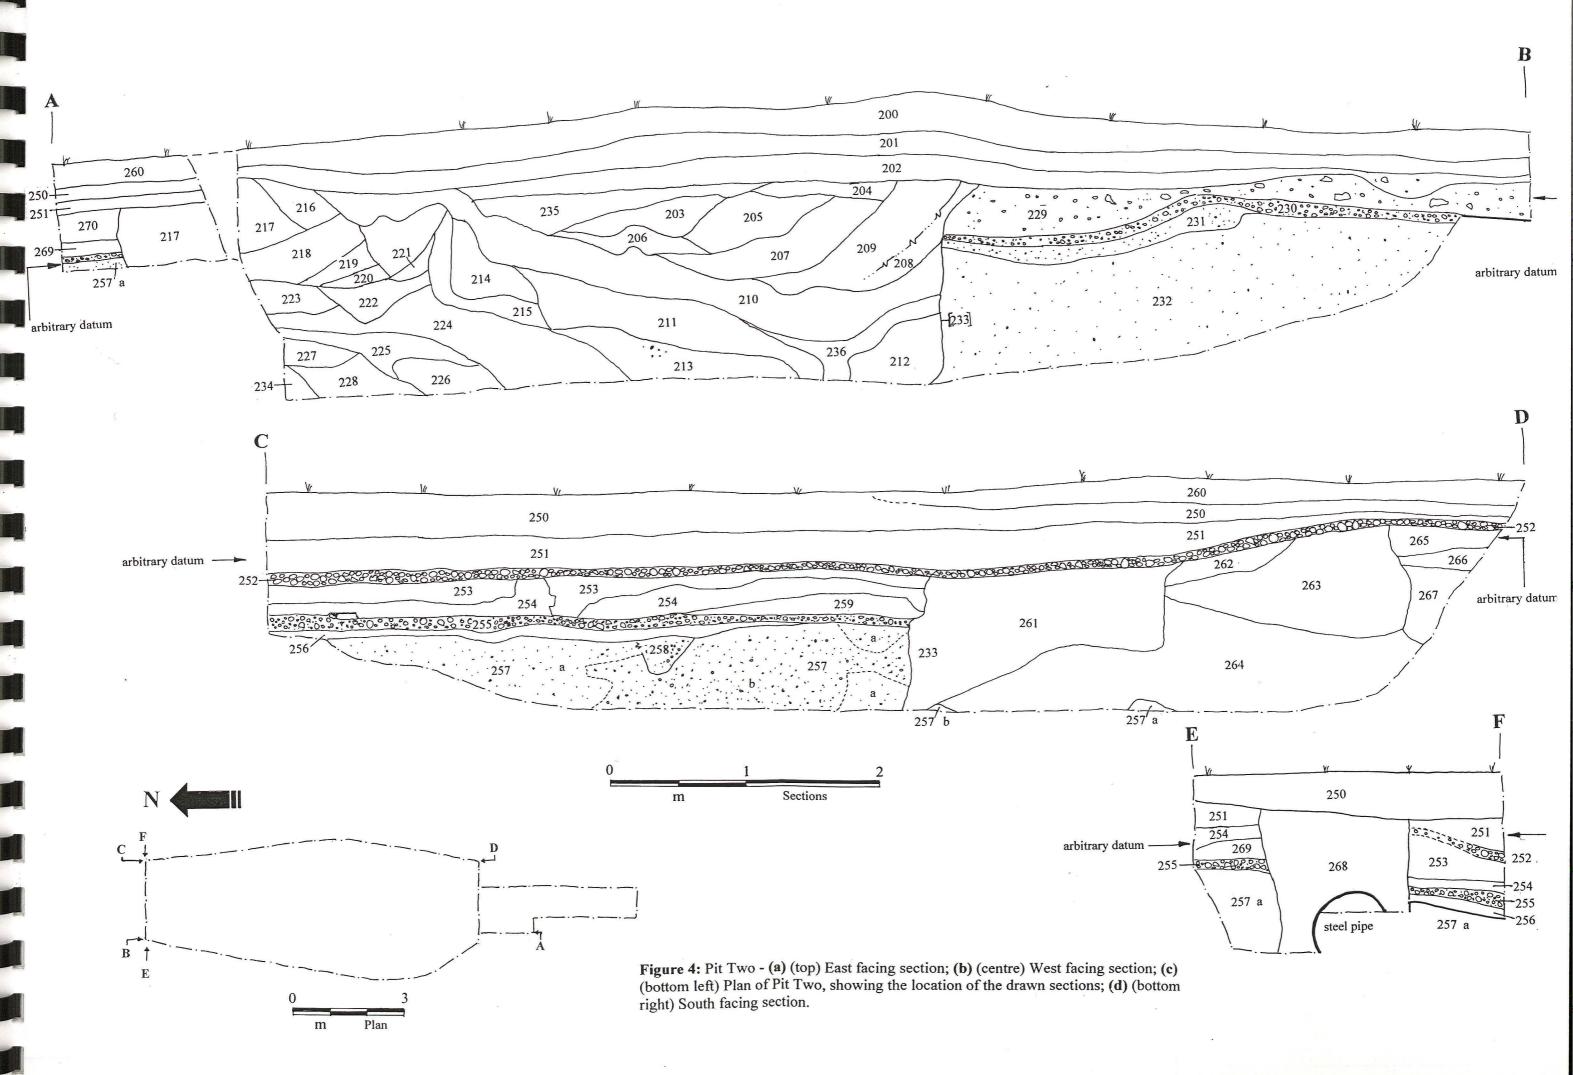
(see figure 4)

The western edge of this pit was located approximately 1.0m east of the edge of High Dike. It was trapezoidal in plan, widening toward the centre of the longer sides, measuring c. 2.20m east-west at the ends and c. 3.40m in the centre (figure 4c). The

main north-south axis of the pit was c. 9.60m long, but there was a narrow, ramped extension, c. 4.2m long, made at the southern end of the pit to allow access for the pipe. The sides were relatively compact and stable in the northern half of the pit, but there was some slumping in the southern part during the interval that the trench was open. However, it was not necessary to insert shoring. The hole had a maximum depth of c. 2.15m, but the base of the archaeological deposits was not reached in the southern half of the trench. As with Pit One, the earlier steel water pipe had been laid in a trench that had removed the stratigraphic relationships between the east and west facing sections.

Beneath this rubble layer was a deposit of small to medium sized, water-rounded quartzite pebbles, (230), which was up to c. 0.12m thick. A small proportion of this layer comprised sub-rounded to sub-angular limestone rubble, having a maximum dimension of less than 0.1m. It was possible to clean back the overlying deposits exposed in the section to reveal a strip of (230), c. 0.20m wide, in plan. This was shown to be a relatively flat, compact surface, the upper plane of which showed some evidence of wear. It is with a high degree of confidence that this stratum is interpreted as a Roman road. As with Pit One, these pebbles did not appear to be a component of the local geology and are thus likely to have been imported especially for the purpose of creating a road surface.

A deposit of small to medium sized, water-rounded quartzite pebbles, (255), up to c. 0.12m thick, was situated beneath (254)/(259). A proportion of this layer comprised sub-rounded to sub-angular limestone rubble, having a maximum dimension of less than 0.1m. As with the portion exposed in the east facing section, i.e. (230), it was possible to clean back the overlying deposits to reveal a strip of (255) in plan. Again this was a relatively flat surface, which showed evidence of wear, strongly indicative of use as a road.

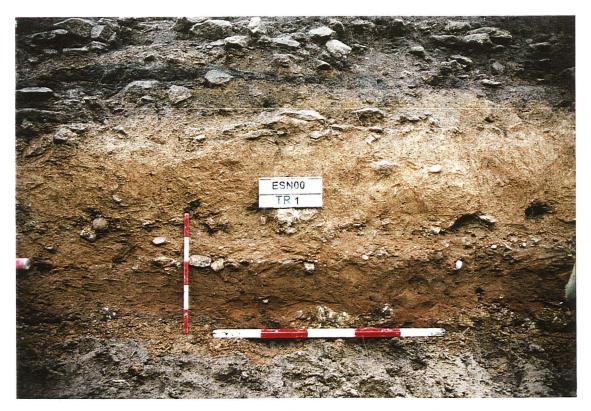
**Plate 4:** Pit One – close up of the base of the east facing section, showing the Roman road surface (020), situated at the interface between the orangey-brown ?buried soil, (019), and the yellowy material, (021), looking west.

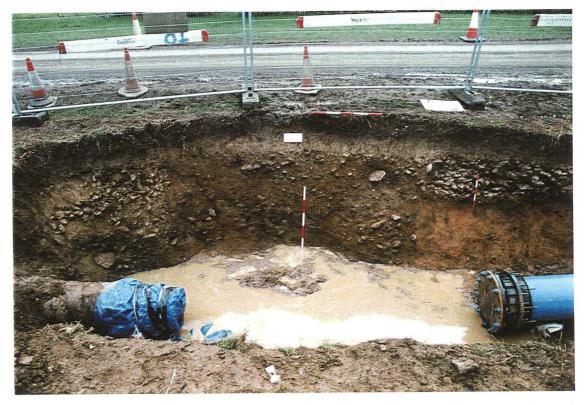
**Plate 5:** Pit Two – east facing section, looking west. Note that the fills of the quarry pit(s), [233], are of a distinctly different nature to the earlier, truncated deposits on the right hand third of the picture.

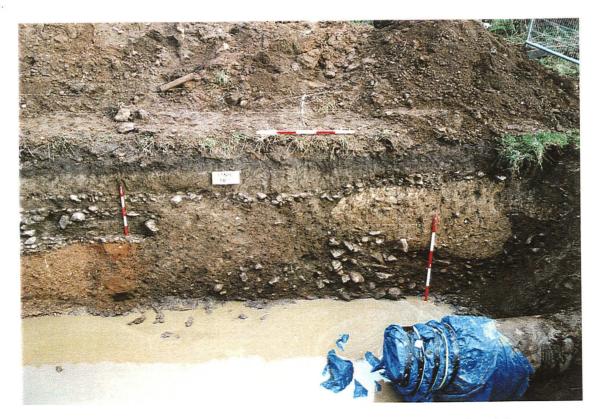
Plate 6: Pit Two – west facing section, looking east. Predominantly showing the fills of the quarry pit(s), [233], with earlier deposits in the left hand quarter of the picture.

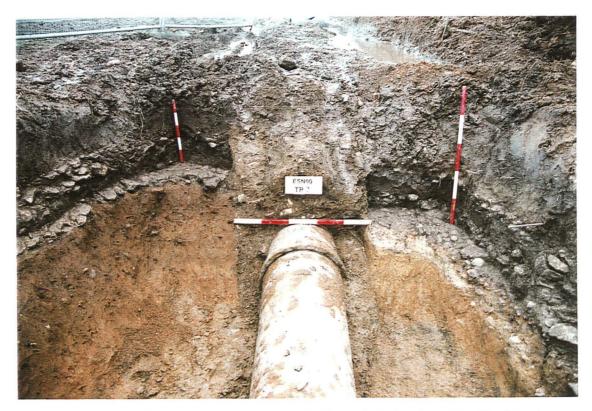
Plate 7: Pit Two – south facing section, looking north. The steel trunk main and the fill of the pipe trench occupy the centre of the picture. The two vertical scales are resting directly upon exposed sections of the Roman road surface. (255); the eastern section is much lower as a result of the camber of the road.

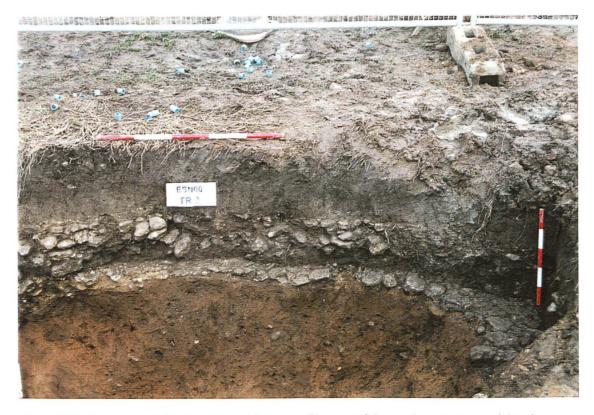
**Plate 8:** Pit Two – east facing section, looking west. Close up of the north-west corner of the pit, showing the exposed surface of Ermine Street, with the vertical scale resting directly upon it. Overlying this surface is a substantial deposit of limestone rubble, (229).
