**West Street, Crowland, Lincs.**

**Archaeological Watching Brief**

**LAS Report No. 474**

**October 2000**

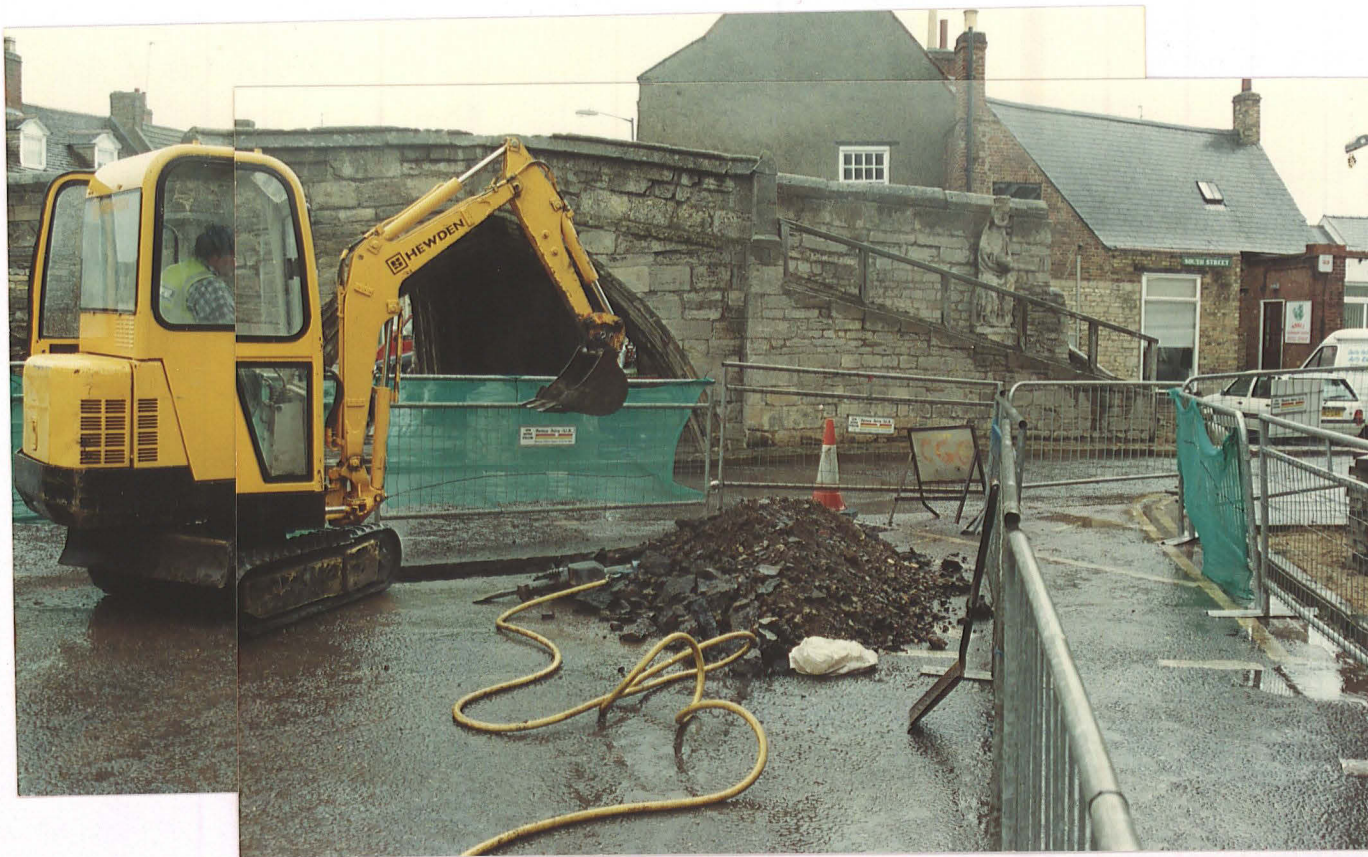
1. A 0.4m deep trench was examined within West Street, at the junction of South Street (Pls. 1 and 2). This cut through the tarmac road surface to a stone rubble levelling layer, covering a mixed deposit with soil, gravel and brick fragments.

Pl. 1 The trench at the junction of West Street (foreground) and South Street (right). Looking east towards Trinity Bridge.

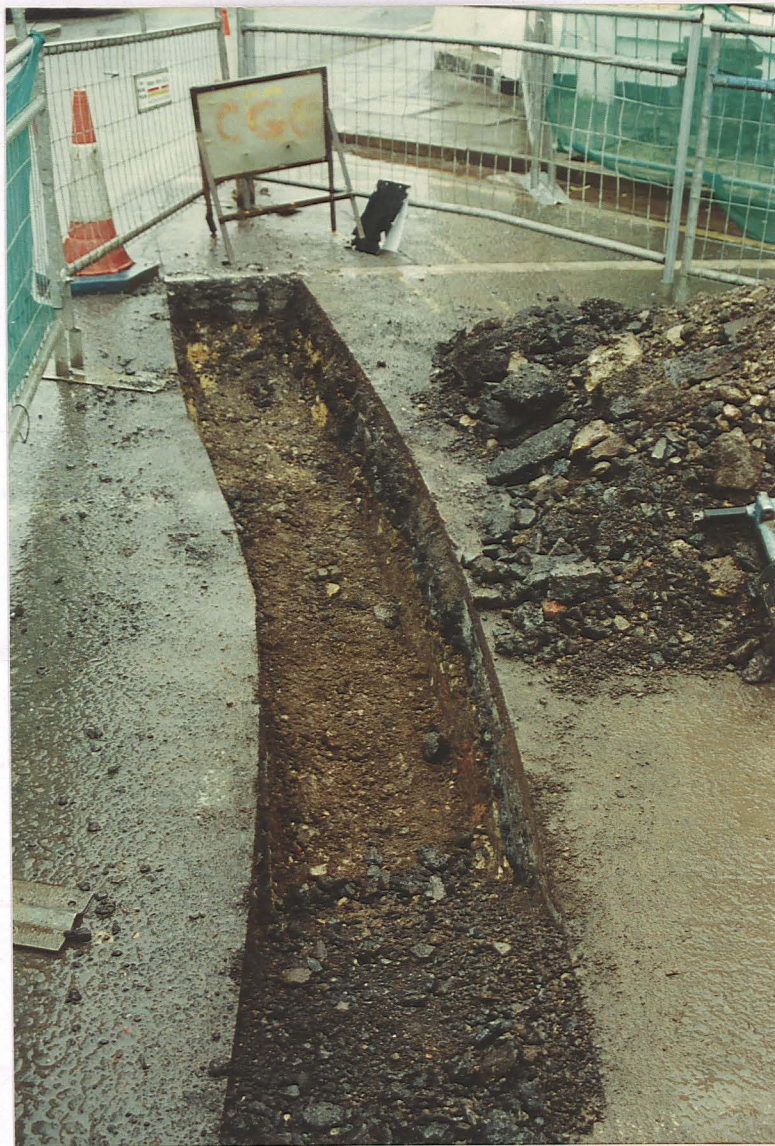
Pl. 2 Deposits visible in the trench at 1, junction of West Street and South Street (looking south).

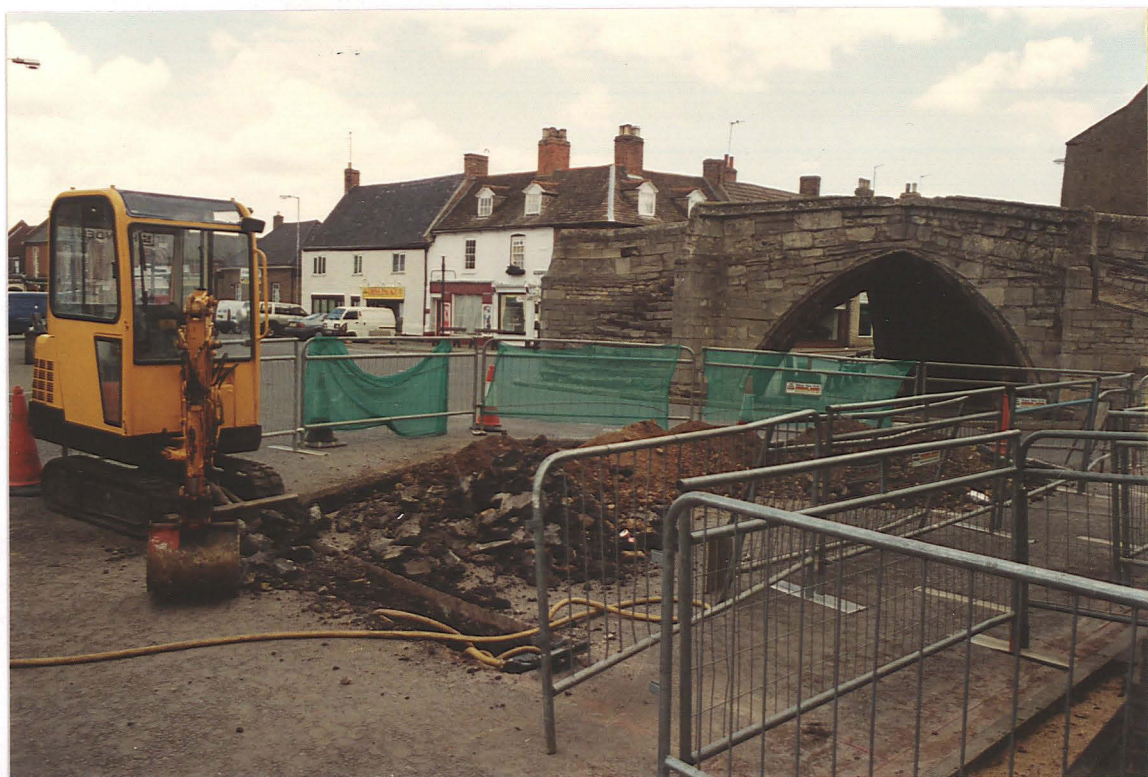
The works were undertaken to the west of Crowland's Trinity Bridge, along West Street. The medieval bridge originally crossed two watercourses, one flowing towards Spalding, the other towards Peterborough. The watercourses are now culverted below the modern roads.

Pl. 3 View of the medieval bridge (looking NE from 2).

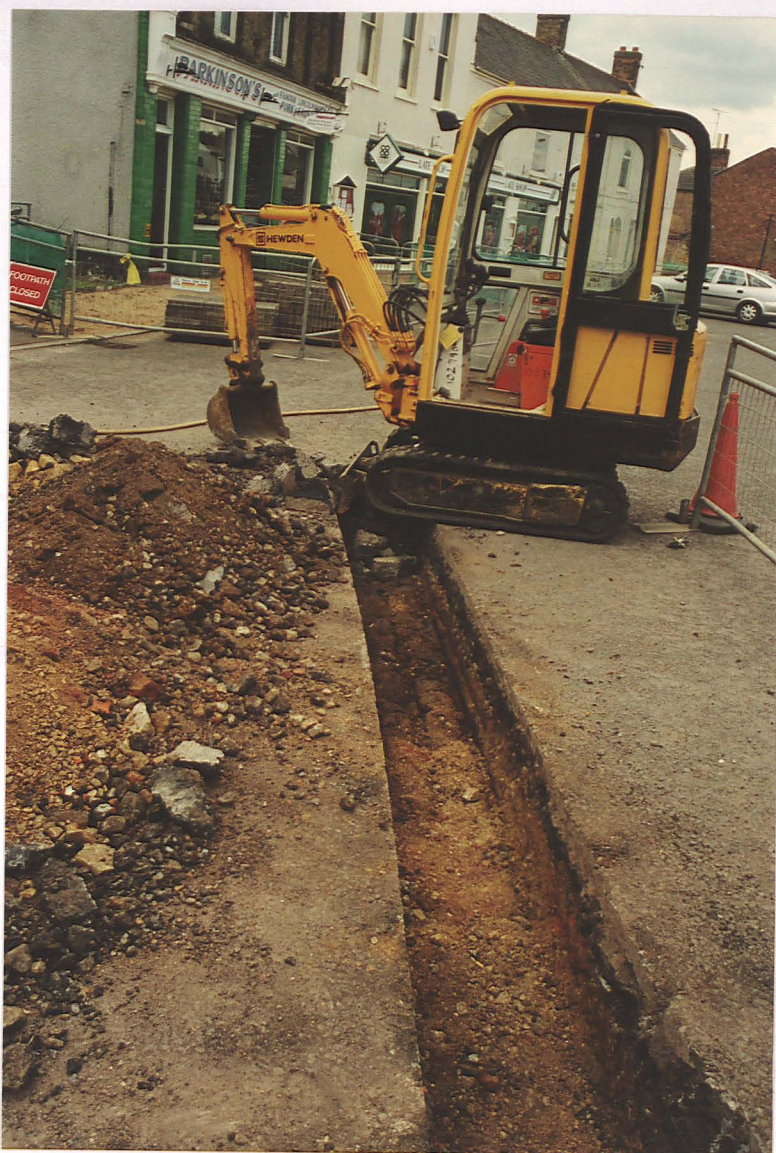
2. On the west side of the junction with South Street, beneath the 0.2m thick tarmac layer was a mixed layer of orange sandy clay with fragments of mortared brick (Pls. 3-5).

**Pl. 4** Mixed backfill deposits and gravel in the trench at 2 (looking SW in West Street).

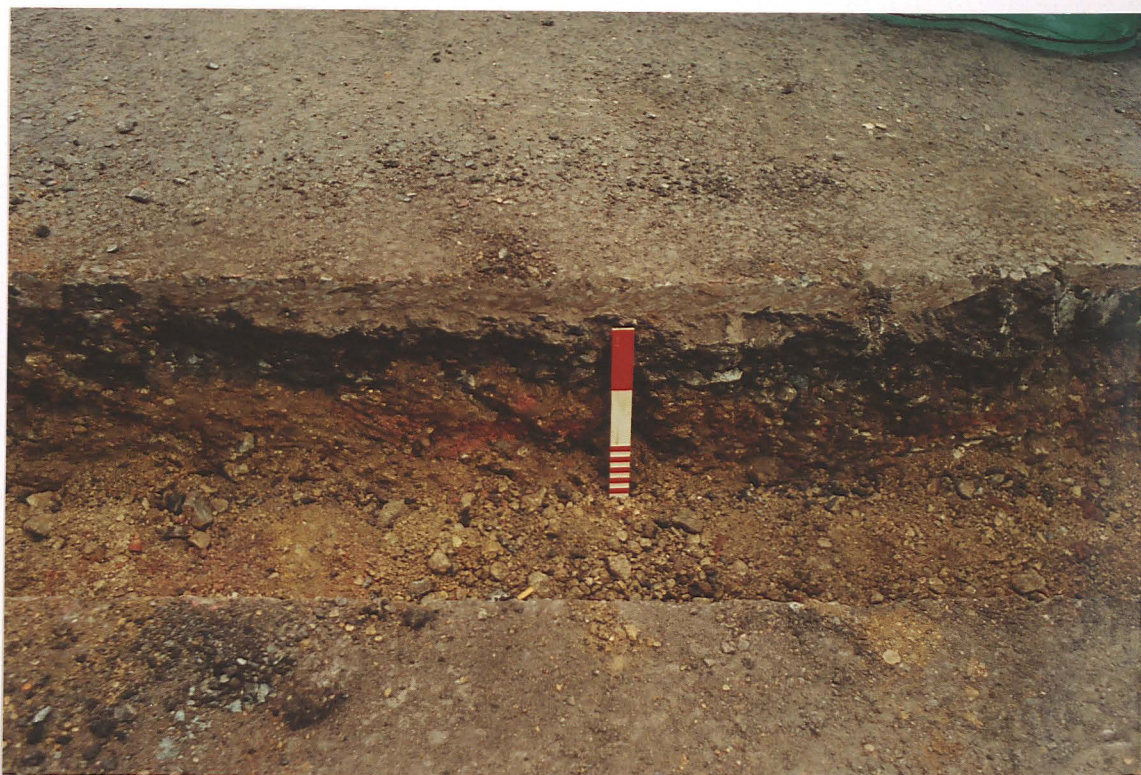
**Pl. 5** Section through levelling deposits onto probably redeposited gravel at 2.

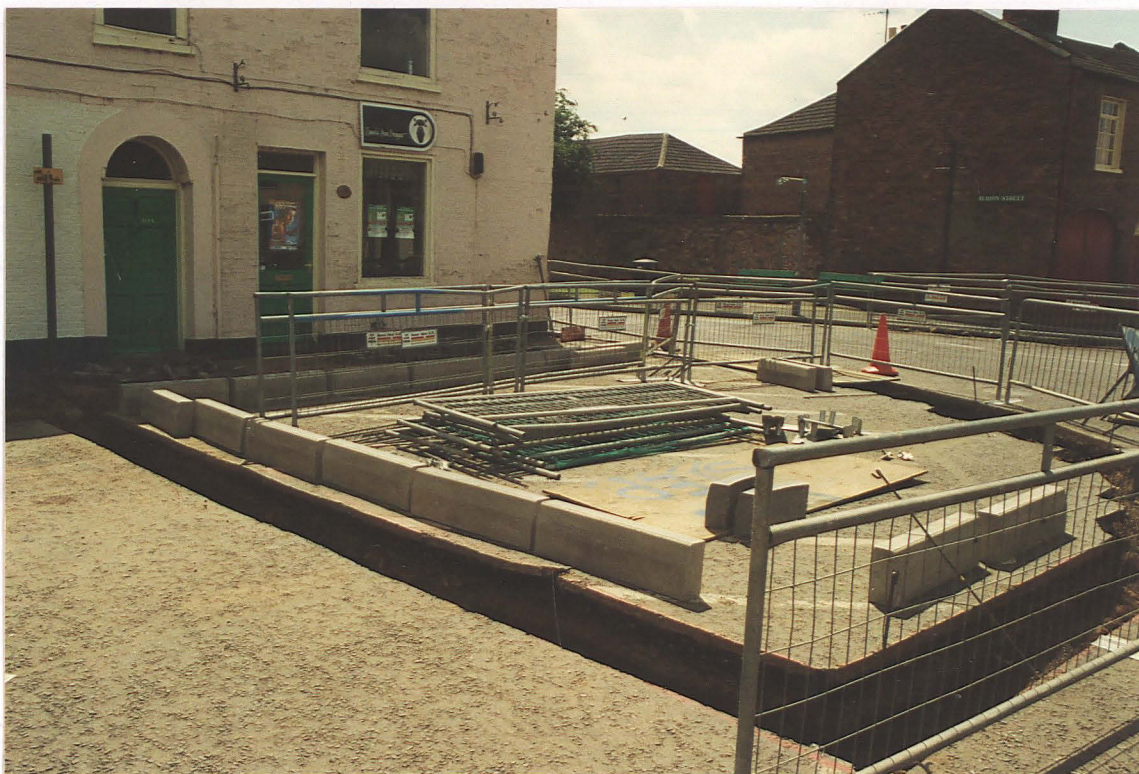
3. Immediately east of the junction of Albion Street and West Street, the 0.35m deep trench revealed a mixed layer of clay with some brick rubble (as at 2), but containing a high proportion of gravel (Pls. 6 and 7). The density of gravel could possibly indicate a medieval road surface, but is more likely to derive from naturally deposited gravel associated with the culverted stream.

**Pl. 6 The monitored groundworks at 3, east of the junction of Albion Street and West Street (foreground). Looking SW.**

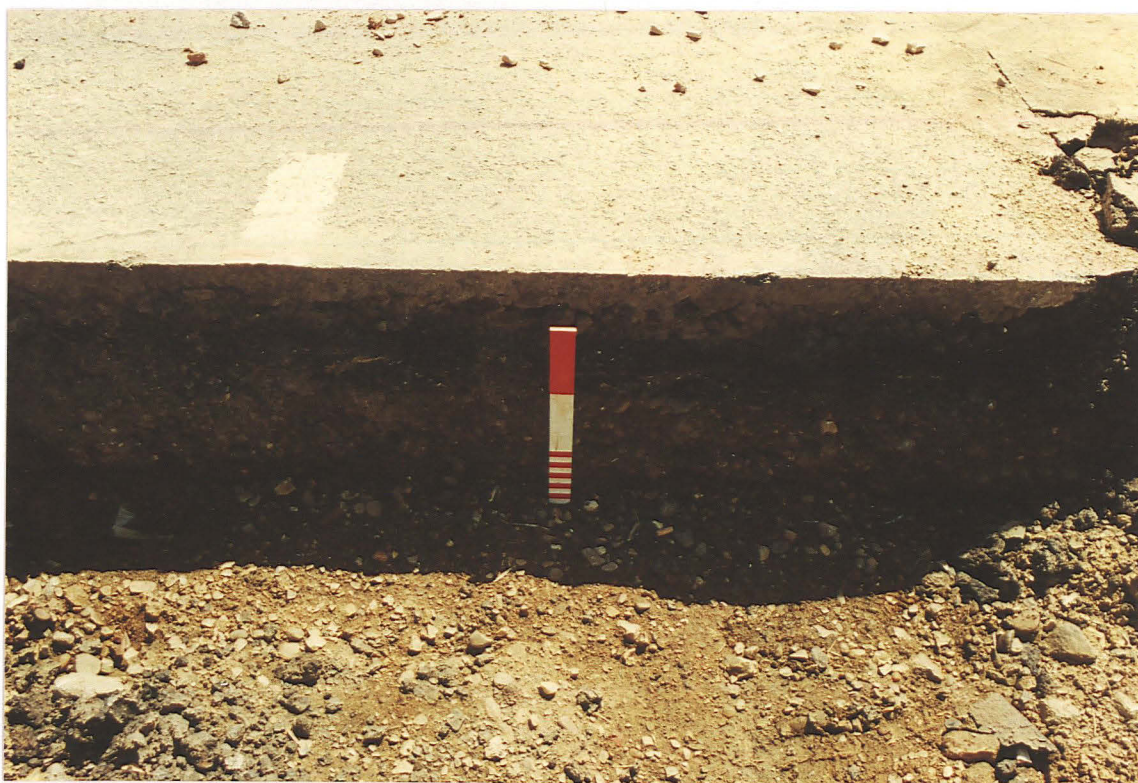
**Pl. 7 Gravel layer at junction of Albion Street 3. Scale 0.2m.**

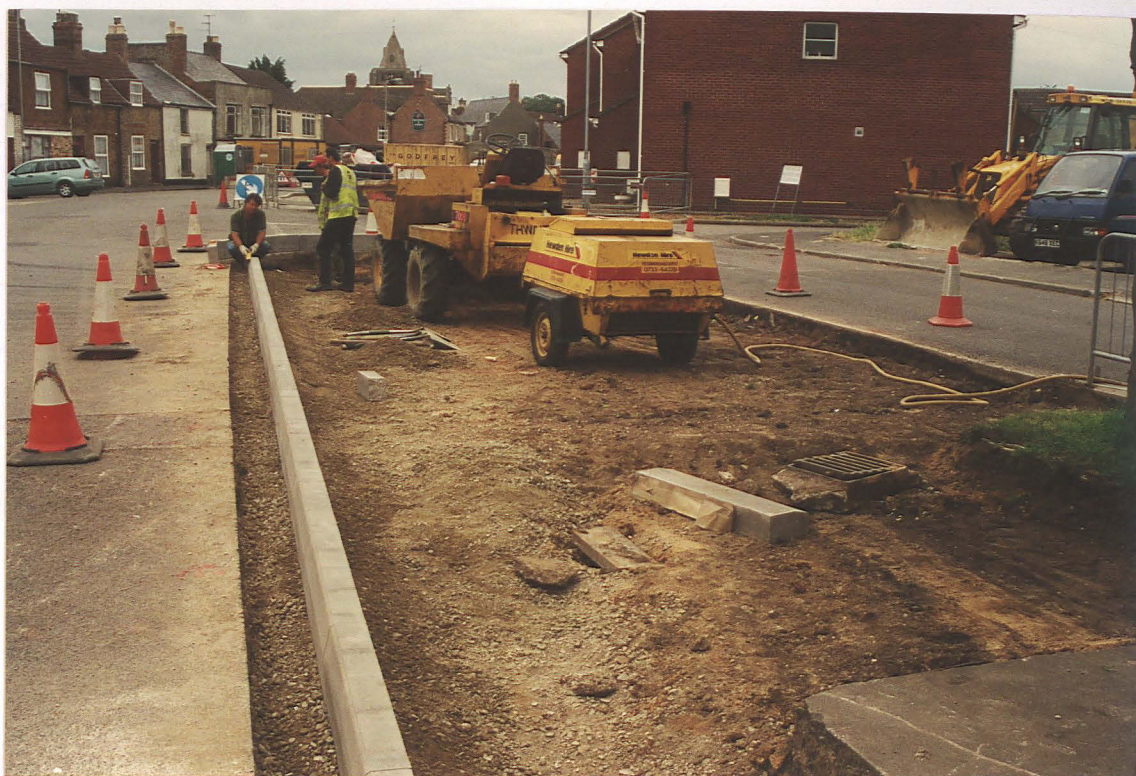
4. To the west of the row of shops, the excavations for new kerbing cut through the tarmac and just into the underlying material (Pl. 8). Nothing of interest was revealed.

Pl. 8 Limited extent of groundworks in West Street 4 (looking NE).

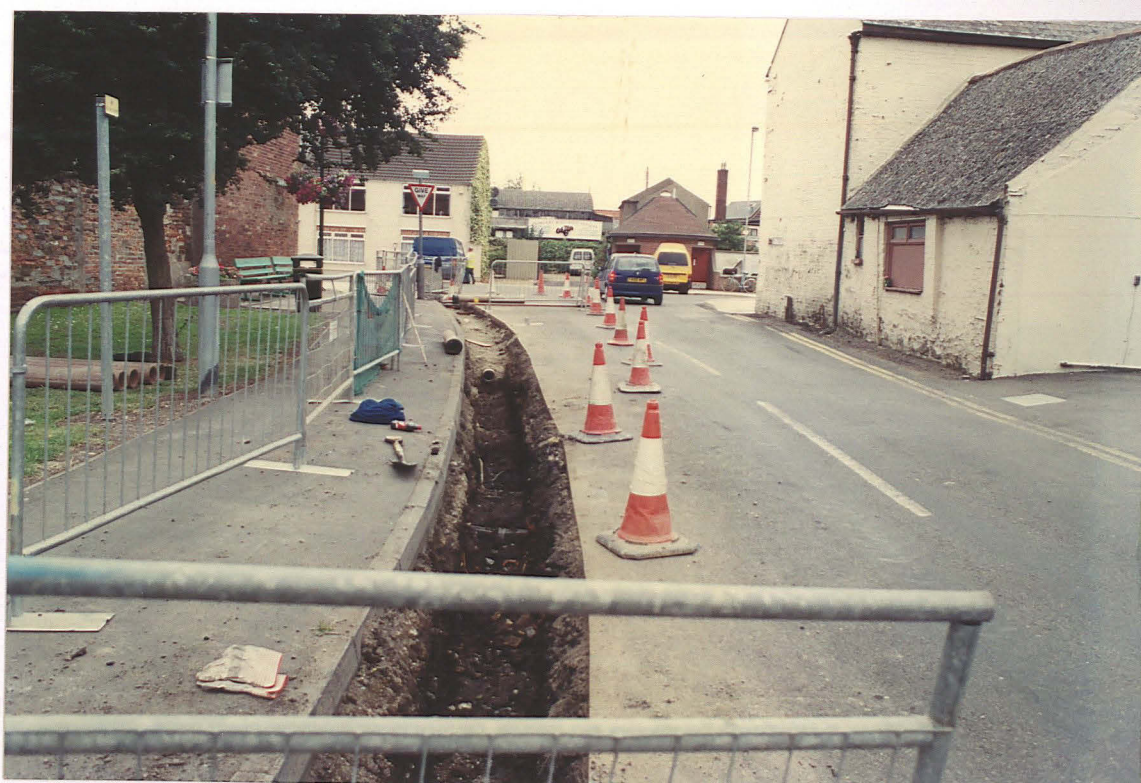
5. During the last site visit, a trench for a new drain along the west side of Albion Street was examined (Pl. 9). Beneath the tarmac at the junction with West Street was a layer of brick rubble

Pl. 9 Position of the monitored drain trench in Albion Street, looking north to West Street.

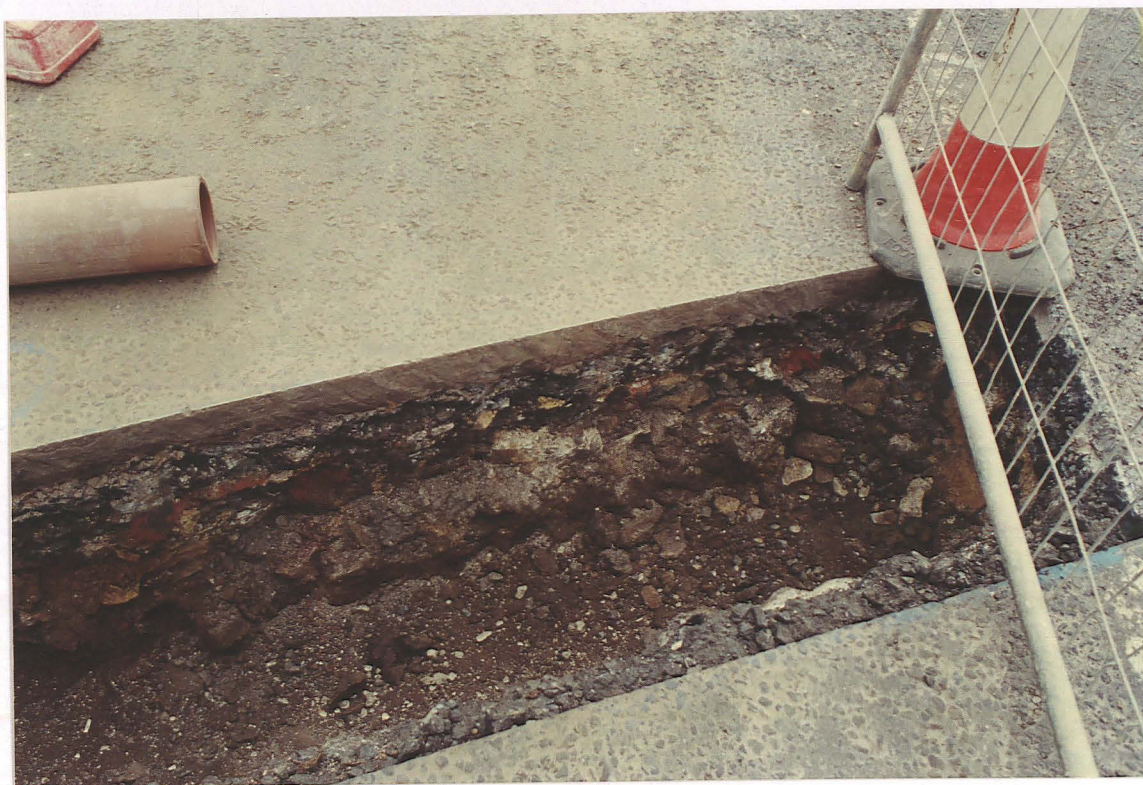
**Pl. 10 Brick rubble below the modern road surface at the junction of Albion Street and West Street.**

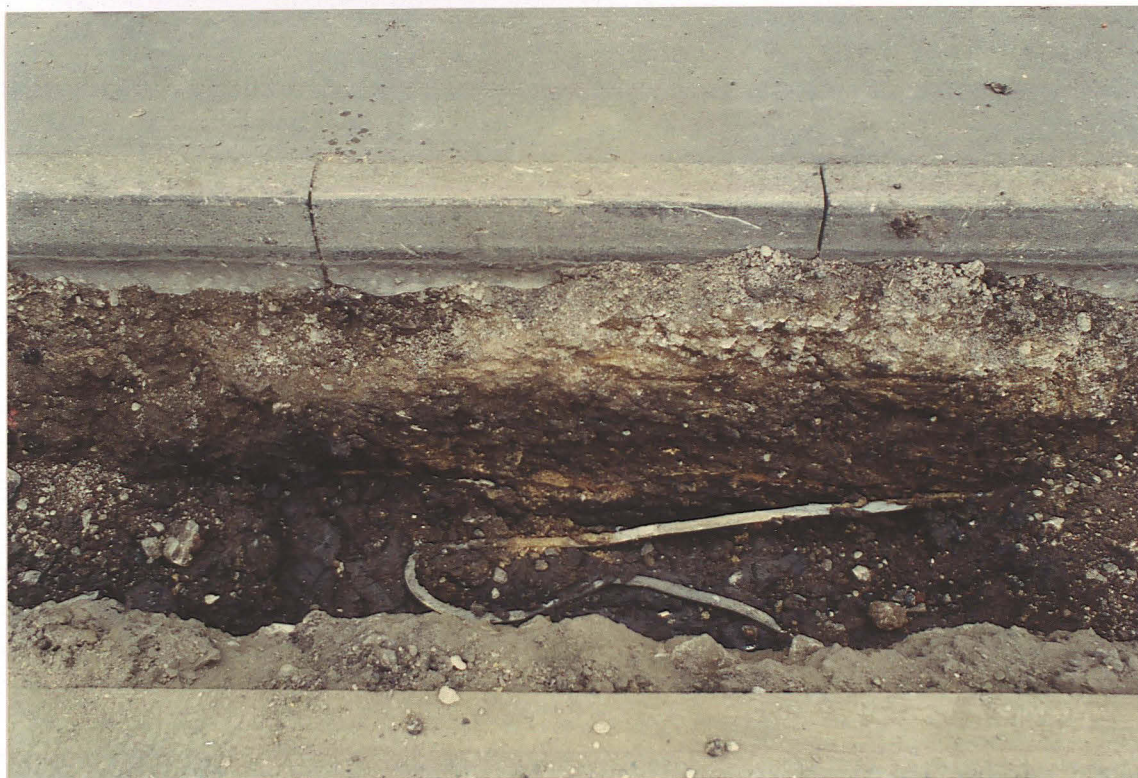
(Pl. 10). Further to the south, the brick rubble thinned, and the trench revealed clay loam and a darker deposit of silt or dried peat (Pls. 11 and 12). The trench exposed existing services, and the extent of previously disturbed ground could not be defined. The contractors produced a copper alloy spoon which had apparently been found in the trench, but its exact provenance is unknown (Pls. 13 and 14). It has been identified as of late medieval date (Appendix 1).

**Pl. 11 Clay loam and peaty deposits, Albion Street. The trench exposed existing services, and may have been fully within redeposited material.**

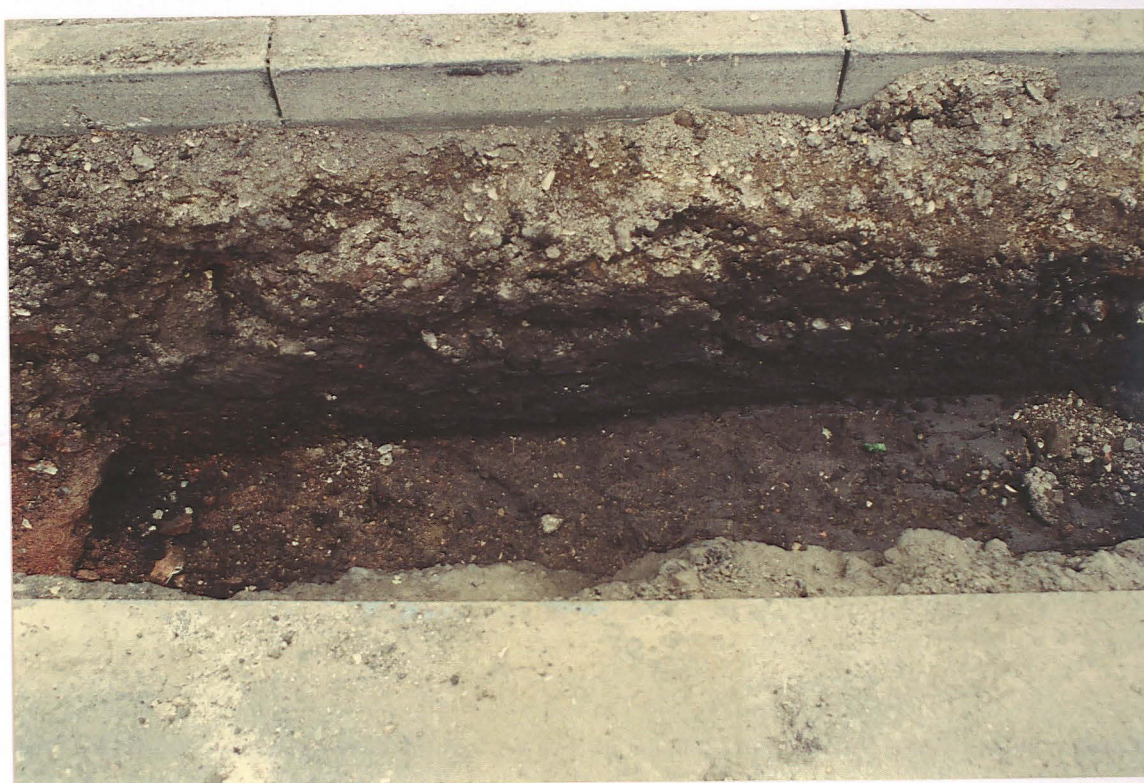
Pl. 12 Dark silty or peat deposits in the drain trench, Albion Street.

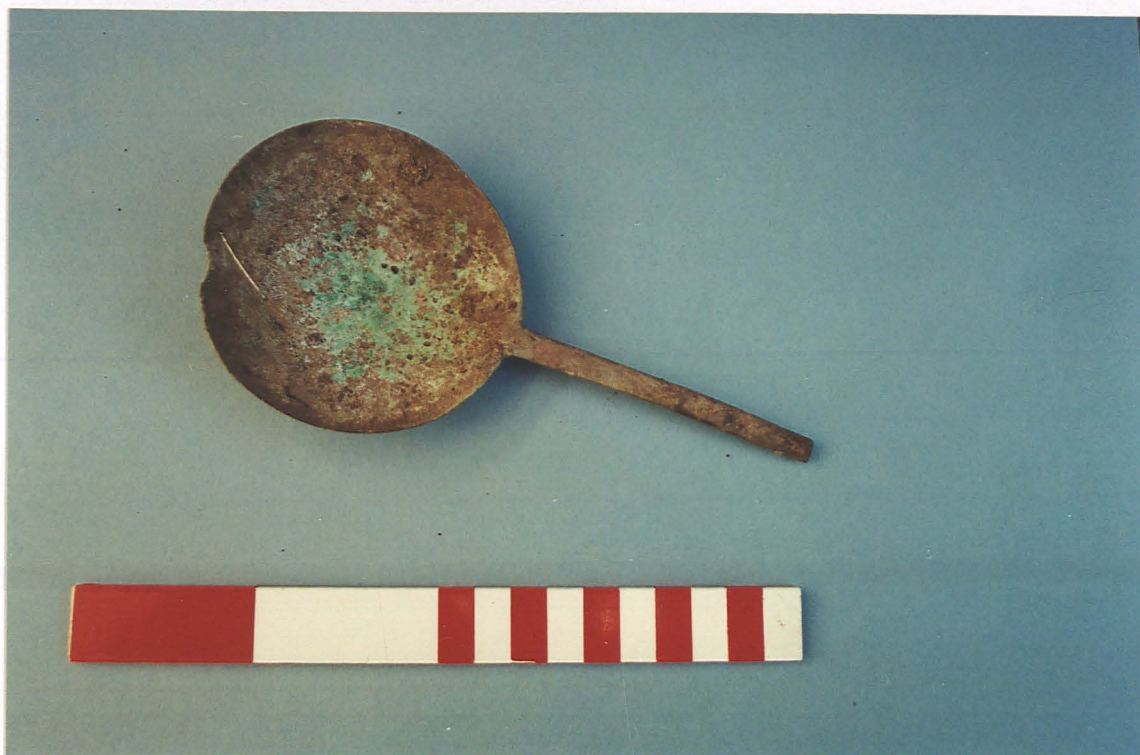
The spoon <1> has a slightly bent, broken hexagonal-sectioned handle and a large circular bowl, the size of which suggests that it could have been used as a shallow ladle. The lower edge of the bowl is chipped, while among the adhering soil are soot and traces of charcoal, suggesting that the spoon had been near a fire or buried within a deposit of fire debris. A large scratch and several smaller, parallel scratches on the inner face of the bowl are very recent (unlike the other damage), and were probably accidentally made during recovery.

This piece is almost certainly of late medieval to early post-medieval date, most probably within the earlier part of that period. The bowl lacks the characteristic late medieval 'fig-shape'; its length is fractionally greater than its width, perhaps suggesting an intermediate form between circular and fig-shaped, while hexagonal-sectioned handles occur on spoons of the 14th to the mid-17th centuries - occasionally in conjunction with circular bowls. Closer dating is not possible in the absence of any other distinguishing feature such as a terminal knop.

Pl. 13 Copper alloy spoon from Albion Street (scale 0.2m).

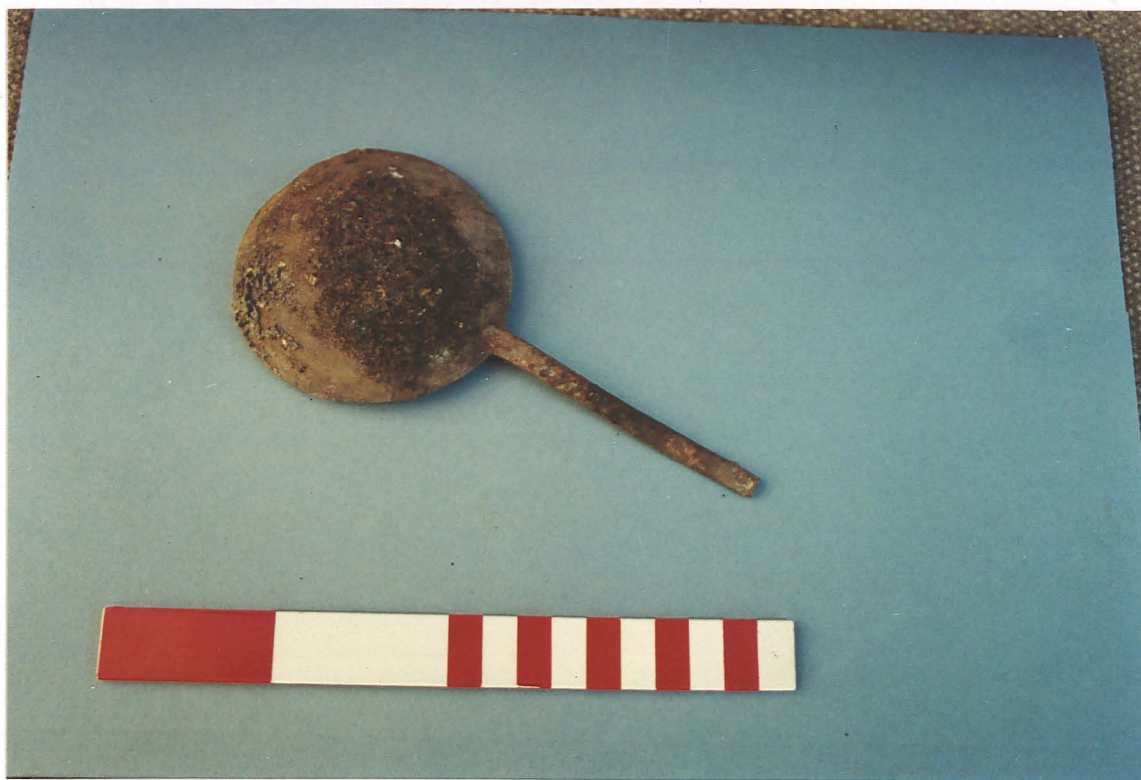
Pl. 14 Base of spoon from Albion Street (scale 0.2m).
