Land between 129-135 Station Street, Rippingale

Archaeological Desk-Based Assessment

Report prepared for Stamford Homes Ltd

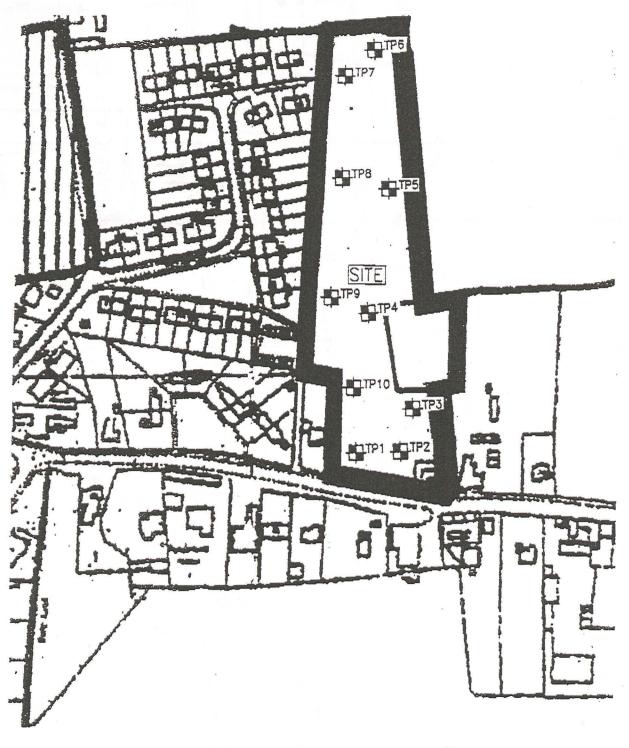
Fig. 3 Position of geotechnical test pits on the application site (reproduced from plan supplied by Abatech International. © Crown Copyright, reproduced with the permission of the Controller of HMSO. LAS Licence No. AL 50424A).

Ten geotechnical pits were excavated by machine across the site in late September 2000 (Fig. 3; Abatech 2000). The test pit logs indicate that topsoil thickness is fairly constant at about 0.3m, fluctuating by no more than 0.05m. They give no indication of archaeological features, and the only extraneous material noted was bricks in TPs 1 and 2 at the southern end. The topsoil covers a firm clay with limestone gravel, darker in TP1 at the SW corner of the site. The clay covered 0.3m -0.5m of intervening limestone in TP1 and TP3 (at about 1.1m - 1.4m deep), but elsewhere the upper clay directly overlies dark grey Lias clay at about the same depth. The limestone seems to have been too ephemeral to have had an effect on land use.

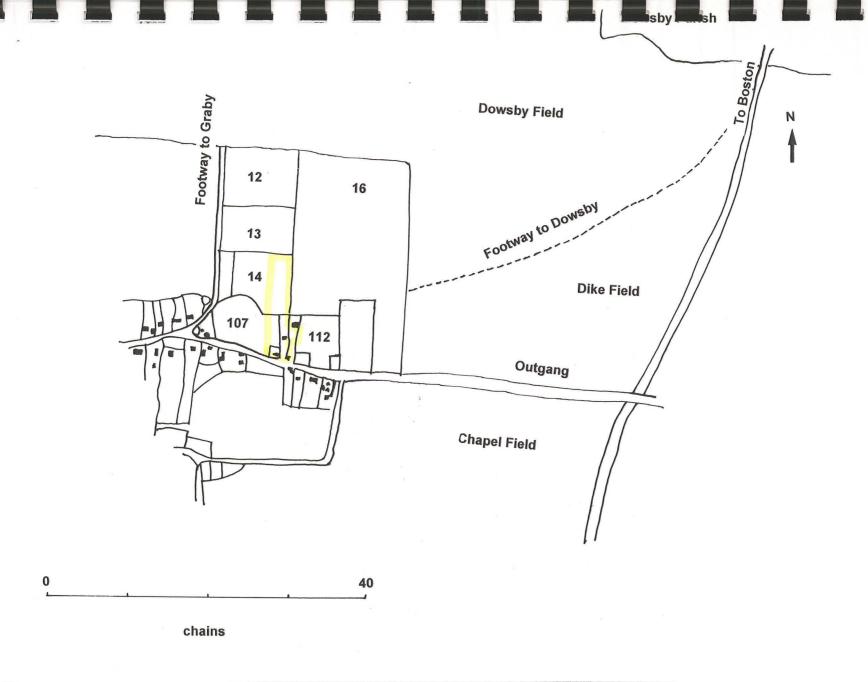
Fig. 5 Traced extract from the 1806 Rippingale Enclosure Award (LAO Rippingale parish, 17/2).

The caption 'clay pit' was omitted from the small plot west of 14 on Figure 5, traced from the 1806 Enclosure Award.

The earliest available depiction of the application site is the 1806 Enclosure Award (Fig. 5; LAO Award 17/2).

The application site has been formed from an amalgamation of part of three plots, marked on the Award as Plots 13, 14 and 107. Plot 107, despite being on the street frontage, was entirely undeveloped, with a single dwelling marked at the front of the application site.

It appears that Plot 14 had lain within Dowsby Open Field, but Plot 107 was within the area of older enclosure. The plan shows a 'footway to Dowsby' leading from the northern edge of the old enclosures, and crossing a field in a NE direction towards Dowsby village. This path explains the map's distinction between Dowsby Field and Dike Field, both labelled within a single area north of the Outgang road to Rippingale Fen. The path represents an old lane linking Rippingale with Dowsby, and formerly created a division between open fields. A glebe terrier for 1671 mentions 'the north field to Dowsby', and this could give a late seventeenth century date for the lane, predating the open fields division into two (Hall 1992, 24). The field to the east of the old lane was Dike Field. This probably referred to the Station Street stream, but possibly to the Car Dyke 220m to the east; the land immediately west of the Car Dyke was meadow land that may have been reclaimed from the fen (Hall 1992, 25).

The 1806 plan shows that the footpath to Dowsby had its origins in a path along the northern edge of the old enclosures, probably serving as access to the open field. A curiously rounded northern boundary to Plot 107 appears to reflect some feature previously within that field, protruding north of the back of the plots. The rounded boundary post-dates the footpath (as shown in 1806) but was responsible for the route of the footpath altering during the nineteenth century, when it headed off further to the north, and up to Glebe Farm. It may be related to the 1806 clay pit shown to the north, possibly reflecting a brick kiln site (a brick kiln is marked south of the village on Bryant's map of 1828).

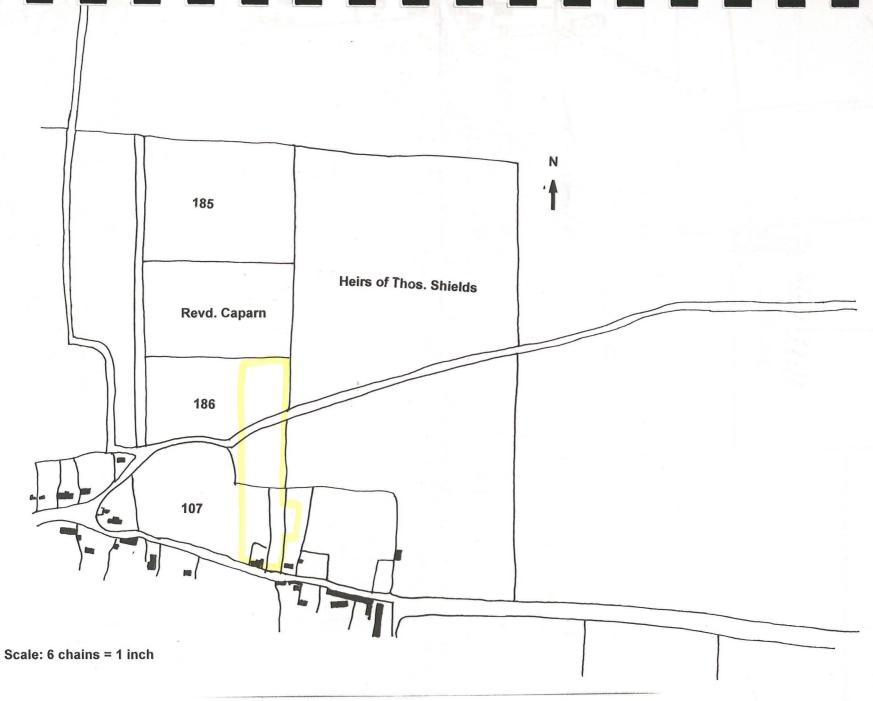
Fig. 6 Traced extract from an undated late nineteenth century plan of Rippingale (LAO 5Anc/5/B/1/8/1).

An undated, but late nineteenth century, plan of the village shows a similar picture, except for the lane to Dowsby no longer following the rear of the old enclosures (Fig. 6; LAO 5Anc 5/B/1/8/1). Plot 14 has become renumbered as 186, and the clay pit is not marked. The southern part of the application site lay within the tenure of J. Atkinson, jnr., with a third field to the north held by the vicar.

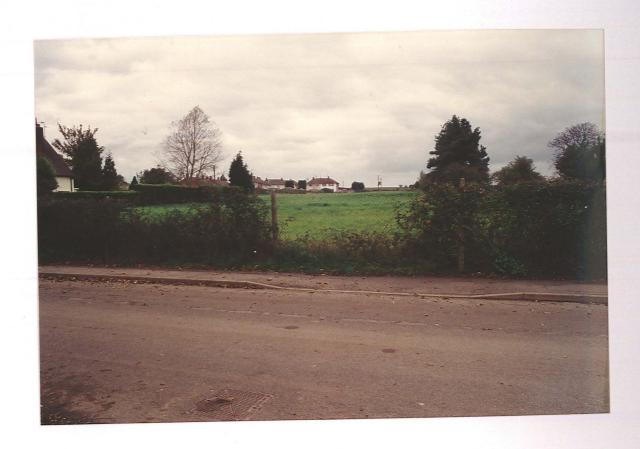
PI. 1 The application site, looking north from Station Street. Note the dropped kerb and the gap in the hedge.

Although at first sight this looks like two further house platforms, the nearby geotechnical pits have disturbed modern brick rubble, and concrete rubble or foundations are detectable within the thick grass. These two features are probably associated with twentieth century structures or localised dumping, rather than medieval settlement. A section of dropped kerb was seen outside the site, possible related to that landuse.

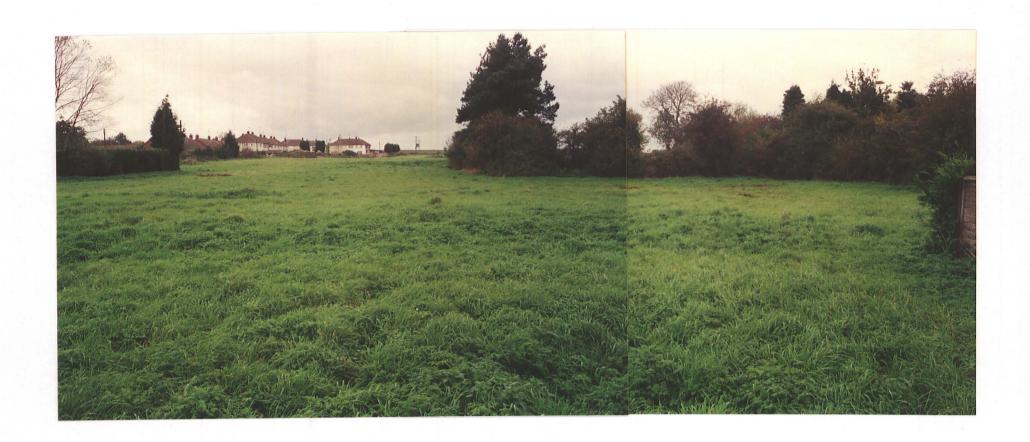
Pl. 2 The application site, showing the hedged field to the right, and the possible house platform beside the backfilled ditch and levelled bank beyond it. The ridge in the foreground may be medieval house platforms or the sites of more recent structures (looking north).

Within the general north to south downward slope are various variations. The most pronounced is behind the house to the west, where a broad ridge crosses the entire site from east to west. This appears to be the effect of a bank breaking the slope, and it coincides with the projected line at the rear of old enclosures fronting onto Station Street. At the western side of the site, a damp area beside this ridge reflects a relatively recently backfilled section of ditch, but most of the line is only visible as a crop mark (greener vegetation) alongside the ridge. The courses of the nineteenth century lane to Dowsby are not evident on a separate alignment, but may have used the same boundary at this point.

Beside the most recently backfilled section of ditch, the ground to the south seems to be level and slightly raised within a roughly square area. It was suspected that this might represent a house platform. A backfilled geotechnical pit beside this area had much darker subsoil than elsewhere on the site, and an unstratified sherd of pottery was recovered from the surface of the disturbed ground beside TP 4 (Context 1). The sherd has been examined by Jane Young and Barbara Precious, and both suspect it to be of Roman date. The interior fabric is grey, sandy and wheel-thrown, but the outer surface is absent. Ms Precious has suggested a date after the second century AD but before the fourth century. This is the first reported find from the site.

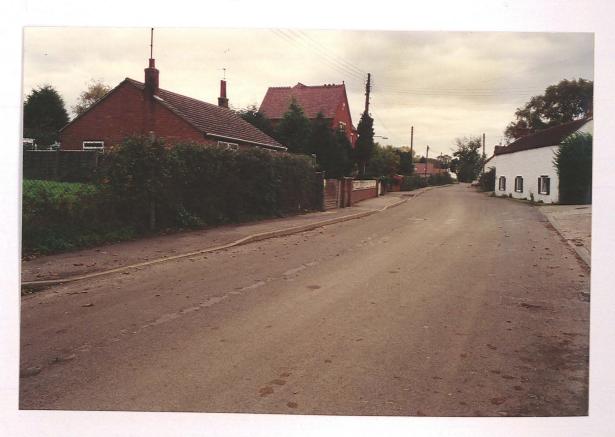
- Pl. 5 The ground rises either side of Station Street, possibly marking a former stream course (looking south through the site gateway).
- Pl. 6 Rough vegetation in the small attached field to the east. The rear boundary is the back of the block of old enclosures. Looking north).

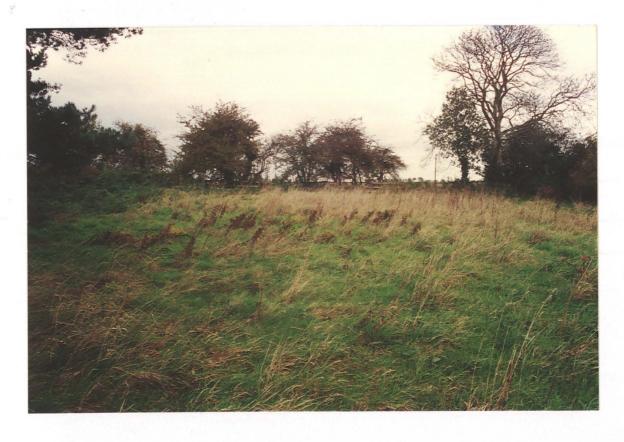
PI. 7 Rough grass in the northern part of the application site (looking north).

The main part of the application site is under rough grass, which appears to be vegetation growth in a stubble field that has not been cultivated for several years. A small pile of cut hay on the western side of the site may have been mown from the large field. The small field is under taller rough vegetation, with brambles and some scrub. Although the vegetation in the large field may still be suitable for geophysical survey, this technique could not be used in the small field in its present condition. The entire site was wet when visited, with water close to the surface or standing in machine ruts.
