**ARCHAEOLOGICAL
WATCHING BRIEF REPORT;
WELTON SOUTH PHASE II, HEATH ROAD,
SCOTHERN, LINCOLNSHIRE**

NGR: TF 0082 77610 - TF 0188 7758
SITE CODE: WSP 00
LCNCC ACC. NO. 2000.190

Report prepared for
Anglian Water Services Ltd.
by Chris Clay
November 2000

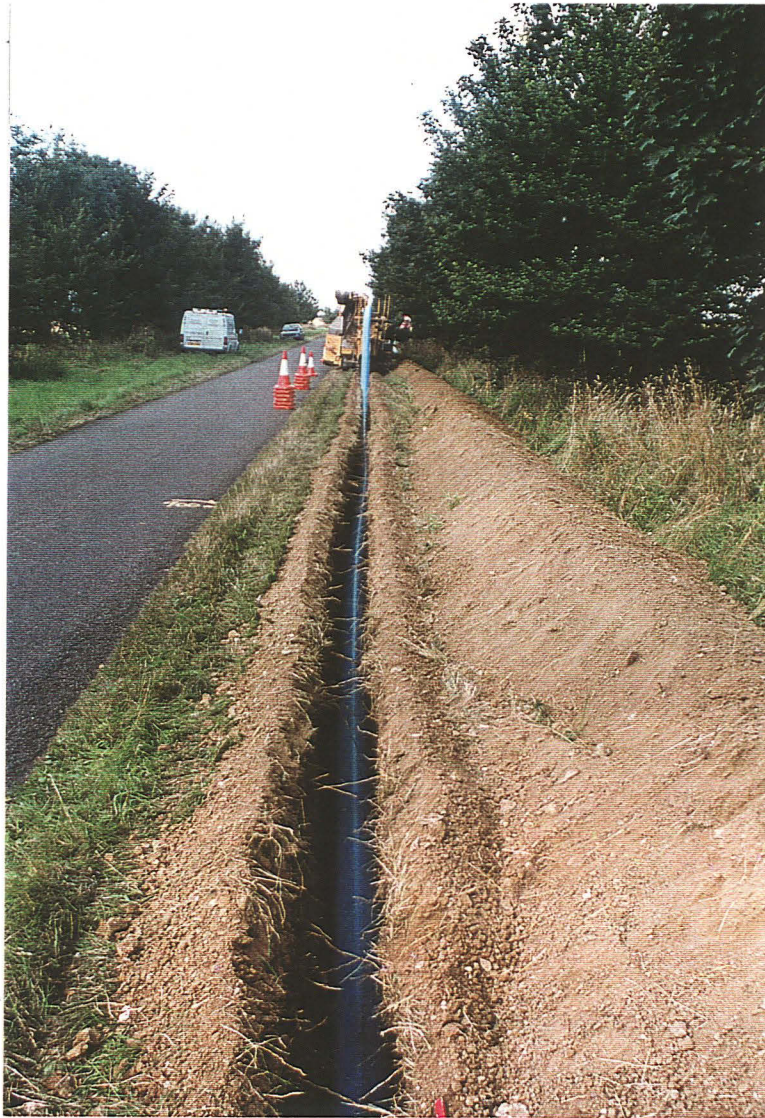
Plate 1: Working shot, showing simultaneous trenching and pipe laying (looking west).

The pipe trench was 0.3m wide and 1.2m deep. It was excavated using a rotary trenching machine, which inserted the new pipe as soon as it had cut the trench. It was then rapidly backfilled by a conventional mechanical excavator. Initially the trench ran along the north edge of Heath Road, crossing to the south immediately west of Scothern Heath Farm. On both sides the trench was approximately 0.8m from the road edge.

Several problems were encountered during this watching brief. Firstly, the pipeline trench was excavated by a rotary trenching machine, which caused the sides of the trench to be heavily scored, hindering the identification and interpretation of archaeological features.

Secondly, the small size of the trench, only 0.3m wide, made it difficult to clean and examine the sections. This problem was further enhanced by the trenching machine simultaneously excavating the trench and laying the pipe, which meant that only the upper 0.8m of the 1.2m vertical section was clearly visible.

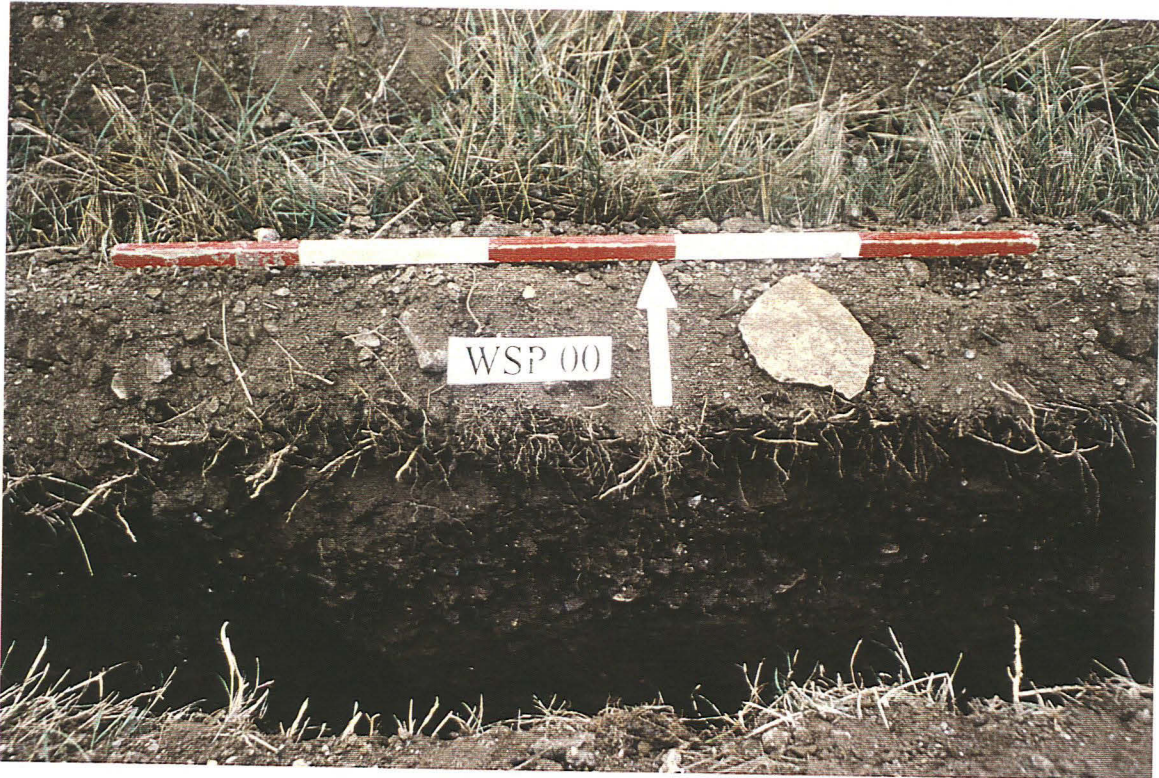
Plate 2: Gravel layer in (010), looking north

(009), (010): These two layers, 3.3m by 0.2m, and 2m by 0.05m respectively, both consisted of compacted, gravelly, sandy silt deposits, orientated north-south. Again, there was no associated dating evidence, although the compacted nature of the deposits suggest these may be former trackways.

The remaining positive features, (009) and (010), were wide and shallow, both characterised by layers of densely packed gravel. These may be former trackways; (009) representing a realignment of the track shown on the modern Ordnance Survey map (fig.1), and (010), visible only in the south section, may be a trackway associated with the property at Scothern Heath, which is present on the 1904 Ordnance Survey Map (fig.3)

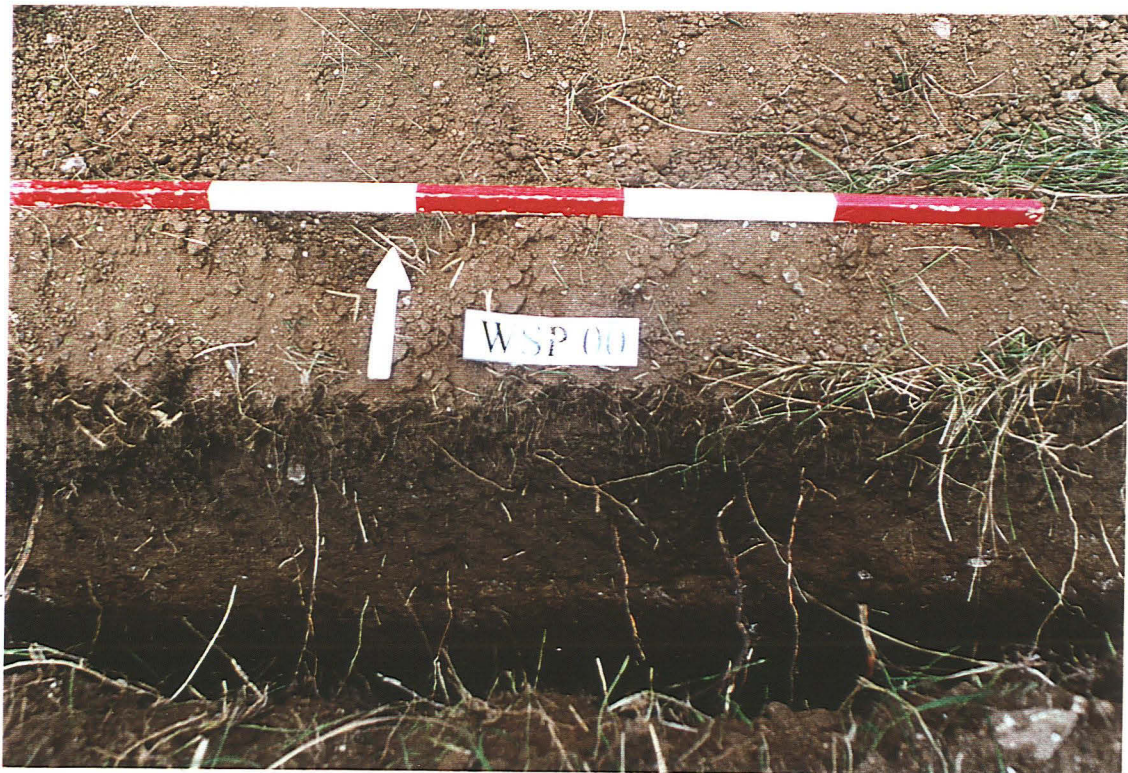
Plate 3: Ditch [008], looking north

[008], [011]-[020]: A series of morphologically similar ditches, all orientated north-south, and characterised by shallow sloping sides and a concave base. They ranged from 0.3 to 0.5 metres in depth and 0.7 to 1.68 metres wide. They were filled with loose sandy silts, similar to the topsoil, (001), and had all been subject to considerable disturbance by root action. No dating evidence was recovered from any of these features.

The considerable root disturbance in features [008] and [011] - [020], and the similarity of their fills to the modern topsoil, suggests that they are probably post medieval field boundaries. Fig.3, taken from a 1904 Ordnance Survey map (based on an 1886 survey), shows field boundaries which were present in 1886, which have now been removed. Some of these field boundaries appear to tie in with the location of the ditches detected in the pipe trench.
