**ARCHAEOLOGICAL WATCHING BRIEF
REPORT
HARMSTON TO BRACEBRIDGE HEATH,
LINCOLNSHIRE.**

**CENTRAL LINGS TRUNK MAIN
REHABILITATION , PHASE II**

Report Prepared for
Anglian Water Services Ltd.
by Jim Rylatt and Mark Allen
October 2000

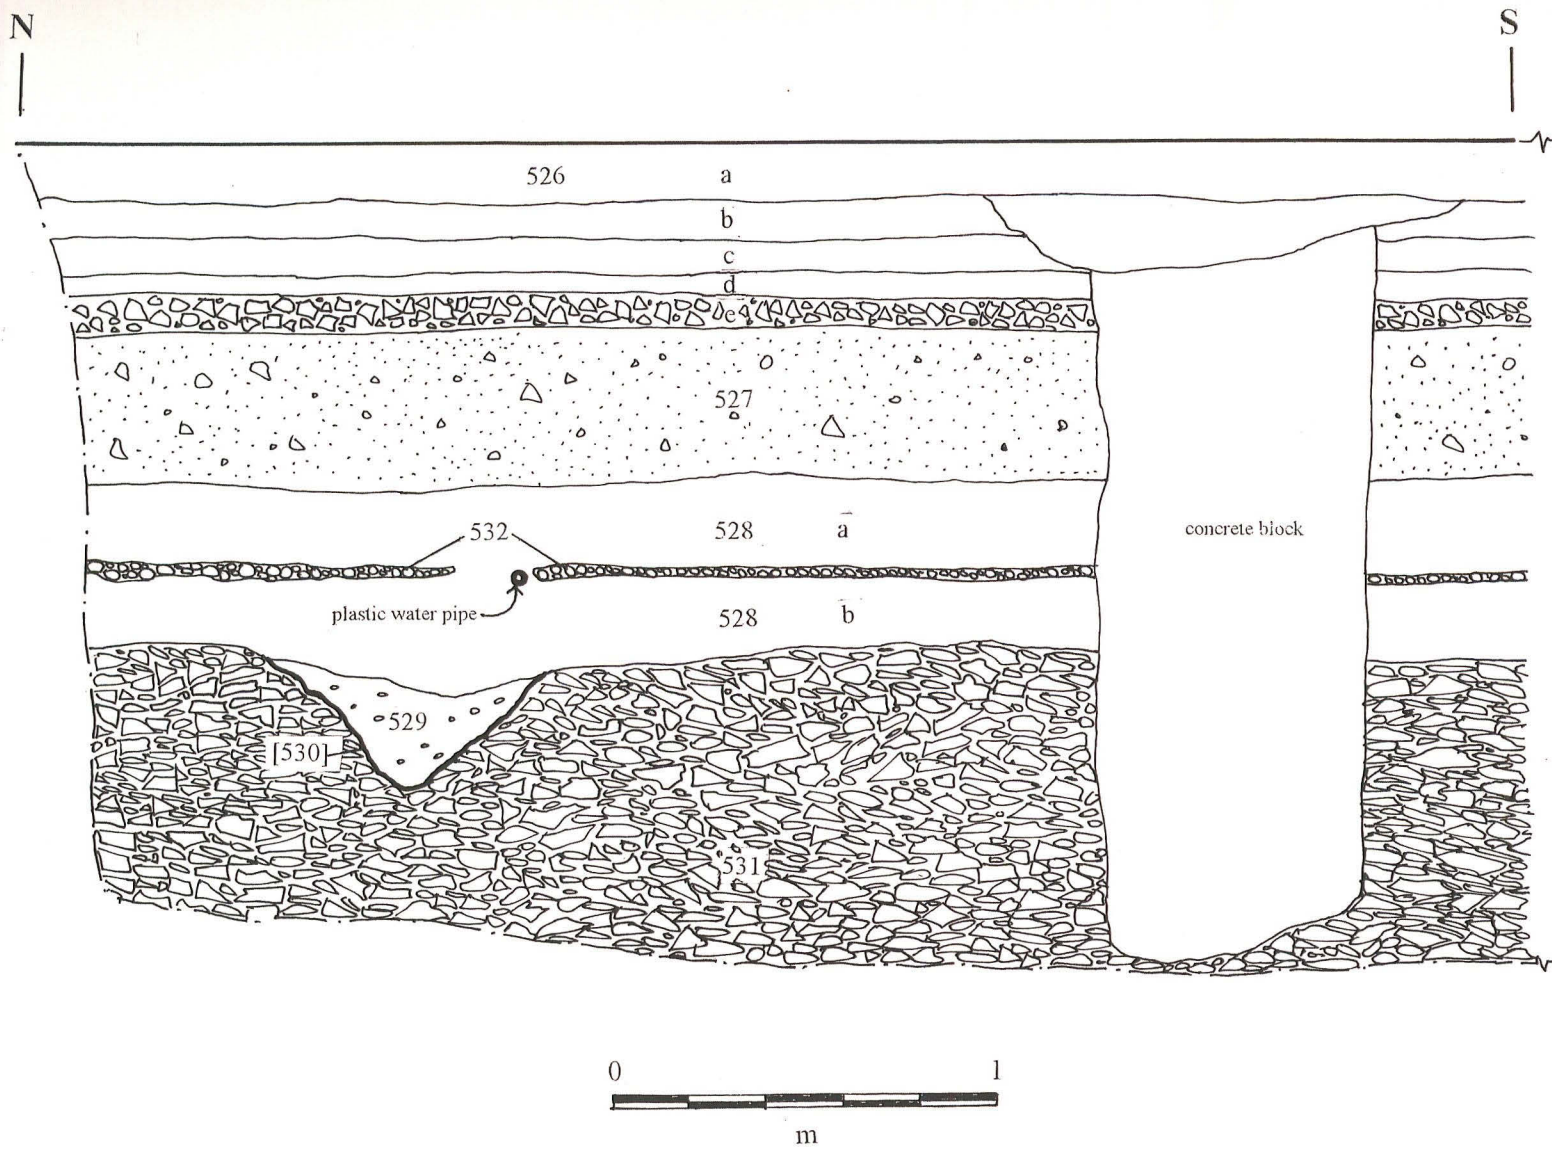
Figure 5: Access Pit 27, west facing section. The possible Roman road surface is deposit [532].

Located on the western side of the road, to the immediate north-east of Pit 26. Positioned to enable the pipe to change direction and run under the road. Cleaning of the west facing section revealed two potential archaeological features (*fig. 5*). The top 0.5m of the section was composed of successive layers of tarmac, (526), representing at least 4 road surfaces. Beneath this was a deposit of crushed limestone hardcore, (527), upon which the road had been laid.

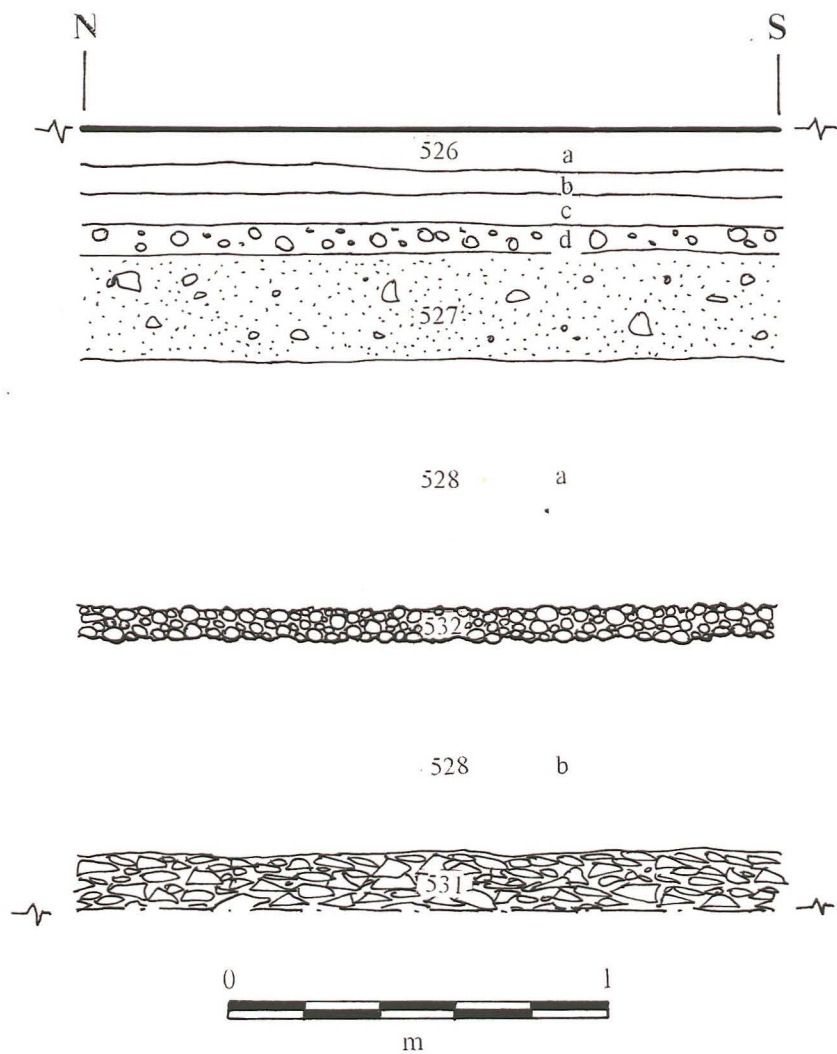
Figure 6: Access Pit 29, west facing section. The possible Roman road surface is deposit [532].

This had sealed a c. 0.42m thick layer of orangey-brown silty sand, (528), which contained occasional charcoal flecks and tile fragments. Within this layer, c. 1.10m below the modern road surface, was a layer of sub-rounded quartzite pebbles, (532), c. 0.02-0.05m thick. It was only possible to examine this layer in section, but it closely resembled the Roman surface of Ermine Street exposed at Navenby (Rylatt, 2000: this volume). Certainly (532) does not have a natural origin as scraps of tile were recovered at the base of (528), c. 0.25m below this 'surface'. Consequently, there is a possibility that (532) represents either the Roman surface of Ermine Street, which would mean that it enters Bracebridge Heath on a slightly different alignment than that currently projected, or that it represents a minor road running perpendicular to this early highway. The latter interpretation has some credibility, as there are significant scatters of Romano-British artefactual material in the fields to the west of this access pit.

Layer (532) was also detected in Access Pit 29 (*fig. 6*), again there was no associated datable material, but the arguments for a Roman date, given above, also hold true for this example. This access pit lies c. 450m to the north of Pit 27, on the section of Grantham Road that appears to overlie or closely mimic the course of Ermine Street. This suggests that in Pit 29, layer (532) is the surface of Ermine Street. Access Pit 31 also overlay this particular alignment. Therefore, a further band of sub-rounded quartzite pebbles situated at the interface between a sandy silt deposit and the limestone brash may represent another section through the Roman road (*fig. 7*).

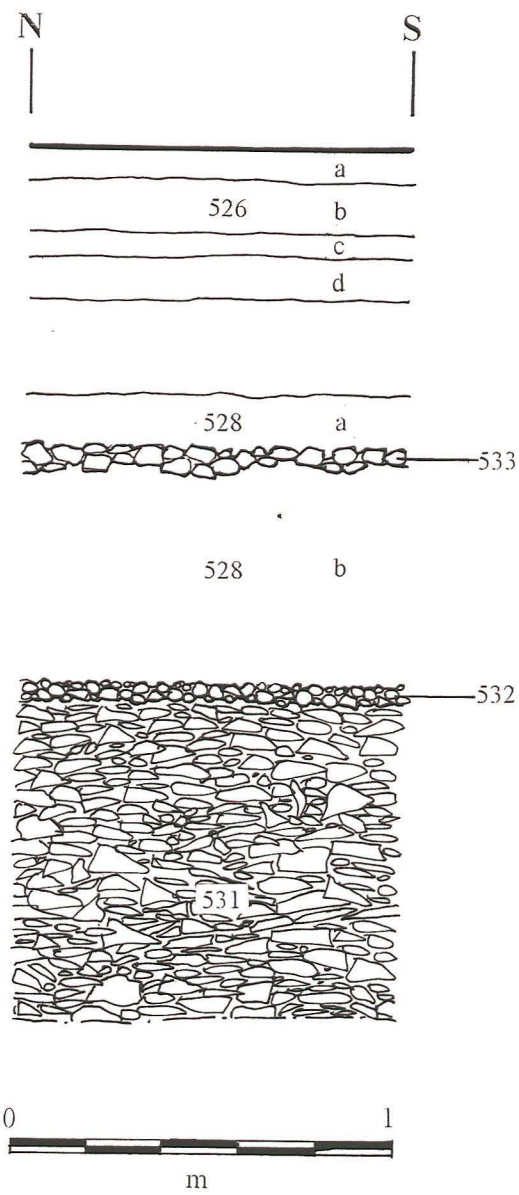
Figure 7: Access Pit 31, west facing section. The possible Roman road surface is deposit [532], with a later surface marked as [533].

This pit was situated on the western side of the road, c. 150m north of St. John's Road. The pipe turns sharply toward the north-east to enter to reservoir compound. The top 0.4m was an accumulation of successive layers of tarmac, (526) (*fig. 7*). Beneath this was a deposit of crushed limestone hardcore, (527), c. 0.26m thick. This hardcore was laid upon the silty sand deposit, (528), noted in the access pits to the south, but in contrast to Pit 29, this was only c. 0.66m deep.

The interface between (528) and the limestone brash, (531), was defined by a thin band of sub-rounded quartzite pebbles, c. 1.42m below the modern ground surface (BMGS). Within this layer was a small quantity (c. 15%) of sub-angular limestone fragments, otherwise it appeared to be very similar to (532), noted in Access Pits 27 (1.10m BMGS) and 29 (1.27m BMGS).

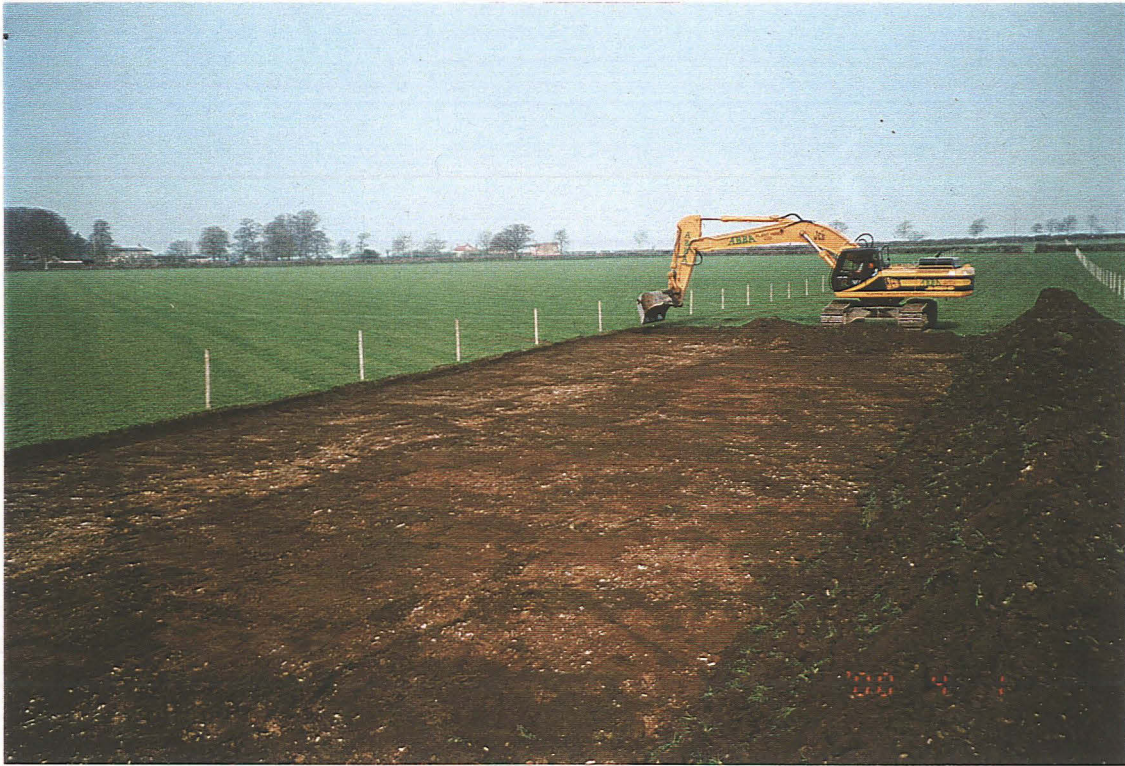
Plate 1: Plot 4. topsoil stripping in progress, note the modern plough scores, running diagonally across the easement, cutting into the subsoil. looking north-west.

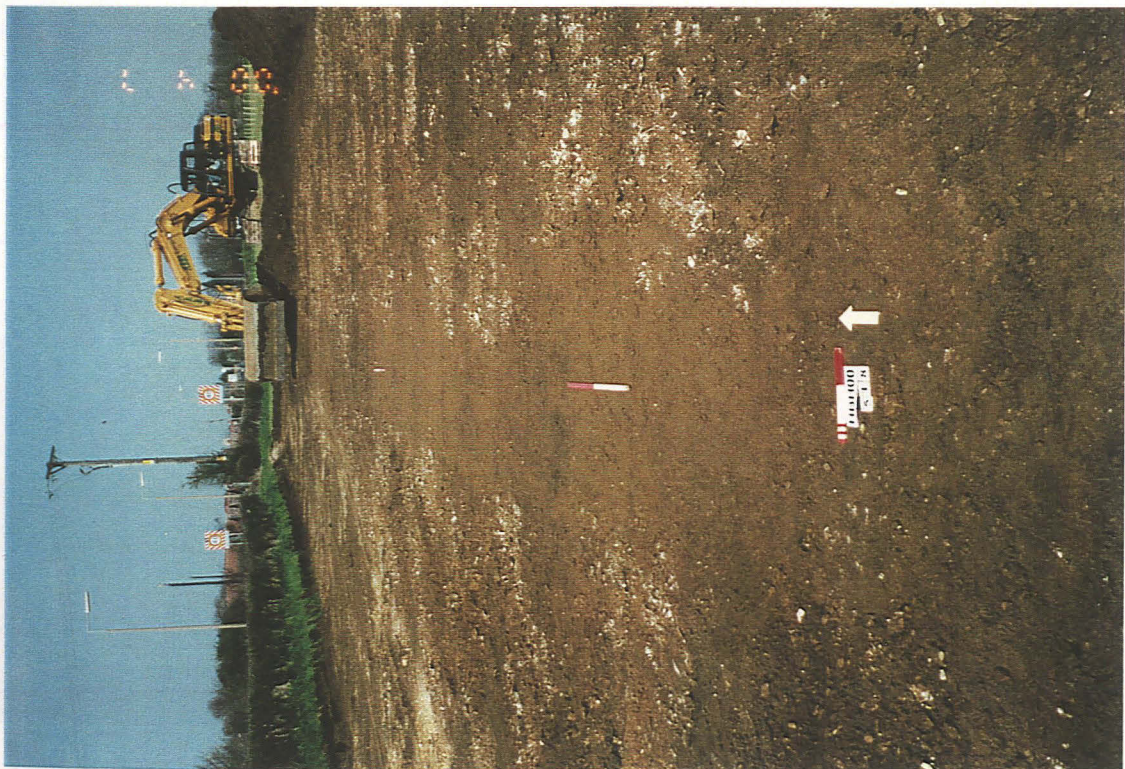
Plate 2: Plot 8, furrow [518] running up the middle of the picture, looking north.

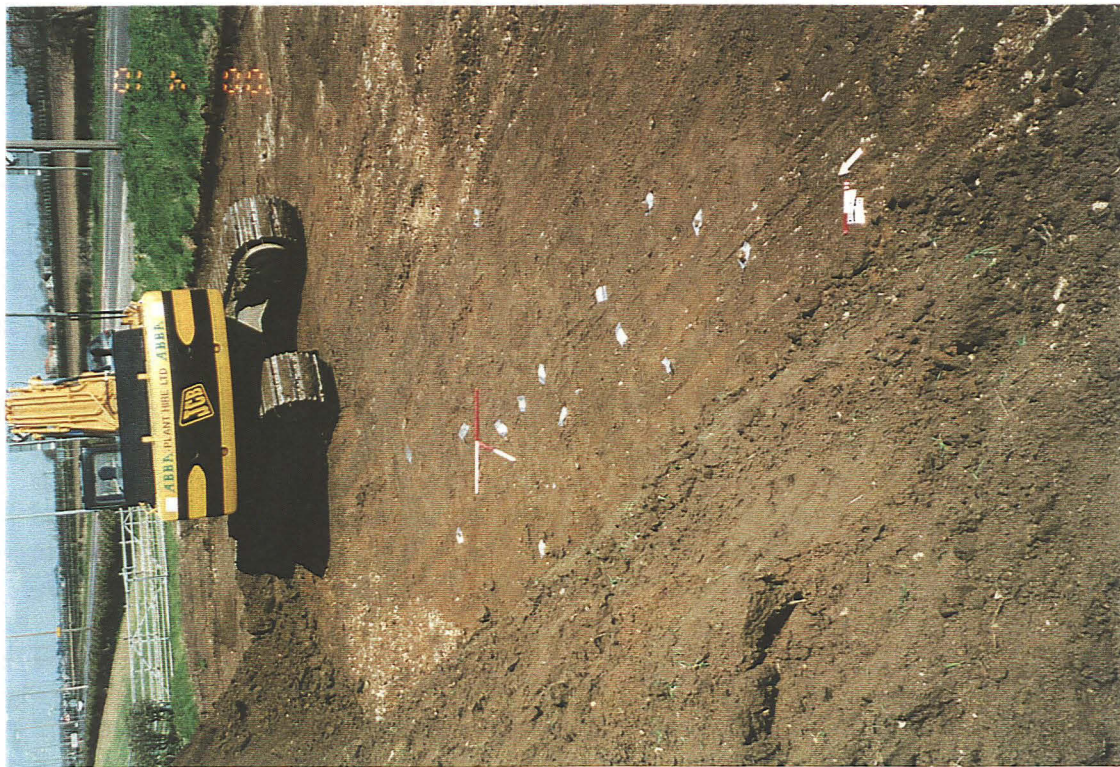
Plate 3: Plot 12, pre-excavation shot of furrow [520], showing distribution of finds exposed by topsoil stripping, looking north-east.

A single furrow, [520], aligned north-east to south-west, was found c. 34m south of the boundary with Plot 13 (*fig. 4*). The furrow was c. 3.18m wide and had a flattened 'U'-shaped profile, c. 0.30m deep. Seventeen sherds of medieval pottery were recovered from this feature. These represented a fairly homogenous group, which was manufactured in the mid- to late 14th century. Accompanying this collection of domestic ceramics was a quantity of tile, which was produced between the 12th and 15th centuries, and an iron barrel padlock, the latter of late medieval or post-medieval construction.

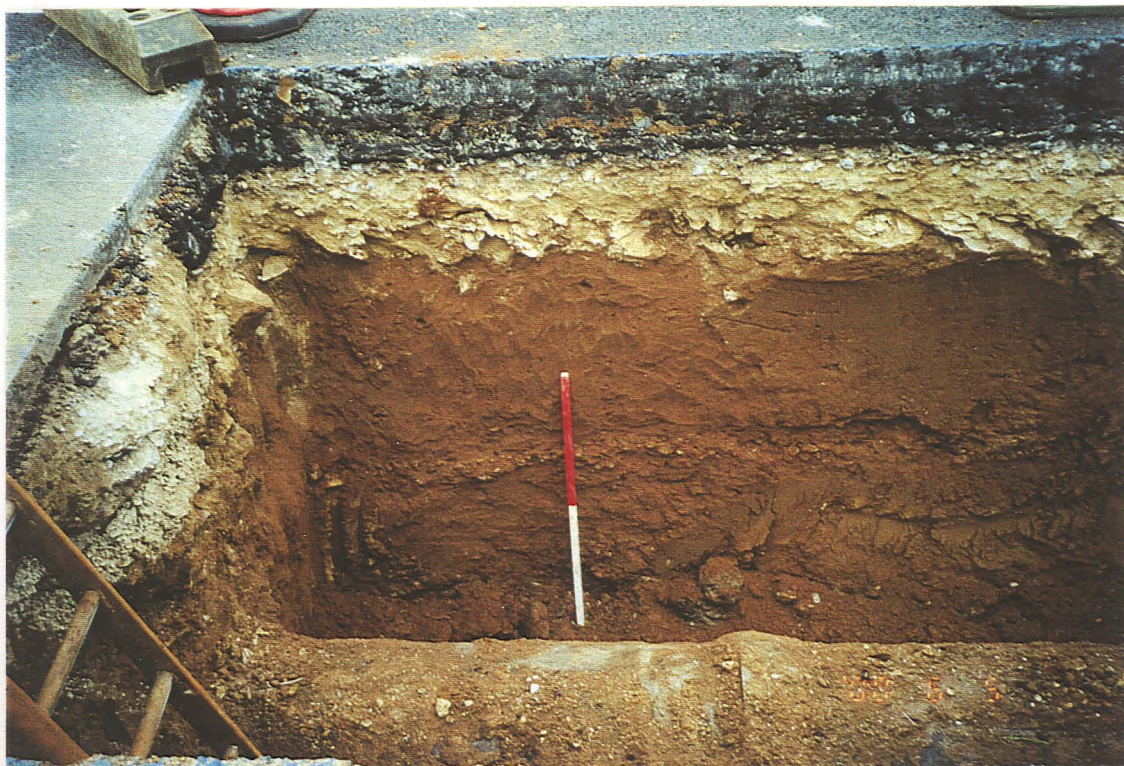
Plate 4: Access Pit 29, west facing section, with the possible Roman road surface, (532), visible half way up the red section of the vertical scale, looking east.

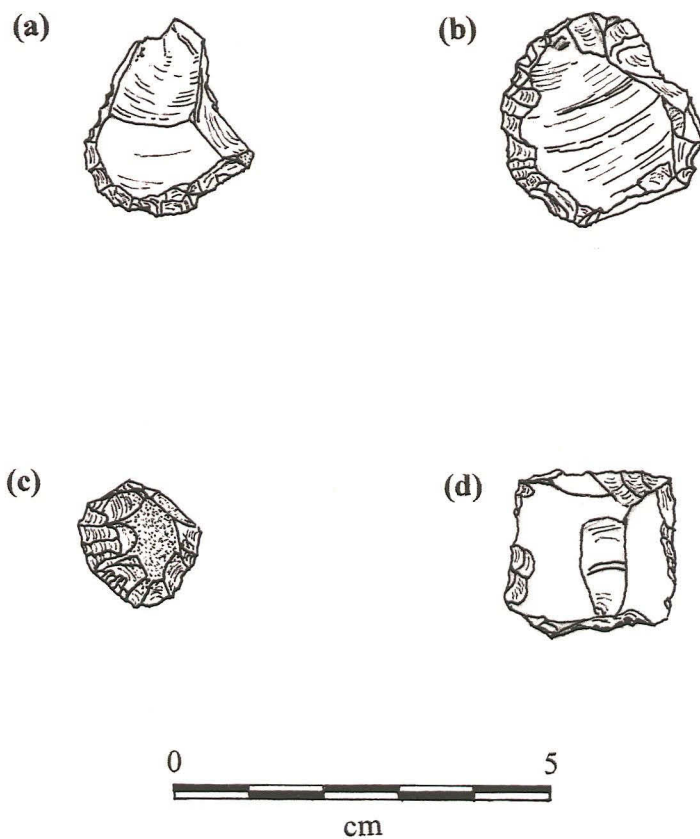
Figure 1: Selection of the lithic material recovered during the Central Lincs Trunk Main Rehabilitation Scheme, Phase II, situated between Harmston and Bracebridge Heath. (a) Scraper, (10), recovered from Plot 4; (b) Side scraper, (12), recovered from Plot 5; (c) Thumbnail scraper, (43), recovered from Plot 13; (d) Wedge technique gun flint, (40) also recovered from Plot 13.

The gun-flint (40) found in Plot 13 is of a type mass produced in the post-Medieval period for use in flintlock weapons.
