**ARCHAEOLOGICAL
WATCHING BRIEF REPORT;
PLOT 4, LEGSBY ROAD,
MARKET RASEN, LINCOLNSHIRE**

NGR: TF 1136 8846
SITE CODE: MRAA00
LCNCC ACC. NO. 2000.295
Planning ref: M00/P/0465

Report prepared for
Mr K. Reid
by Chris Clay
December 2000

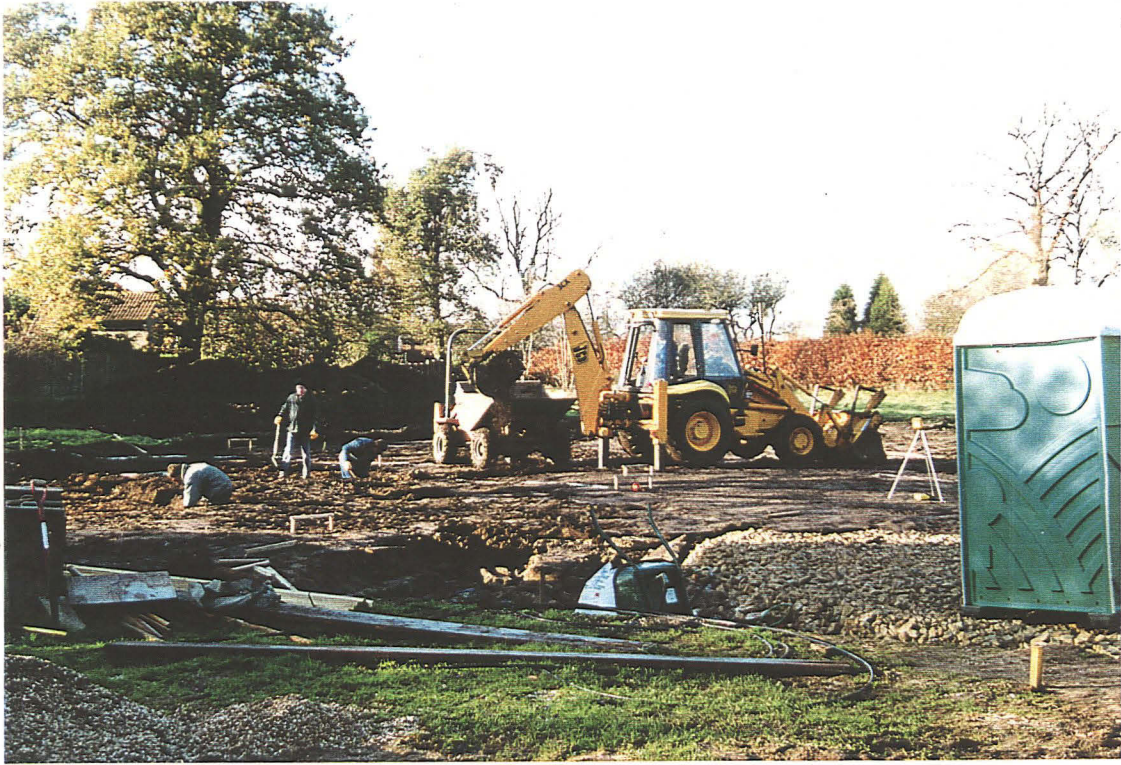
Plate 1: General working shot, looking northwest

The stripping of vegetation and a proportion of the topsoil from the house footprint showed the area to have been subject to considerable modern disturbance. The site had formerly been part of an orchard, which had resulted in large amounts of root disturbance and had left abundant organic material in the topsoil. A garage had formerly stood in the southern corner of the site, causing further disturbance and leaving a spread of modern building debris over much of the site.

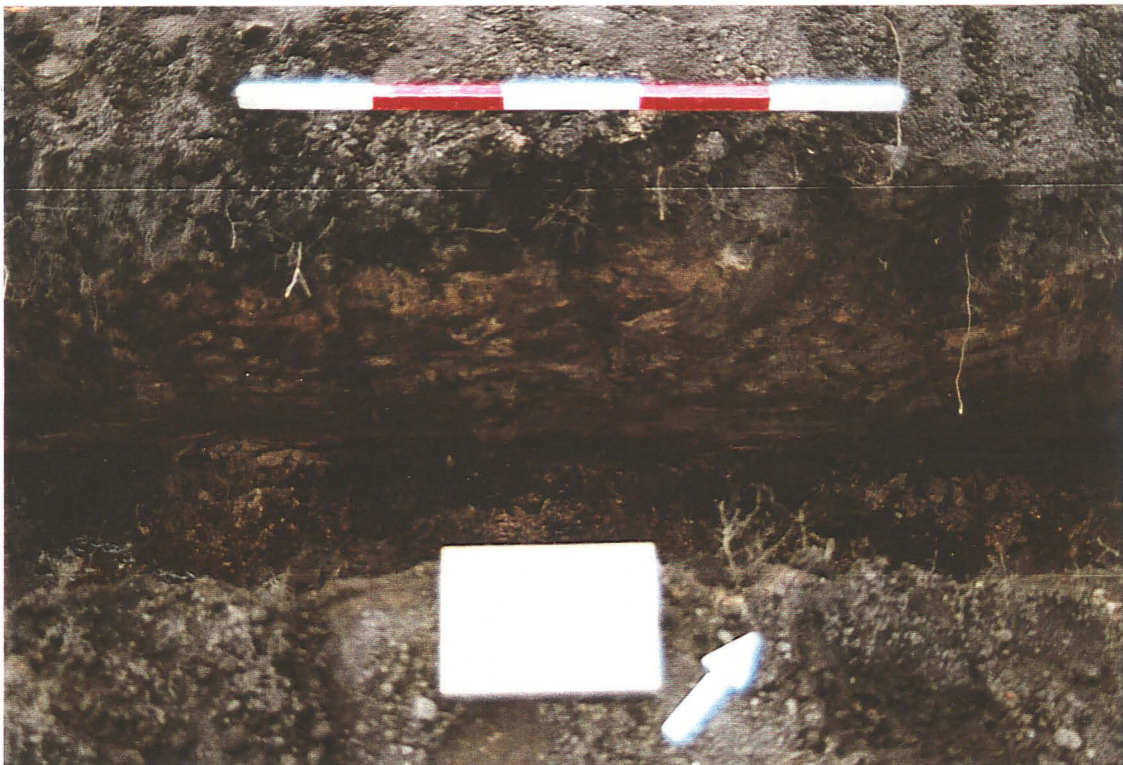
Plate 2: Foundation trench section, looking northwest

The foundation trenches were excavated to between 0.4 and 0.9m below ground level, being shallowest towards the northern corner of the house plot. The stratigraphy within the trenches was simple and relatively uniform. The uppermost layer consisted of a very dark brown topsoil containing large amounts of roots and other organic material, as well as modern building debris. The depth of this layer was subject to small variations across the site, but on average measured approximately 0.5m from the original ground level. Below this layer was a mid to dark brown sandy subsoil, approximately 0.2m deep. The final layer noted was an orange/yellow sand, which was revealed only in the deeper areas of excavation and was interpreted as the natural drift geology of the area.
