**Lower Road, Hough On the Hill
Plot between Cherry Cottage and Hillside**

Archaeological Watching Brief

**LAS Report 495
January 2001**

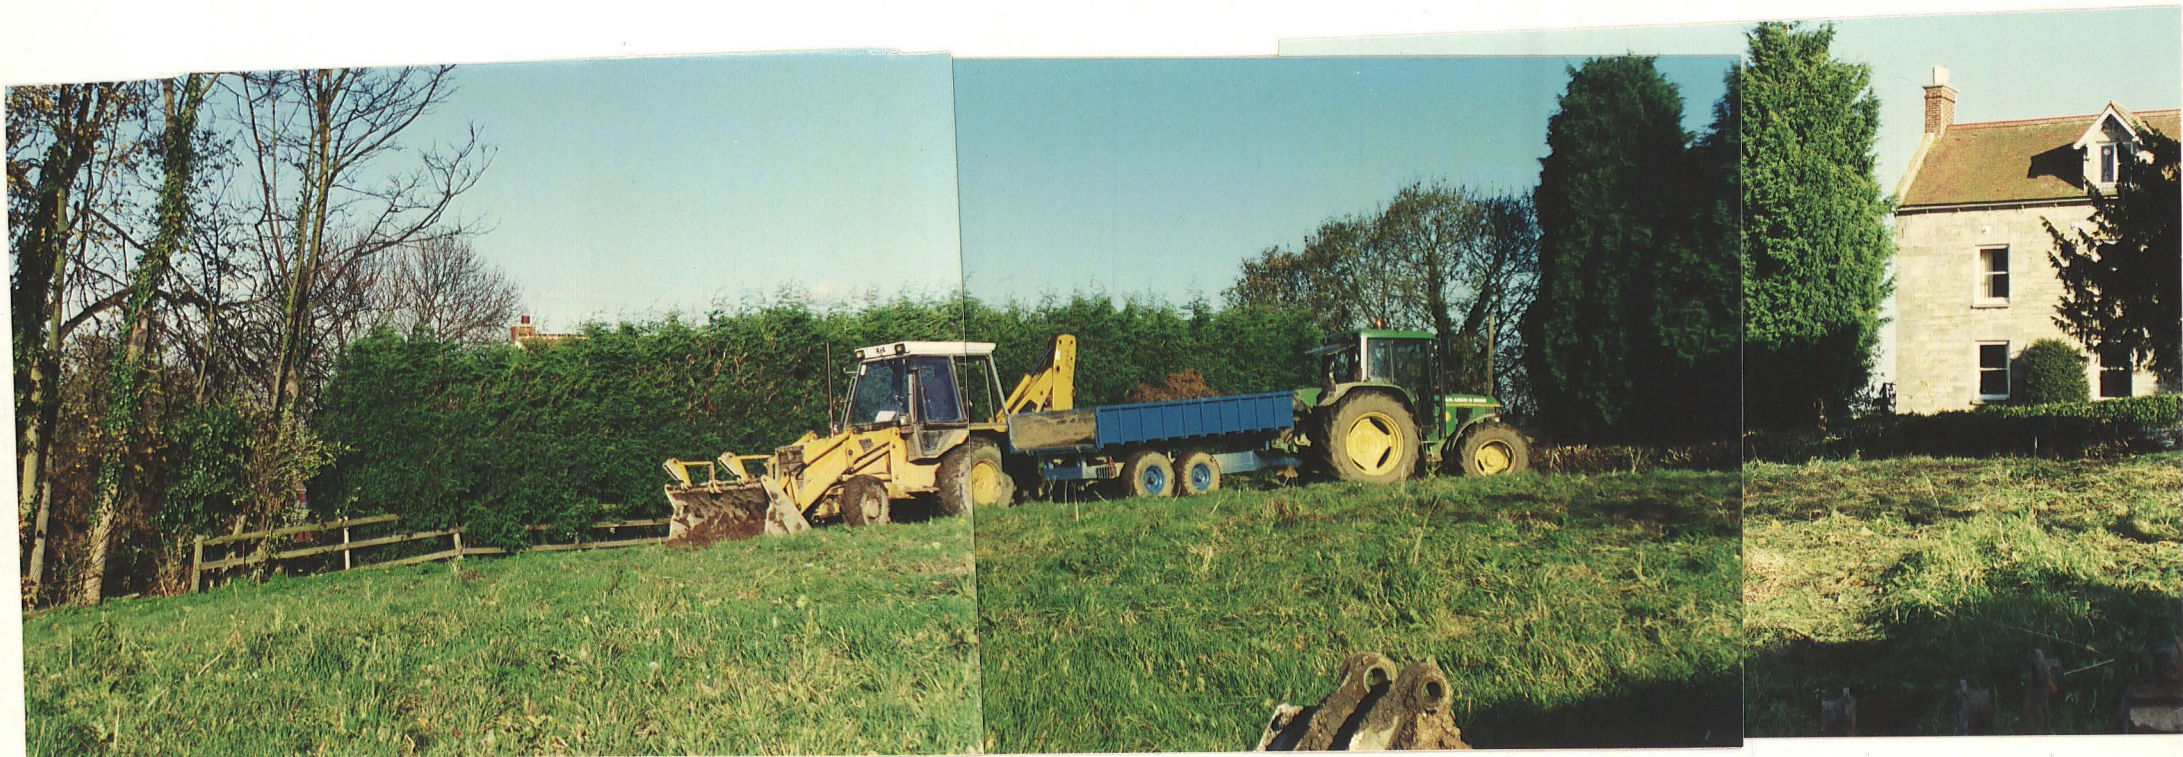
Pl. 2 General view of site looking north-east showing ground sloping to the west .

The plot of land is a grass field on the west side of Low Road. It is rectangular in shape and has a pronounced ridge through its centre with land falling rapidly to the west towards a stream which lies beyond the plot boundary (up to 1.30m) and more gradually towards the road (up to 0.60m), which forms the eastern boundary of the plot.

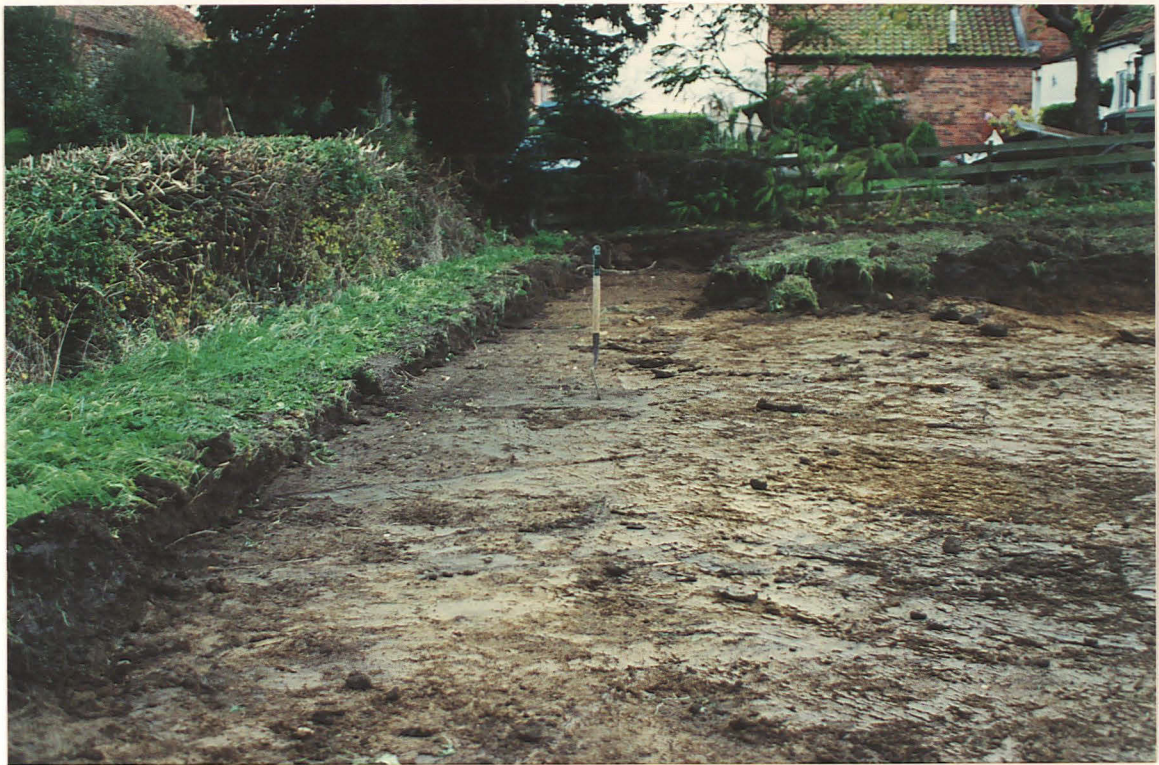
Pl. 3 Area next to Lower Road stripped of topsoil looking south. Grey soil discolouration near spade is associated with modern tree roots.

An area of discoloration in the soil close to the hedgeline proved to be the burnt remains the roots from a tree or bush. No other features were seen during the topsoil stripping. Given that the vast majority of the area had been stripped to the natural clay the watching brief was abandoned.

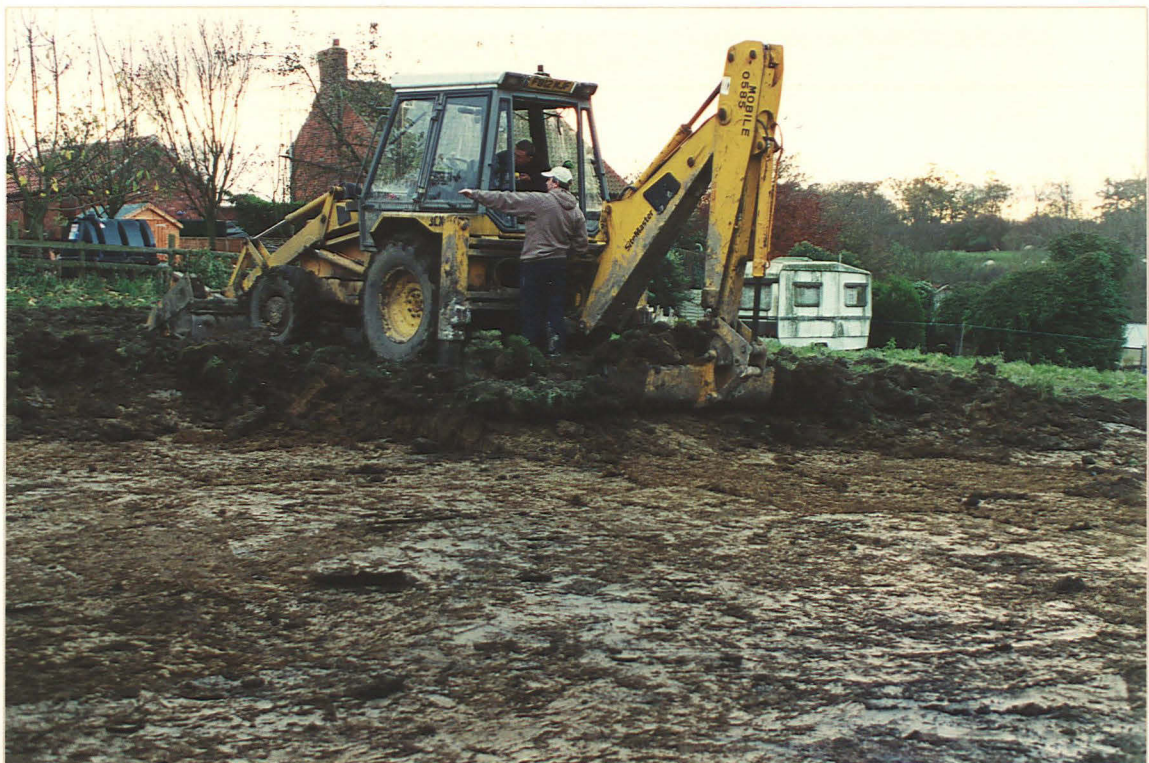
Pl. 4 Topsoil clearance in centre of site, looking south.

The whole building footprint and associated access areas were stripped of topsoil (**100**) to provide a level area from which to excavate the foundation trenches. In some places at the edge of the footprint (to the west and east) the topsoil was not penetrated. Towards the middle of the site 0.20-0.30m of the natural clay (**101**) was removed in order to achieve the correct level.

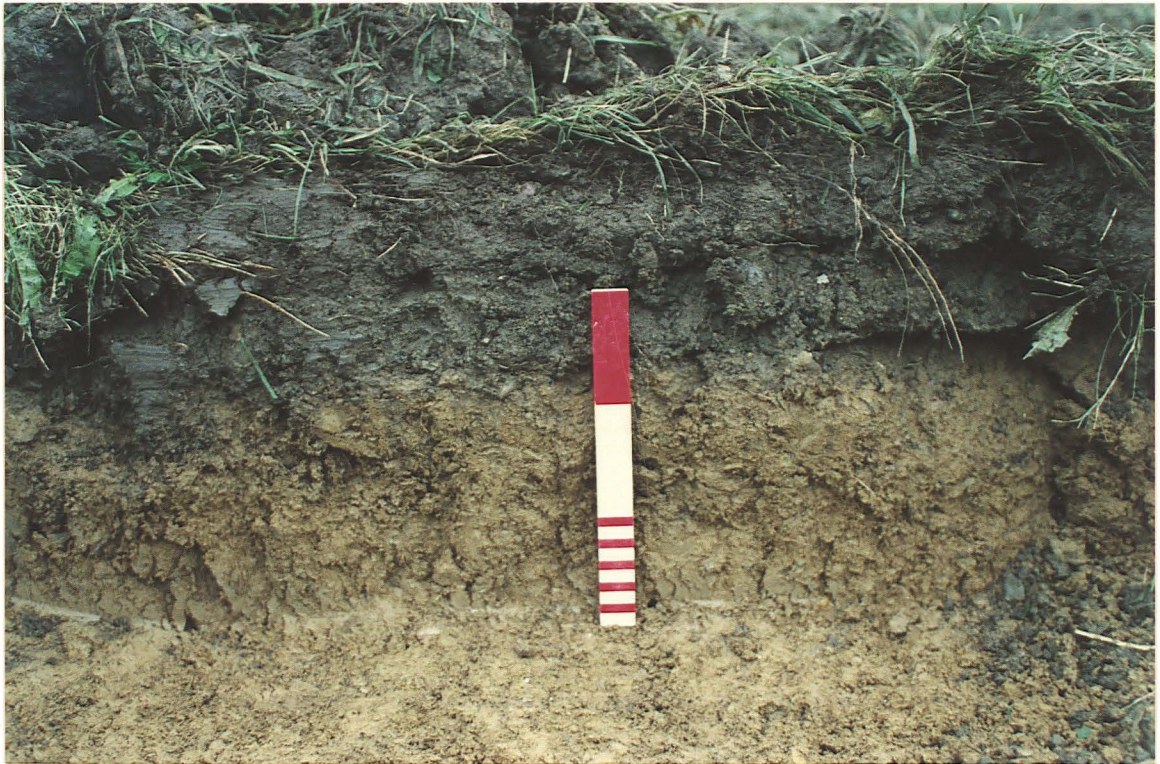
Pl. 5 General sequence of deposits (topsoil over light ochrous brown clay)
