**Glebe Paddock, Tinkle Street,
Grimoldby, Lincs.**

**Earthwork Survey and
Archaeological Watching Brief**

**LAS Report No. 489
January 2001**

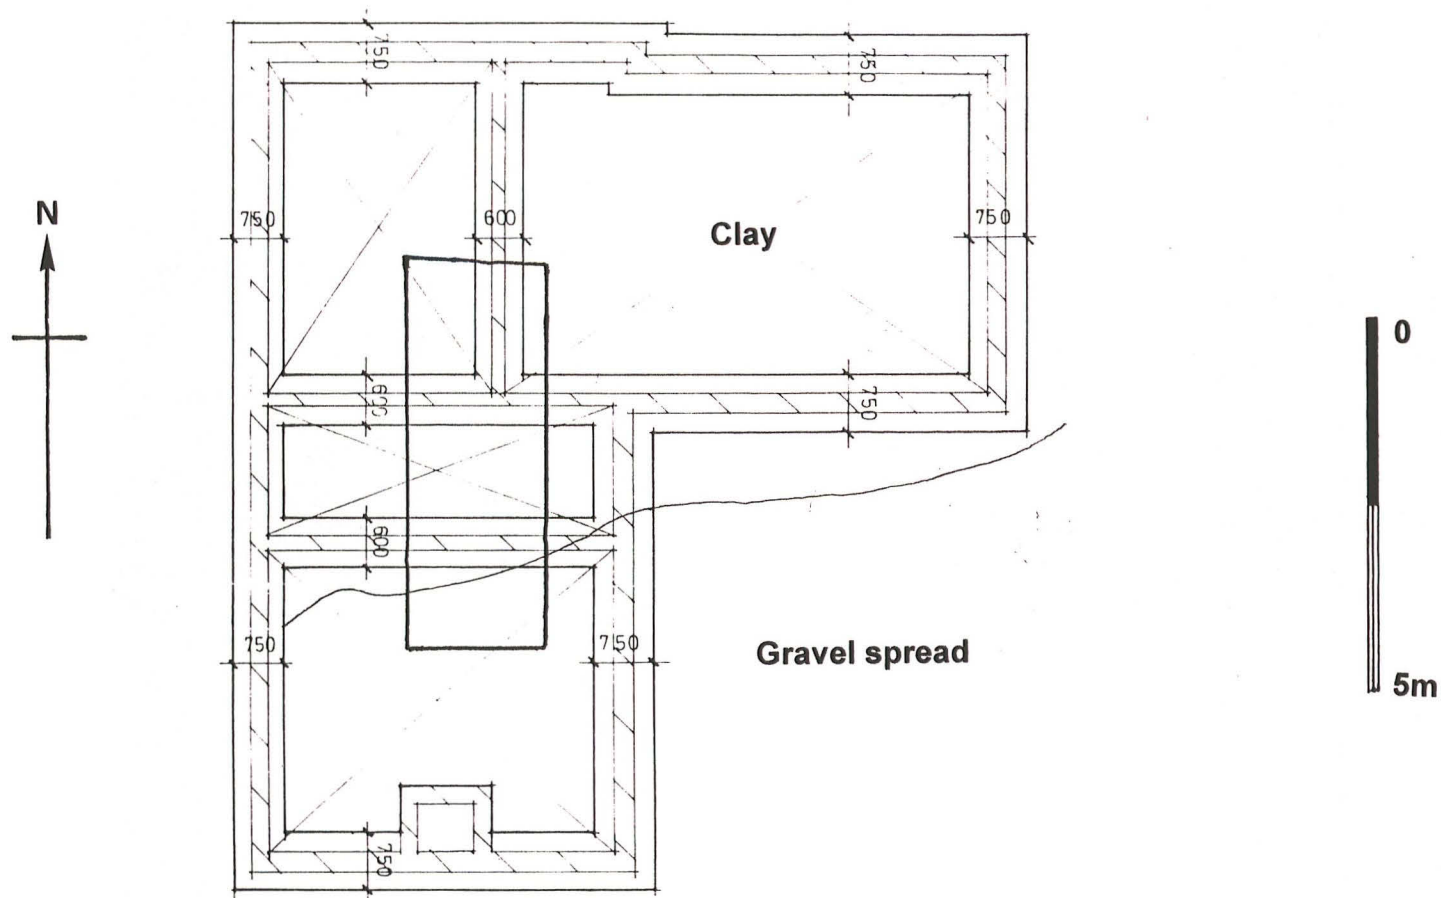
A spread of gravel was revealed below the topsoil, curving from the SE corner of the paddock around to the southern side of the broad area behind the new house site (Fig. 6). This coincided with the shallow track recorded in the earthwork survey which led to the demolished building(s) and beyond. The original evaluation trench was clearly visible (Pl. 9) and it cut through a spread of chalk at its north end and the gravel spread to the south.

Fig. 6 Plan of new property based on drawing supplied by the architect (M. Kingsley) showing gravel zone and position of original evaluation trench. Scale reduced

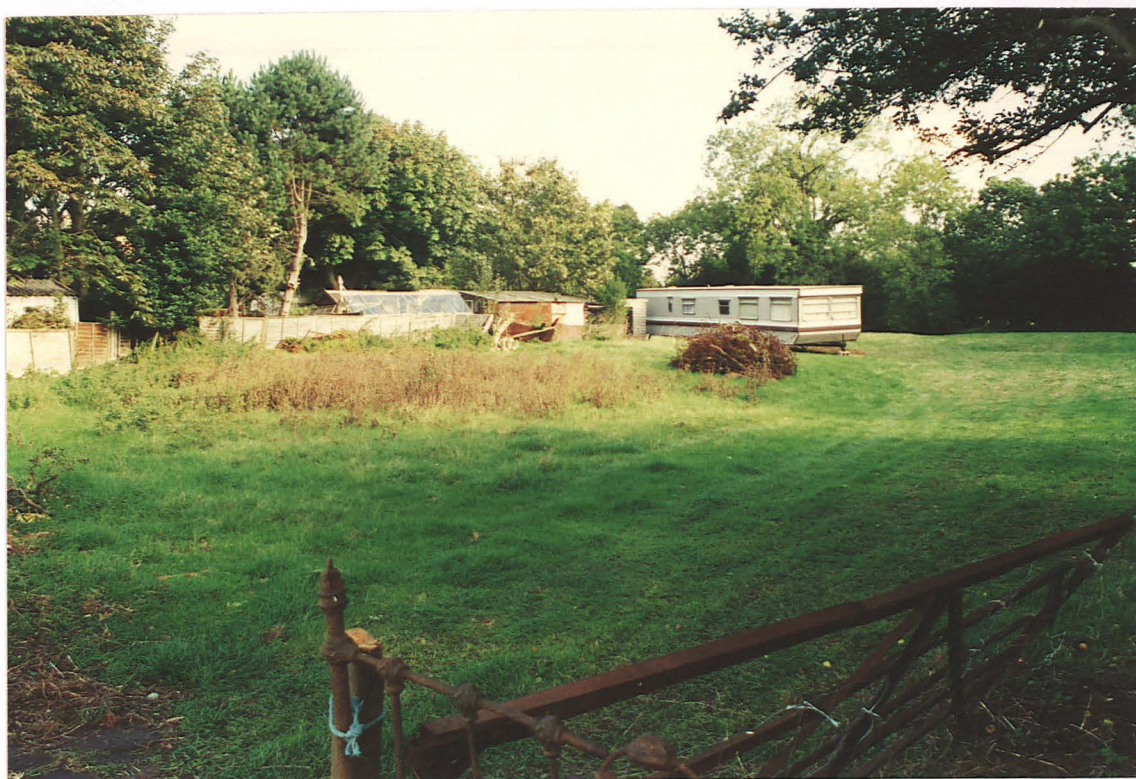
The site entrance was through a gate in the SW corner, following a curving depression which may represent a medieval 'hollow way' or abandoned lane (Pls 1 and 2).

The site of the proposed new house and garage occupies an area of raised ground set back from the street frontage, where an existing concrete slab foundation was visible (Pl. 1). This area was overgrown with thistles and was difficult to record. LAS was advised by a local resident that there had been a coalyard on the site; gas masks have been unearthed in the field, and the demolished structure may originally have had a civil defence function during World War II.

Pl. 1 Glebe Paddock, Grimoldby. General view looking north-east showing proposed location of new building on overgrown area of ground. Shallow hollow way is visible to right.

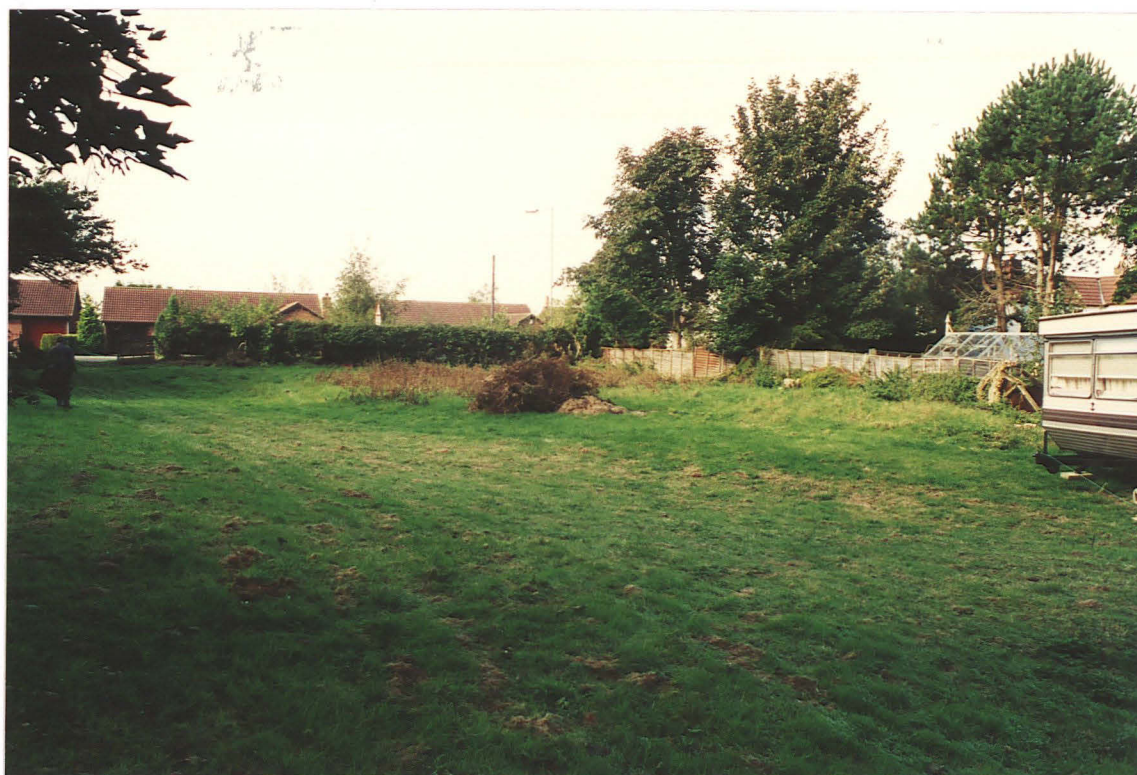
Pl. 2 General view looking west towards Tinkle Street showing shallow hollow way in centre.

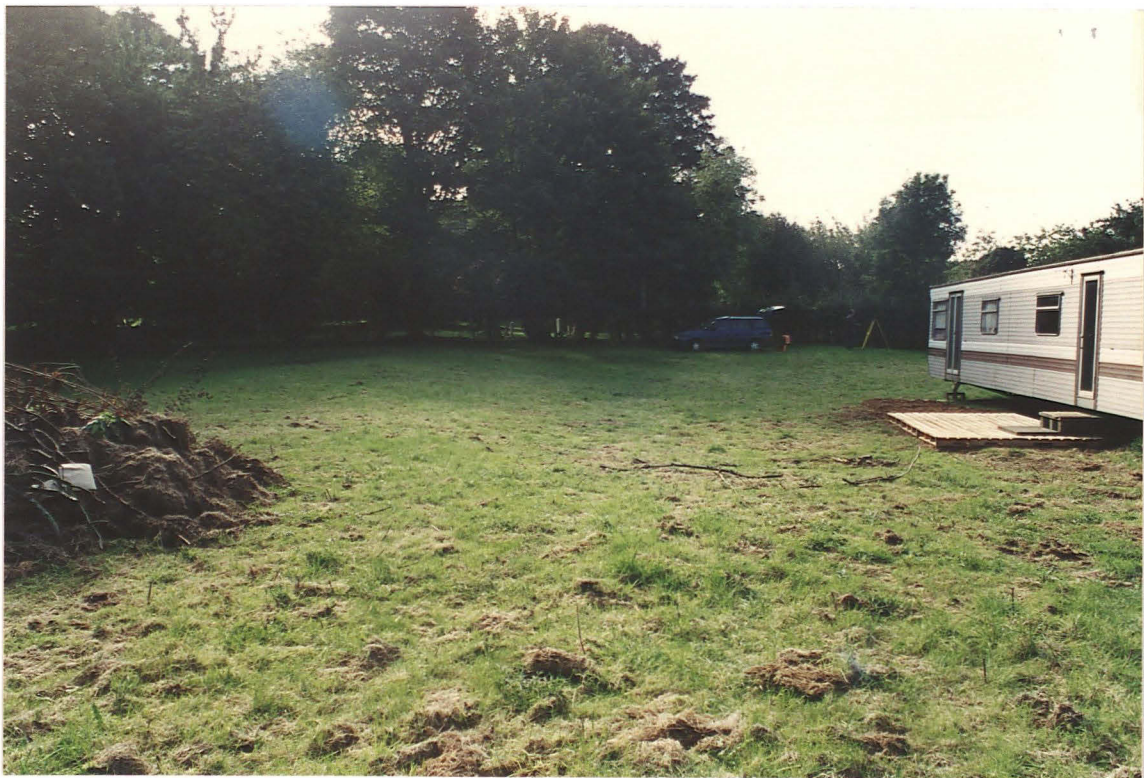
To the east of the house site was a NW-SE aligned ridge, parallel to Tinkle Street, which appeared to extend into the adjacent churchyard area (Pl. 4). It was interpreted as the original rear boundary of former plots fronting onto Tinkle Street. To the north of Mill Lane, a projection of this line remains the rear boundary of Tinkle Street properties.

Pl. 4 General view of site looking south towards churchyard, showing ridge marking former land boundary.

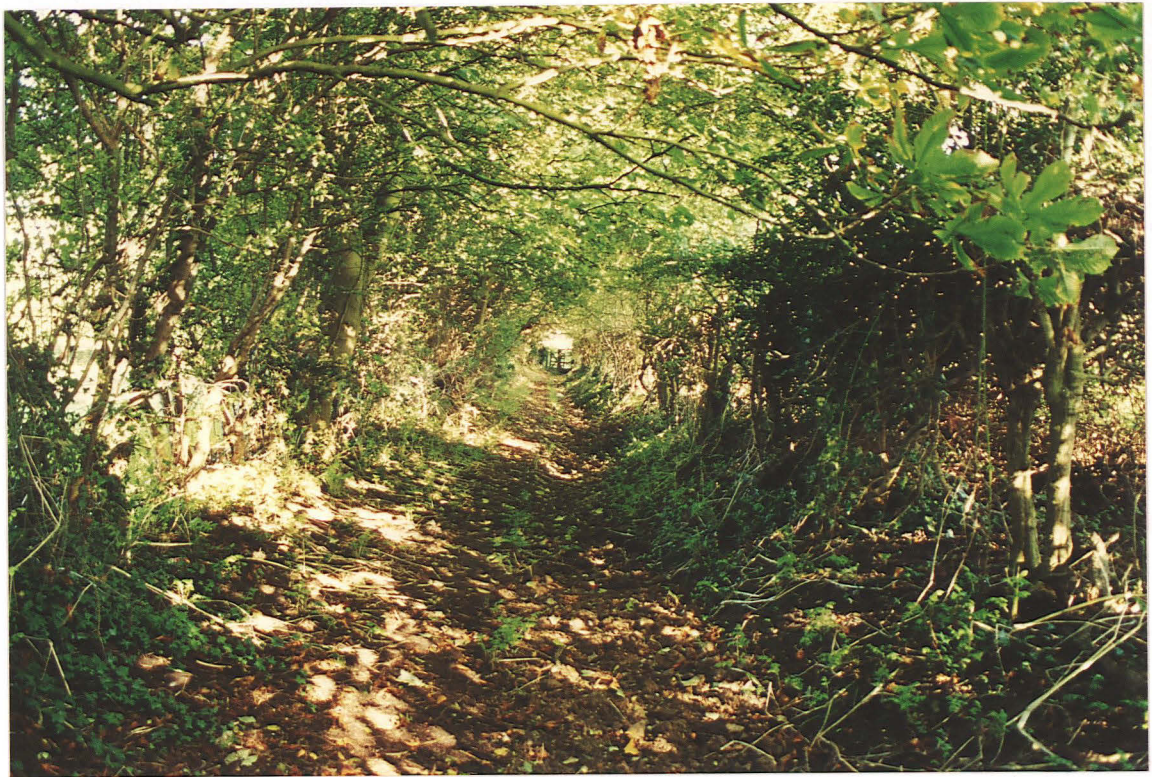
The ground slopes down to the east of the ridge, towards the eastern boundary hedge which is alongside a hollow way. The hollow way connects Mill Lane with a path east of the church and formerly extended northwards to Eastfield Lane (Pl. 5). The 20m wide strip of land between the two former boundaries contains broad but shallow depressions and a small modern pond (Pls 6 and 7). The depressions cut through the ridge and are therefore later in date than this land division. Their function is unknown.

Pl. 5 Hollow way marking the eastern boundary of site looking north towards Mill Lane

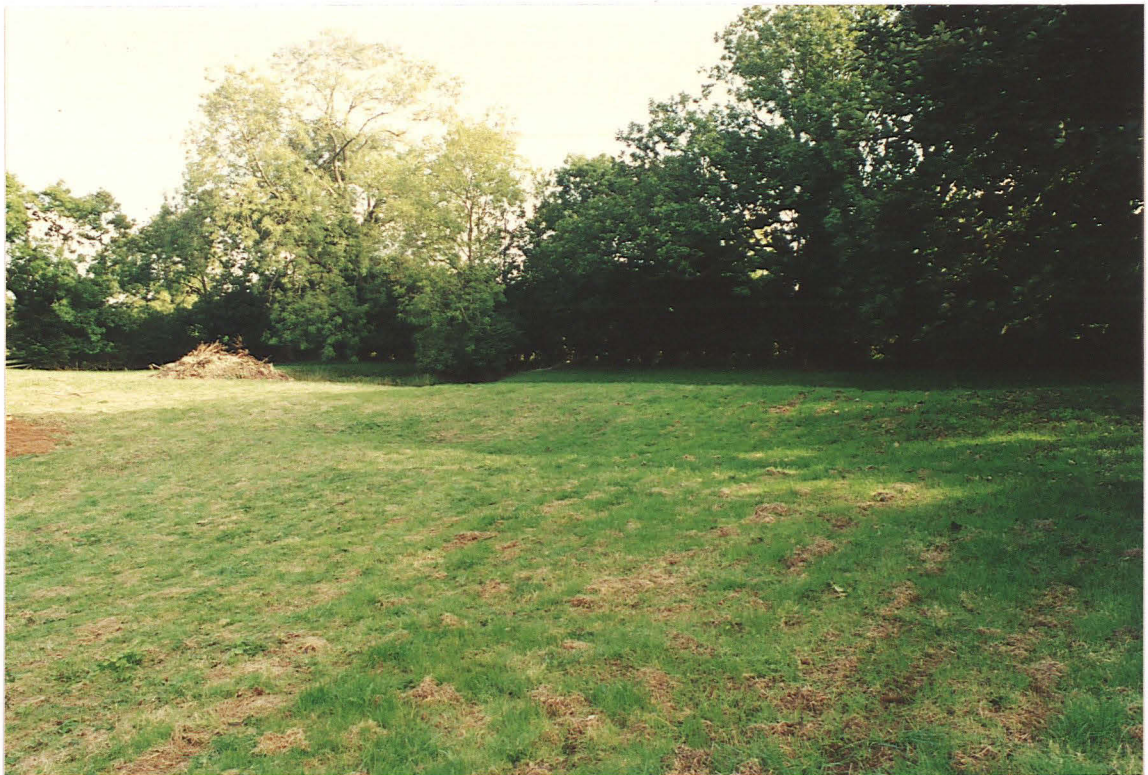
Pl. 6 General view of site looking north showing undulations in the foreground and pond to the rear

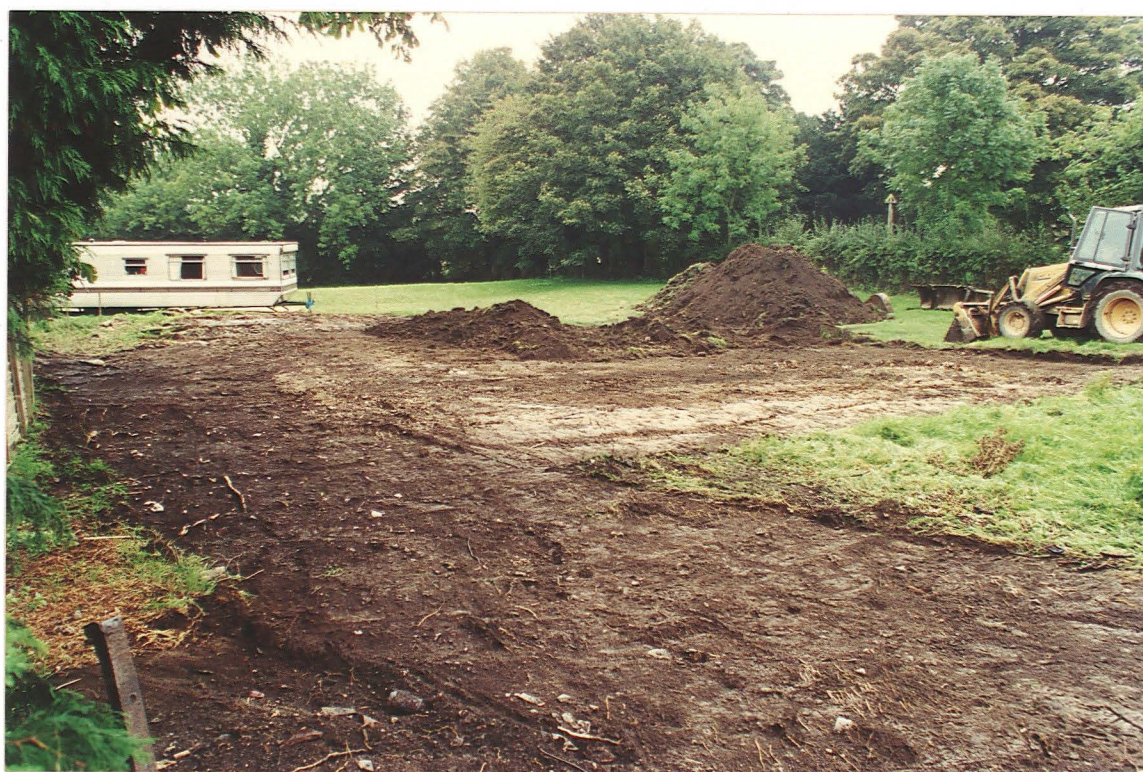
Topsoil was stripped from the area of the new access road at the north-west corner of the plot and the site of the new buildings (Pls. 8 and 9). The ground levels along the access road were already close to those required and the topsoil was not completely removed in the north-west part of the site.

Pl. 8 Site clearance in progress looking east, showing new site access from Tinkle Street at north-west corner of plot.

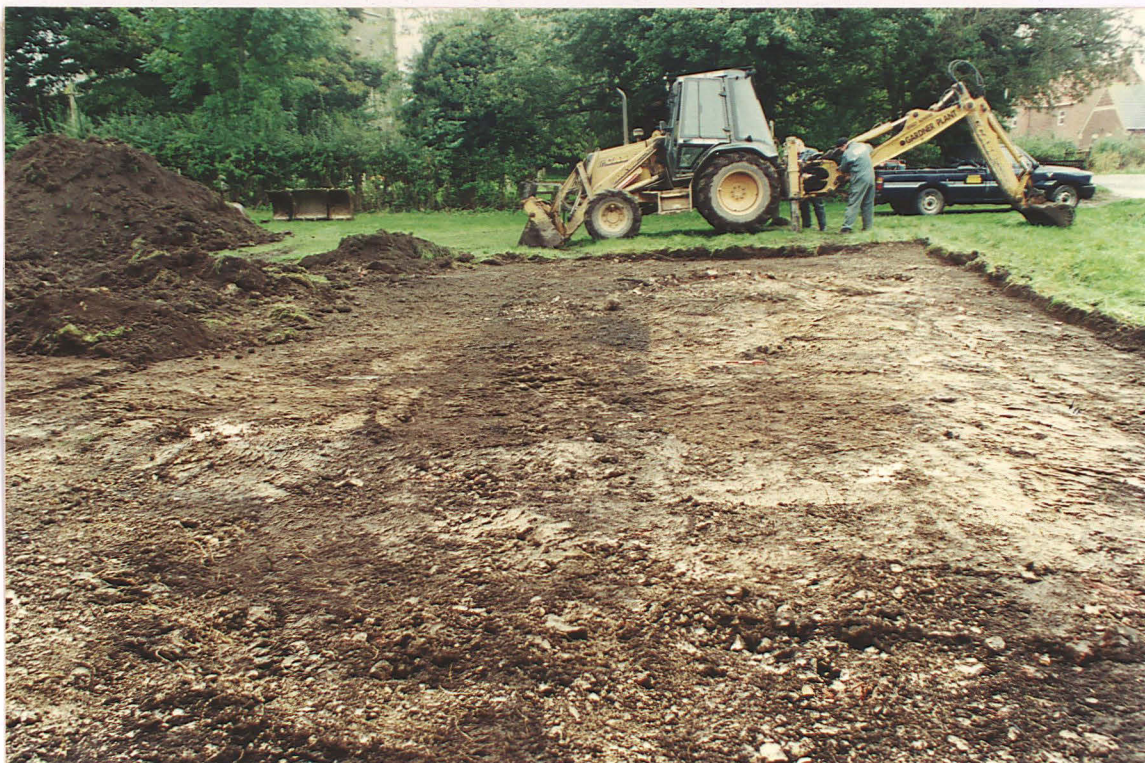
Pl. 9 Site clearance in progress looking south, showing outline of archaeological evaluation trench dug in 1996.

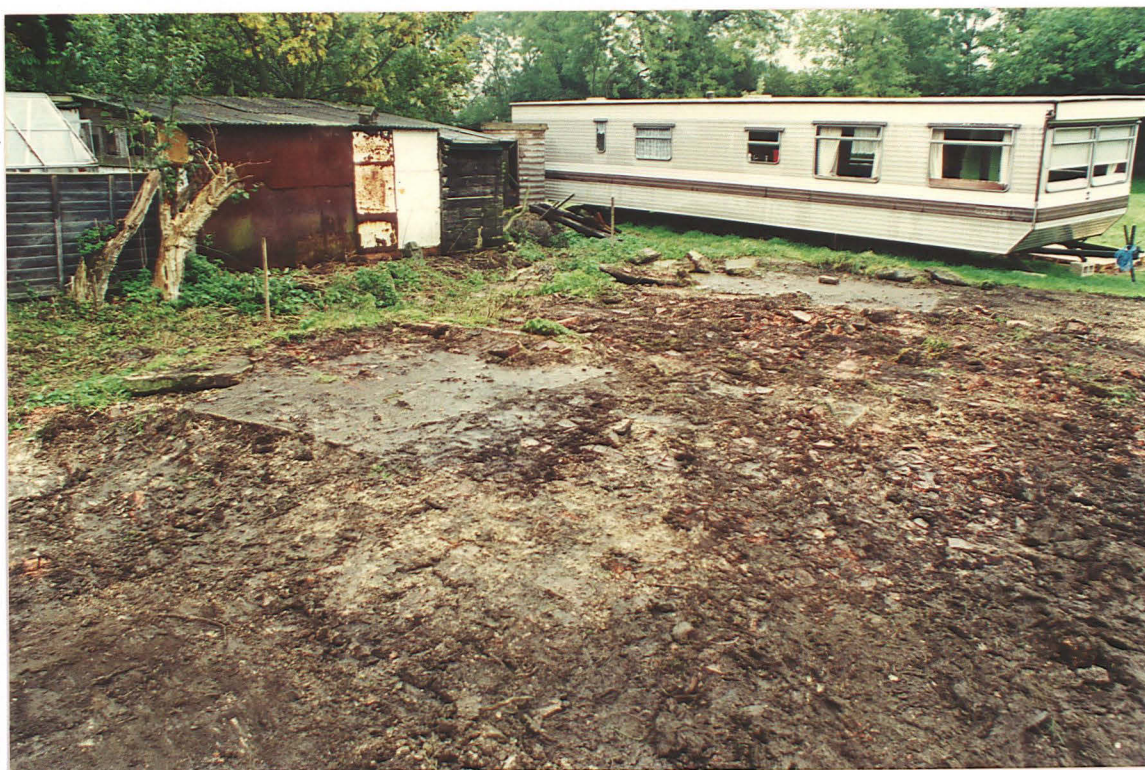
Clearance of topsoil exposed more of the foundations of the demolished building (Pl. 10). A 3.65m x 4m brick floor area was sited at the western end of a 6m or longer concrete surface also of 4m width. On the western side of the brick floor was a 3m wide spread of brick rubble, presumably from demolition of the structure, with a concrete surface below it. The concrete and brick building bases were removed and the raised area of ground was levelled.

Pl. 10 Rear of house plot after topsoil clearance showing concrete and brick foundation slabs with demolition spread of brick rubble, looking east.

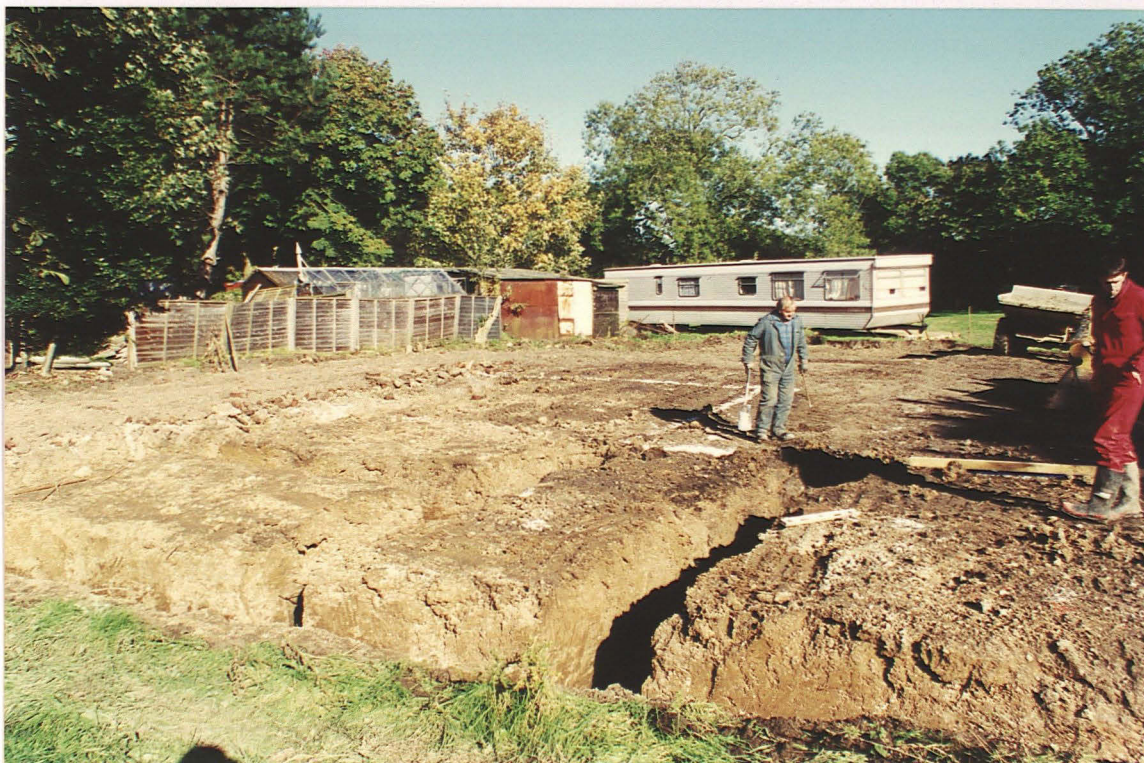
The foundation trenches for the new house were excavated to a width of 0.75m. The trench depth varied from 0.75m in the western trench to 1.3m in the northern trench where tree roots were encountered (Pl. 11).

Pl. 11 Excavation of foundation trenches in progress, looking east.

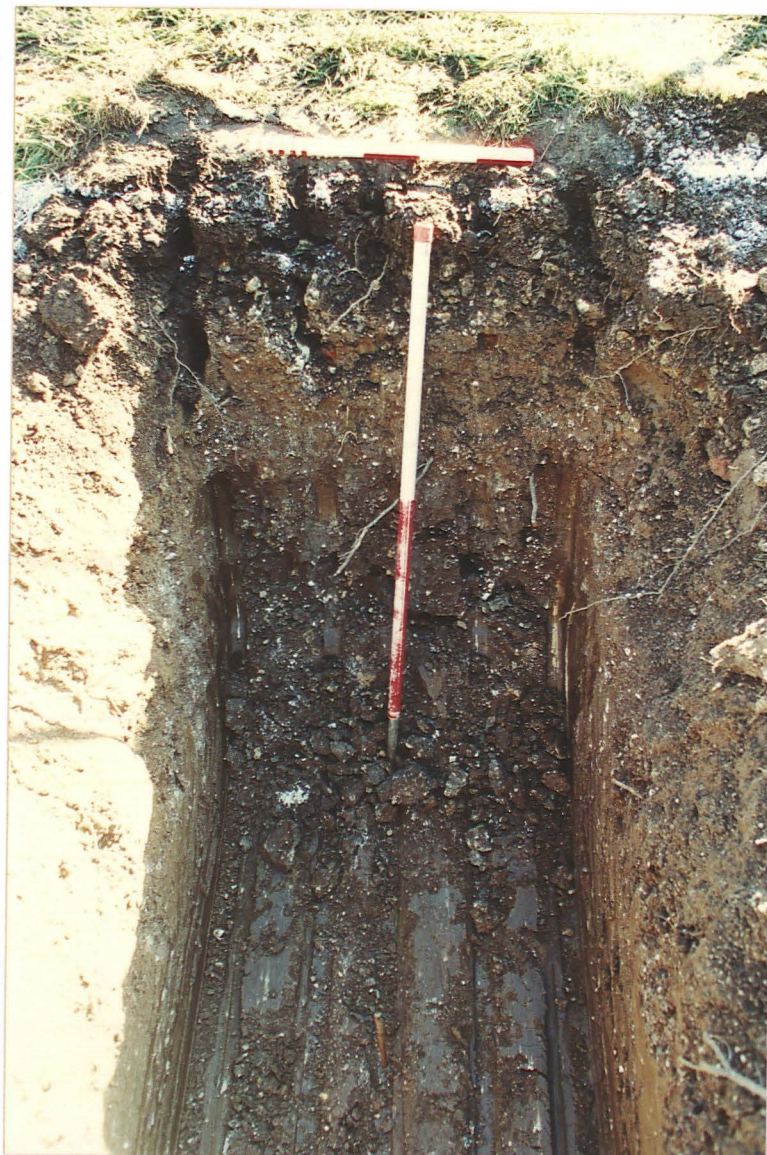
Within the foundation trenches for the new house, the thin topsoil layer 1 covered a 0.28m thick layer of red/brown clay with chalk 2, containing tile fragments. Beneath this layer was undisturbed boulder-clay 3 (Pls 11 and 12). No archaeological features were exposed during the groundworks, and finds were restricted to post-medieval pottery from the topsoil layer (Appendix 1).

Pl. 12 Representative sequence of deposits in foundation trench at east end of house plot showing topsoil, subsoil with brick fragments and chalky boulder clay below.
