**All Saints Church, Tealby
Churchyard Wall Reconstruction**

Archaeological Watching Brief

Report for Tealby PCC

LAS Report No. 505

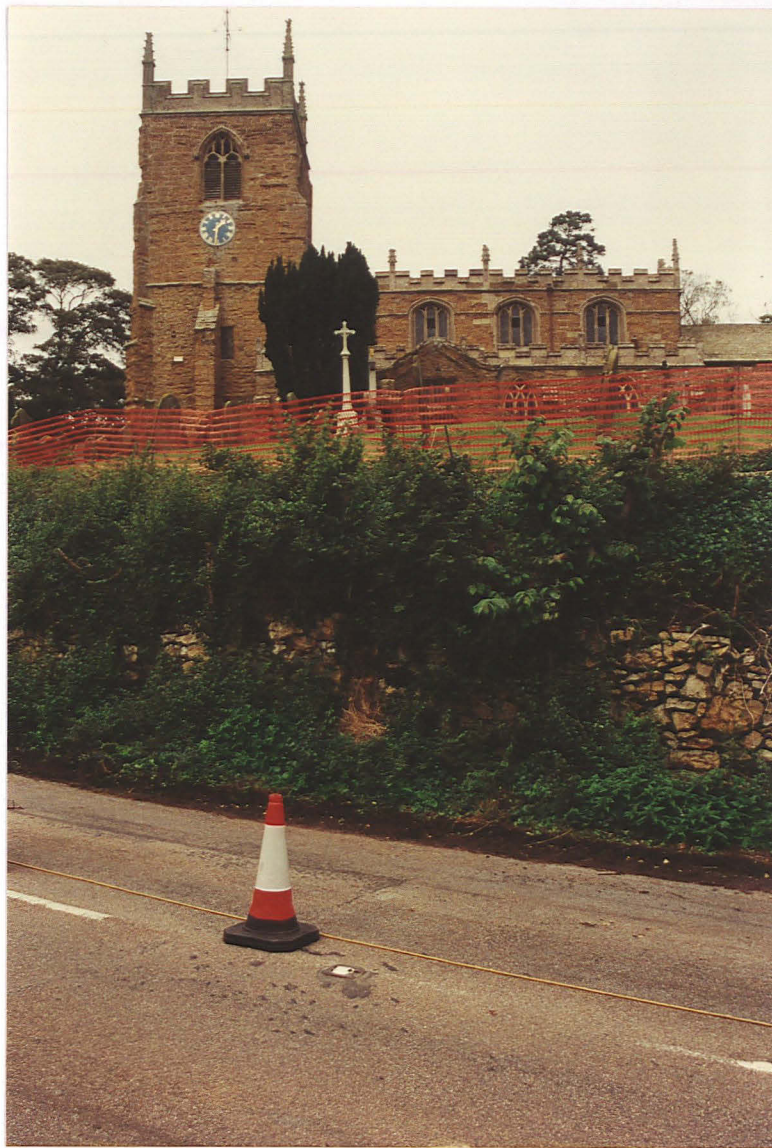
Pl. 1 Tealby All Saints Church, showing the existing drystone wall alongside Rasen Road, and remains of a former hedge behind it. Note the difference in height between the road and the graveyard (looking north).

The monitored groundworks comprised the mechanical excavation of a trench alongside Rasen Road, around part of the churchyard, in order to construct a retaining wall (Pls. 1 and 2). At the same time, tree stumps close to the new wall line were removed to reduce damage by tree roots.

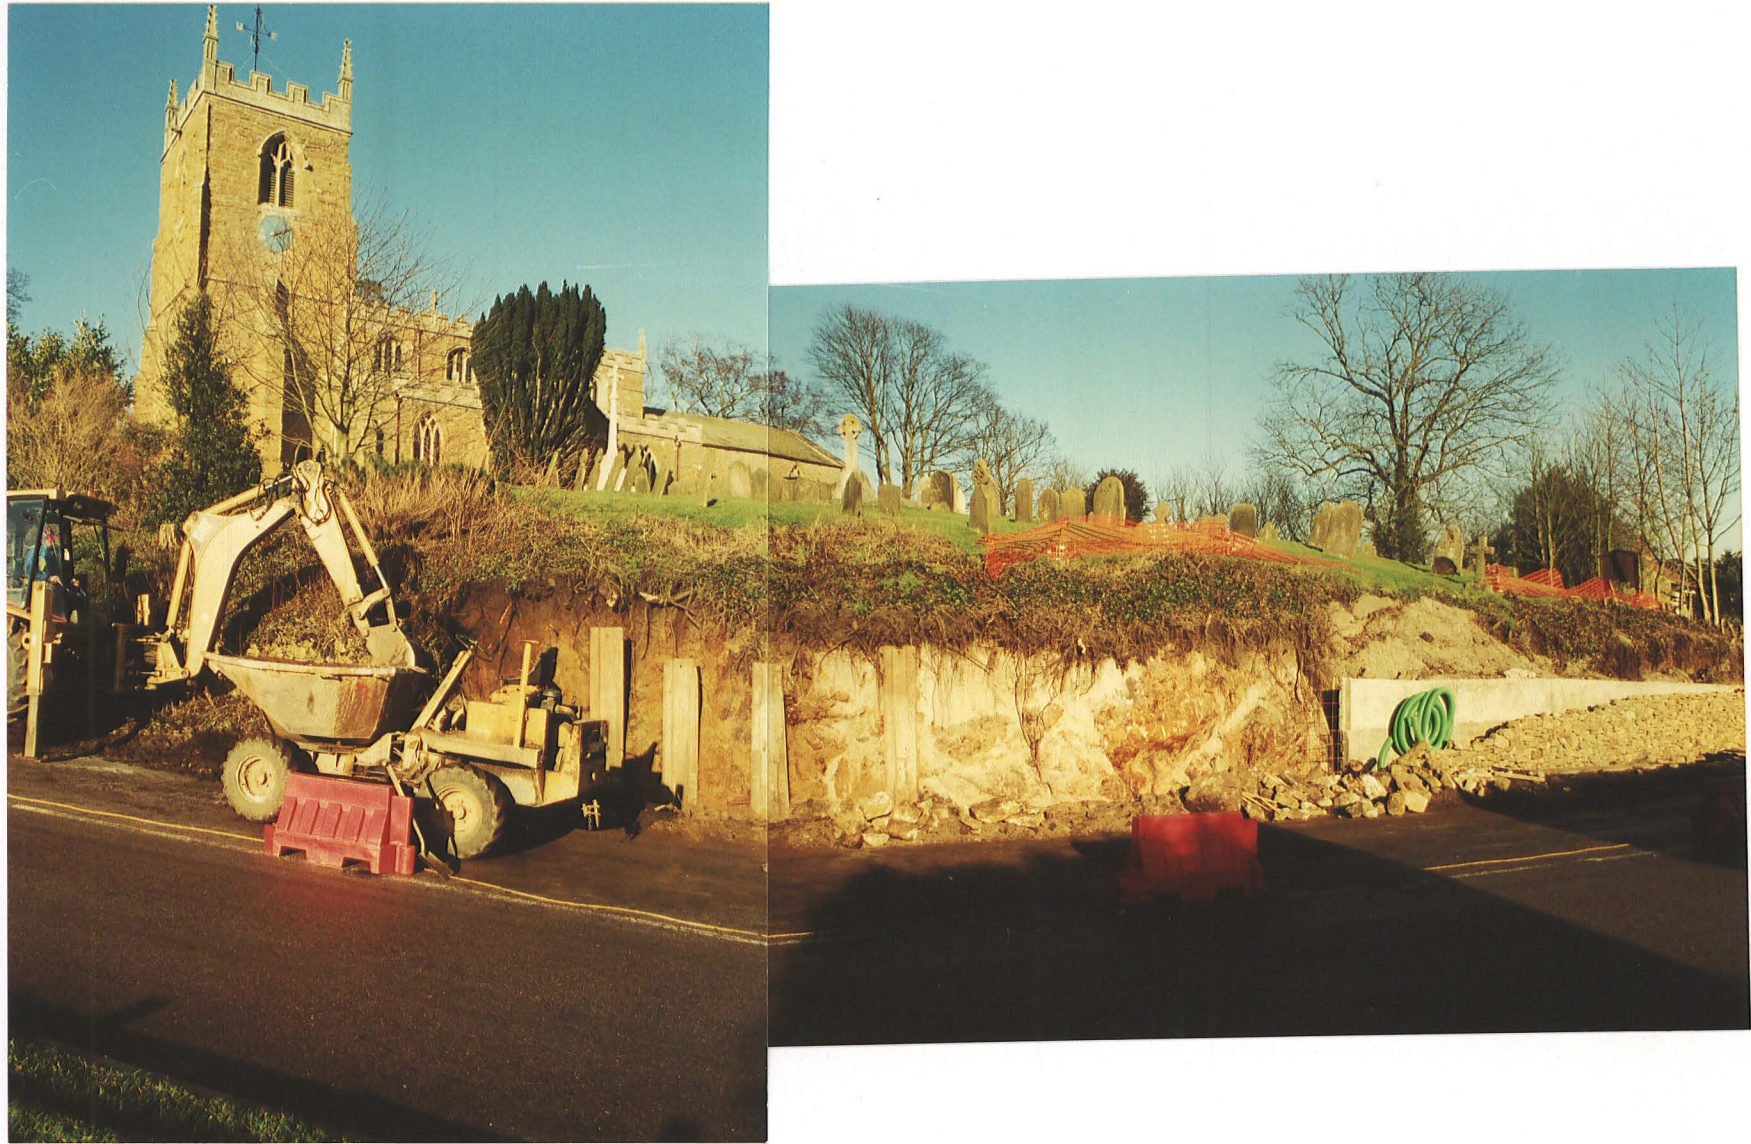
Pl. 2 Construction of the replacement retaining wall alongside Rasen Road (looking NE).

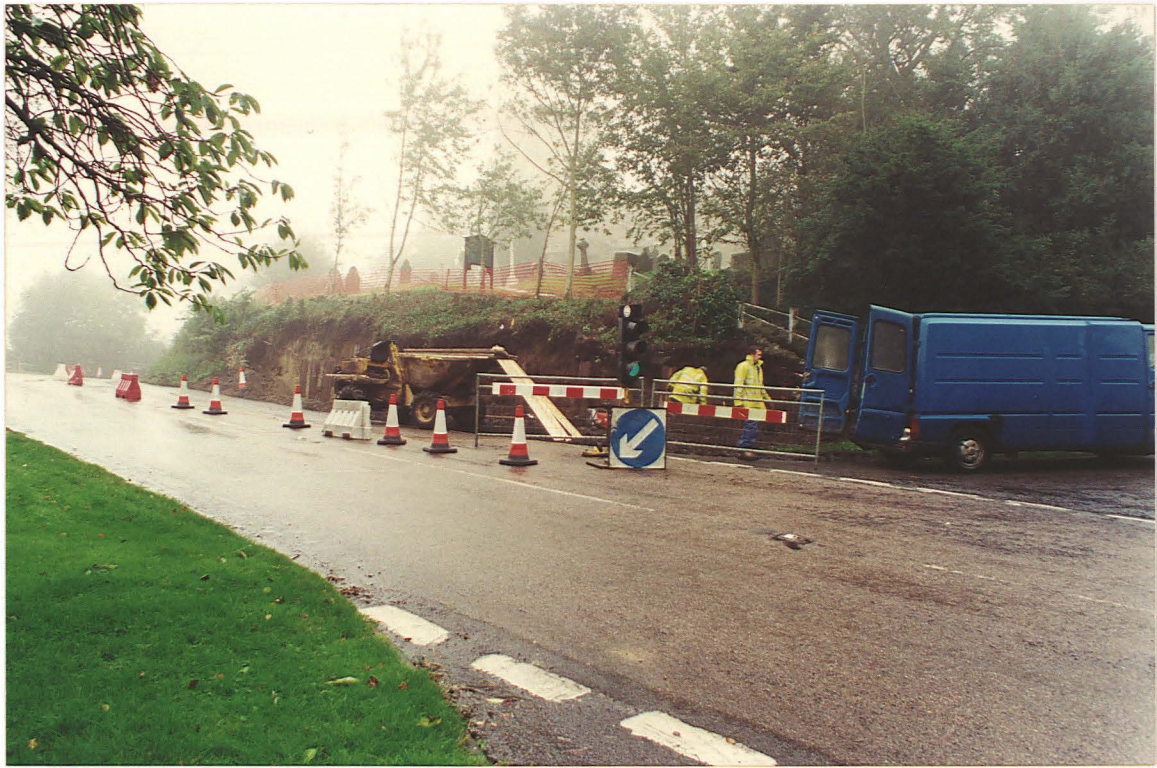
Pl. 4 Location of the groundworks at the junction of Rasen Road and Caistor Lane (right). Looking west.

Works for the new wall began beside the churchyard steps beside the junction with Caistor Lane, where the height difference between the churchyard and the road below is least (Pl. 4). A JCB was used to clear the remains of the existing drystone wall from the foot of the scarp, and to remove vegetation surviving from a former hedge on the north side of the wall. A trench was then cut into the hillside to give sufficient room for a concrete retaining wall beside the new drystone wall.

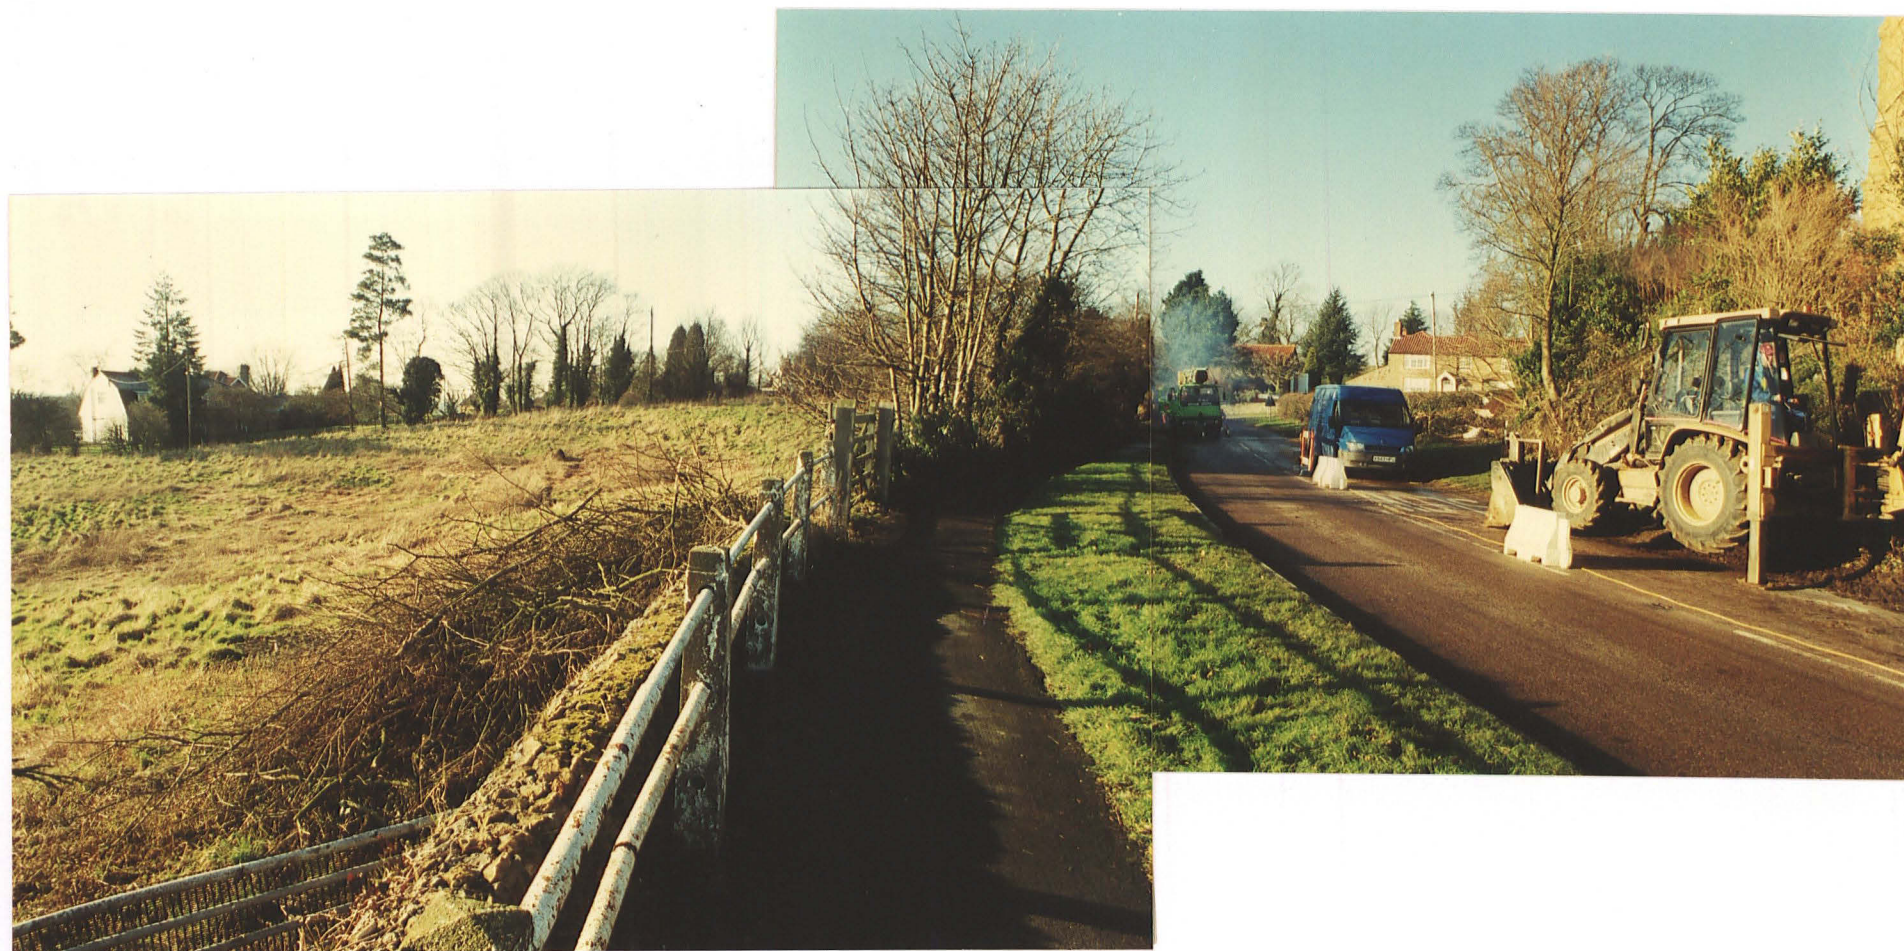
Pl. 3 Ground levels to the south and west of Tealby Church (looking west along Rasen Road). The car park area (right of the blue van) may be a former quarry. Rasen Road has been terraced into the natural slope.

The slope is only partly developed, and most lies within a large field under rough grass (Pl. 3). A north-south aligned hollow crosses the field, and although this could be a watercourse, it could equally represent a medieval lane. At the NW corner of the field, the slope alters and this area may have been terraced with the importation of soil. Where Rasen Road passes beside the churchyard, there is a retaining wall at the field boundary. On the north side of Rasen Road is a level plot NW of the church, used as a car park.

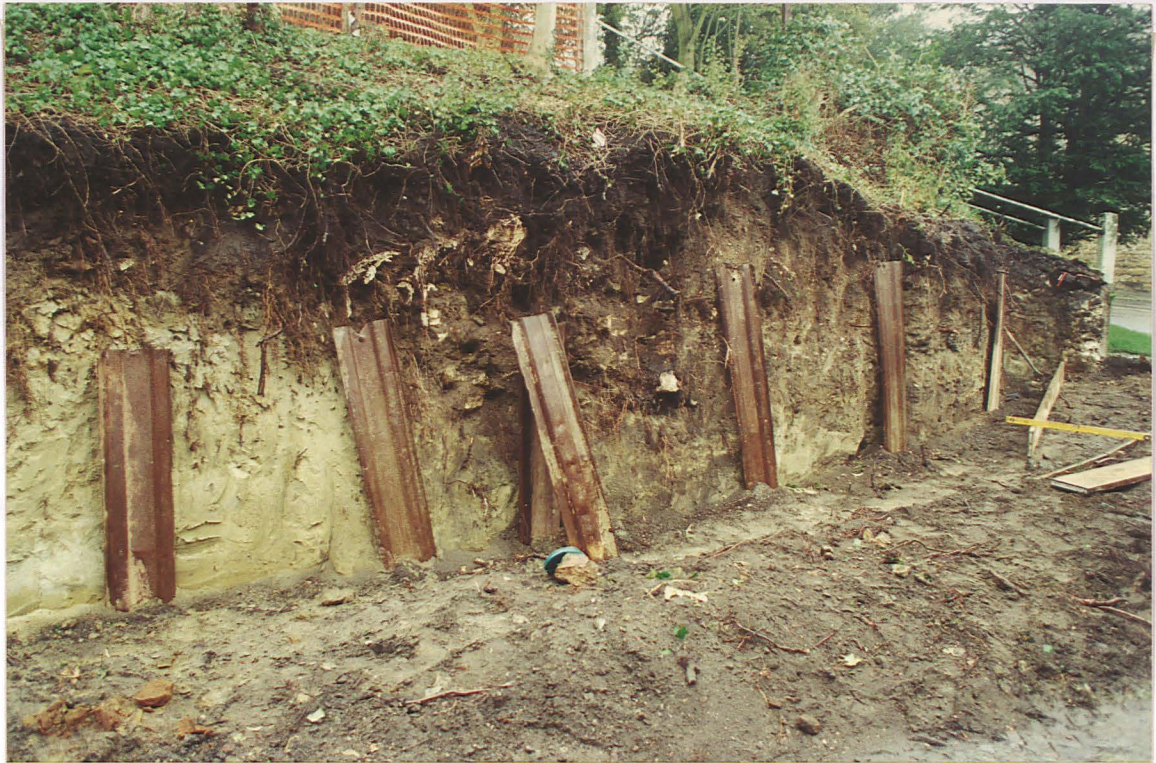
Pl. 6 View of the mixed clay material 1 overlying sandstone bedrock at the SE corner of the churchyard (looking east).

1. Immediately to the west of the churchyard steps, the revealed ground was a mixed material incorporating clay, gravel, sand, and either limestone or chalk chips, with sandstone at the level of Rasen Road. The clay material extended for about 8m, sloping up at a uniform angle of about 35° to the west (Pls. 5 and 6). 1.75m below the modern ground surface was a horizontal band of limestone or chalk chips up to 0.2m thick, and revealed for a length of 3m. This appeared to have been a surface, but it is unclear whether it was laid naturally or artificially. The local Wolds are chalk, and limestone would represent a deliberate import. The former churchyard wall was of limestone, and conceivably the layer of chips could be associated with it, perhaps in soil tipped into a construction trench behind it. Without knowing the extent to the north of the mixed clayey material, interpretation of

this feature is impossible, but if the deposit extends further north it could be either the western side of a glacially filled channel, or a medieval hollow way (the precursor of Caistor Lane) reclaimed to allow extension of the churchyard. The glacial channel seems the probable explanation.

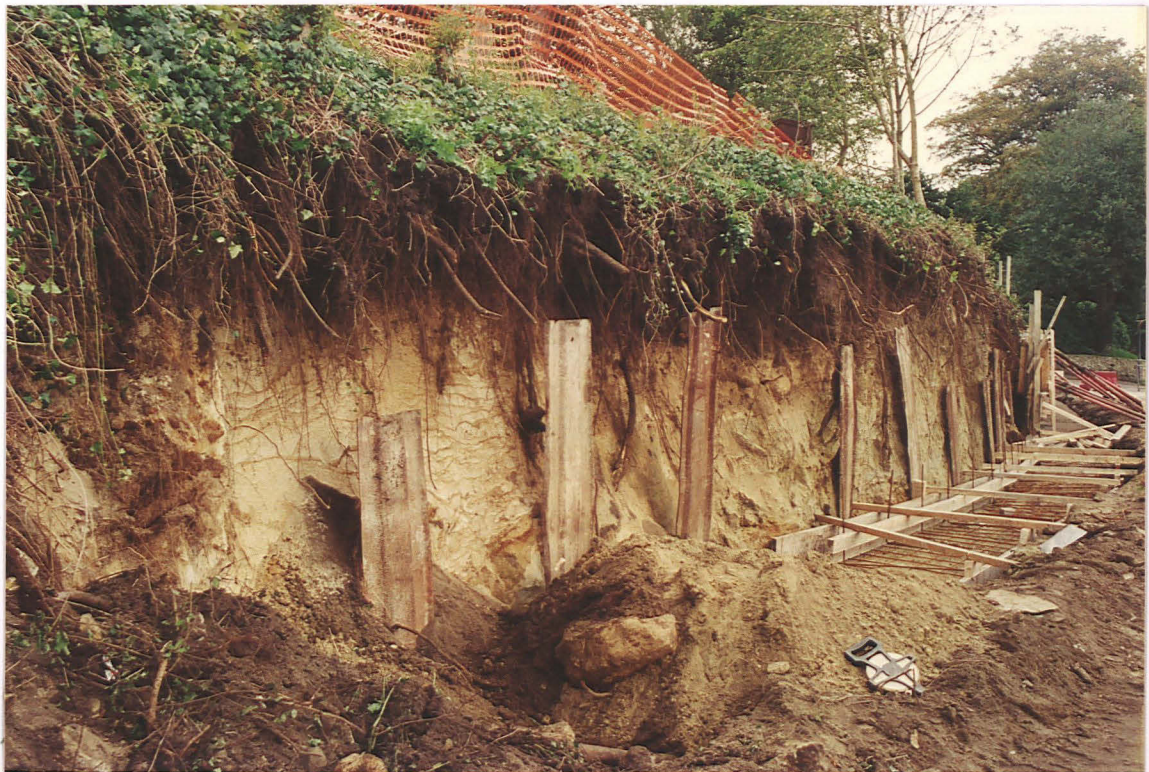
Pl. 7 Location of boundary ditch 2 behind roots in the new wall trench (looking east).

2. 29m west of the churchyard steps, a feature containing dark brown loam was observed at the top of the new cutting (Fig. 3; Pls. 7 and 8). The base of the feature was about 1.5m below the churchyard level, and 1.3m above the road level. Tree roots and other vegetation obscured the lateral extent of the feature, but it seemed to be about 6m wide. It was interpreted as part of a ditch aligned at about 90° to Caistor Lane, and revealed at an oblique angle. This could have been a boundary feature defining the churchyard limit.

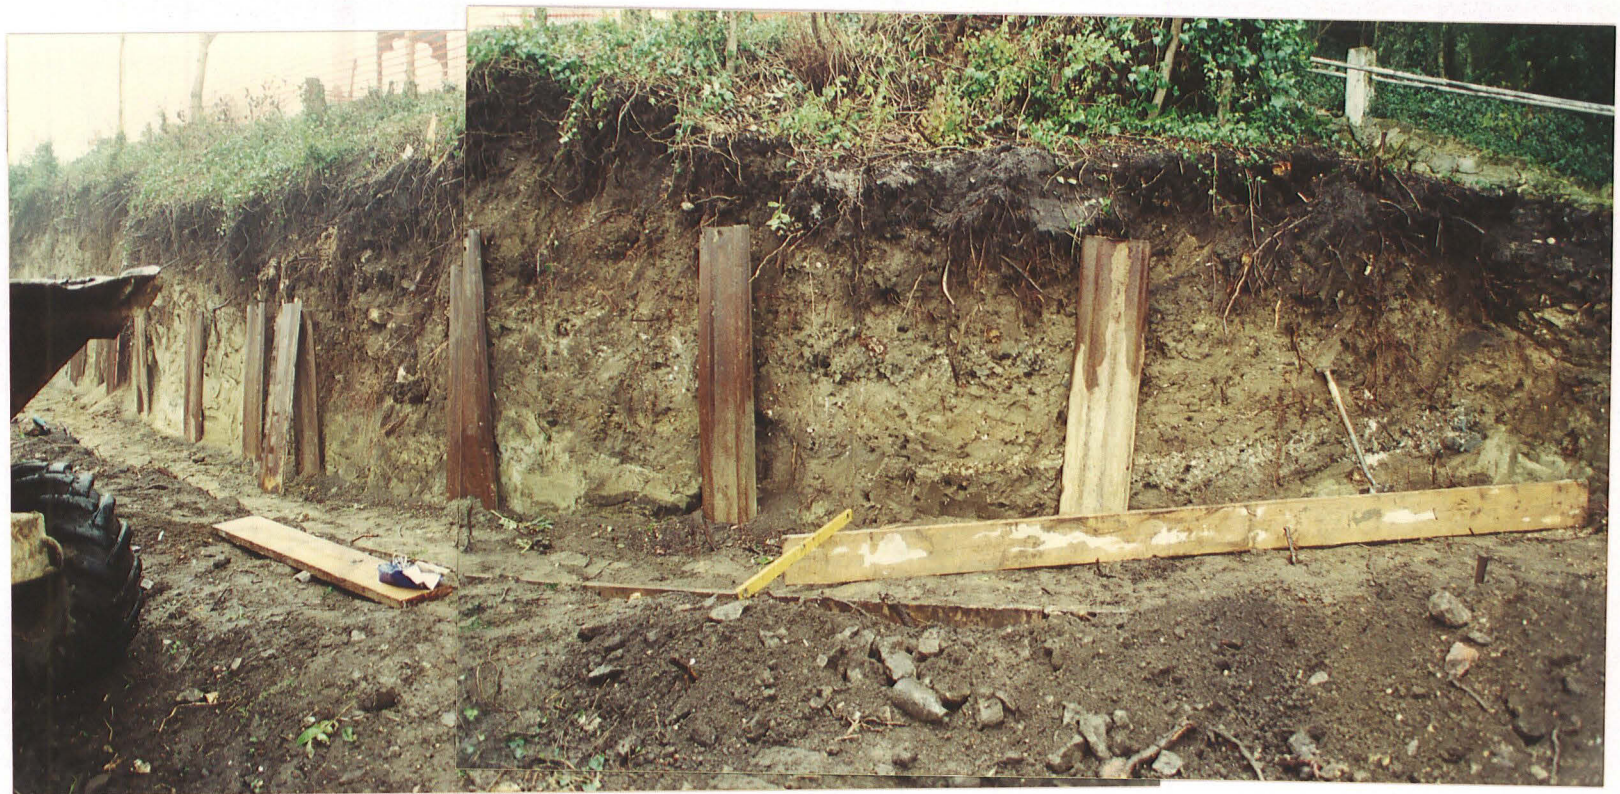
Pl. 5 Mixed clay fill 1 exposed in the new wall trench at the SE corner of the churchyard (looking north).

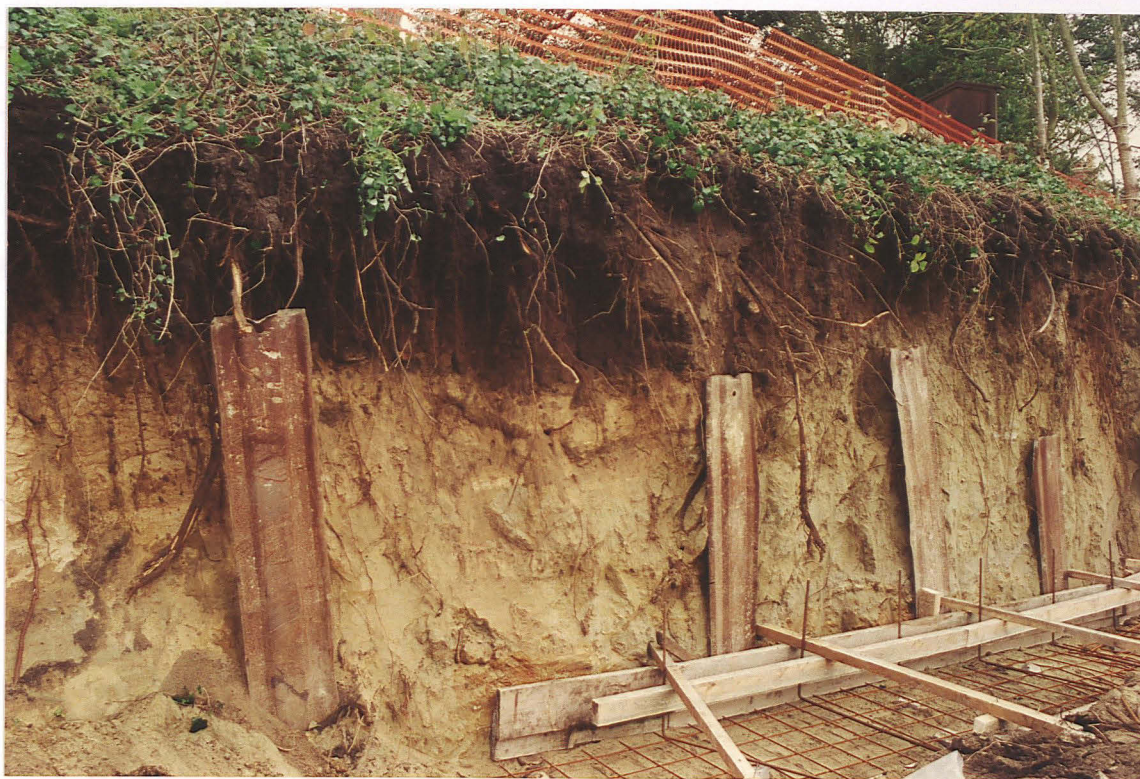
Pl. 8 Dark fill of boundary ditch 2 cut into sandstone, near the top of the scarp beside Rasen Road (looking north).
