**ARCHAEOLOGICAL IMPACT ASSESSMENT**  
**LAND OFF VINE STREET / BEDFORD PLACE,**  
**SPALDING, LINCOLNSHIRE**

Planning Ref. H16/0678/00  
Client: Patterson Homes  
NGR: TF 24790 22500

Prepared by Colin Palmer-Brown

July 2000

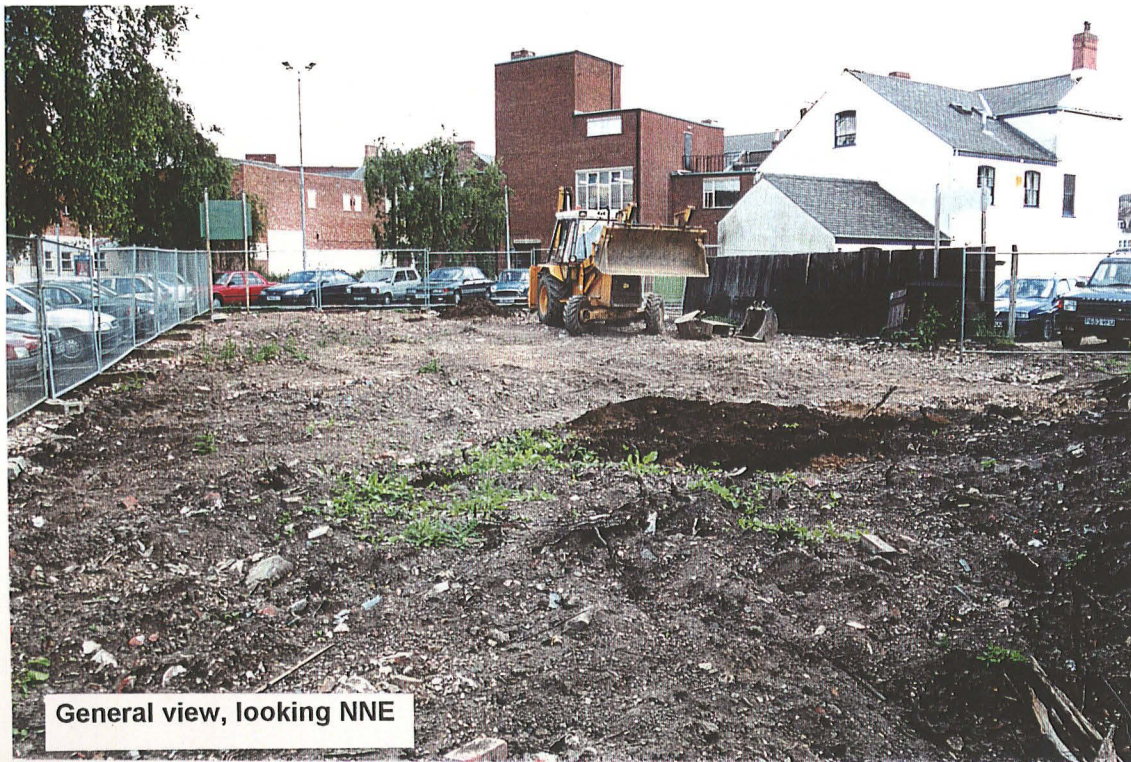
General view, looking NNE

The proposed redevelopment site is close to the town centre and comprises a small irregular unit that is situated between Vine Street and Bedford Place (NGR TF 24790 22500). The unit has previously supported brick structures, believed to have been part of a former bakehouse (Patterson Homes, pers. com.). Remains of these buildings were recently demolished, and the site is currently level and covered with brick and other rubble (see colour photograph at end of text).

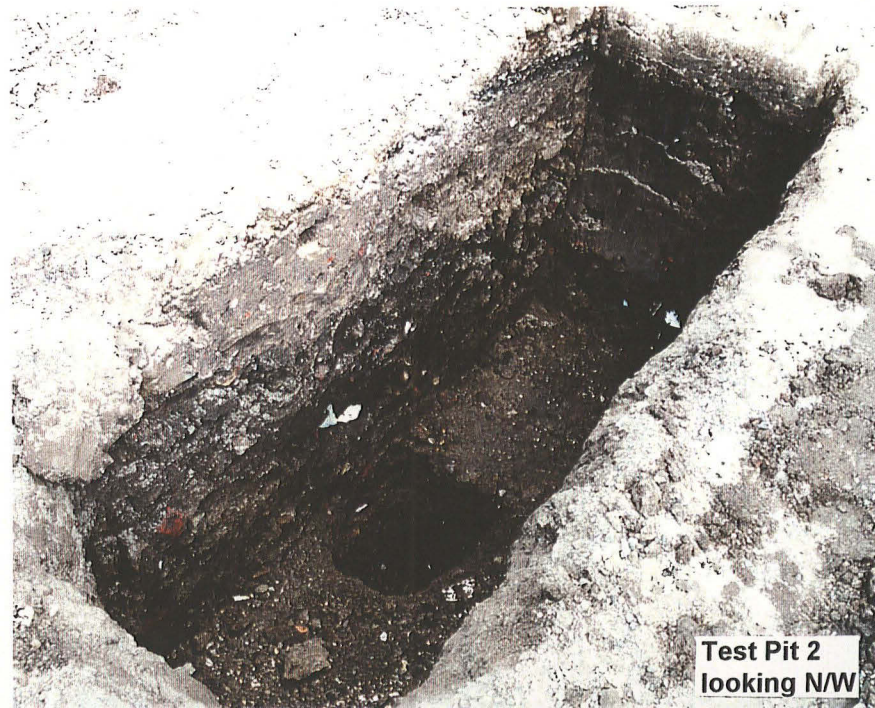
Test Pit 2  
looking N/W

This pit was also orientated north-south and measured approximately 1.8m x 0.6m in plan (maximum depth 1.35m). The stratigraphy has again been simplified, and it is noteworthy that all of the deposits exposed appeared to slope in a south - north direction. A summary of deposits is presented as follows:

10cm of very loose demolition debris (from recent demolition and levelling)

/  
20 - 35cm of redeposited natural yellow silt mixed with mortar and coal fragments, brick rubble and C19th/C20th white china pottery fragments

/  
28 - 45cm+ of very mixed dark brown soil incorporating lenses of brown degraded organic material; associated with white china.

/  
60cm+ of dirty redeposited natural silt containing quantities of white china, willow pattern pottery, brick fragments and clay tobacco

Exact interpretation of these deposits is limited by the smallness of the pit. They could represent cumulative ground raising dumps but, given that there was a general south - north trend, it is possible that they filled a substantial void such as a large pit. One sherd of residual green glaze medieval pottery was recovered.
