Lincoln, Moorlands Water Main Rehabilitation

Archaeological Watching Brief

LAS Report No. 509

March 2001

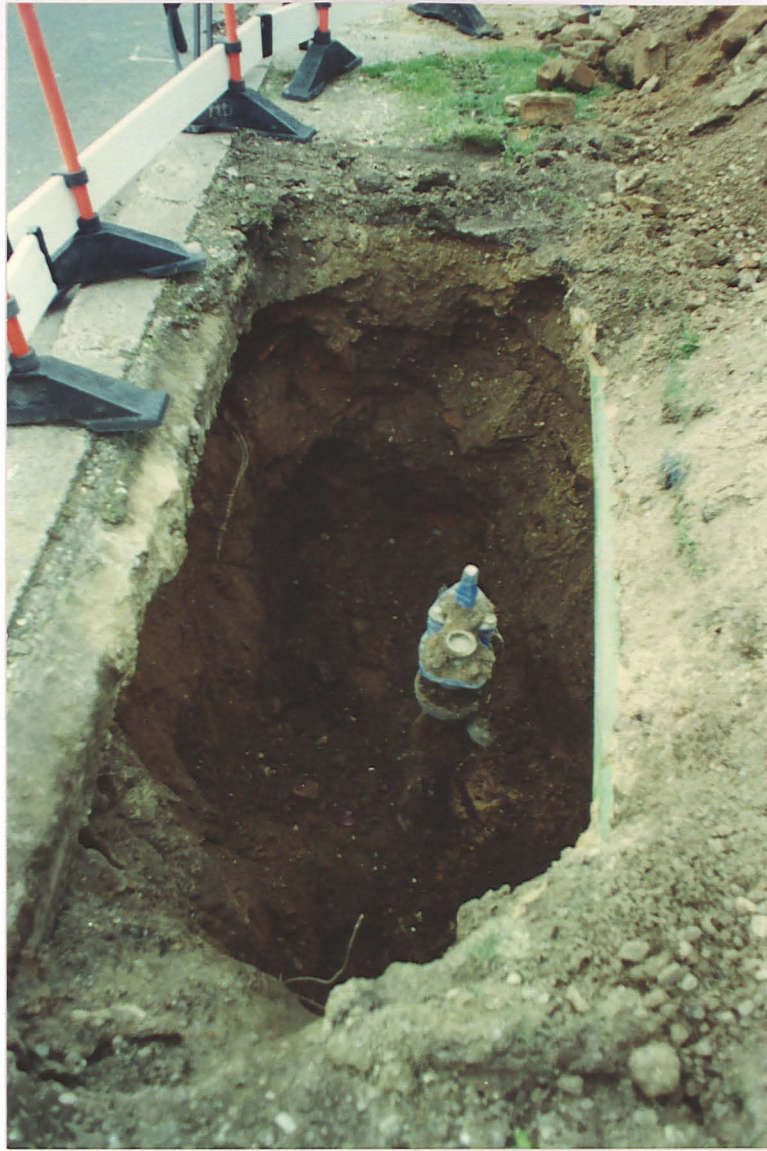
Pl. 1 Access hole alongside De Wint Avenue; many of the trenches remained within the backfill of earlier mains trenches.

Monitoring began south of Shannon Avenue, outside 53 De Wint Avenue, where the ground was sandy gravel. Sand was present near No. 85. The excavated trenches removed backfill from the

existing mains trench, although small areas of undisturbed natural stratigraphy were seen. A concentration of brick and concrete rubble close to a hydrant point near No. 71 was probably contemporary with the housing estate. Close to Pike Drain, outside Murfin House, the trench was excavated in an extensive area of backfilled material, possibly representing tipping to consolidate marshy ground.

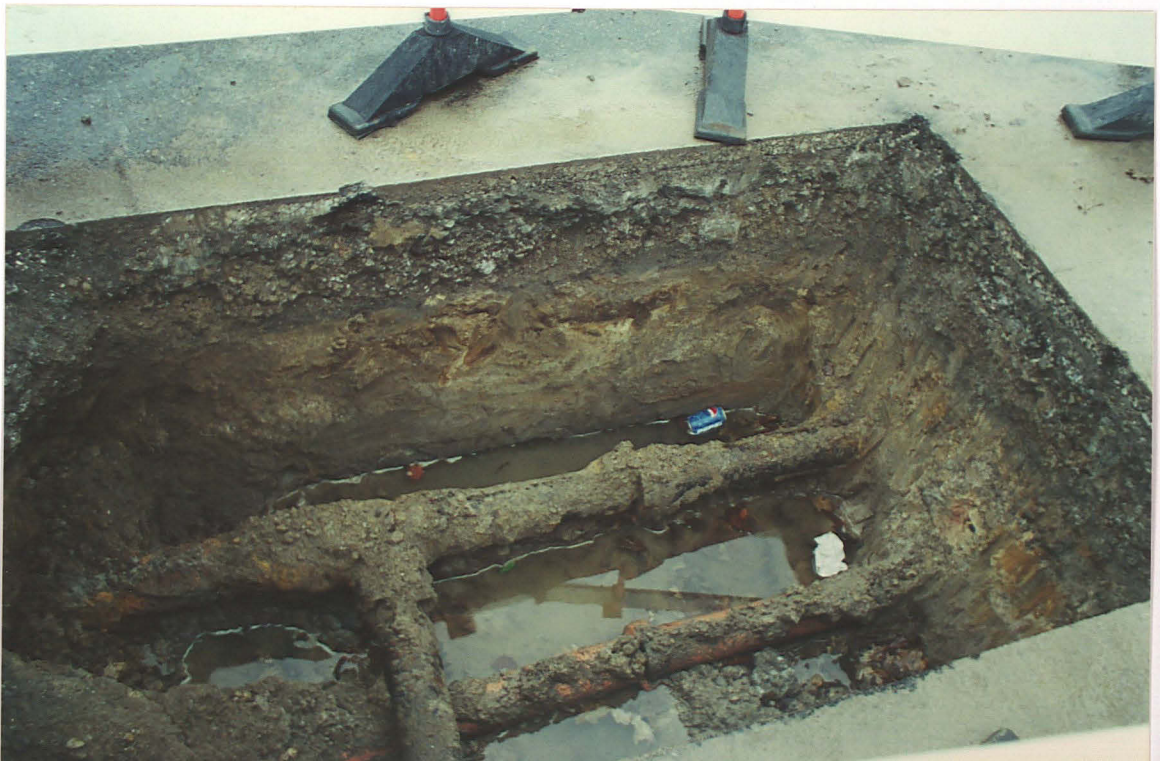
Pl. 2 Access hole in Bowden Drive; where undisturbed stratigraphy was exposed, no archaeological features or finds were identified.

Trenches were inspected at intervals along Bowden Drive and Greenbank Drive, but most revealed ground disturbed by previous utilities trenches. At the northern end of Bowden Drive, undisturbed gravel was recorded outside De Wint Court. Trenches in Greenbank Drive exposed sand when undisturbed material was encountered.
