## **Woolsthorpe Manor, Lincolnshire**

## **Archaeological Watching Brief**

**Report for The National Trust**

**LAS Report No. 460**

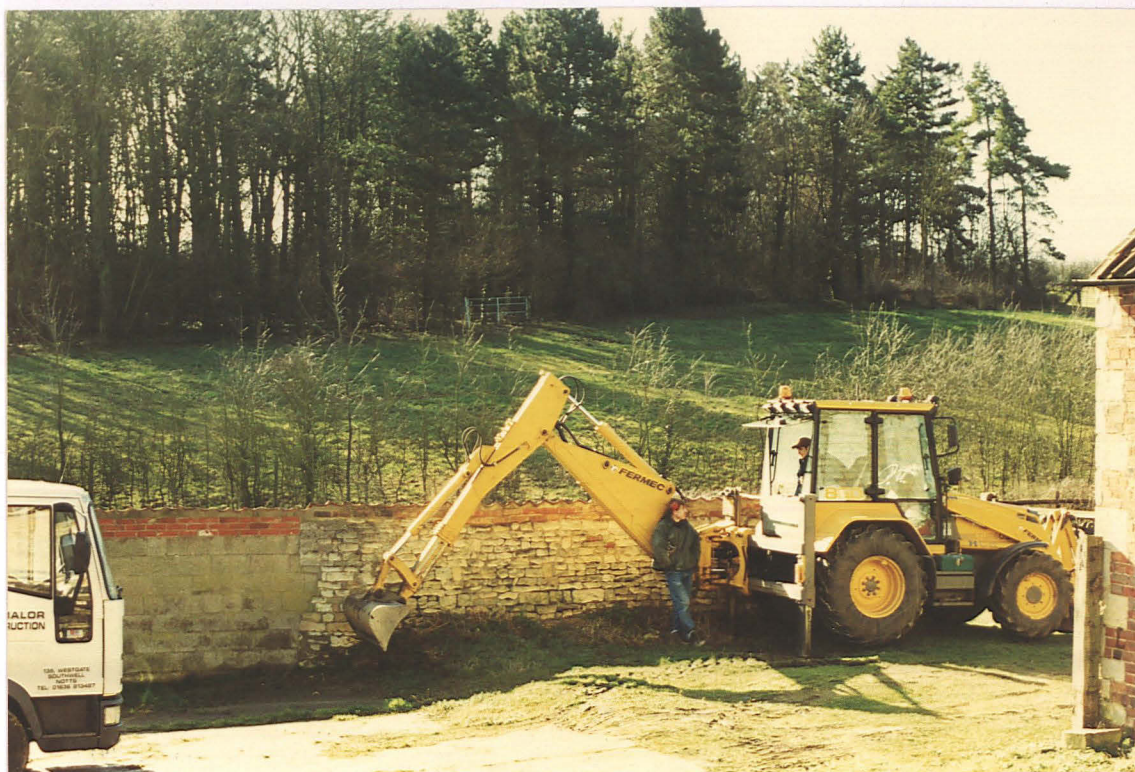
**Pl. 1** Site of the new toilet block, prior to groundworks. Note the junction between the stone boundary wall and the breeze block wall, coinciding with the limit of the concrete yard area (looking SE).

The 5m north-south by 12.5m east-west monitored development was alongside a stone boundary wall in the SW corner of the farmyard, close to the entrance and driveway (Figs. 2 and 3; Pl. 1). Beyond the wall, the ground rises with a belt of trees on the top of the slope. The yard area is almost surrounded by farm buildings, with a former threshing barn to the NE and smaller outbuildings to the NW. The eastern part of the yard is concreted, although the remainder is under low grass; the yard has a slight slope to the east

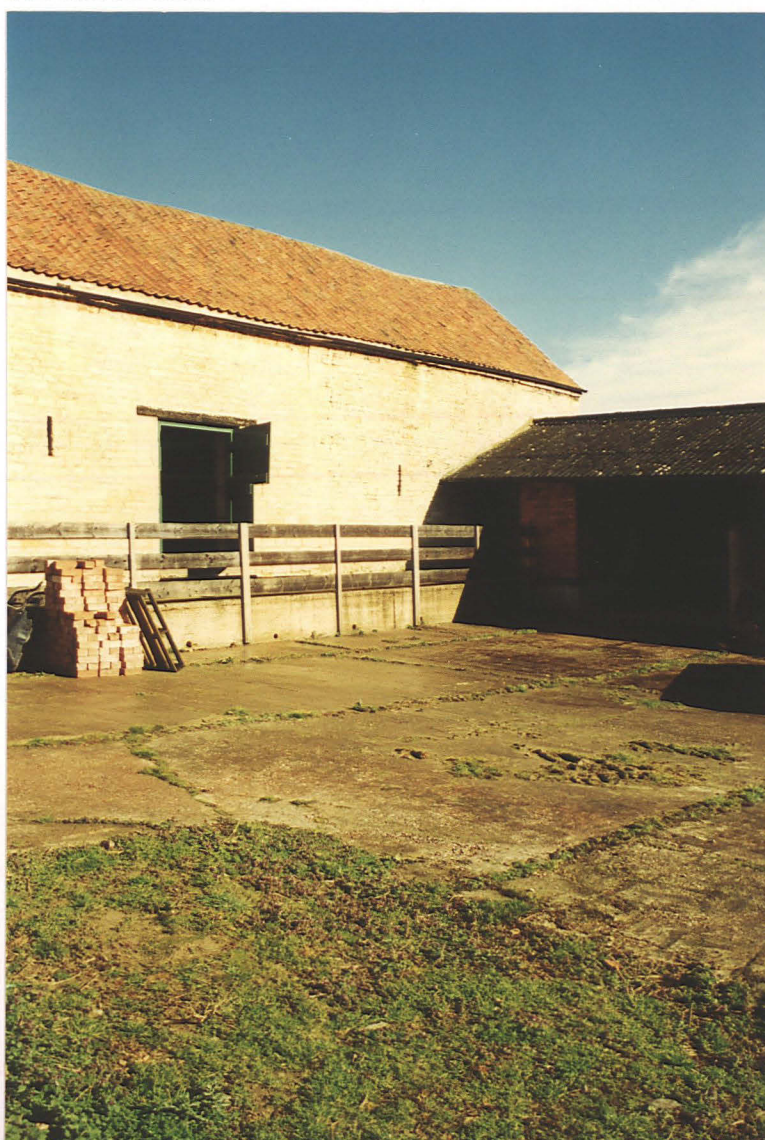
**Pl. 2** The stone threshing barn and other outbuildings beside the concrete yard, NE of the toilet block site.

(Pl. 2). Beside the concreted yard, the boundary wall has been rebuilt in breeze blocks, suggesting that this area corresponded with some previous land use.

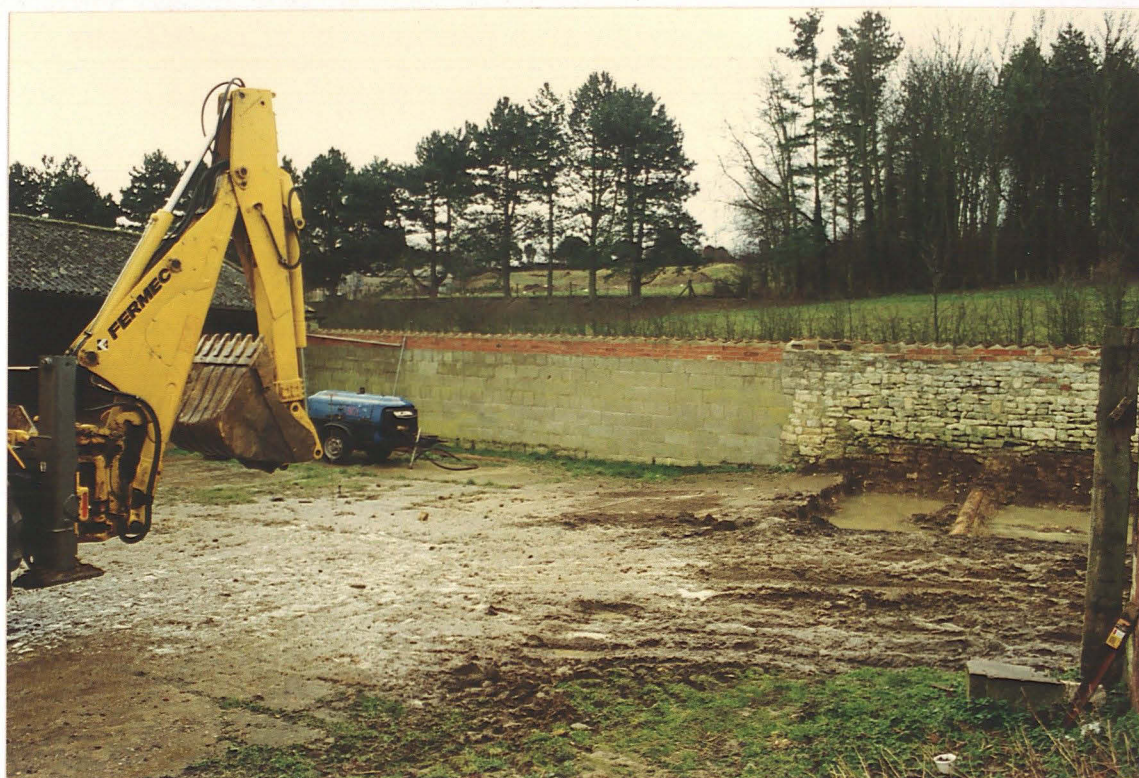
**Pl. 3** Standing water obscuring the excavated site of the new toilet block (looking south).

The area was machine-excavated under archaeological supervision using a JCB with 1.8m wide toothless bucket to depths varying from 0.3m at the concrete-covered eastern end to 1.2m at the western end (Pls. 3 and 4). Any archaeological features identified were recorded using colour photographs, scale plans and sections. Archaeological features and deposits were assigned context numbers by LAS for recording purposes; these context numbers are used (in bold) in this report and the illustrations.

Much of the southern part of the trench was under water, as was the eastern trench face, making it difficult to record features. Parts of wall foundations were not photographed as they were too far under water. Their presence was established by trowelling under the water to establish the presence or absence of stone.

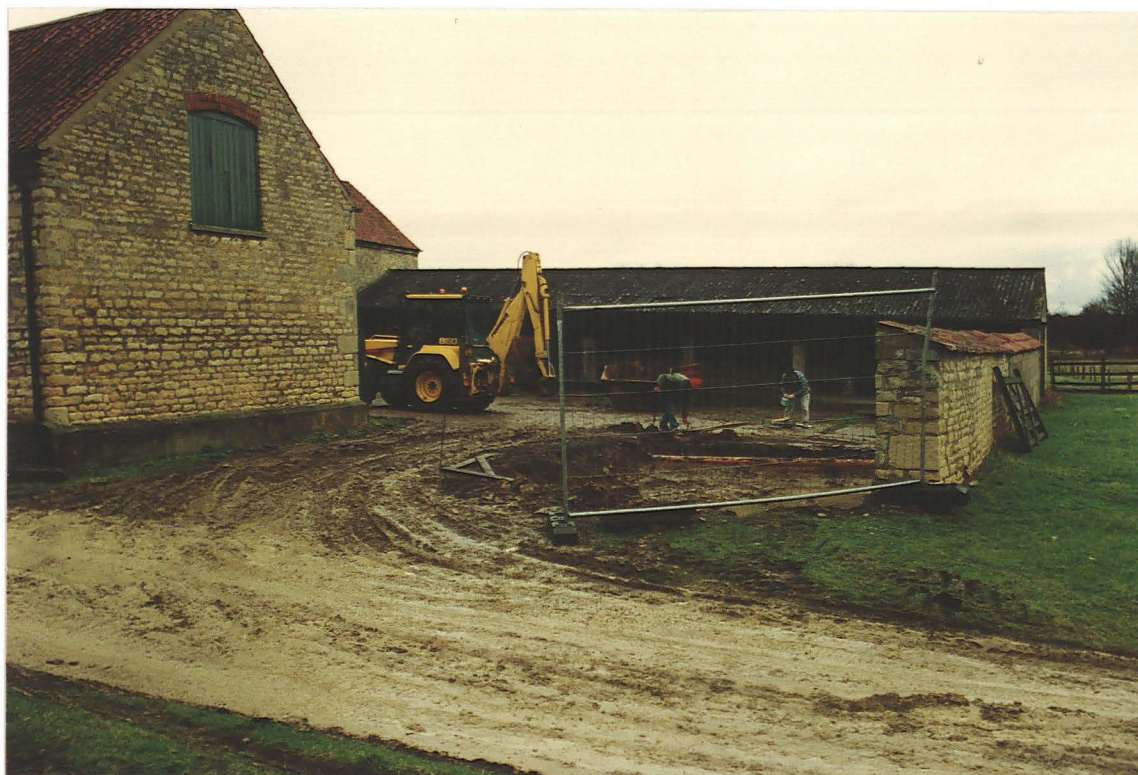
**Pl. 4** Position of the monitored groundworks within the former farmyard (looking NE).

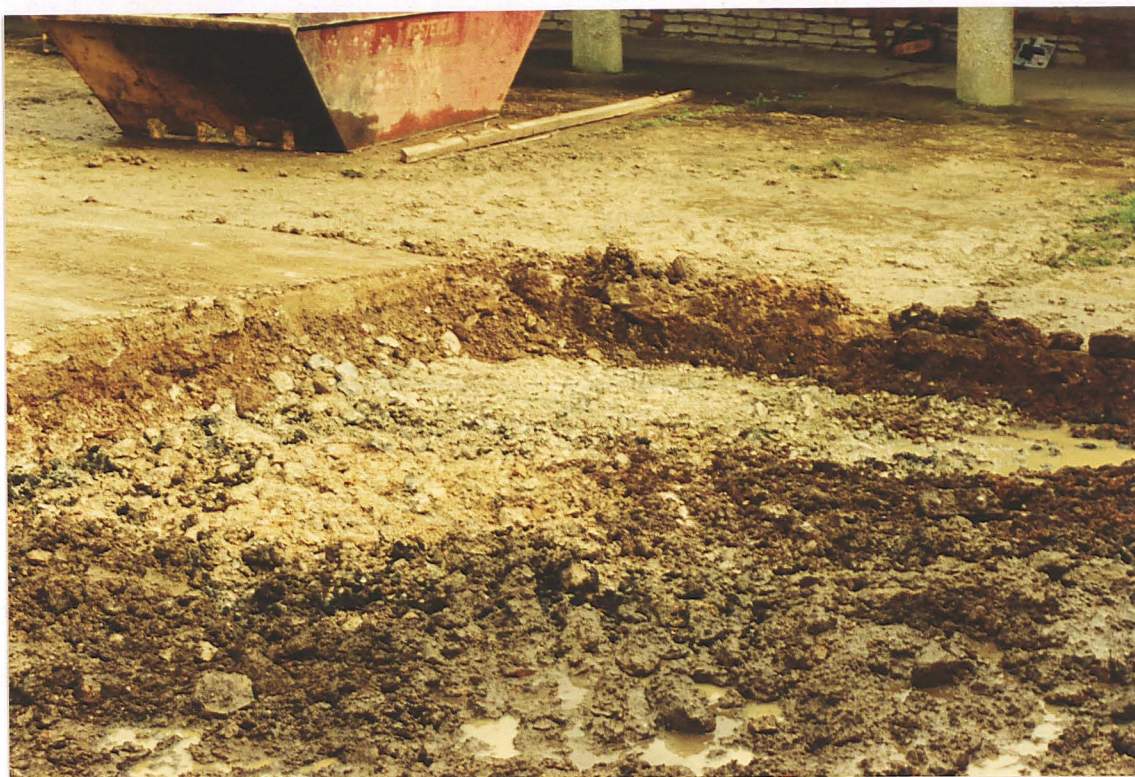
**Pl. 5** Limestone rubble spread 118 at the eastern end of the excavated area, below the concrete yard surface (looking NE).

A 0.15m - 0.2m thick layer of concrete **116** covered the eastern end of the trench. This formed part of a more extensive surfaced yard area, extending beyond the site of the new toilet building. A 0.12m thick make-up layer of sand and gravel **117** lay beneath this, with a limestone rubble spread **118** below (Pl. 5).

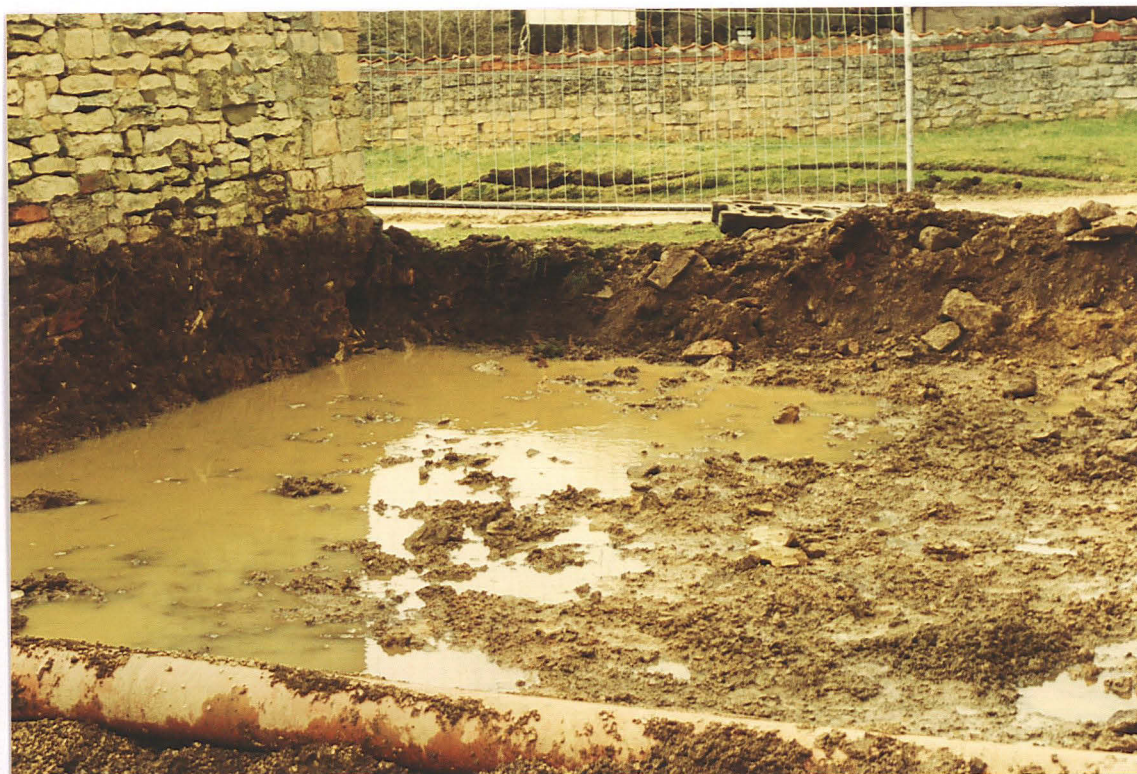
**Pl. 6** Western end of the new toilet block site, after excavation (looking SW). The void left in the fabric at the base of the stone boundary wall at its western end may indicate the position of a demolished return wall, but no sign of this was identified in the trench.

Across the remainder of the trench, the topsoil **100** consisted of a grey-brown loam approximately 0.05m deep. Immediately below this, and extending 0.6m eastwards below the concrete, was a grey-brown silty clay make-up layer **101**, containing 140 sherds of mostly nineteenth/twentieth century pottery and modern debris including brick, glass, and stone rubble. Both table-wares, stone and earthenwares were recovered, although the majority of material was fine wares, including the remains of several tea services. Some seventeenth/eighteenth century sherds were also found (Appendix 2). A number of bottles were recovered, including one labelled as containing butter colouring, suggesting that butter was made on site. It is possible that, in addition to the butter produced for consumption in the manor, surplus was sold in the neighbourhood. Layer **101** appears to represent a deliberate dump of material, possibly to form a level surface at this end of the farmyard (Pl. 6).

The north-south stone wall foundation **106** found within the monitored area is in the approximate position of the eastern gable end of the rectangular 'Dove House' marked on Barrows' 1797 plan of Woolsthorpe Manor (Fig. 3). As the buried foundation appears to be a return wall related to the existing stone boundary wall, it is suggested that the foundation forms part of the mapped dovecote and that a substantial part of the late eighteenth century or earlier dovecote survives reused as the boundary wall. A north-south wall survived in this position until the late twentieth century, and is shown on Ordnance Survey maps. Irregularities in the stonework of the boundary wall at its western end may indicate another removed return wall, although this was not identified in plan (Pl. 6). The entire south wall of the dovecote may survive.

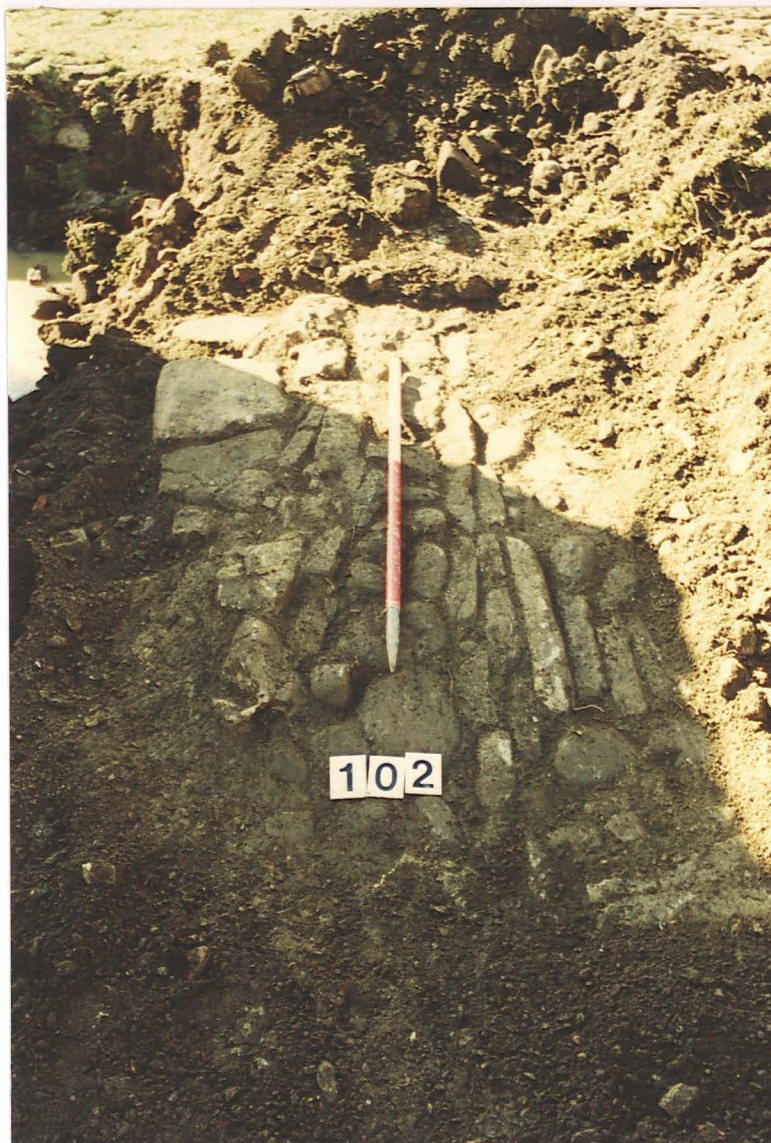
**Pl. 7** Detail of pitched stone surface 102, possibly a floor within the demolished dovecote (scale 1m).

A stone surface **102** was covered by the make-up layer, bedded on a layer of yellow-brown clayey sand **103** (Pls. 7-9). The paved surface extended across most of the area covered by grass, but did not continue below the concreted area. A small part of the exposed surface was of pitched stones, possibly marking an entrance or path, while the remainder was of regular sized, cut small blocks of limestone which were rounded as if by frequent use. The surface may have been within a building delimited to the east by wall **106**.

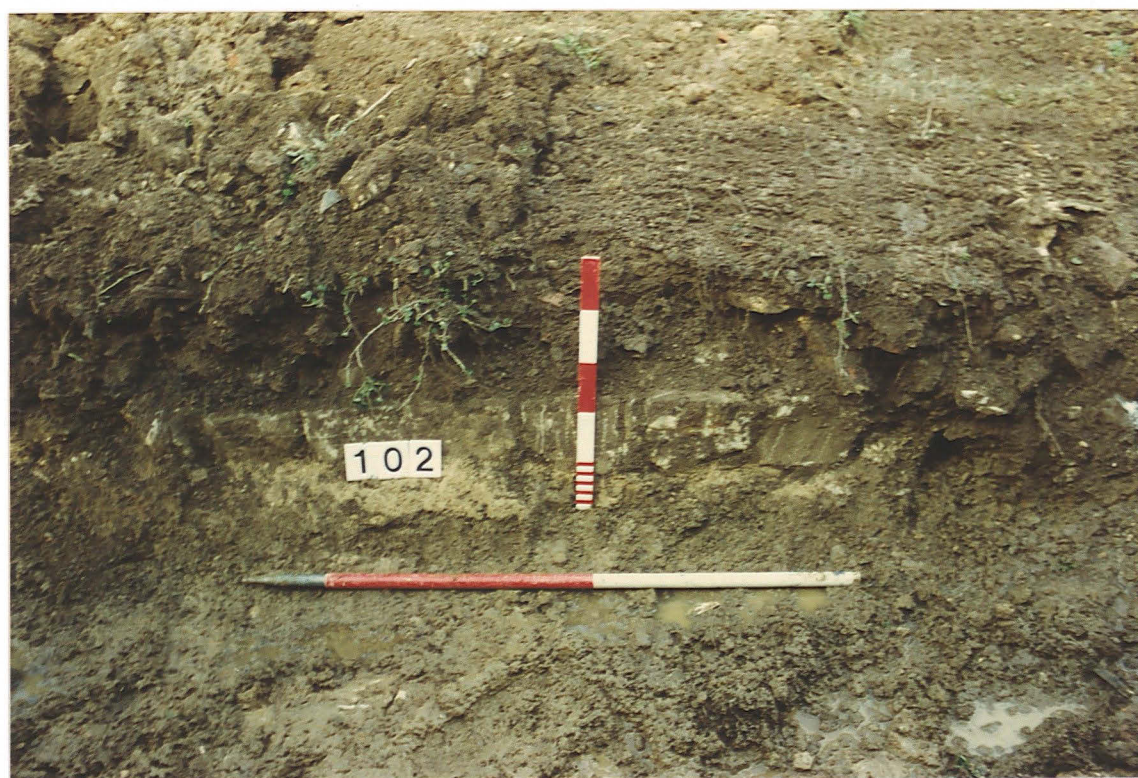
**Pl. 8** Stone floor 102, bedded onto mortar and clayey sand layer 103 (scales 1m and 0.5m).

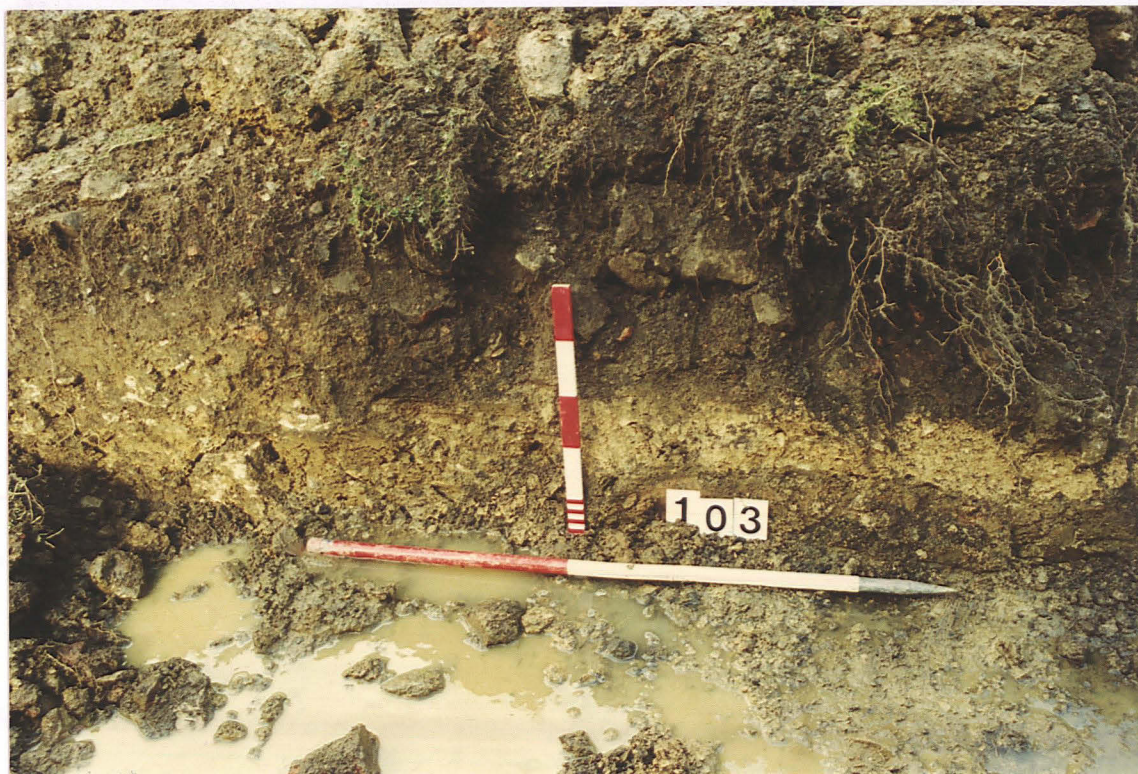
Pl. 9 Floor bedding layer 103 (scales 1m and 0.5m).

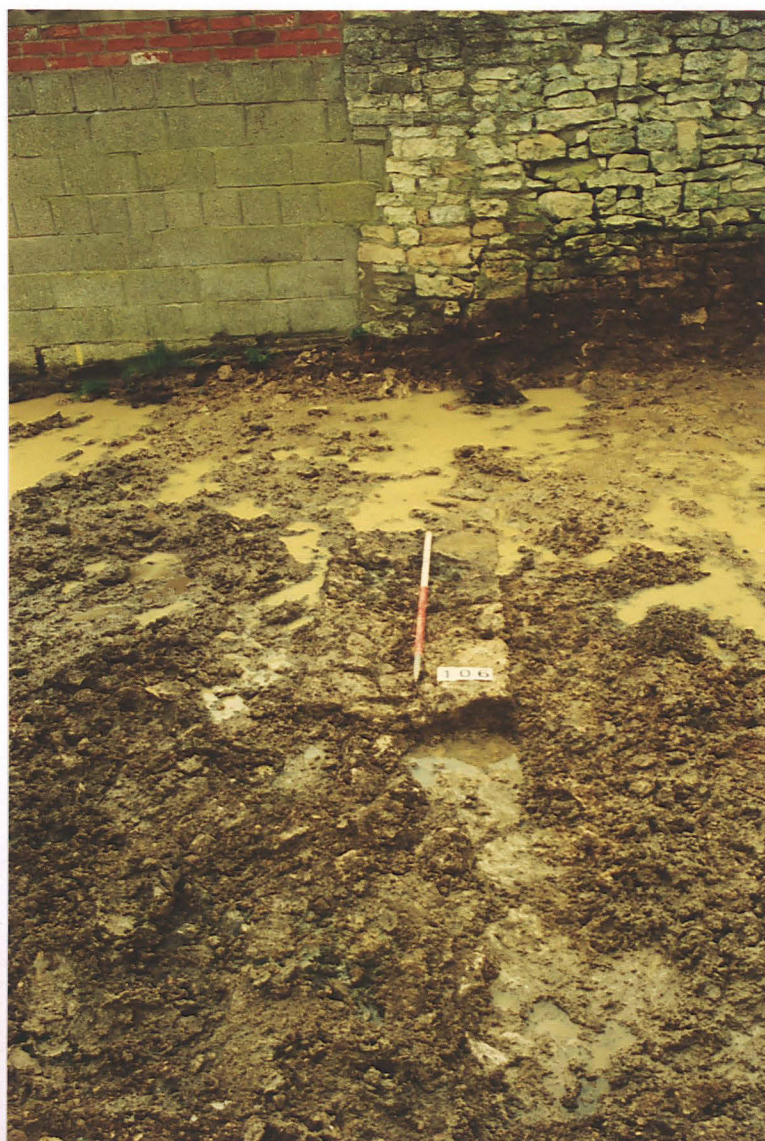
Pl. 10 Wall foundation 106, probably the east wall of the demolished dovecote. The foundation may be contemporary with the upstanding stone boundary wall (looking south, scale 1m).

At the junction between the overlying topsoil **100** and concrete **116**, coinciding with the eastern edge of stone surface **102**, a north-south aligned 0.8m wide limestone wall foundation **106** was revealed (Pl. 10). The foundation was not continuous, but it was unclear whether it marked the position of piers from an open-fronted building or gaps for doorways (Pl. 11). The nature of the surrounding material and standing water made it very difficult to record these features. No foundation trench or backfilled wall-robber trench could be identified, although the foundation did appear to have a deposit of red clay **112** associated with it. The relationship of **106** to the standing boundary wall could not be ascertained, but it is possible that they were both part of the same structure.
