**ARCHAEOLOGICAL  
WATCHING BRIEF REPORT;  
CHURCH STREET,  
BILLINGHAY, LINCOLNSHIRE**

NGR: TF 1567 5498  
SITE CODE: CSB01  
LCNCC ACC. NO. 2001.44  
Planning ref: N 09/0260/00

Report prepared for  
Ploughsound Ltd.  
by Chris Clay  
April 2001

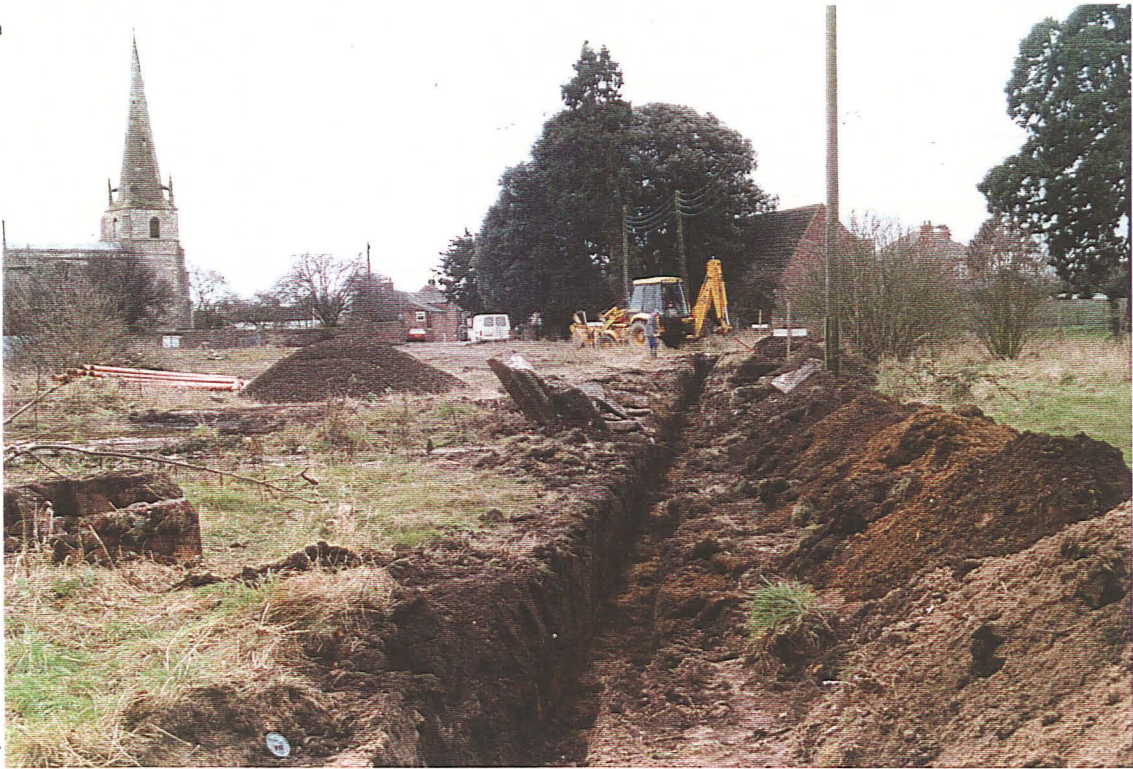
**Plate 1:** General view of the site, showing excavation of the main sewer trench (looking south-west)

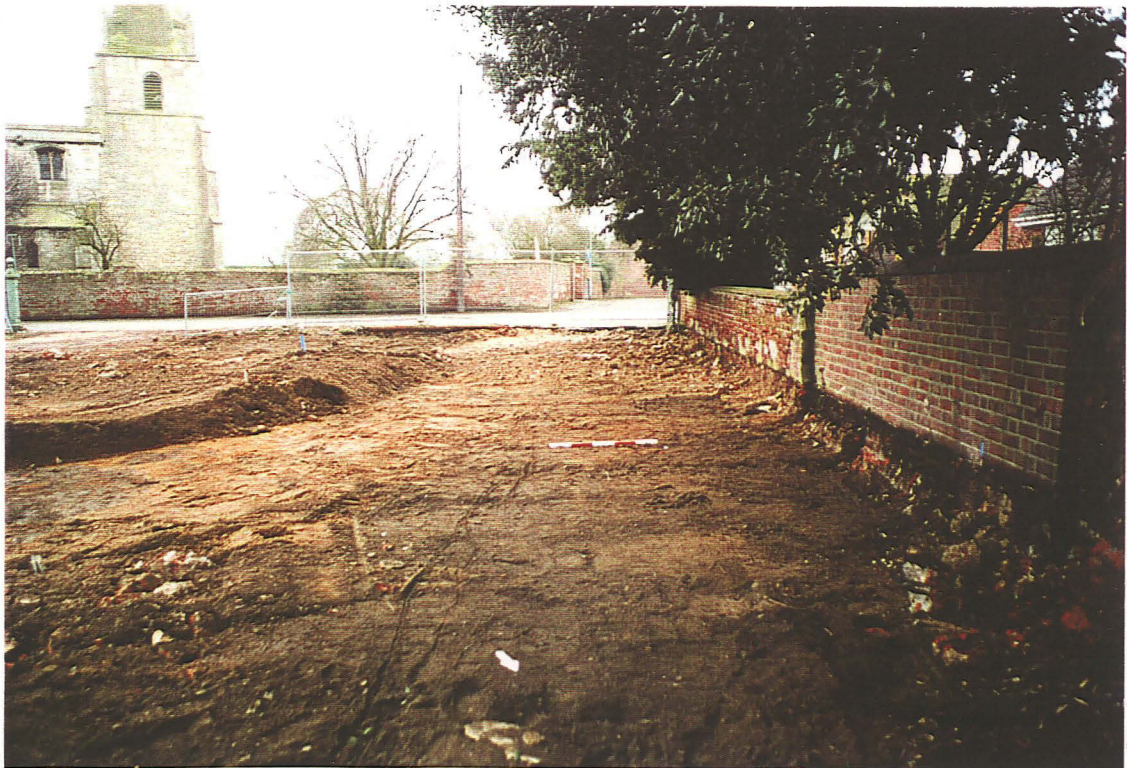
An area was stripped along the western edge of the site, to accommodate the access road. This was excavated to a depth of 0.4m, running northwards from Church Street. The first 8m exposed large amounts of brick rubble, roof tile and small amounts of roughly dressed limestone (004). Beyond this, the deposits changed to dark grey silty sand with smaller amounts of brick and tile rubble (005). Again, no archaeological features were exposed.

**Plate 2:** Shot of access road, looking south-south-west
