Church Lane, Glentham, Lincs.

WLDC Planning Application: 98/P/0710
Site Code: GCL 01
NGR: TF 0038 9050
LCNCC Museum Accn No.: 2001.69

Archaeological Watching Brief

LAS Report No. 522

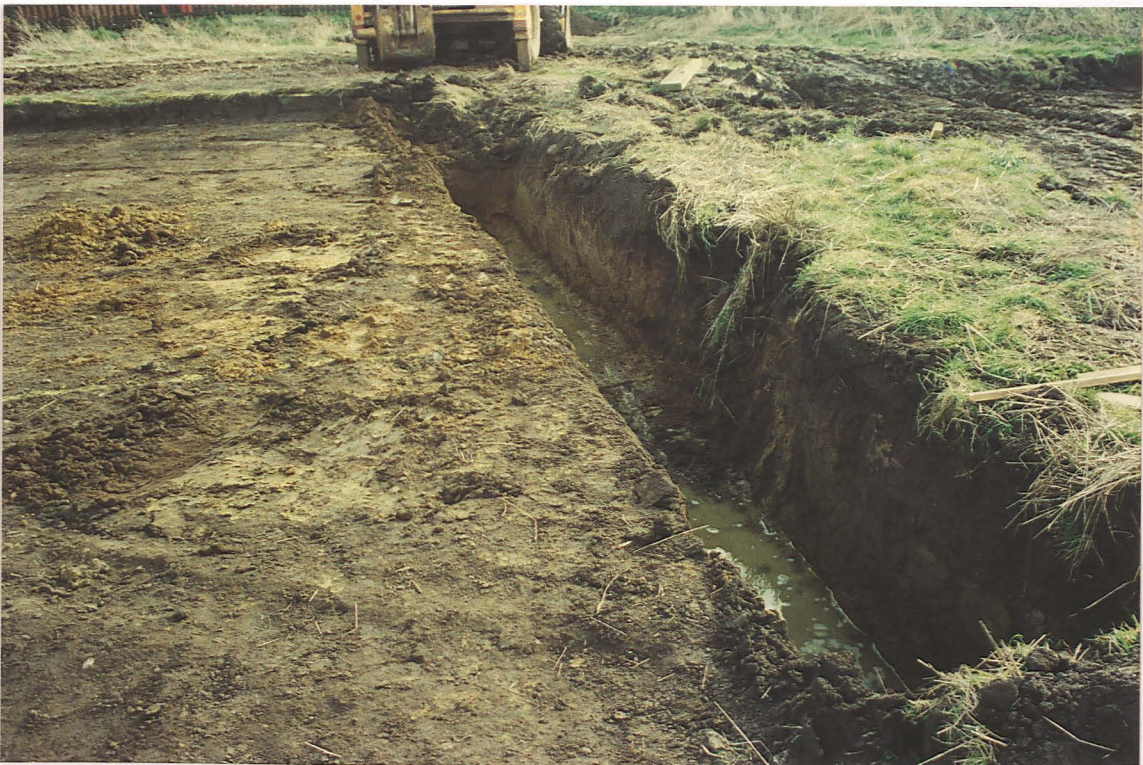
Pl. 6 Foundation trench, note in the foreground feature 104, looking south-east.

North of both linear features was **104**, a large depression containing a single fill, **105**, a mid grey brown silty sand with occasional sandstone and sub-rounded stone inclusions (PI. 6). One sherd of 13th century pottery was recovered from this deposit.

Feature **104** may relate to the former quarrying of sand in the area or may represent the infilling of a former pond or natural depression. Indeed local sources have suggested a pond existed on the site in living memory

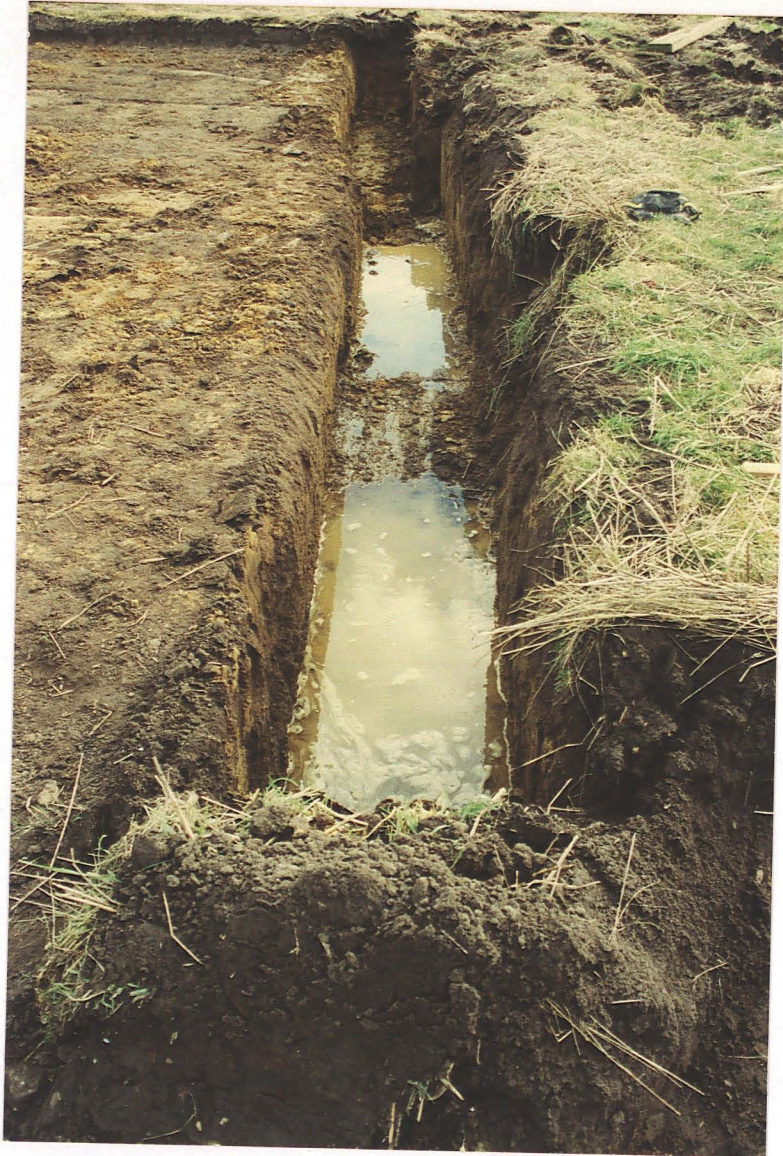
PI. 7 Footing displaying difficult ground conditions.

Further interpretation of these features was difficult due to very wet ground conditions (PI. 7) inevitably making the sides of the trenches unstable and prone to collapse, therefore no further excavations were possible.
