Middle Rasen, Church Street

Site Code: MRCS00

Archaeological Watching Brief

LAS Report No. 478

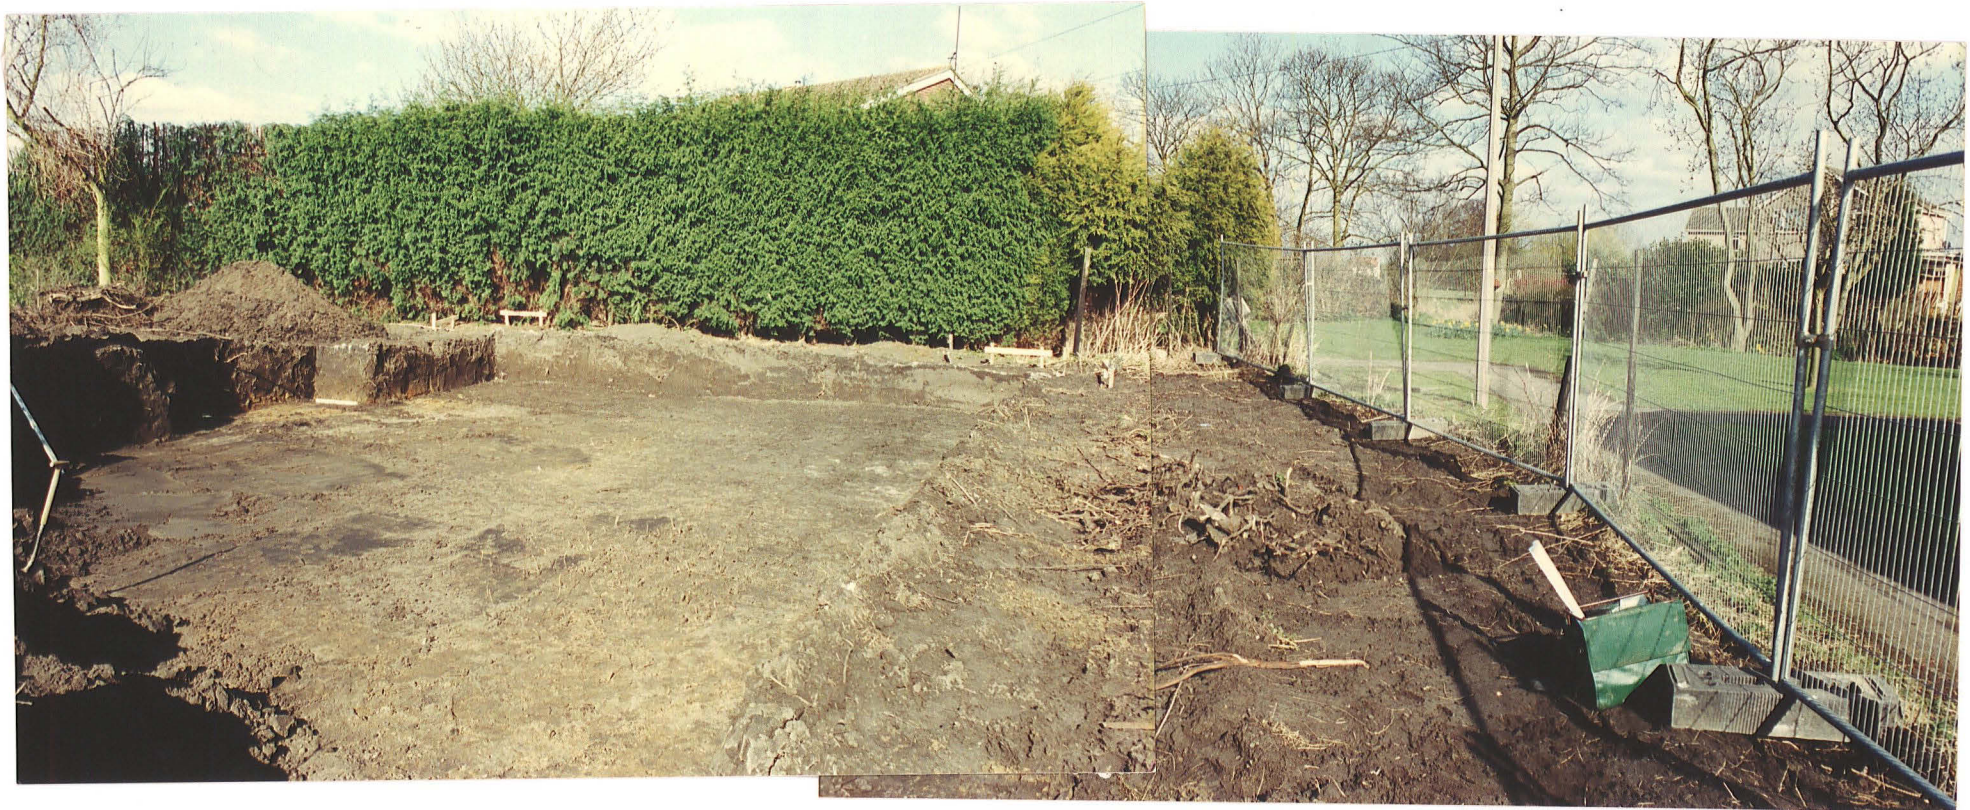
Pl. 1 Eastern end of the building area, after excavation for the foundation (looking NE). The stream is visible to the right of the photograph.

The bungalow block was positioned to the south of the building plot, close to an existing, but recent, hedgeline which separated this development from existing bungalows (Pl. 1).

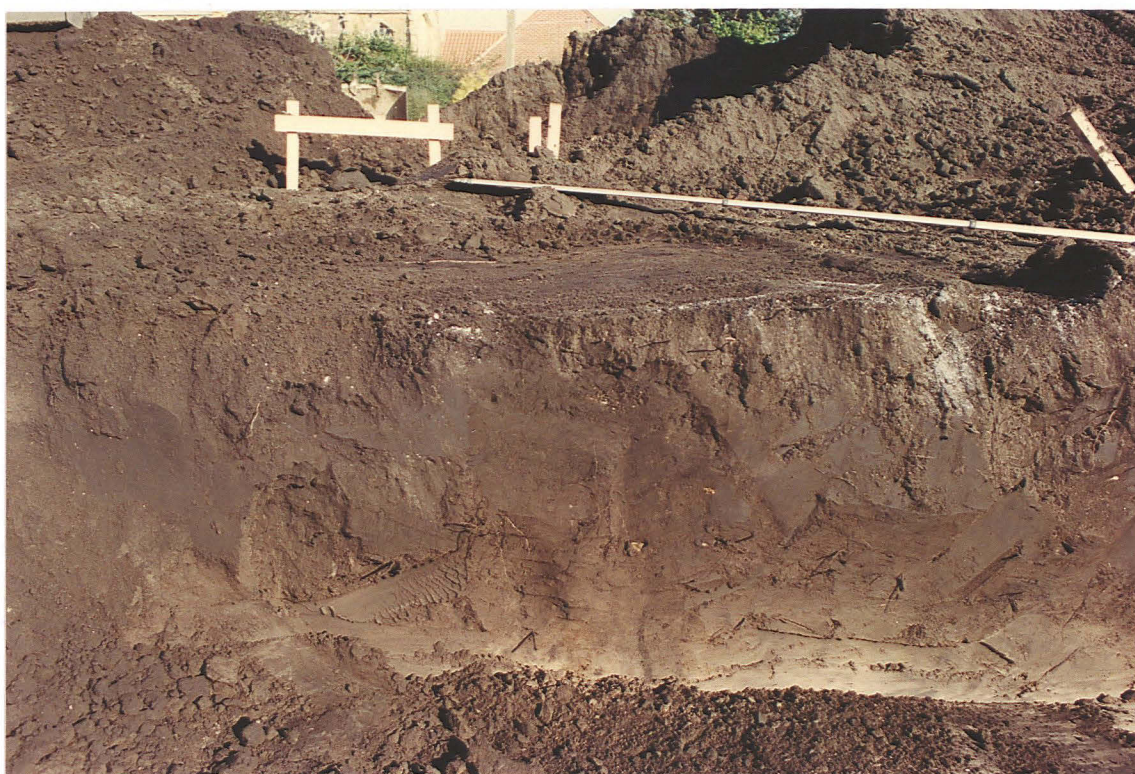
Pl. 2 The thick homogenous dark soil deposit in the NE corner of the building area.

The dark grey loamy silt topsoil **1** was distinguishable only to the west of the foundation area, where it was between 0.15m and 0.4m thick, and near the NE corner where it was 0.25m thick. Along the eastern edge of the site, only a single grey sandy loam deposit **2** could be identified. In the SE corner, this layer was at least 0.65m thick, increasing to at least 0.9m thick in the NE corner (Pl. 2). A fragment of fired clay was seen in the excavation edge, 0.65m below the modern ground surface, and a small piece of limestone was noted 0.4m deep. The same deposit was visible at the base of the stripped foundation, extending 1.7m from the SE corner, but increasing to about 6m along the southern side. Layer **2** was interpreted as an alluvial deposit, filling a former stream terrace to the west of the present Brimmer Beck. It contained five sherds of medieval and post-medieval pottery (Appendix 2).

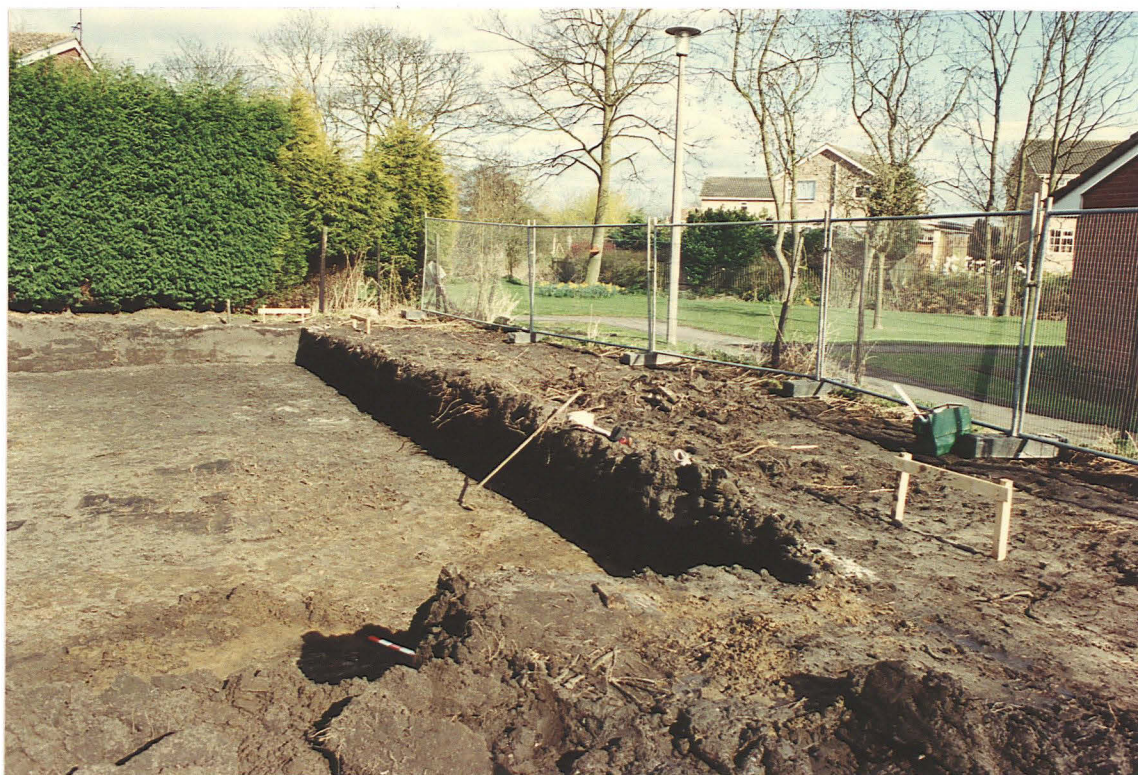
Pl. 3 Position of the post-hole feature 4 (marked by red/white scale), on the southern side of the building area. Looking SE.

Close to the southern side of the foundation area, a deposit of burnt clay **4** was seen at the foundation base, 0.8m below the ground surface (Pls. 3 and 4). Overlying material had already been removed, and it was no longer possible to determine from what level this feature had been excavated. The clay formed an almost circular area, 0.45m diameter, with a soil-filled hole **9**, 0.1m diameter, in the centre. The SE quadrant of the clay was dark red/brown **7**, with the remainder yellow **8** (Pl. 5). This feature was tentatively interpreted as a post-hole **4**, with redeposited clay used as packing around a small diameter post. The interpretation remains uncertain, however, because the clay appeared to have been burnt *in situ*, 0.8m below the modern ground surface, constrained within a circular confine.

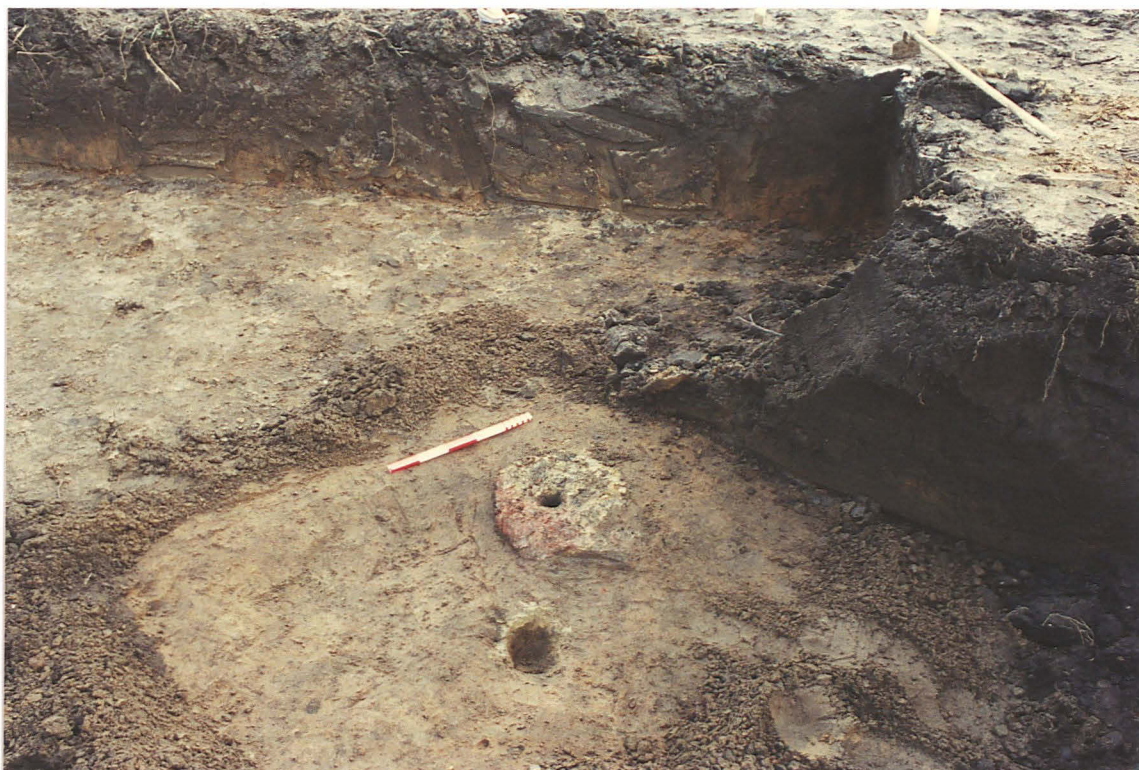
Pl. 5 Clay post-packing 7 and 8, and two excavated post-pipes, in a shallow depression cut into the sand. Looking south; scale divisions 0.1m and 0.01m.

A second post-hole **5** was found 0.3m to the north. This was less well-defined, but was 0.2m diameter, within a small area of yellow clay **10**. Its surviving depth was about 0.12m, and it contained small pieces of animal bone.

Both features 4 and 5 were within a shallow irregular depression 6, filled with discoloured sand 11 and flecks of charcoal and fired clay.

The depression 6 did not seem to be a rubbish pit, but that interpretation would fit best with the depth and fill found at its base. Assuming it to have been dug as a rubbish pit, amongst the first debris to be tipped in was the base of a hearth, together with other burnt material from its environs. At a later date, presumably fortuitously, two stakes 4 and 5 were erected across the backfilled pit, possibly as part of a fenceline of which no other trace was identified.

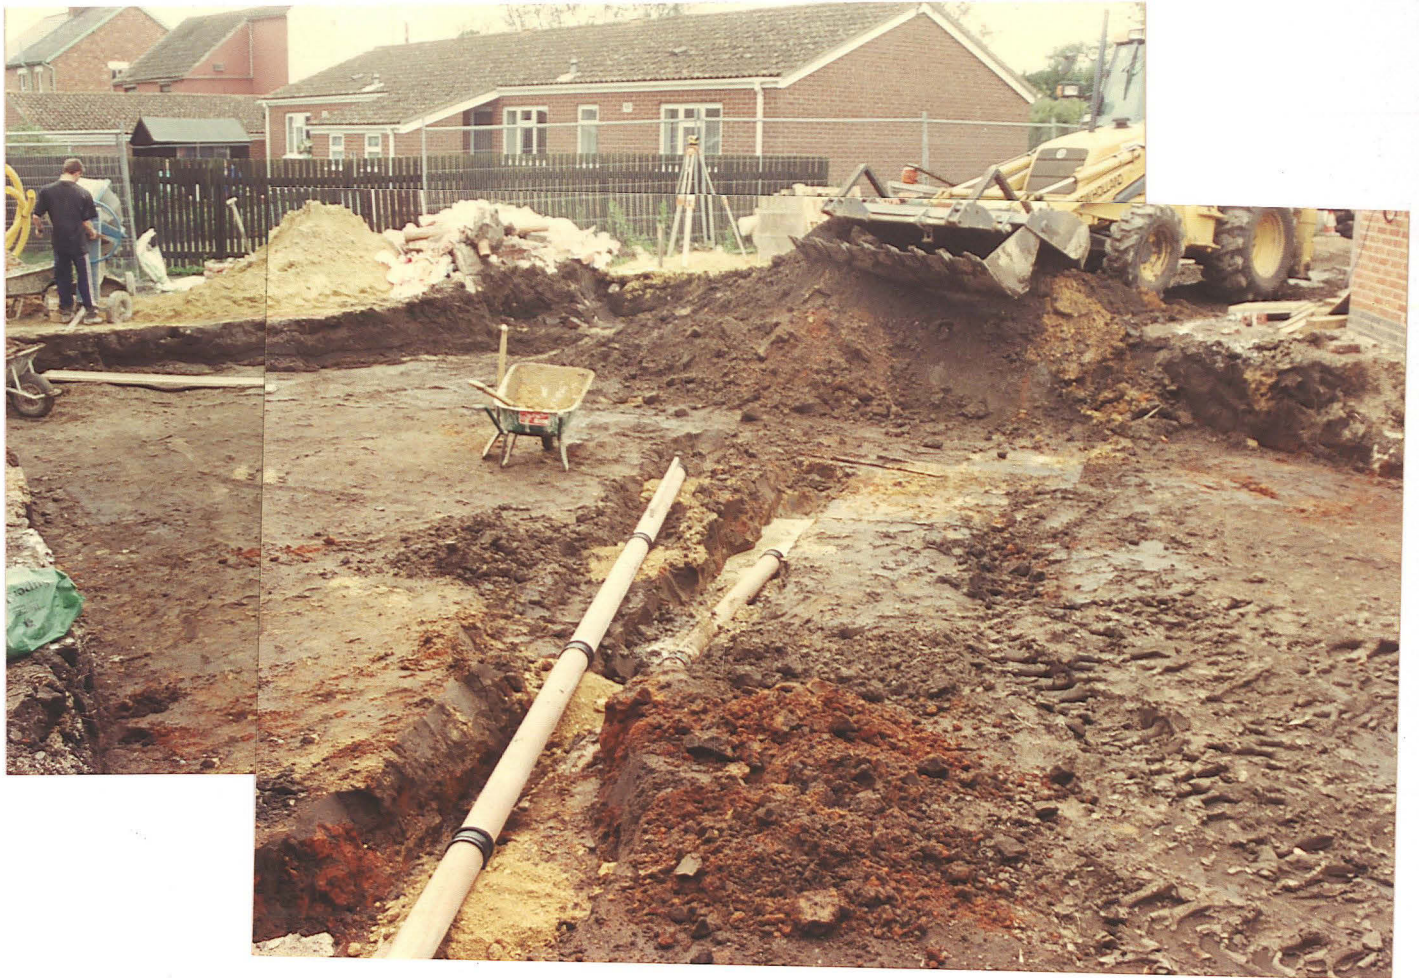
Pl. 6 Service trenches across the access road (looking SW).

The access road was excavated to a depth of 0.5m adjacent to the bungalow block, becoming gradually shallower towards Church Street (Pl. 6). Two service trenches were dug within this stripped area, one to a depth of 0.15m and another on a similar course to a depth of about 0.4m. A single dark grey loamy silt deposit, similar to 1 and interpreted as topsoil, was identified across this area. No archaeological features were revealed here.
