Land off Watery Lane, Mareham le Fen

Archaeological Watching Brief

Report prepared for Owl Homes of Lincolnshire

**LAS Report No. 482
November 2000**

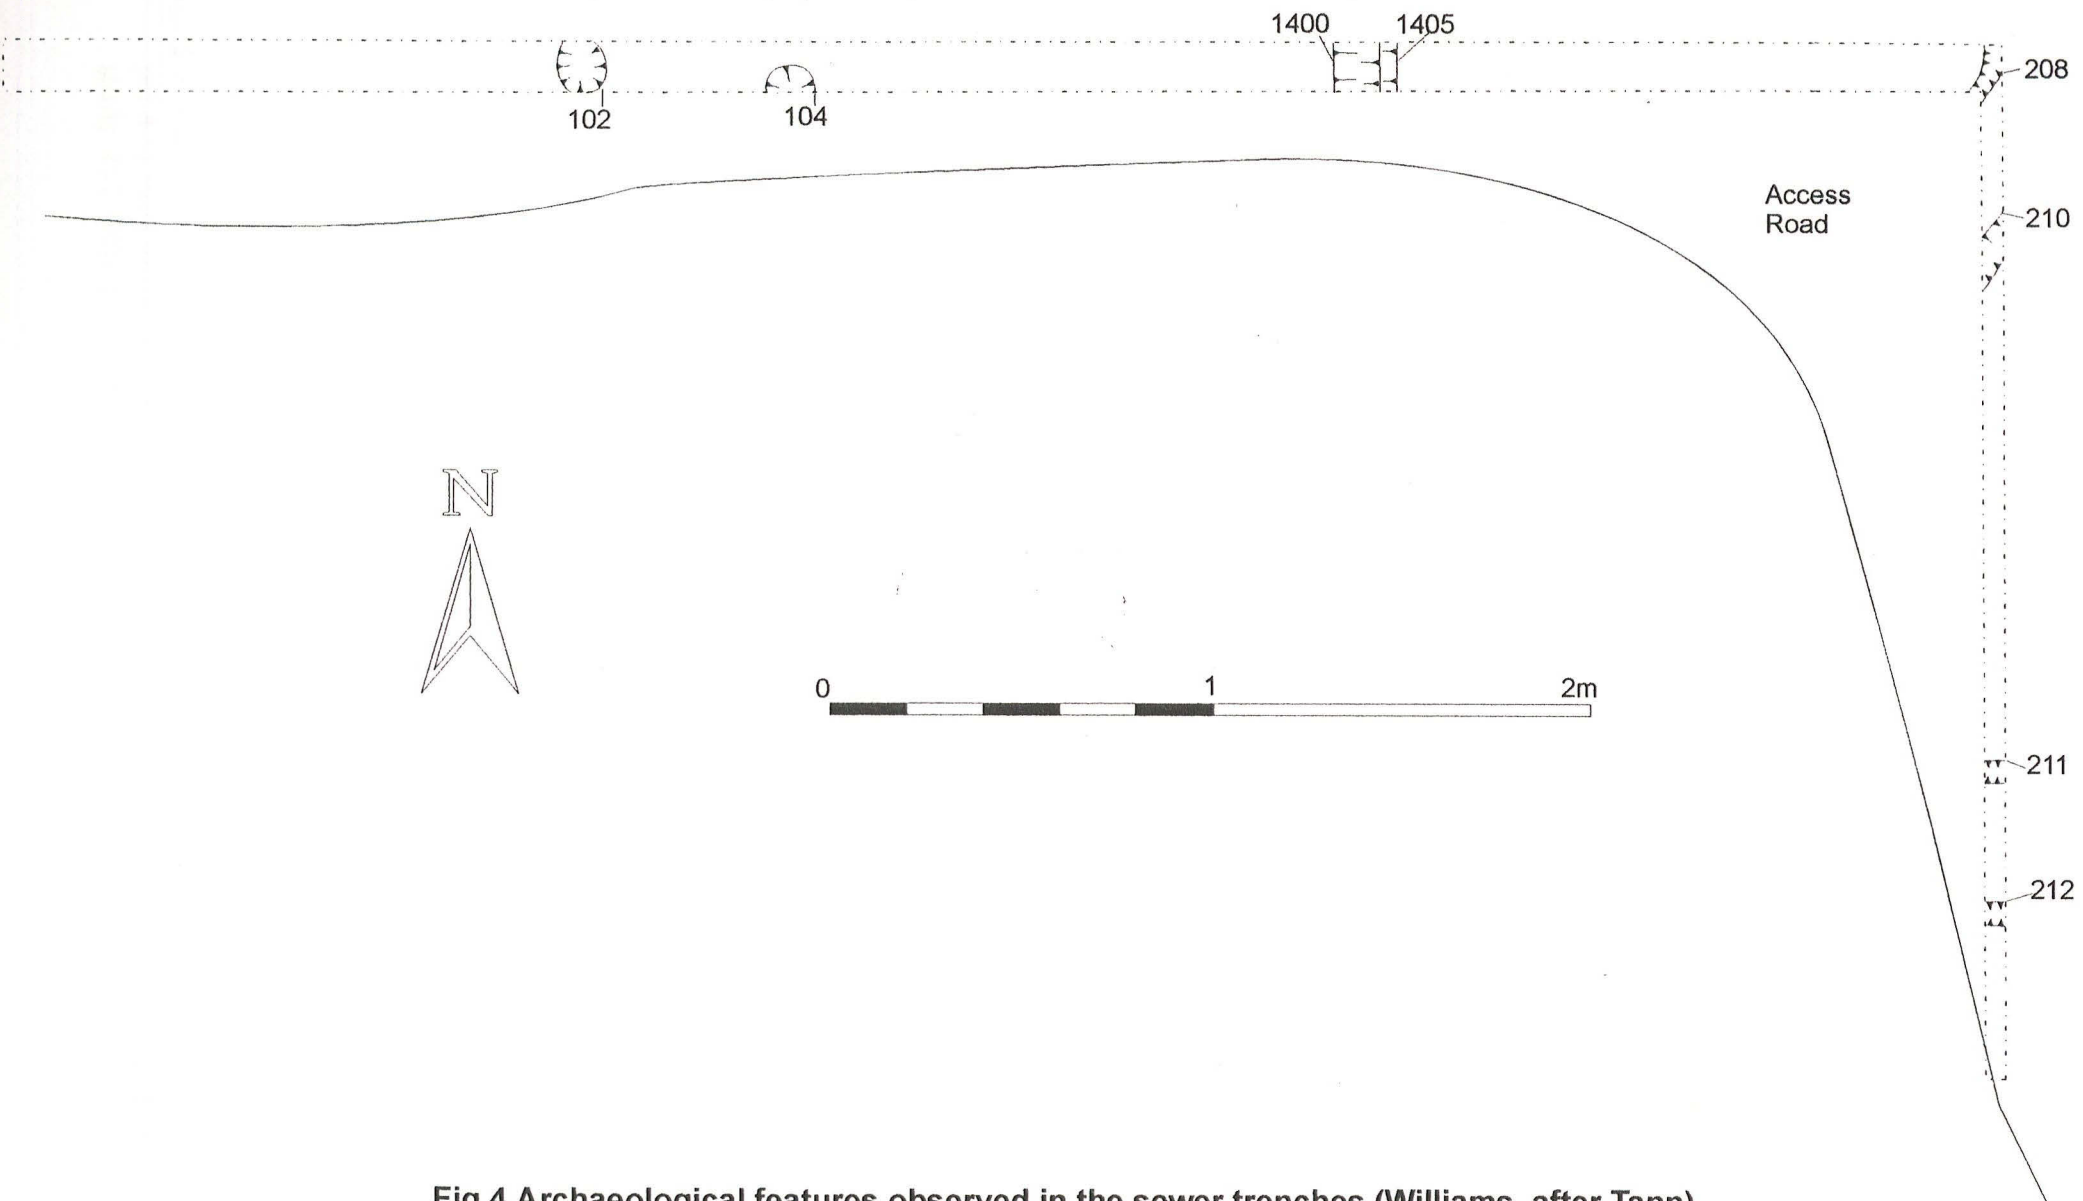
Fig.4 Archaeological features observed in the sewer trenches (Williams, after Tann).

Access Road and Sewer: west-east (Fig. 4)

The modern topsoil **100** was 0.5m thick and produced three anomalous sherds which may have been imported with modern material from elsewhere (Appendix 2). Below the topsoil was orange/brown silty sand subsoil **101**, which was over 1m thick and contained flint gravel.

14m NE of the electricity sub-station, a 1.5m diameter pit **102** was exposed in the sewer trench, immediately east of part of an archaeological evaluation trench (Pl. 2). The pit was over 1.3m deep, and contained root fragments in its grey clay fill **103**.

A shallower pit **104** was seen in the south face of the trench 21m NE of the sub-station (Pl. 3). This was also 1.5m diameter, with a grey fill **105**.

Access Road and Sewer: north-south (Fig. 4; Pl. 6)

The corner of a ditch was seen beside a manhole where the access road forked. Ditch **208** enclosed an area to the NW of the manhole (Pl. 7). Its fill **204** contained five fragments of medieval roof tile and three horse teeth, identified as from the upper right cheek of a young adult animal of about four years. A 1.5m wide parallel ditch **210** was seen 3.7m to the south, aligned NE-SW and filled by **201** (which held one fragment of medieval roof tile (Pl. 8). The space between may have been a field access, but no metalling was visible and no further information could be recovered.

15m to the south, the base of a 0.6m wide ditch **211** was seen in the trench (Pl. 9). This east-west aligned feature was apparently not contemporary with **208** or **210**, but shared the same width and alignment as **212**, 3.7m to the south (Pls. 10 and 11). The similar spacing of these pairs of ditches suggests two phases of a track, but no existing lanes or boundaries on either alignment have been recognised.

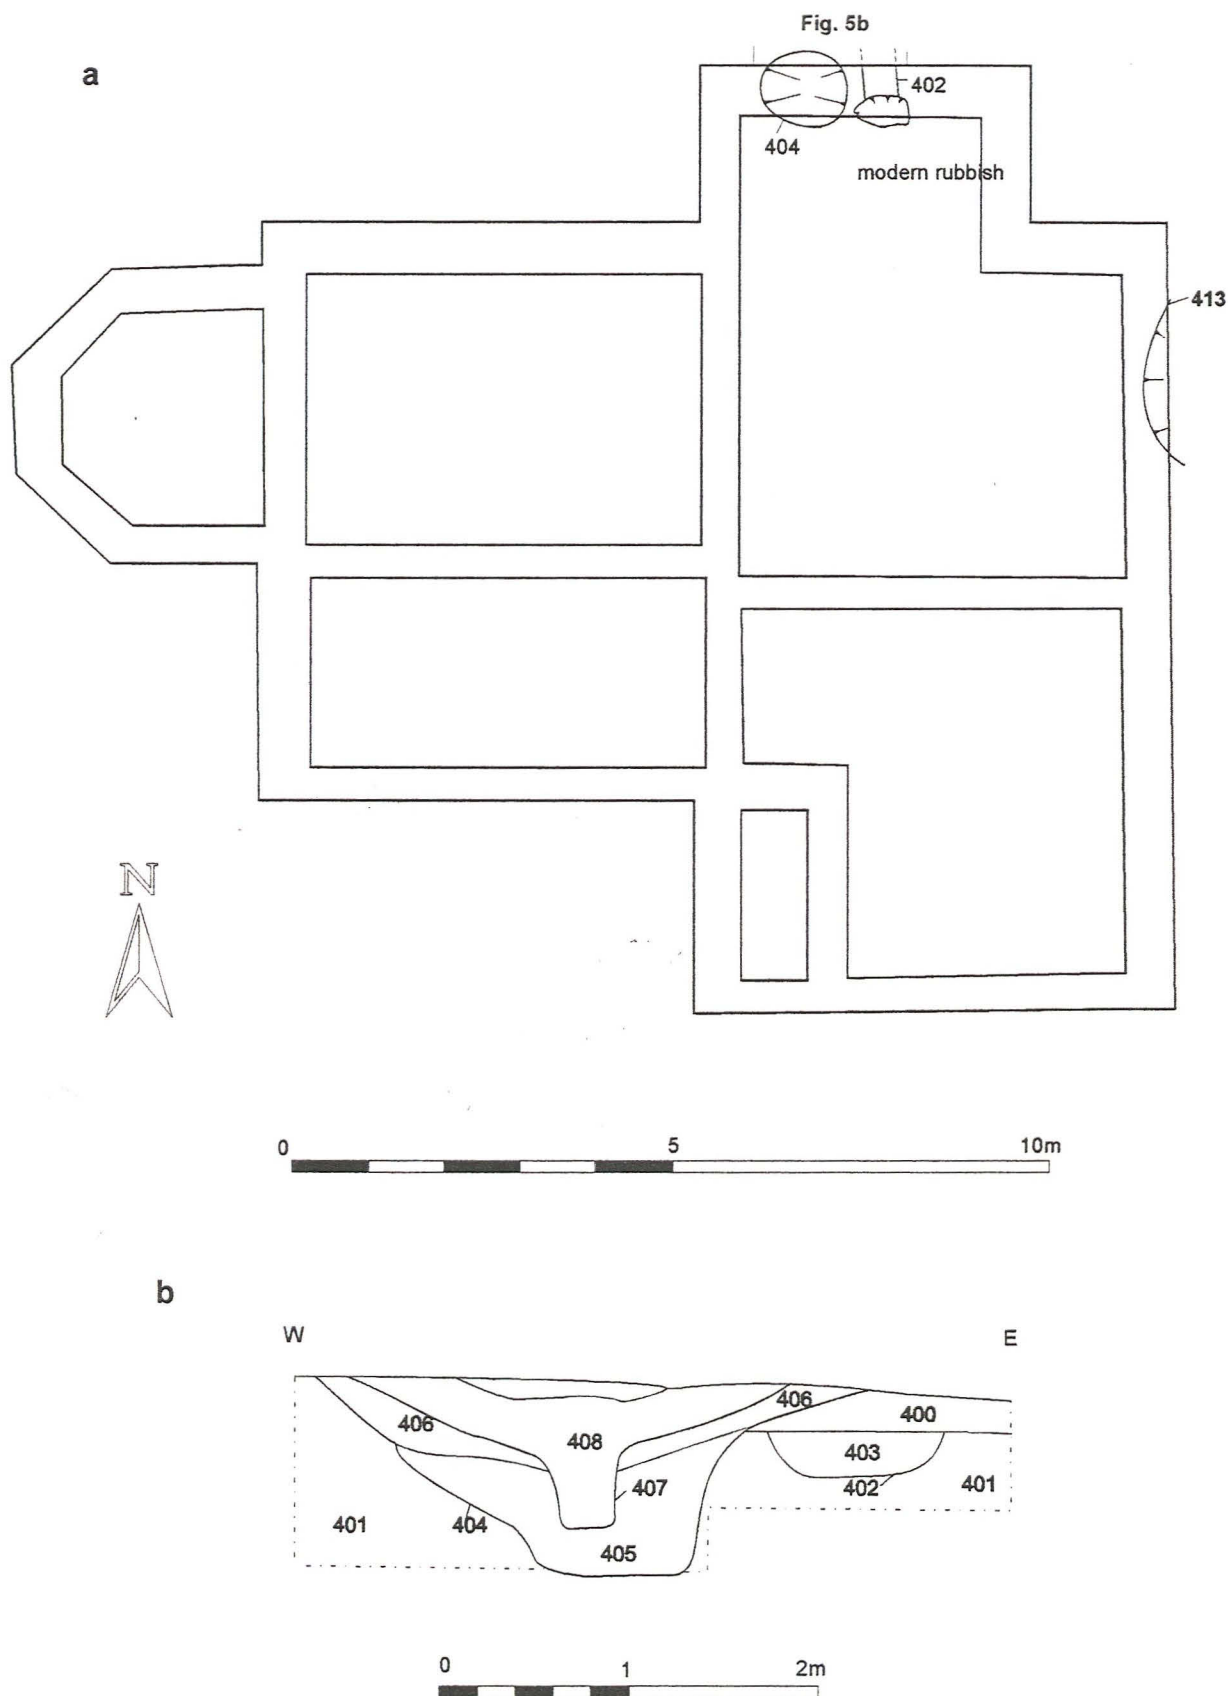
Fig. 5 a) Plot 4, plan of new foundations, showing position of pit 404, gully 402, pit 413 and modern rubbish pit 410; b) Plot 4, section through pit 404 and gully 402 (Williams, after Field).

Plot 4 (Fig. 5)

Topsoil had been cleared from the site prior to excavation of the house foundations, exposing, in places, a 0.2m thick layer of brown sandy clay subsoil **400**, which covered orange sandy gravel **401**. The subsoil **400** produced two fragments of medieval roof tile. Five features were revealed in the trenches for this house plot (Fig. 4a). These comprised pits **404** and **413**, a pit or gully **402**, post-hole **407**, and a late nineteenth/twentieth century rubbish pit **410**. This latest feature produced the right brow antler tine, with part of the beam, from a fallow deer.

Pit **404** was 1.1m deep, with a diameter of about 1.75m (Fig. 4b). Vestigial traces surviving on its east face showed that it had been cut through subsoil **400**. Its west side sloped down irregularly to a rounded base, but the east face exhibited a much steeper slope. The primary fill was **405** (which contained a sherd of thirteenth/fourteenth century pottery), with part of a yellow sandy upper fill **406** surviving. This could be an indication that the pit was deliberately backfilled with the originally excavated upcast.

0.1m to the east of pit **404** was a shallow pit or gully **402**. This only survived in the northern trench face, as pit **410**, containing late nineteenth century material, had removed the opposite side of the trench. The shallow feature was 0.9m wide and 0.2m deep, with a rounded base (Fig. 4b). It was not seen in other foundation trenches, and its shape remains unknown. The fill **403** was a light brown sandy clay (which produced a thirteenth/fourteenth century base sherd of pottery), sealed by the slightly darker subsoil deposit **400**. Feature **402** was the only identified feature that was apparently sealed by subsoil on this site, which would normally indicate that it represented an early phase of archaeological activity. In this instance, it is possible that layer **400** is actually upcast spread from excavation of the adjacent pit **404**.

Another pit **413** was seen 4m SE of **402**, in the eastern face of the eastern foundation trench. In section it appeared to be about 1.2m deep, and 2.1m wide. The fill **414** was similar to that of pit **404**, with the base under standing water. No pottery was seen, but investigation of the feature was impossible because of imminent collapse of the trench.

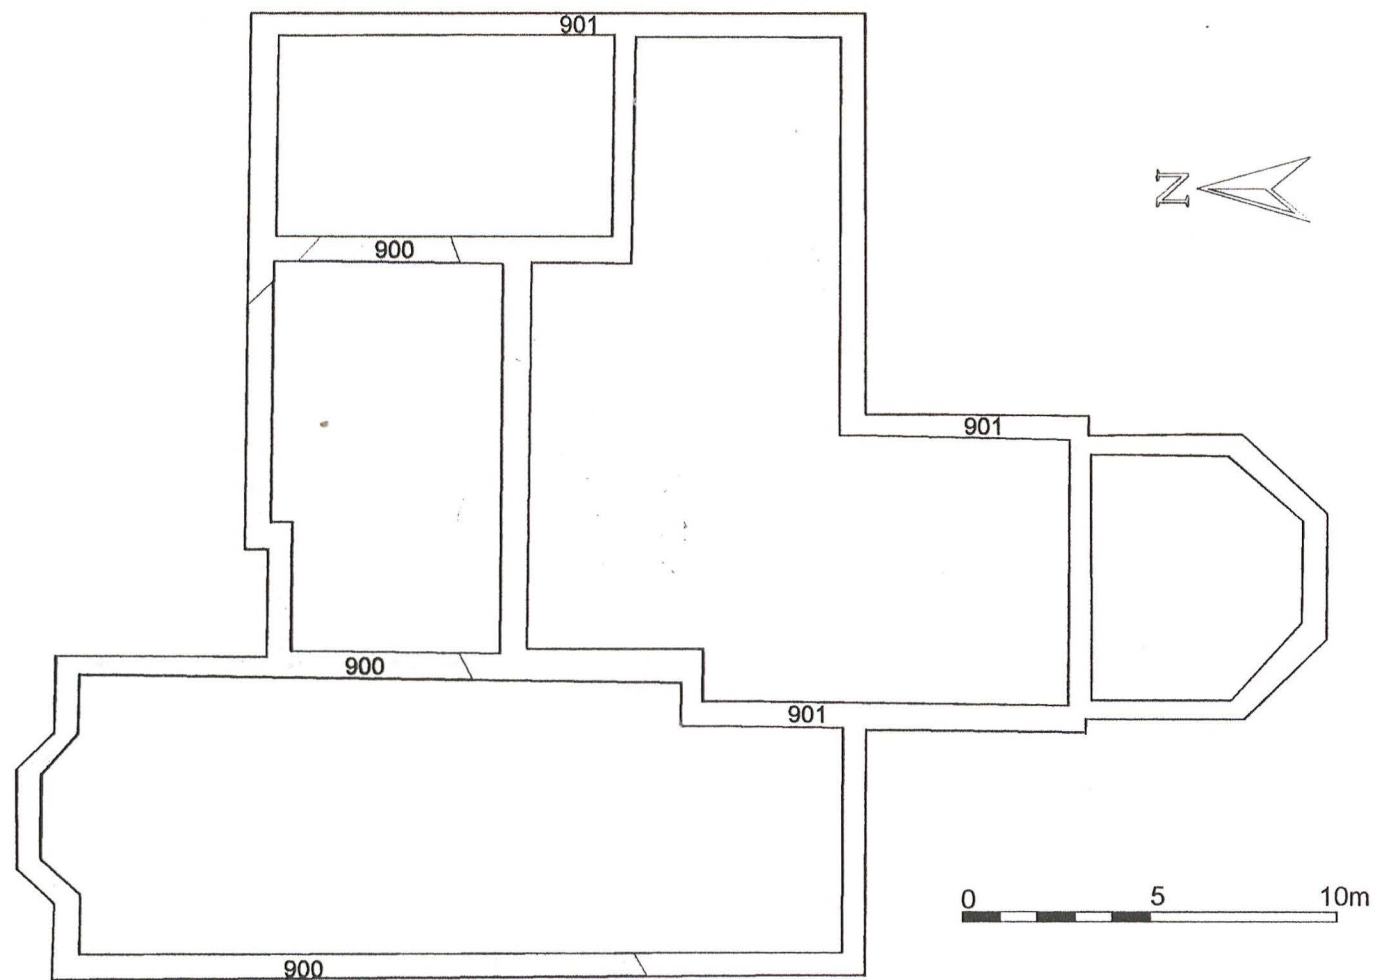
Fig. 6 Plot 9, plan of the new foundation, showing the extent of the deep subsoil layer 900 (Williams, after Field).

This house plot was stripped of topsoil **902** to a 0.4m thick dark brown/black clay loam subsoil **900**. The 0.5 - 0.7m deep trenches only exposed the underlying orange brown sandy clay and gravel natural **901** on the eastern side of the plot, and no features were evident within the darker subsoil material or cutting the lighter natural. The darker material may be indicative of an unidentified feature on the western side of the house plot.

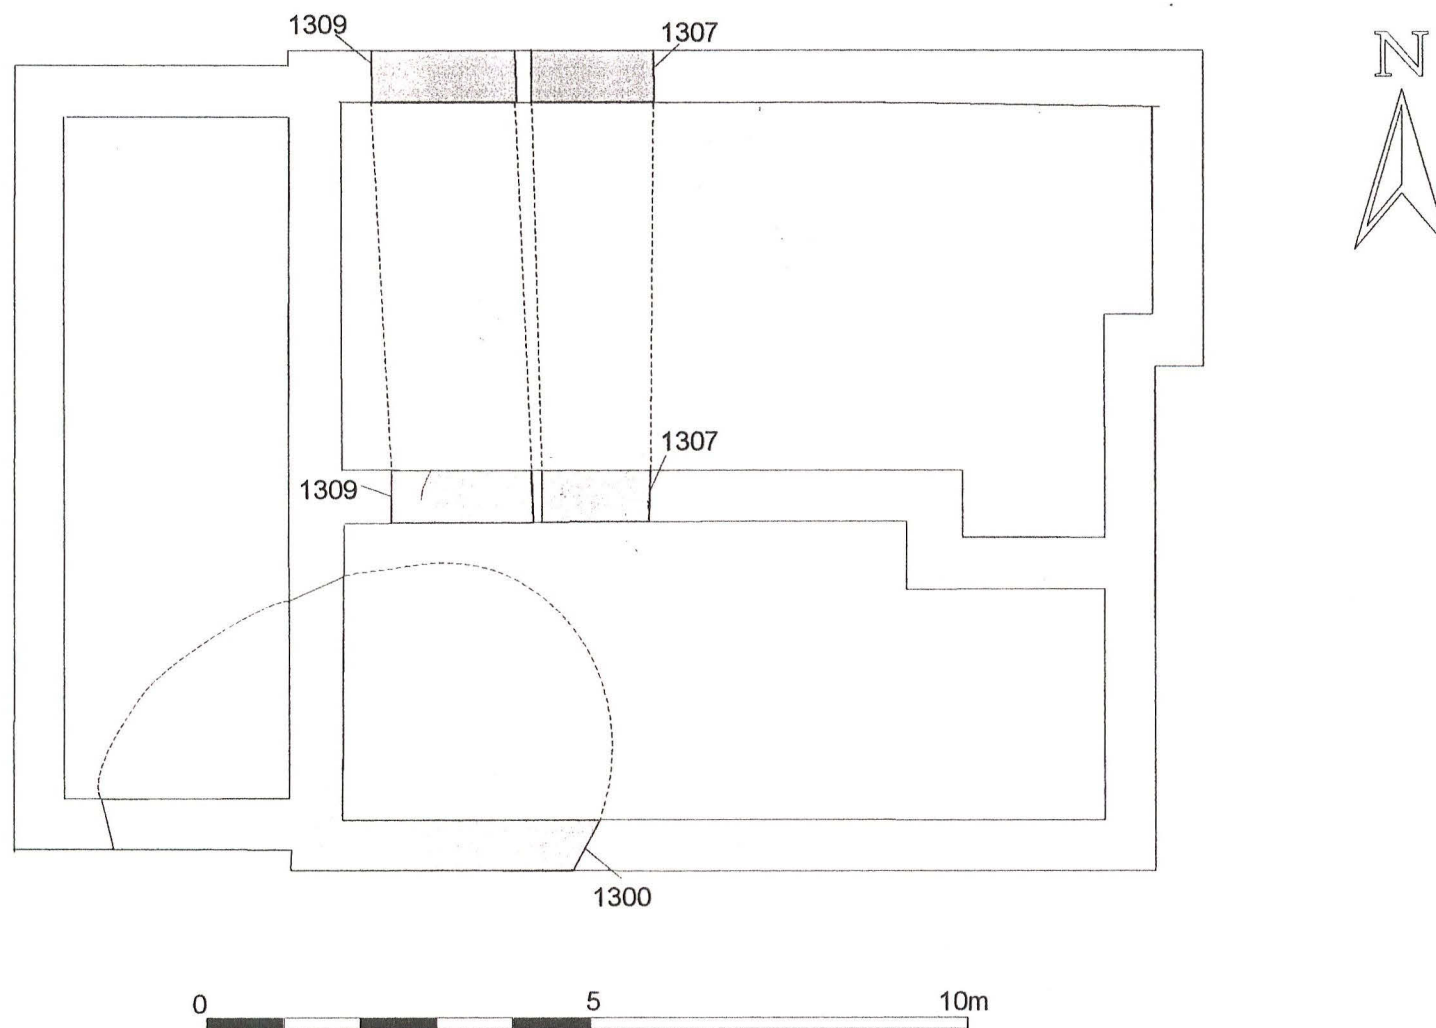
Fig. 7 Plot 13, plan of the new foundations, showing the position of ditches 1307 and 1309, and pit 1300 (Williams, after Field).

Excavation of foundations for this house encountered a large pit **1300** in the SW corner (Pl. 14). The wet ground conditions required the foundation to be excavated to considerable depth, and the sides were battered for stability. As a result, there was no opportunity to record this feature fully. It had been dug through the orange sand and gravel **1303** into an underlying blue clay deposit **1304**.

1309, the later of the ditches, was considerably broader and slightly deeper than its precursor. It was at least 2.3m wide, and about 0.75m deep. Its fill **1308**, a grey/brown clayey sand with yellow sand patches, was below the 0.3m thick topsoil **1305**.

The centre of the earlier ditch **1307** was less than 0.5m to the east. This ditch was 1.5m wide and 0.6m deep, with a grey/brown clayey sand fill **1306**. Both ditches had a flat base and produced no dating material. The alignment could join that of **1400** and **1405** to the north, but is not an obvious part of that boundary. To the south, no extant boundaries appear to be associated with it.

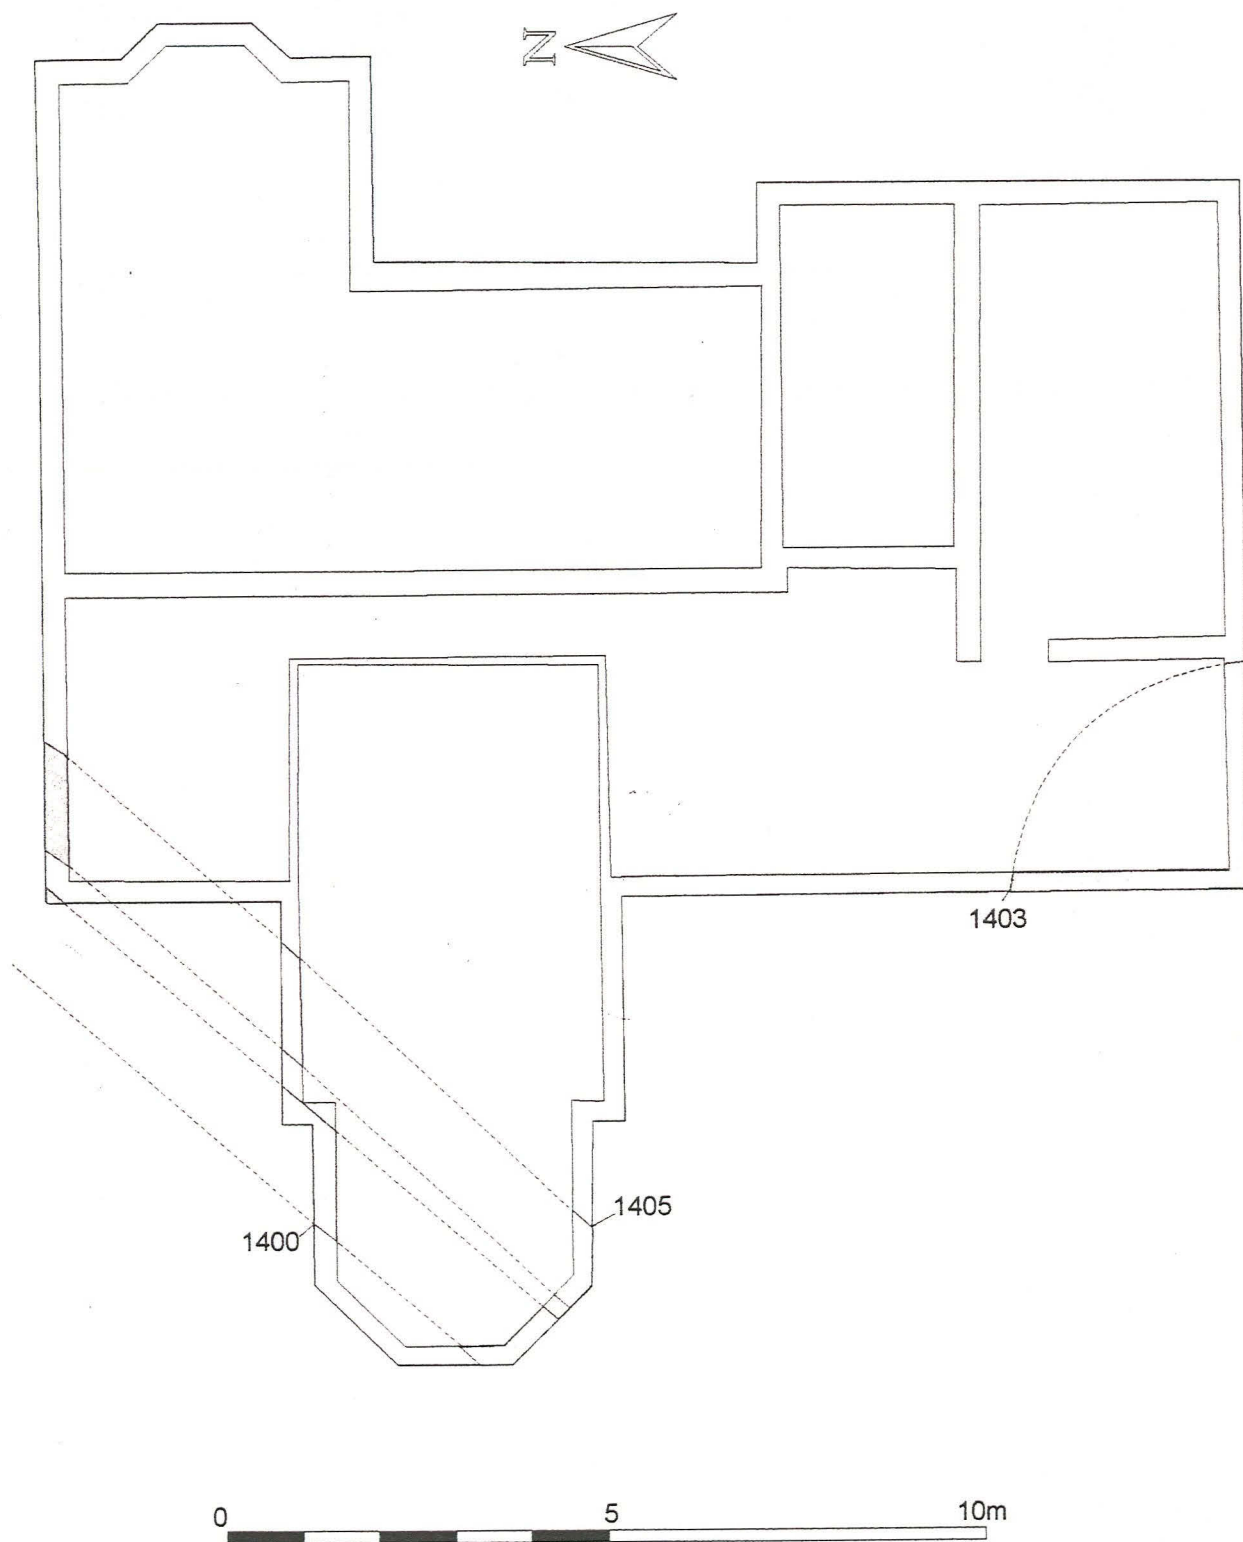
Fig. 8 Plot 14, plan of the new foundation, showing the position of ditches 1400 and 1405, and pit 1403 (Williams, after Field).

This house plot crossed the line of a recently backfilled, 0.6m wide, boundary ditch **1400**, aligned roughly north-south, but curving to the west over the west side of the house plot (Pl. 16).

The backfilled ditch was found to have replaced an earlier ditch **1405**, filled by **1406** (which contained one sherd of twelfth/thirteenth century pottery. The earlier feature was about 0.2m to the east, on the same alignment, and was also seen in the east-west sewer trench (Pls. 4 and 5).

On the eastern side of this ditch, the NE edge of pit **1401** was revealed after removal of the topsoil in the SW corner of the new building. The visible dimensions were 4.5m north-south x 4m west-east, but the full extent was not determined. Fill **1402** was a light brown material which contained one fragment of post-medieval pottery (recorded as 1401).

A large pit **1403** (at least 4m diameter) was filled by **1404**, which contained two pieces of medieval roof tile.

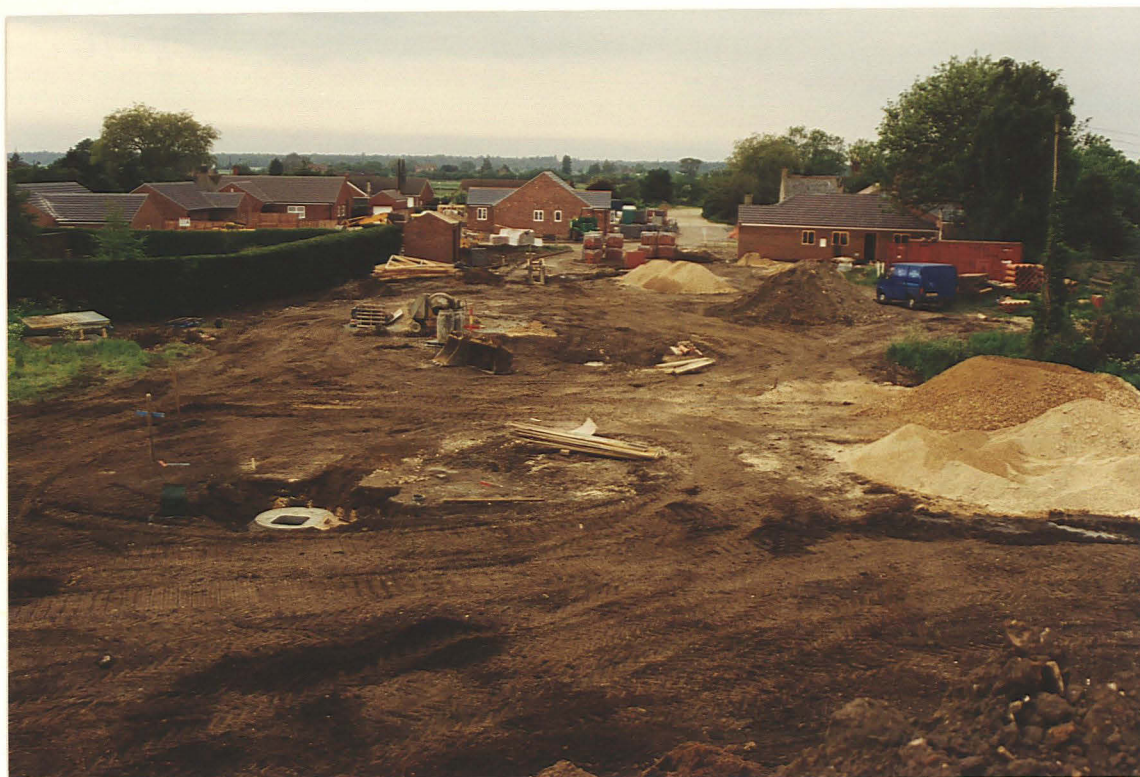
Pl. 1 View of the site during development (looking west towards Watery Lane). The manholes mark the line of the west-east sewer trench (backfilled), with the manhole in the foreground coinciding with the fork in the access road. The electricity sub-station is beside the hedge, centre left.

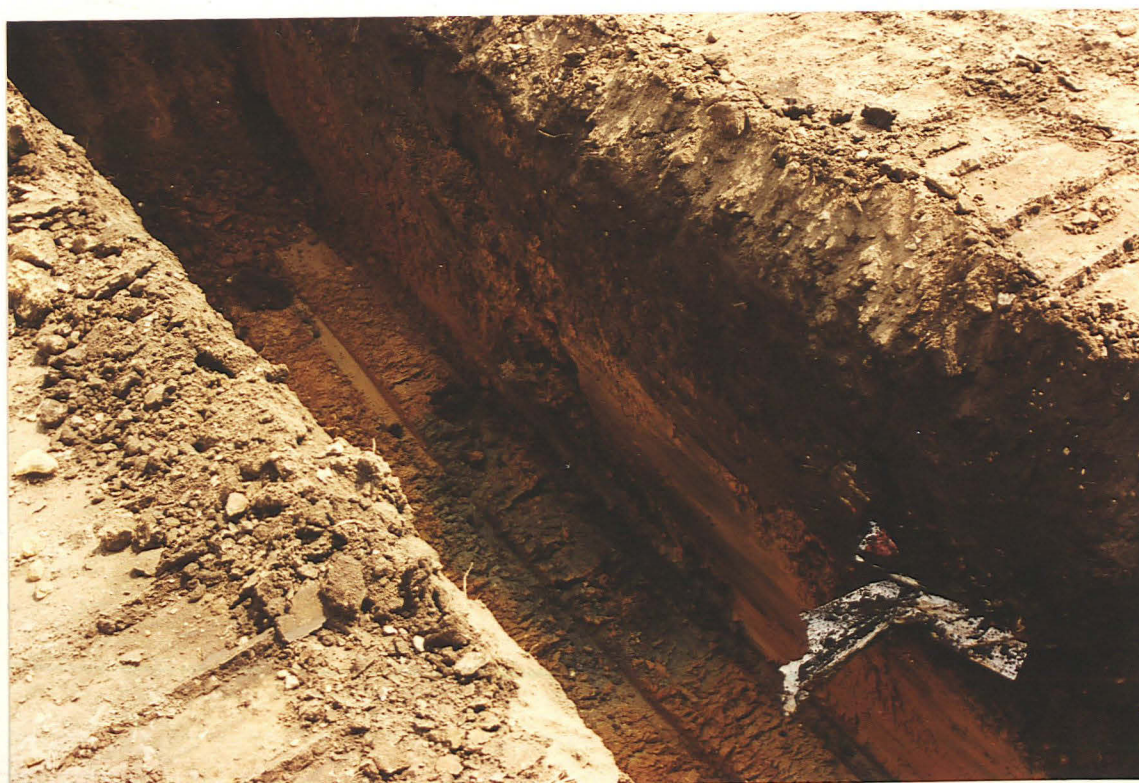
Pl. 2 Dark fill of pit 102 showing at the base of the west-east sewer trench; the plastic marks a backfilled archaeological evaluation trench.

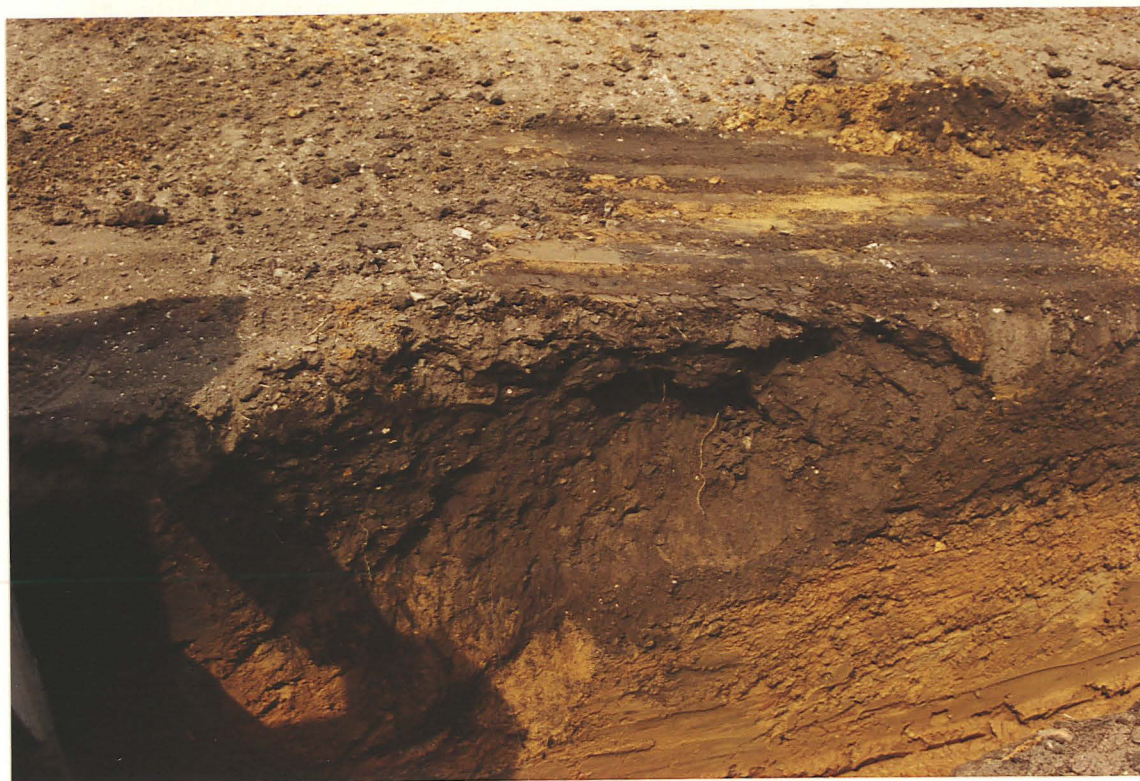
Pl. 3 Dark material backfilling shallow pit 104, seen in the side of the west-east sewer trench.

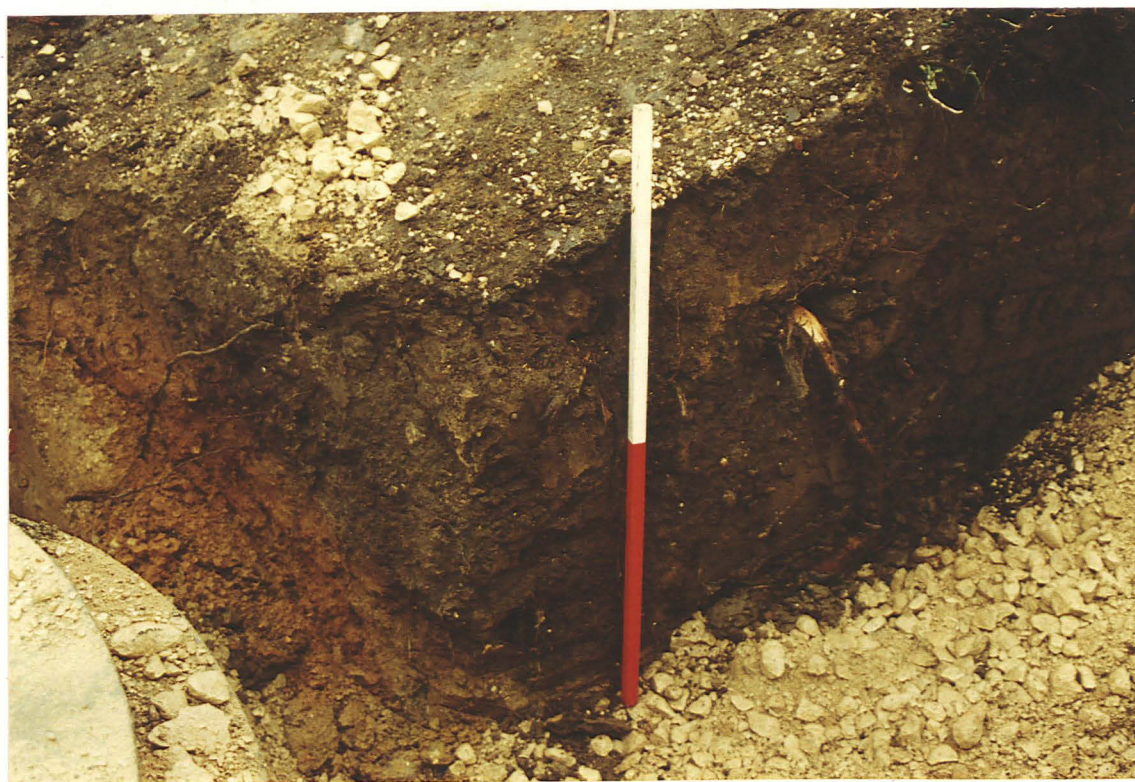
Pl. 4 Dark fill of ditch 1405 (precursor of the recently backfilled boundary ditch 1400), seen in the west-east sewer trench.

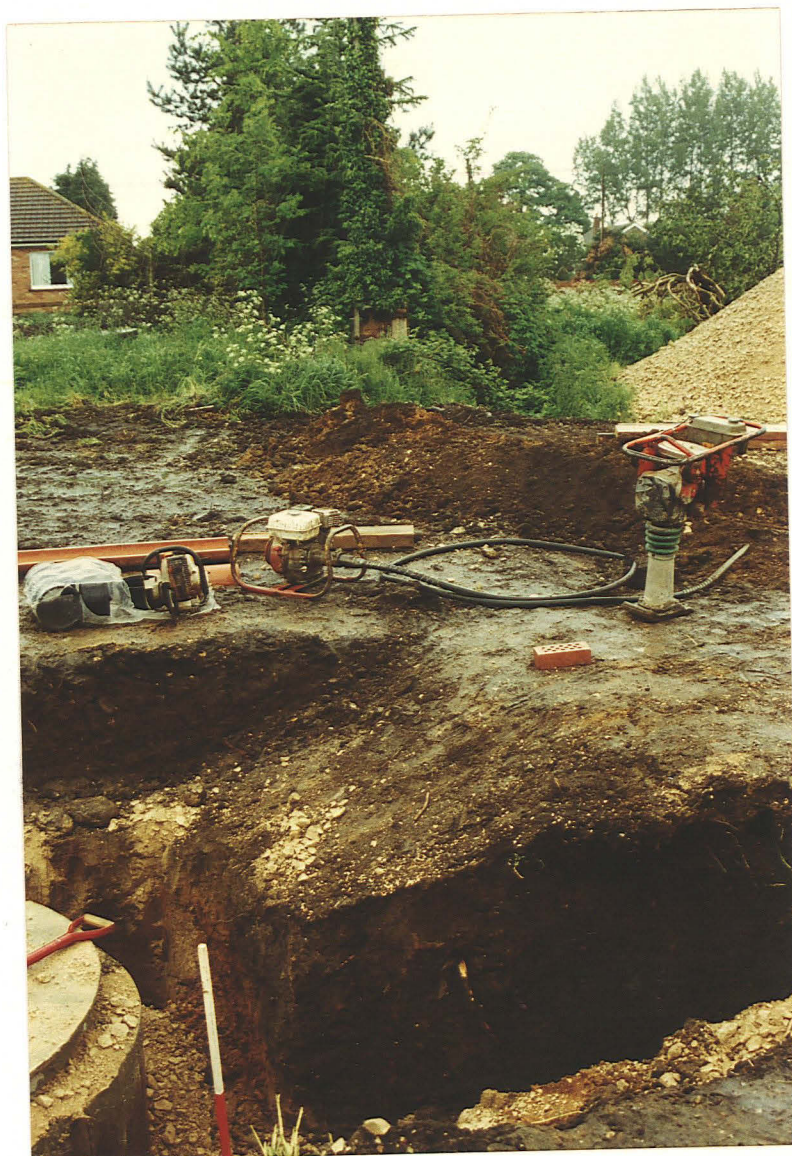
Pl. 5 Fill of ditch 1405, seen in the west-east sewer trench, on the alignment of an extant boundary hedge and ditch (looking east).

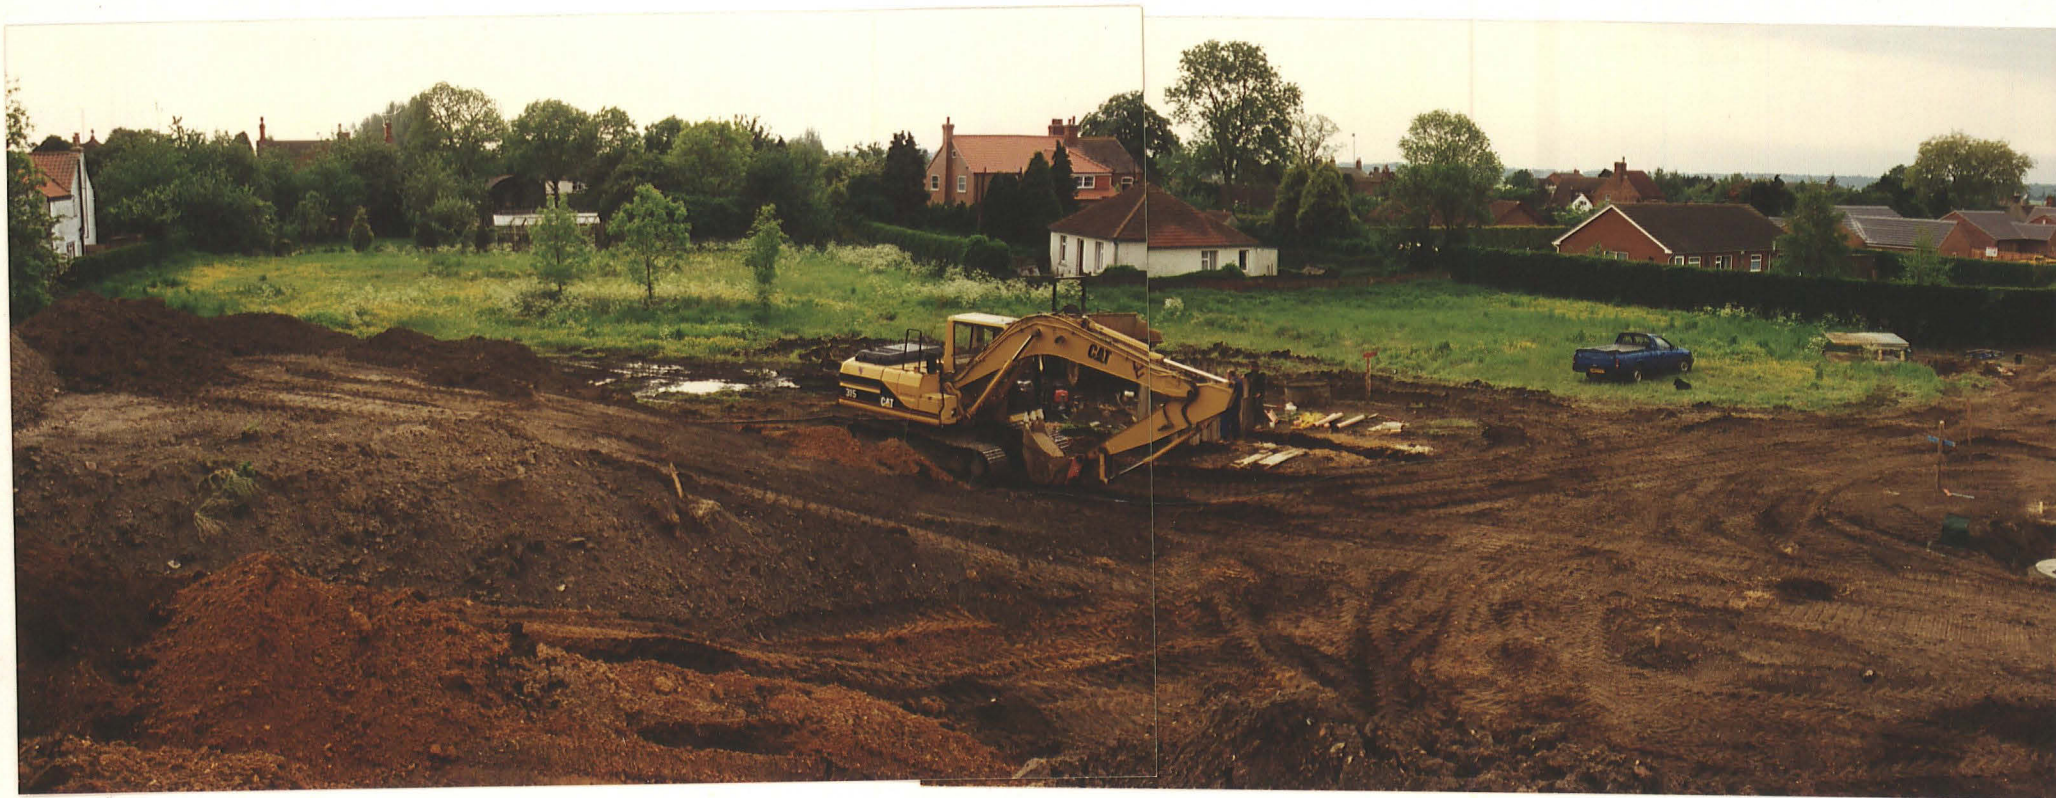
Pl. 6 Wet ground to the SW of the development, showing part of the north-south sewer trench (centre). The manhole at the extreme right is at the fork in the access road (looking NW).

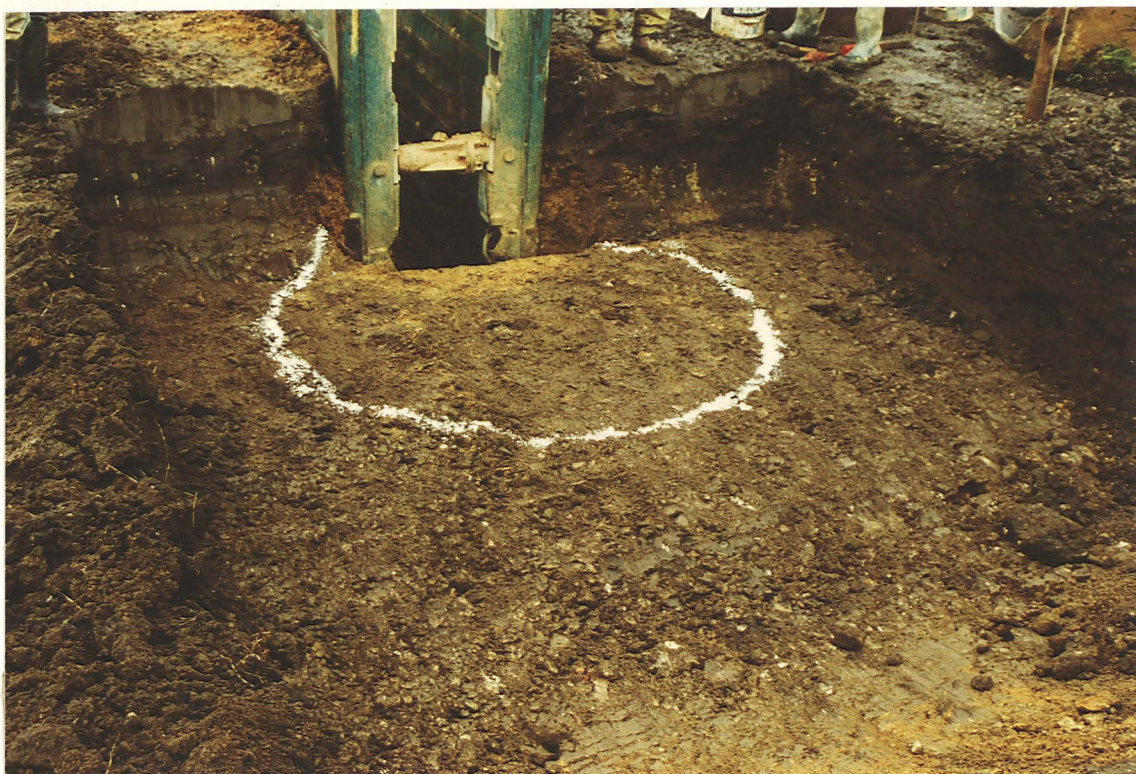
PI. 7 Grey fill of ditch 208 at the eastern end of the west-east sewer trench (looking NW). The chalk indicates the manhole position.

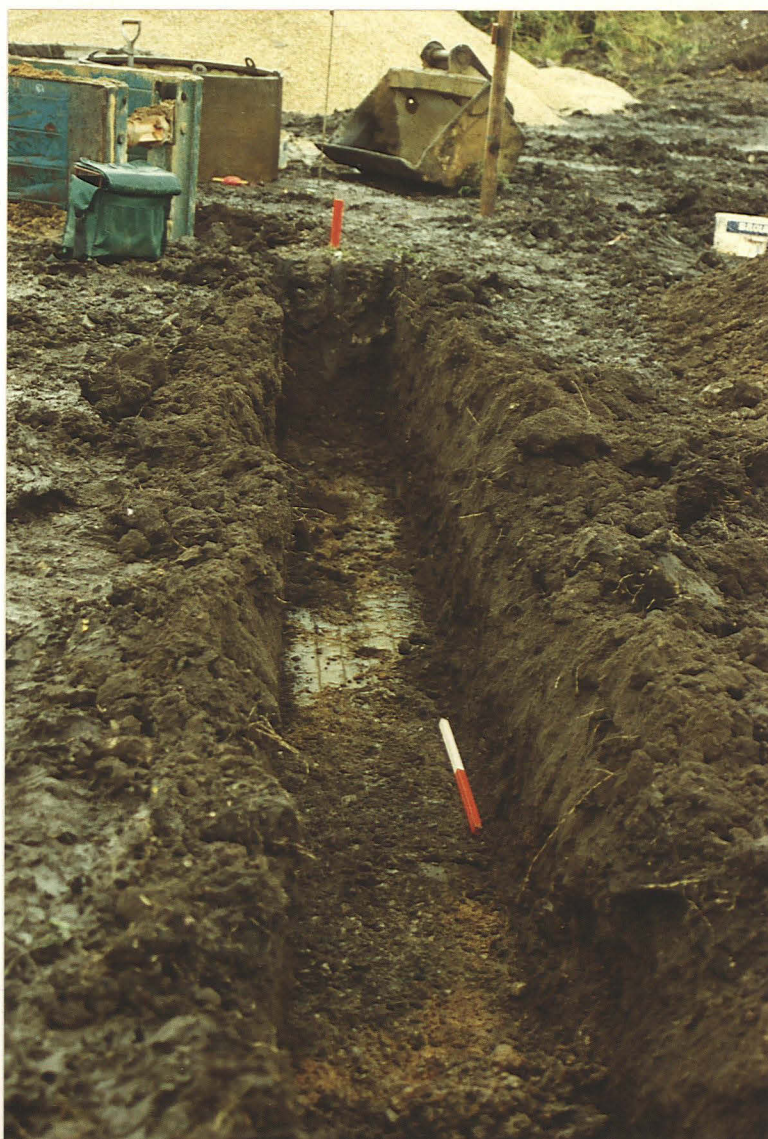
PI. 8 Dark gravelly fill of ditch 210, crossing the line of the north-south sewer trench obliquely (below red/white 1m scale). Looking north.

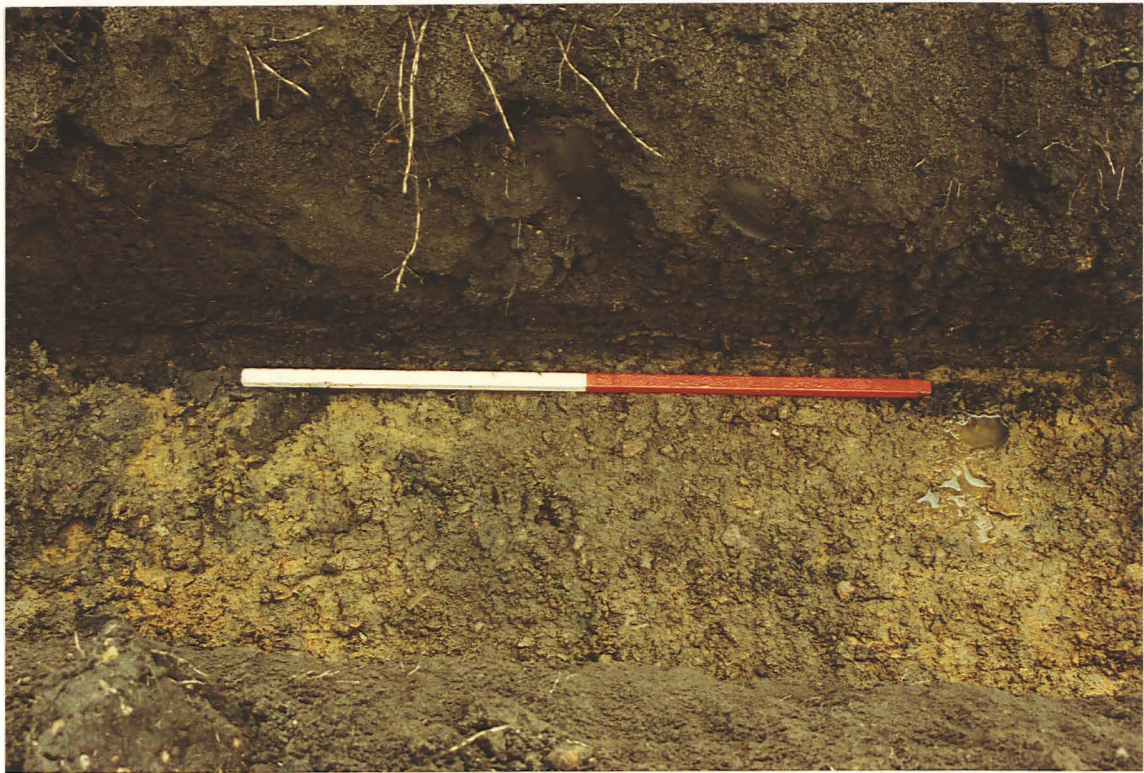
Pl. 9 Grey base fill of ditch 211, crossing the line of the north-south sewer trench (below red/white 1m scale). Looking east.

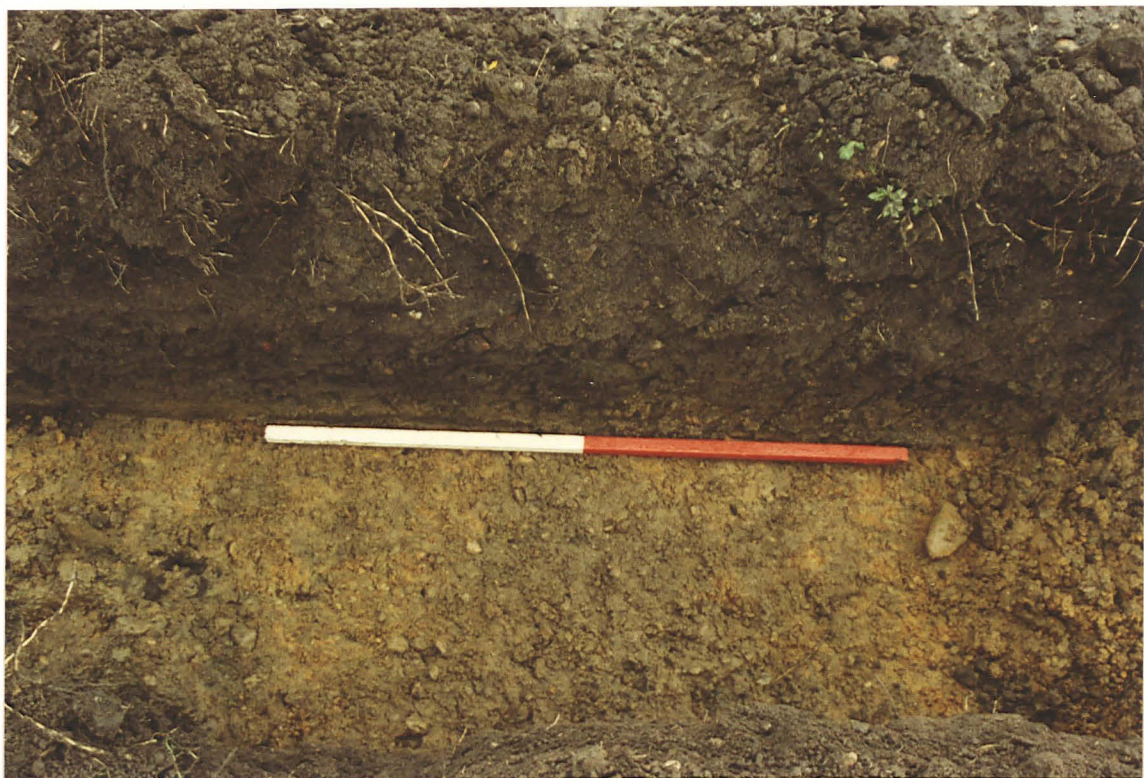
Pl. 10 Grey base fill of ditch 212, crossing the line of the north-south sewer trench (1m scale). Looking east.

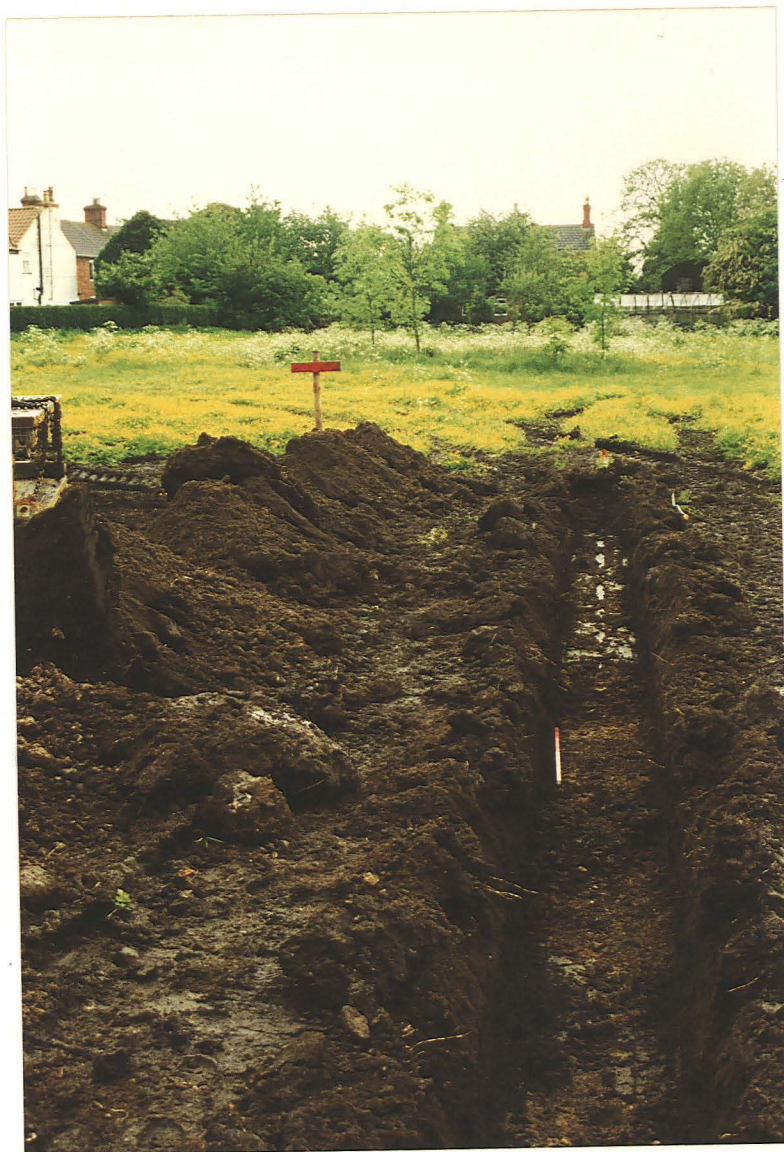
Pl. 11 Trench excavated along the line of the north-south sewer (looking south). The red/white scale marks the position of ditch 212.
