Land off Watery Lane, Mareham le Fen

Archaeological Watching Brief

Report prepared for Owl Homes of Lincolnshire

**LAS Report No. 482
November 2000**

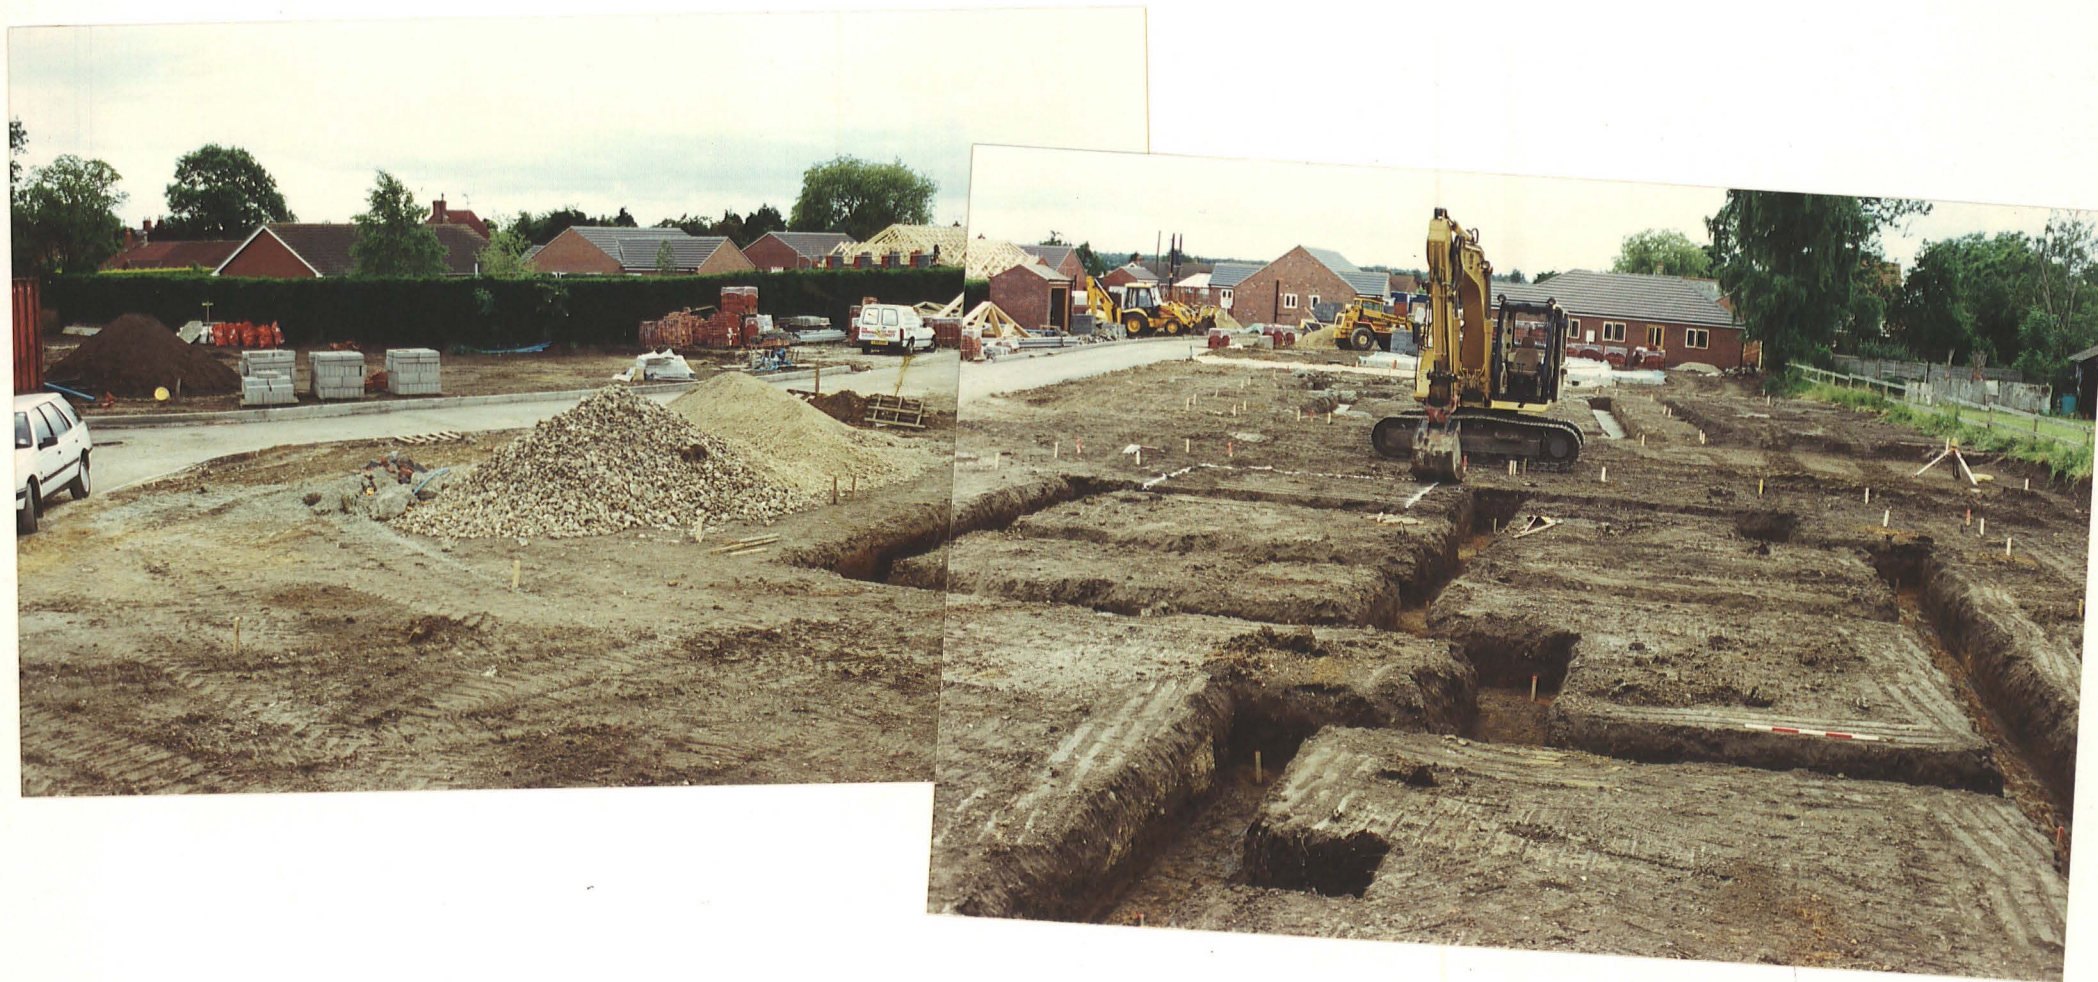
Pl. 12 House foundations for Plot 6 (foreground) and Plot 5 (partly concreted). The site of Plot 14 is behind the stacked blocks. Looking west, red/white scale 1m.

Neither plot had any visible archaeological features, but three sherds of medieval pottery were collected from the stripped surface **500** in house plot 5, and one sherd of sixteenth/seventeenth century pottery was collected from the same horizon **600** in house plot 6.

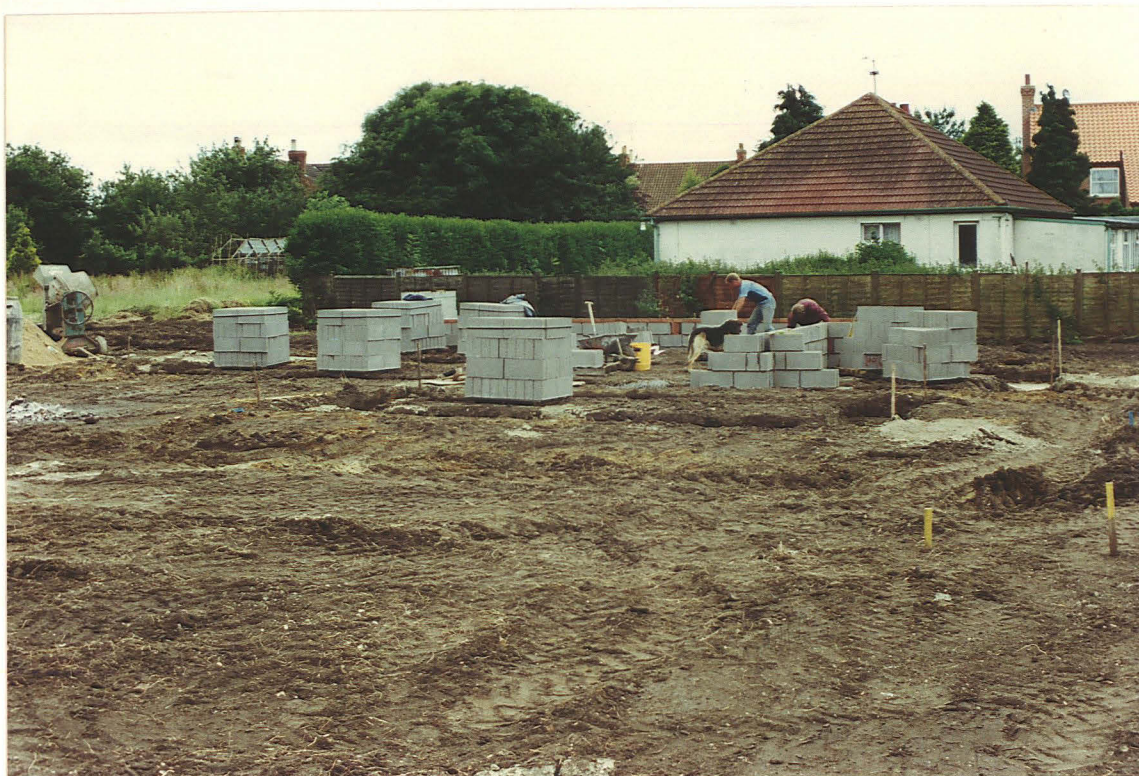
Pl. 13 Plot 13, under construction (looking south).

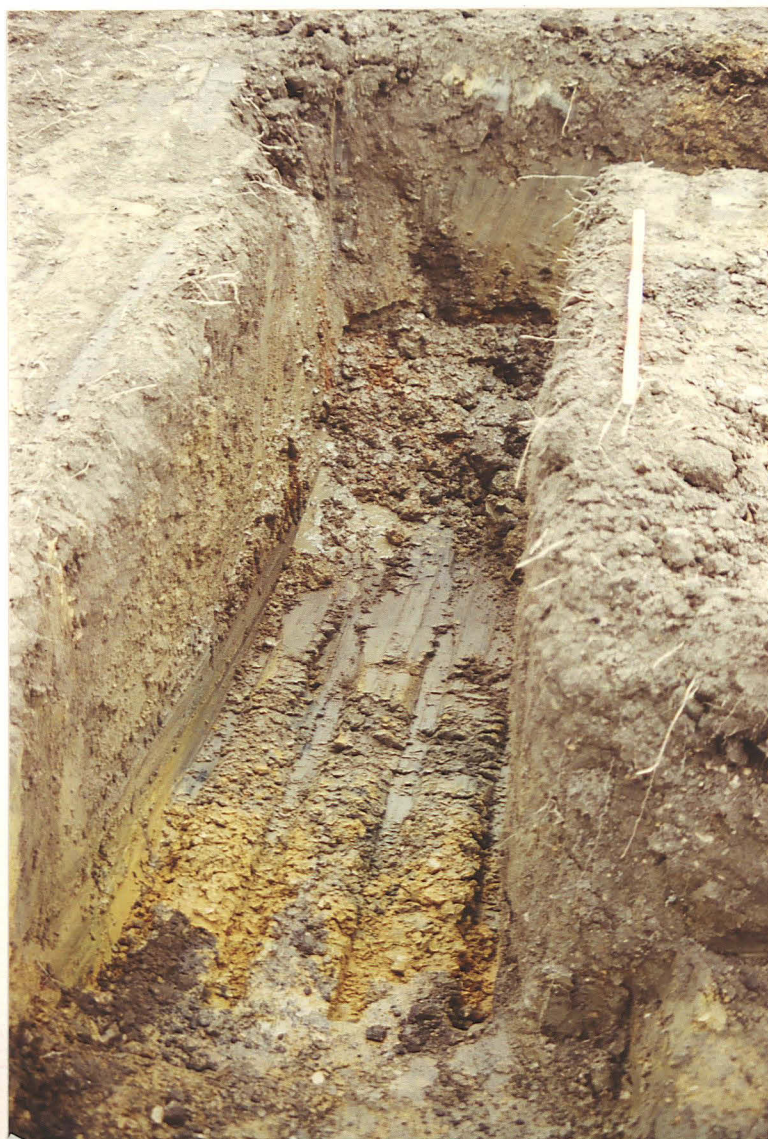
Pl. 14 Brown clay fill of large pit 1300, at SW corner of Plot 13. (Looking west, scale 1m).

Excavation of foundations for this house encountered a large pit **1300** in the SW corner (Pl. 14). The wet ground conditions required the foundation to be excavated to considerable depth, and the sides were battered for stability. As a result, there was no opportunity to record this feature fully. It had been dug through the orange sand and gravel **1303** into an underlying blue clay deposit **1304**.

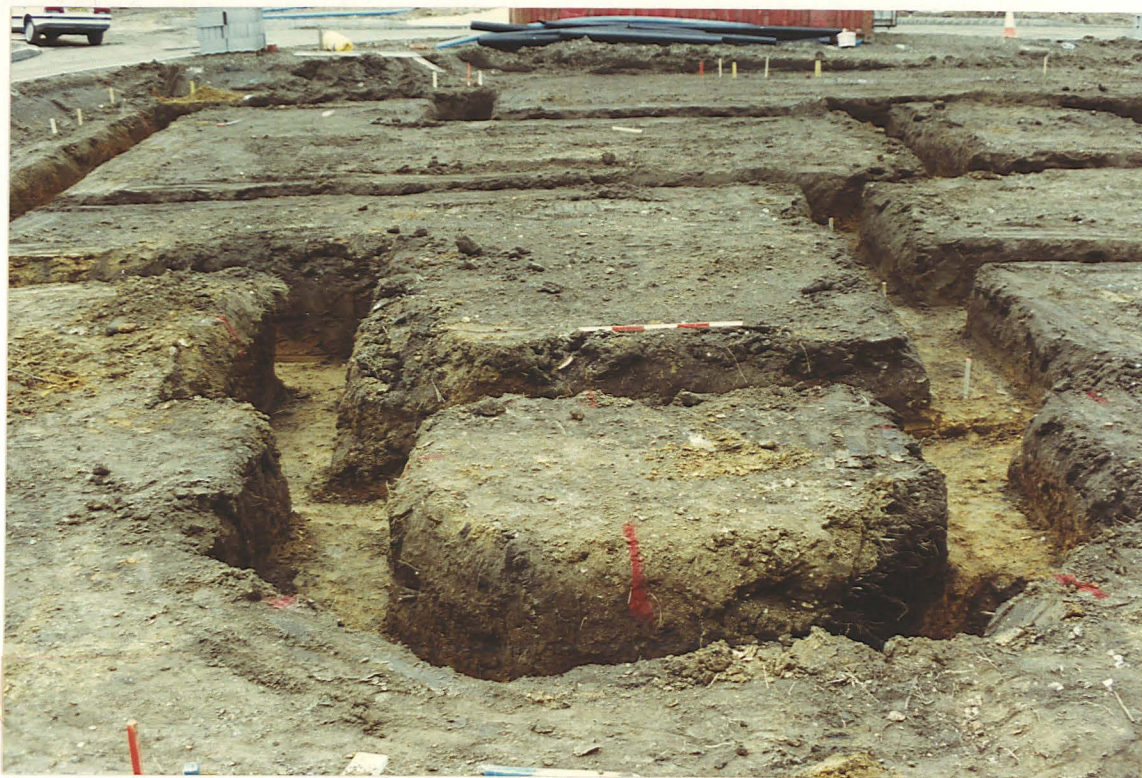
Pl. 15 Foundation trenches for Plot 14 (looking east). Boundary ditches 1400 and 1405 crossed the site in the immediate foreground. Scale 1m.

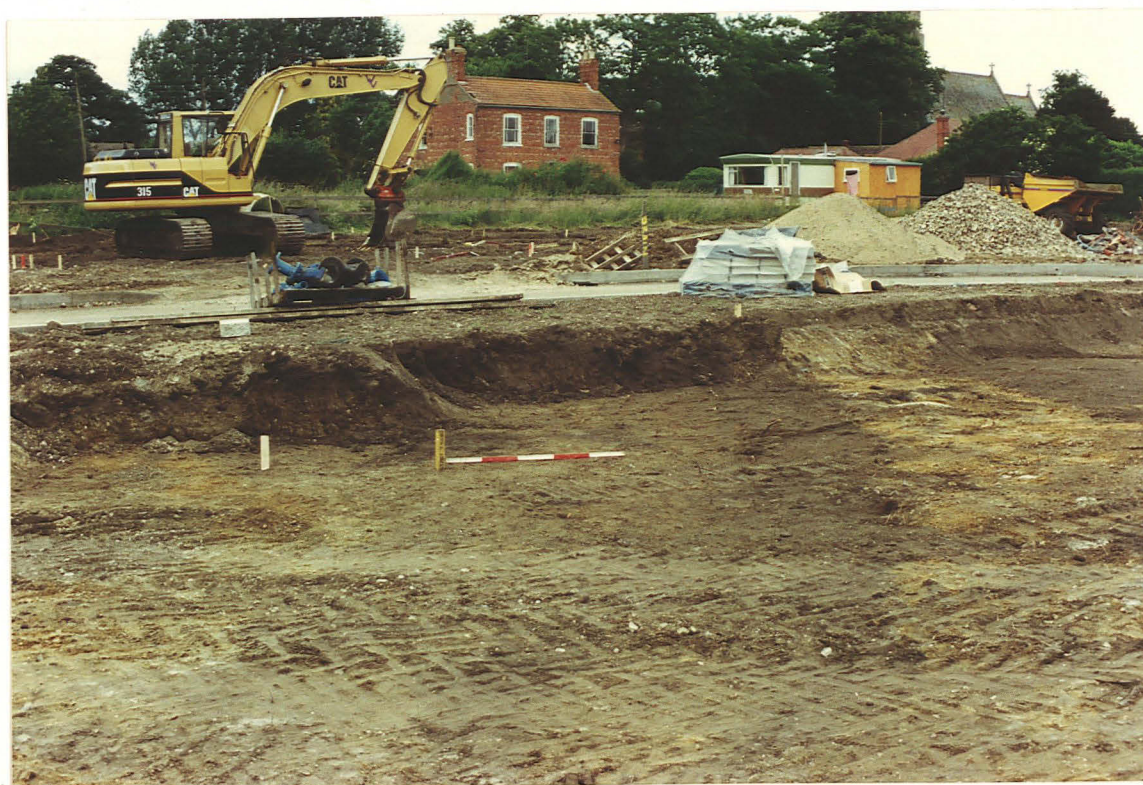
Pl. 16 Yellow fill of recently backfilled boundary ditch 1400 crossing the site of Plot 14 (looking NE). Scale 1m.

This house plot crossed the line of a recently backfilled, 0.6m wide, boundary ditch **1400**, aligned roughly north-south, but curving to the west over the west side of the house plot (Pl. 16).
