**HOLMES ROAD INDUSTRIAL ESTATE  
HORNCastle**

**ARCHAEOLOGICAL EVALUATION**

**EAST LINDSEY DISTRICT COUNCIL**

25th January 1994

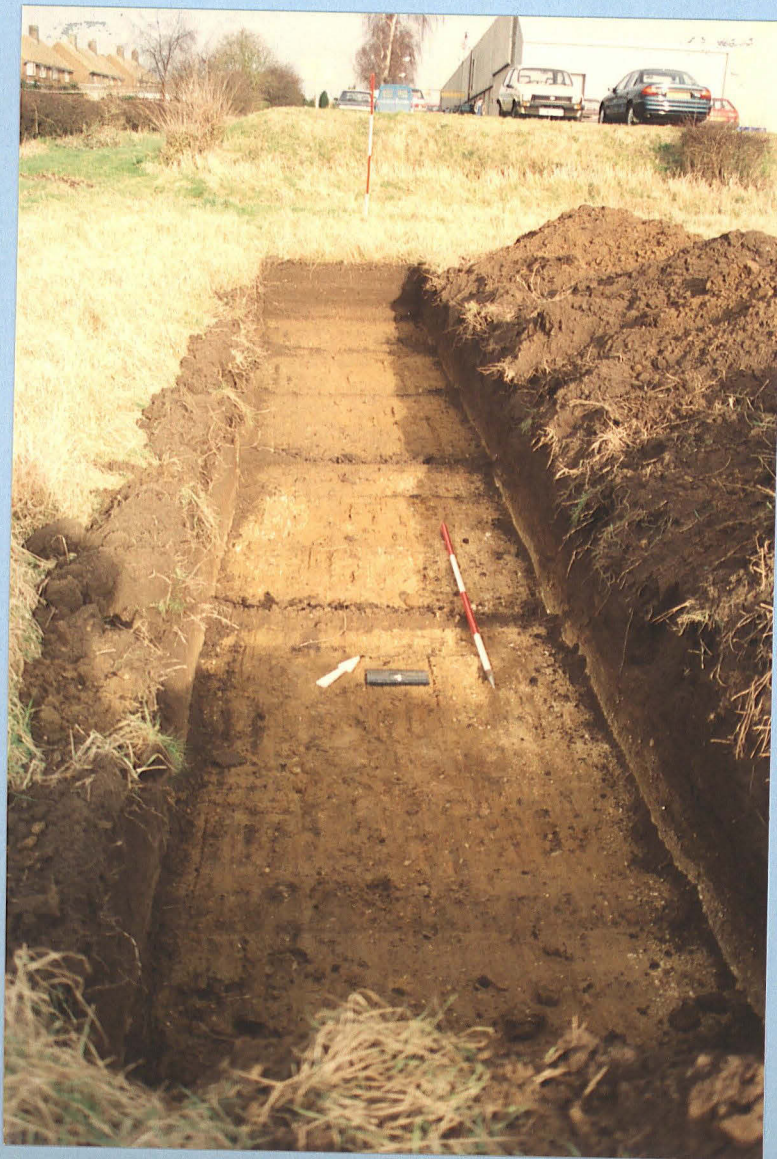
C/1

3.2	Trench 1	Ploughsoil	0.40 m.
		Subsoil	0.12 m.
		Natural	Yellow clay with flints and some chalk and patches of gravel

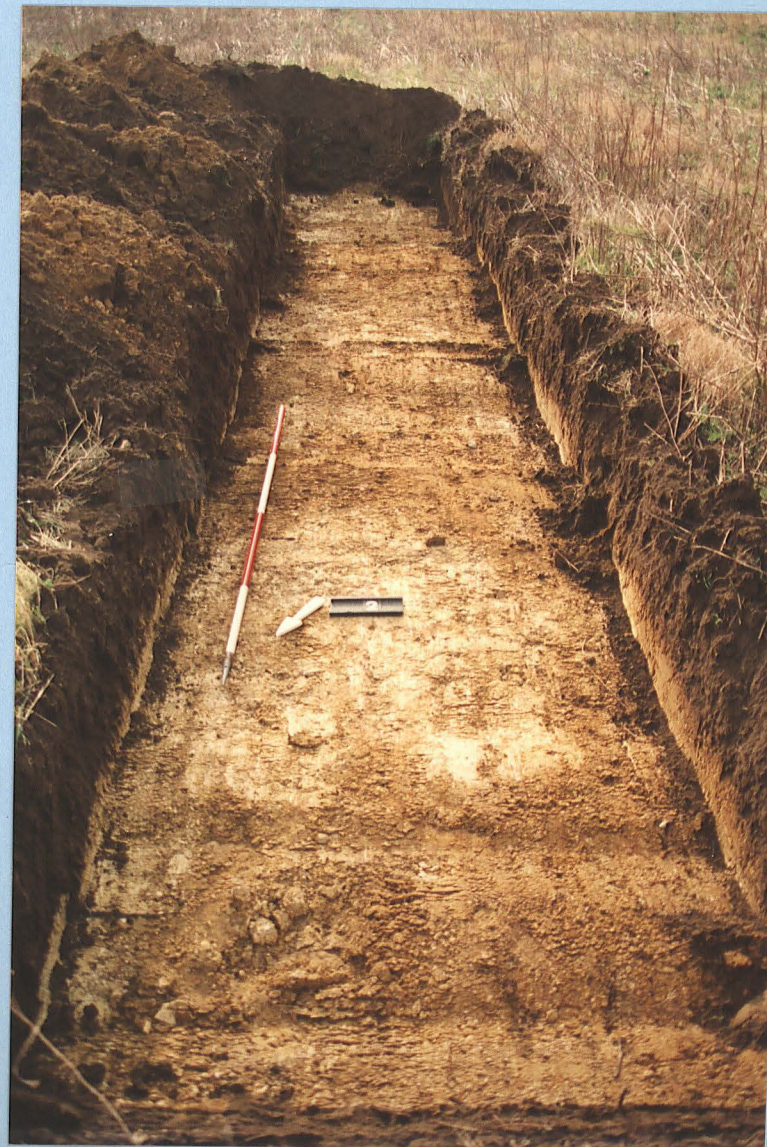
C/2

3.3	Trench 2	Ploughsoil	0.35 m.
		Subsoil	0.11 m. max.
		Natural	Gravelly sand patches and chalky rubble

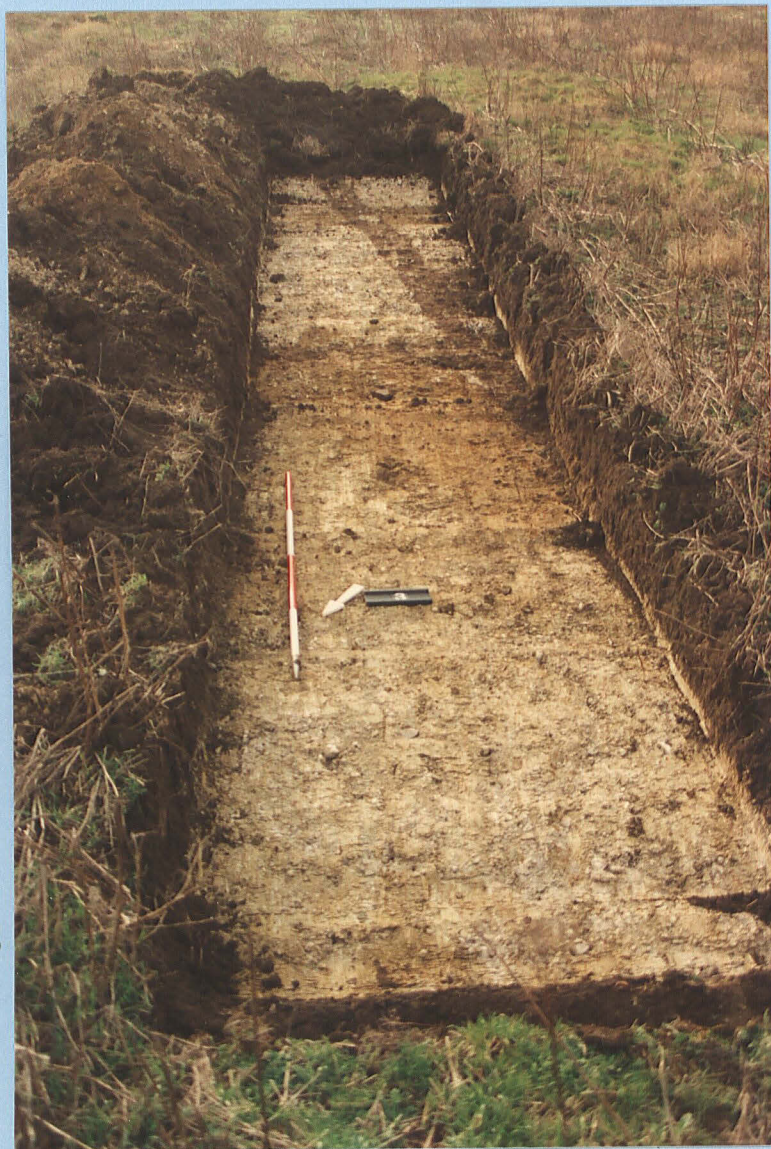
**C/3**

3.4	Trench 3	Ploughsoil	0.30 m.
		Subsoil	only surviving in part to a maximum of 0.80 m.
		Natural	Chalky rubble and sand patches - ? plough mark along length of trench

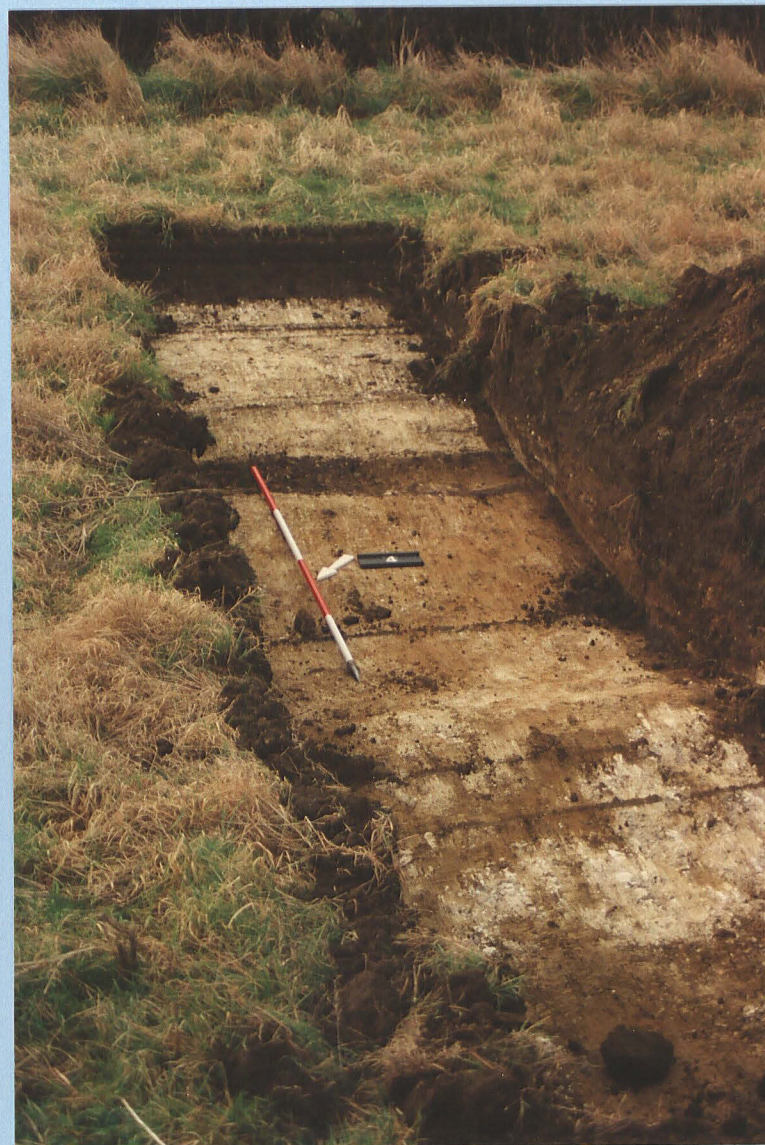
**C/4**

3.5	Trench 4	Ploughsoil	0.40 m.
		Subsoil	0.80 m.
		Natural	Chalky rubble and patches of gravel Trace of a possible field drain running across width and ? plough mark along length of trench

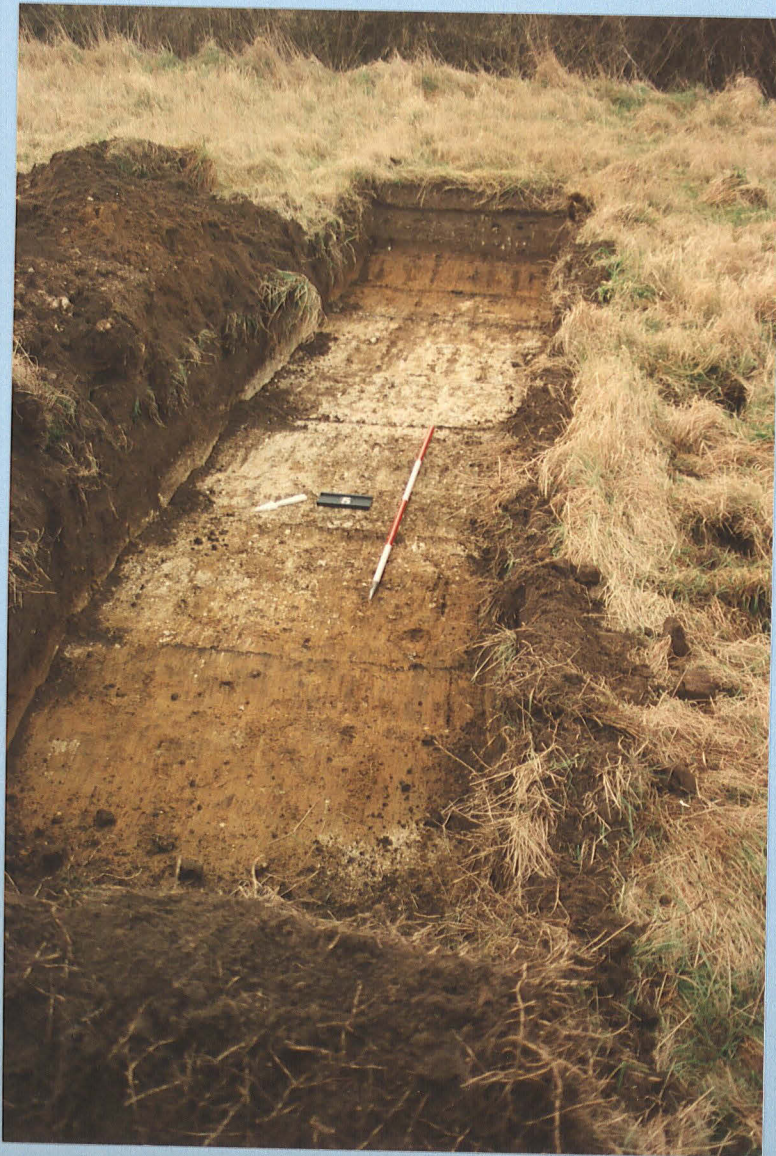
C/5

3.6	Trench 5	Ploughsoil	0.48 m.
		Subsoil	0.80 m. - where it survives
		Natural	Chalk with sand and gravel

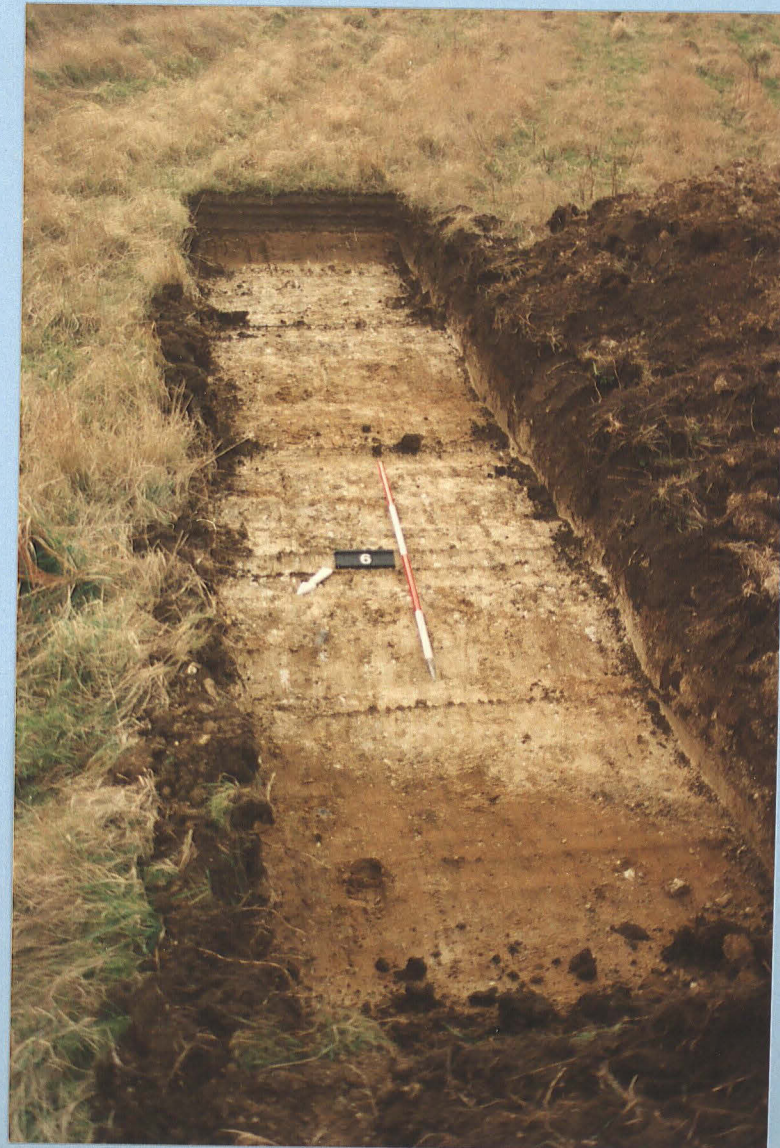
C/6

3.7	Trench 6	Ploughsoil	0.27 m.
		Subsoil	0.60 m. - where it survives
		Natural	Chalk with sandy patches

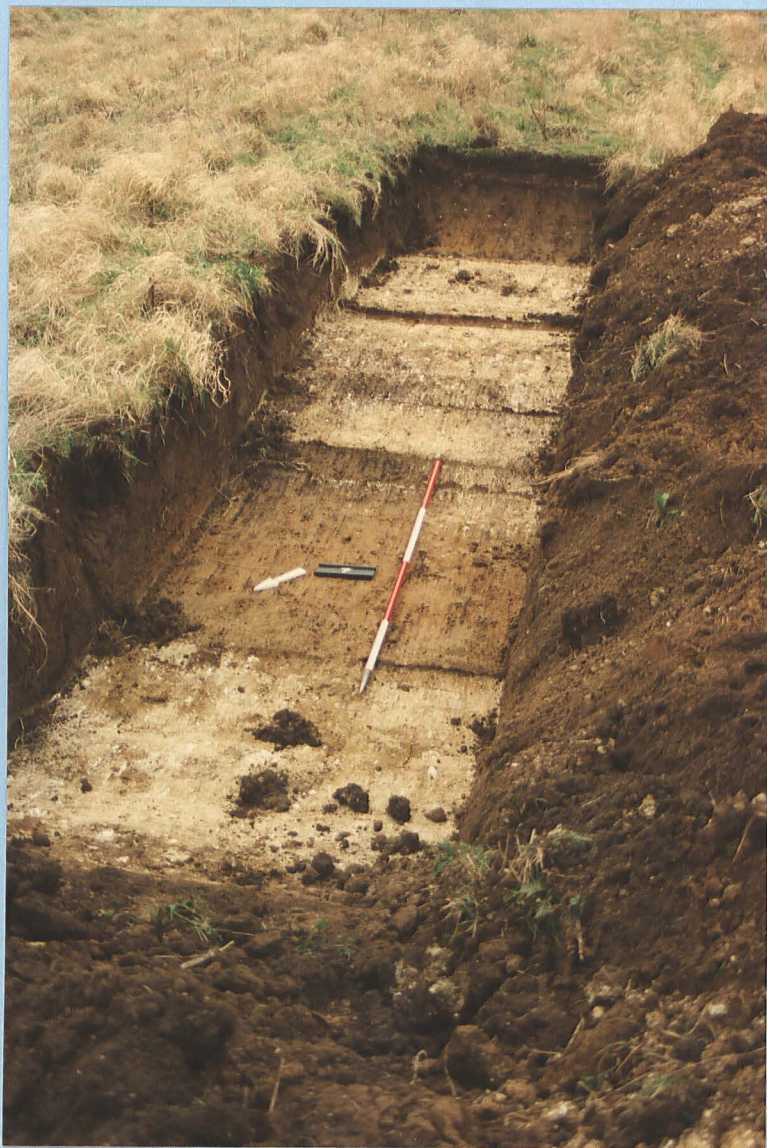
**C/7**

3.8	Trench 7	Ploughsoil	0.28 m.
		Subsoil	0.20 m.
		Natural	Chalk with sandy clay patches

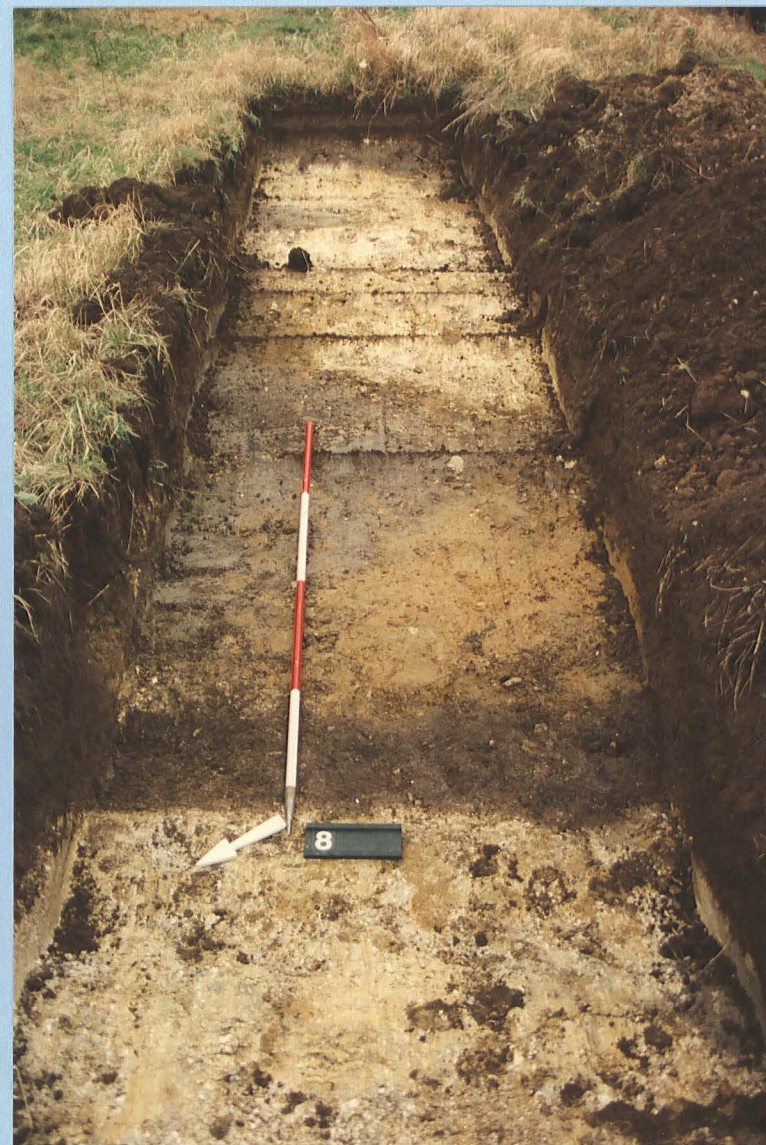
**C/8**

3.9	Trench 8	Ploughsoil	0.28 m.
		Subsoil	0.90 m.
		Natural	Chalk with patches of clay and sand

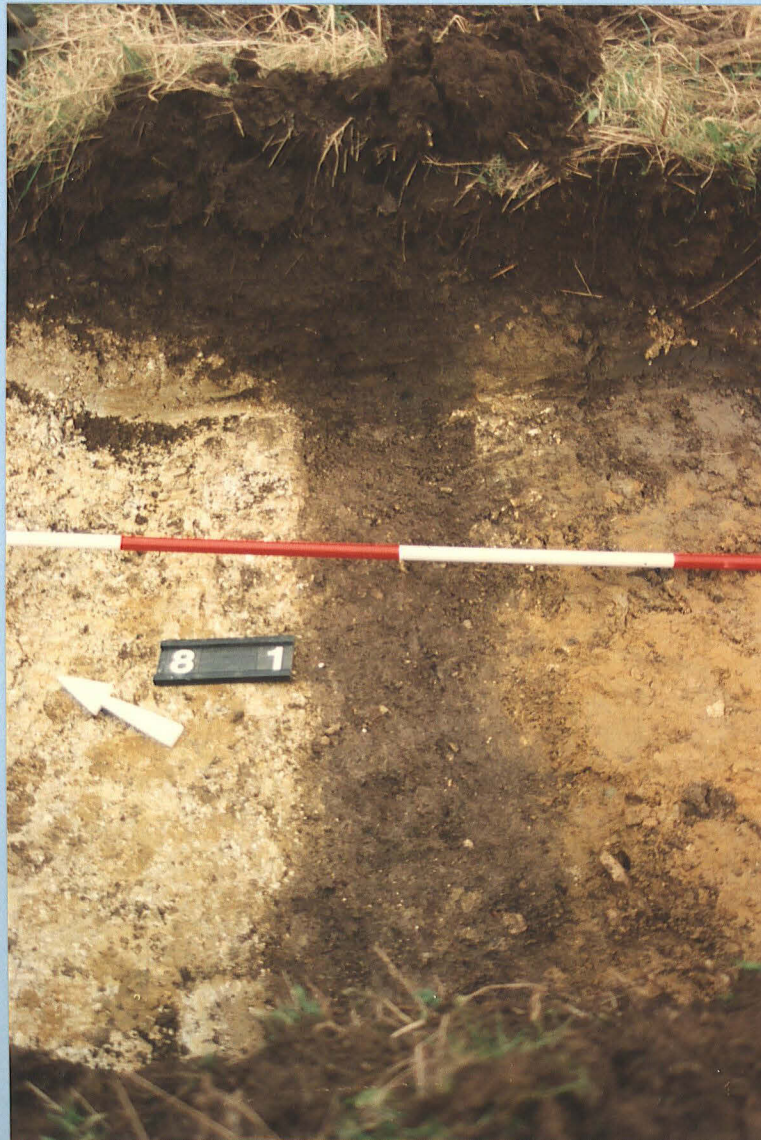
C/8/1

Feature cut into natural - 8.1 - Cut through ploughsoil and at the base is about 35 cms wide where it cuts into the natural, filled with grey brown soil which grades into ploughsoil and probably is of the same material. Considered to be of recent origin - possibly a field boundary (shown on the 6" O.S. as a drain). Lines up with boundary at rear of housing development to the west and running at right angles to the ditch separating the two fields within the development site.

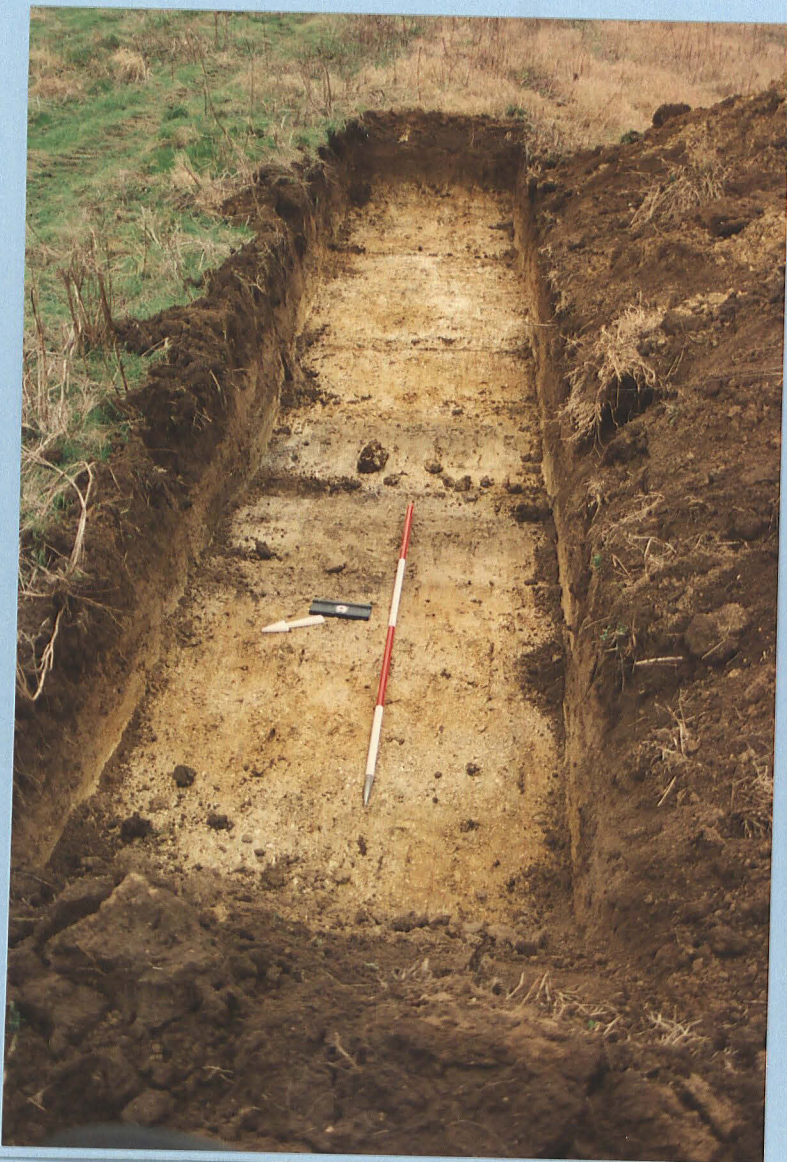
**C/9**

3.10	Trench 9	Ploughsoil	0.26 m.
		Subsoil	0.18 m.
		Natural	Chalk with sand, gravel and clay
		Photograph C/9

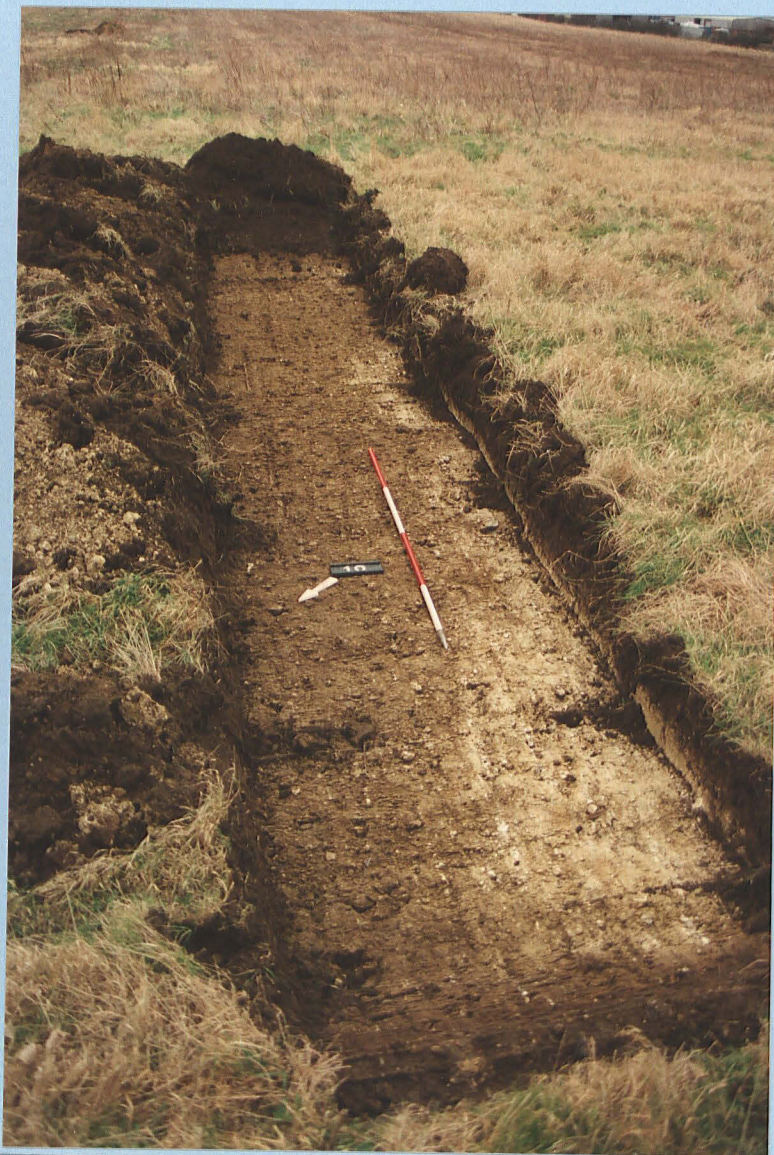
**C/10**

3.11	Trench 10	Ploughsoil	0.26 m.
		Subsoil	0.11 m.
		Natural	Chalk with large patch of grey clay with chalk
		Photograph C/10

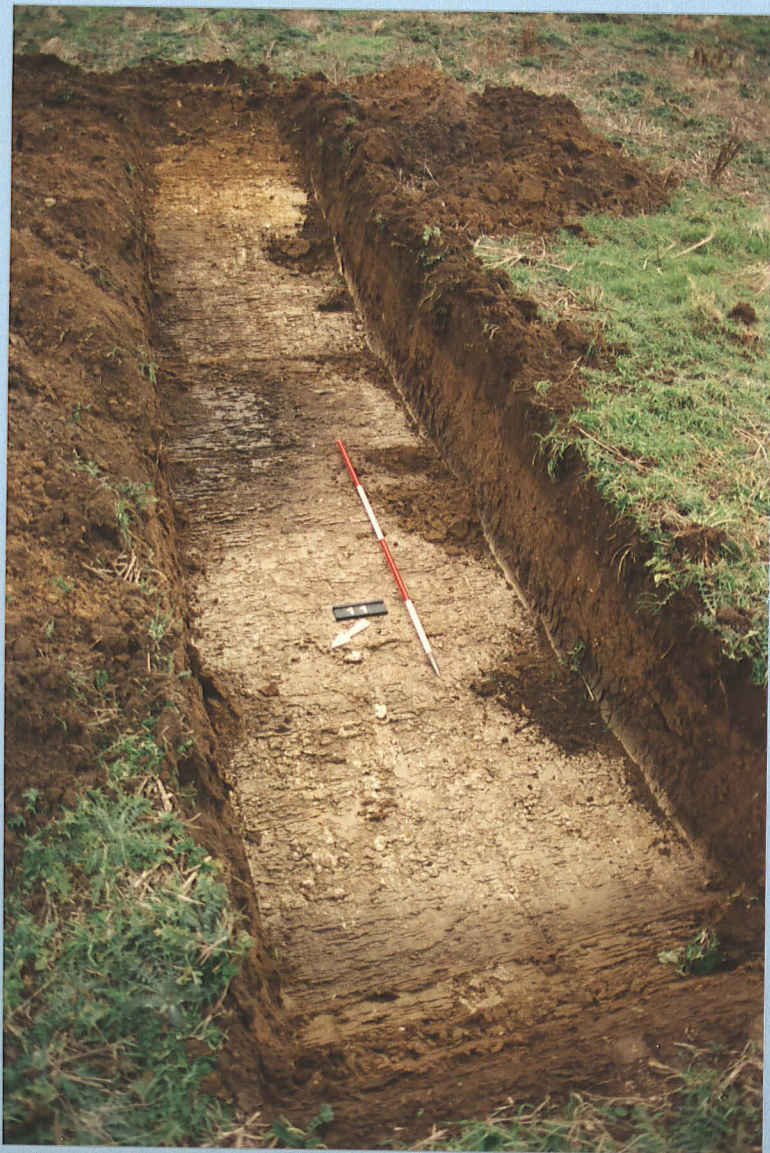
**C/11**

3.12	Trench 11	Ploughsoil	0.27 m.
		Subsoil	0.34 m.
		Natural	Grey clay with chalk and gravel
		Unnaturally thick subsoil - land is sloping gently towards shallow dry valley and this probably represents an area of better preserved subsoil/soil creep

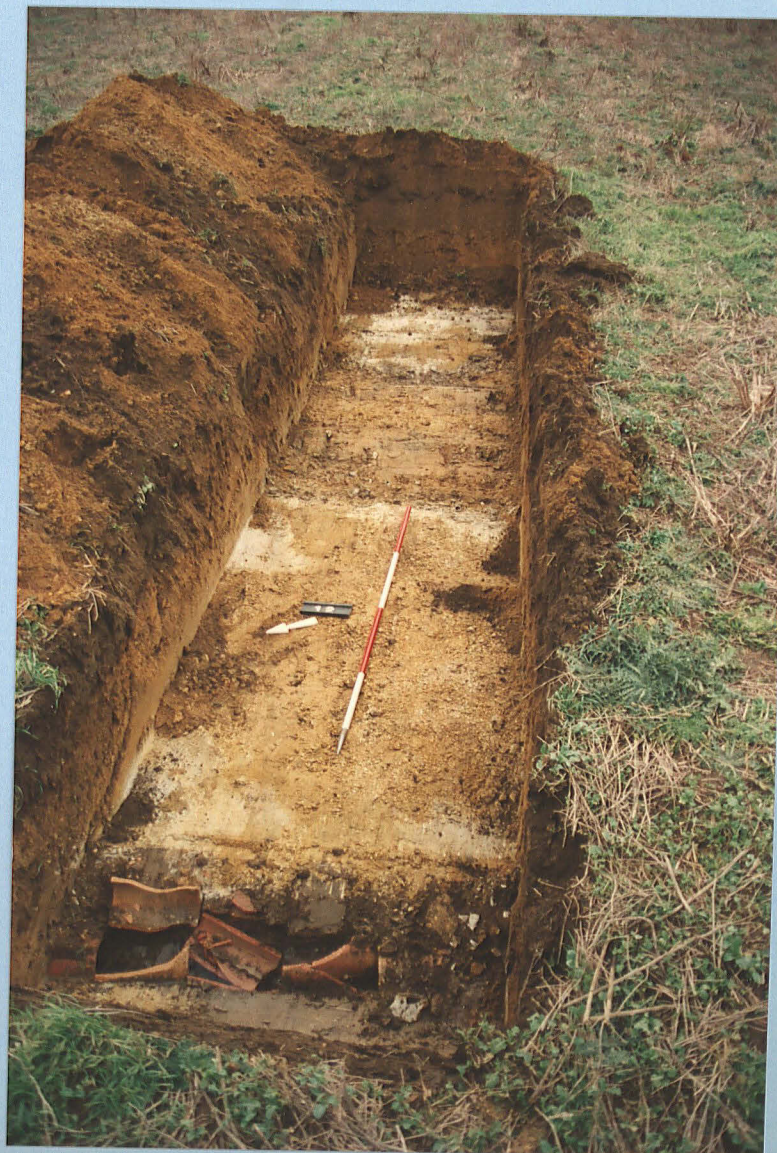
**C/12**

3.13	Trench 12	Ploughsoil	0.26 m.
		Subsoil	0.40 m.
		Natural	Sand/gravel, clay and chalky wash. Patches of flints in gravel.
		Large field drain running East-West broken, digger driver promised to repair it when back filling.

Note: Clay and chalk overlain by gravel layer

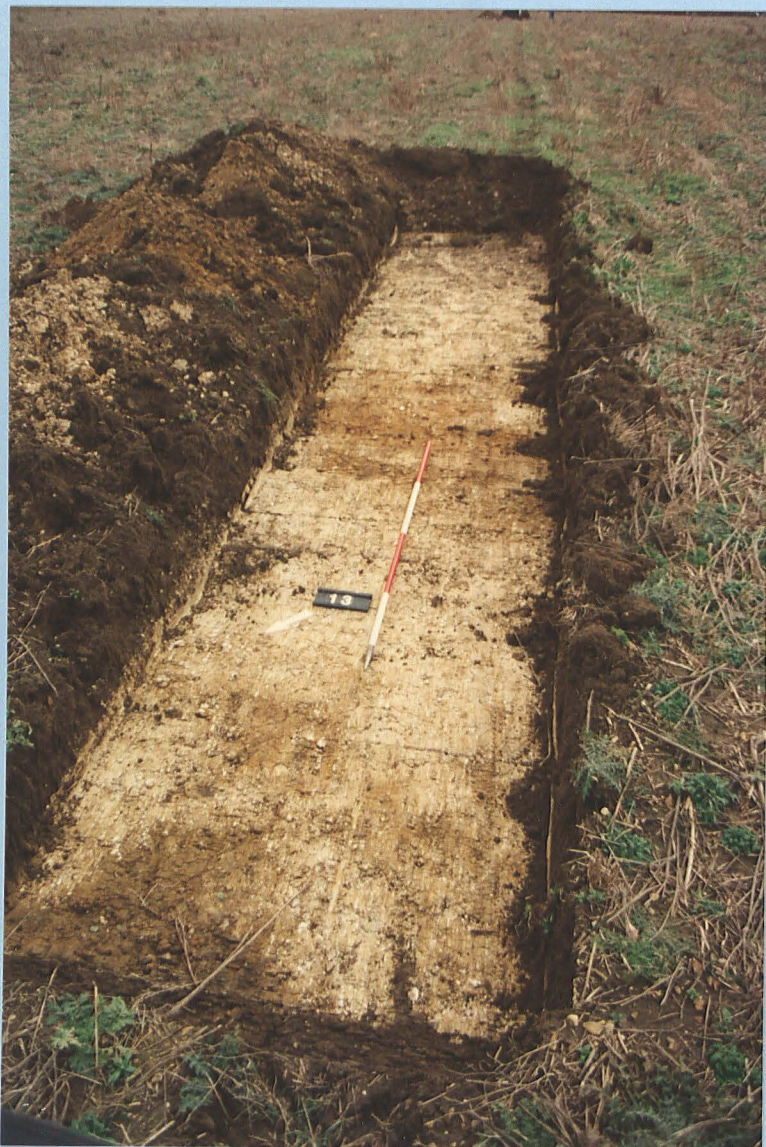
**C/13**

3.14	Trench 13	Ploughsoil	0.28 m.
		Subsoil	None
		Natural	Chalky rubble with patches of sandy clay and sand
		Photograph C/13

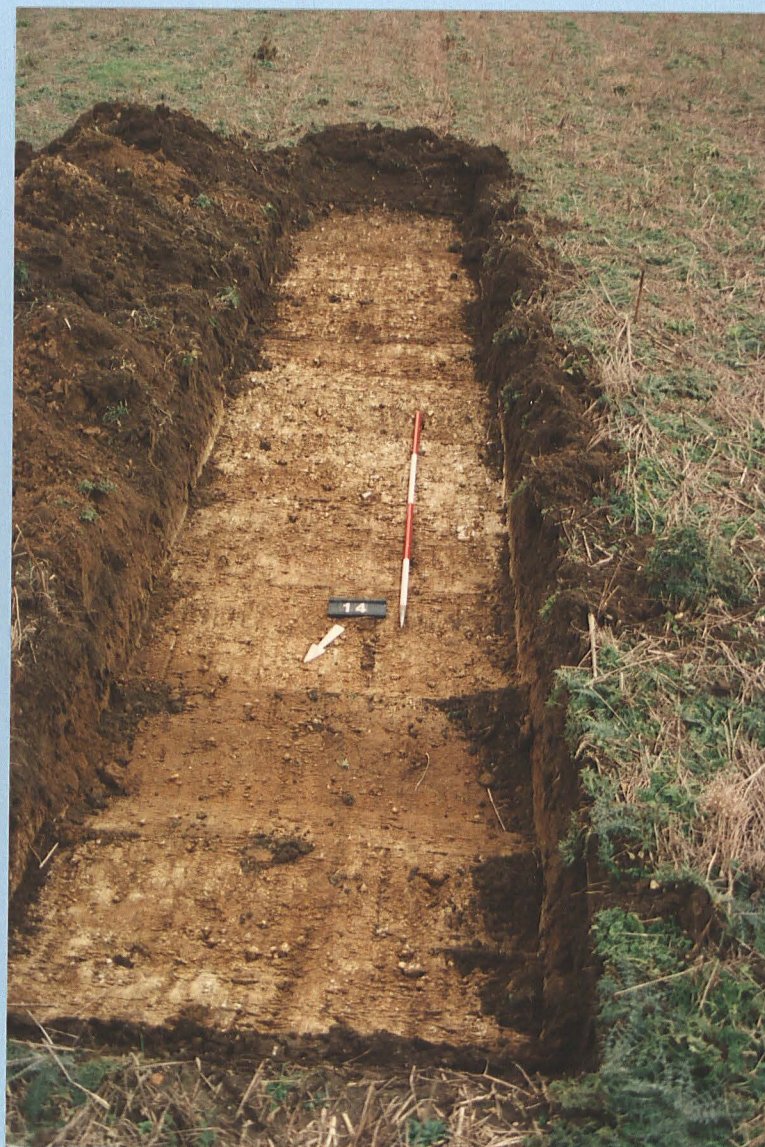
**C/14**

3.15	Trench 14	Ploughsoil	0.26 m.
		Subsoil	0.11 m.
		Natural	Chalky rubble with gravel patches and grey clay

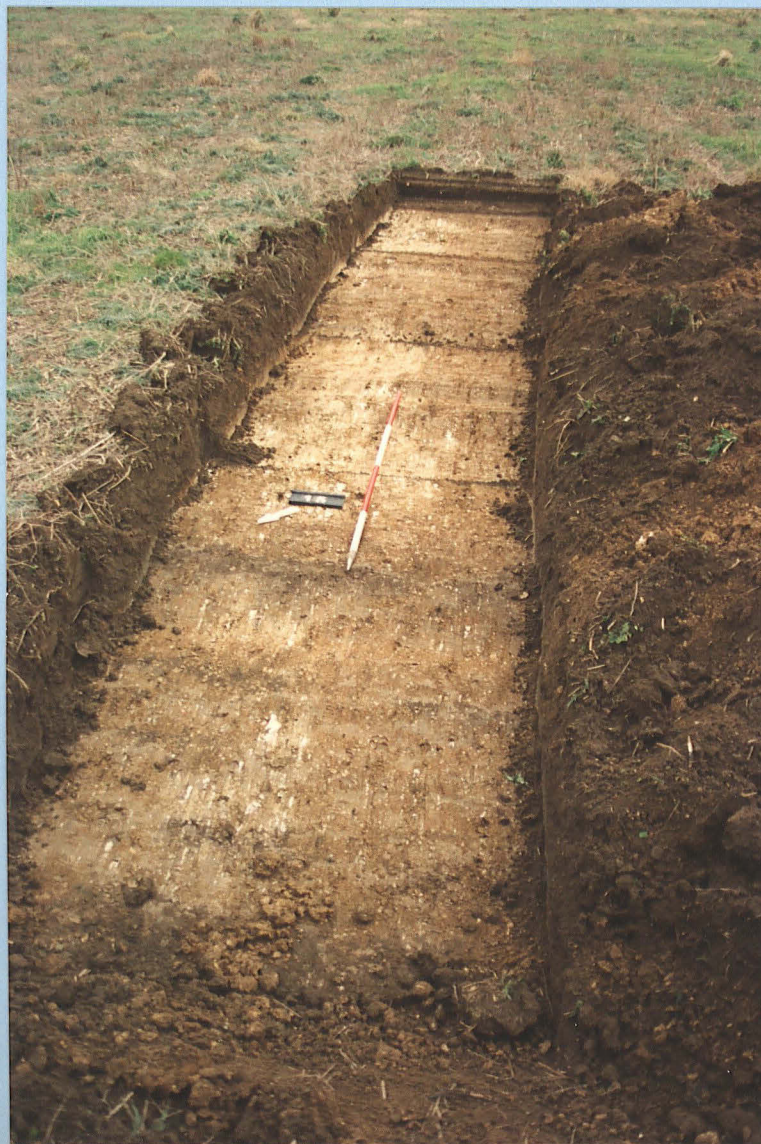
C/15

3.16	Trench 15	Ploughsoil	0.28 m.
		Subsoil	None
		Natural	Chalky rubble with clay and gravel.

Note: This side of the field seems to have been ploughed down to natural with little or none of the subsoil surviving

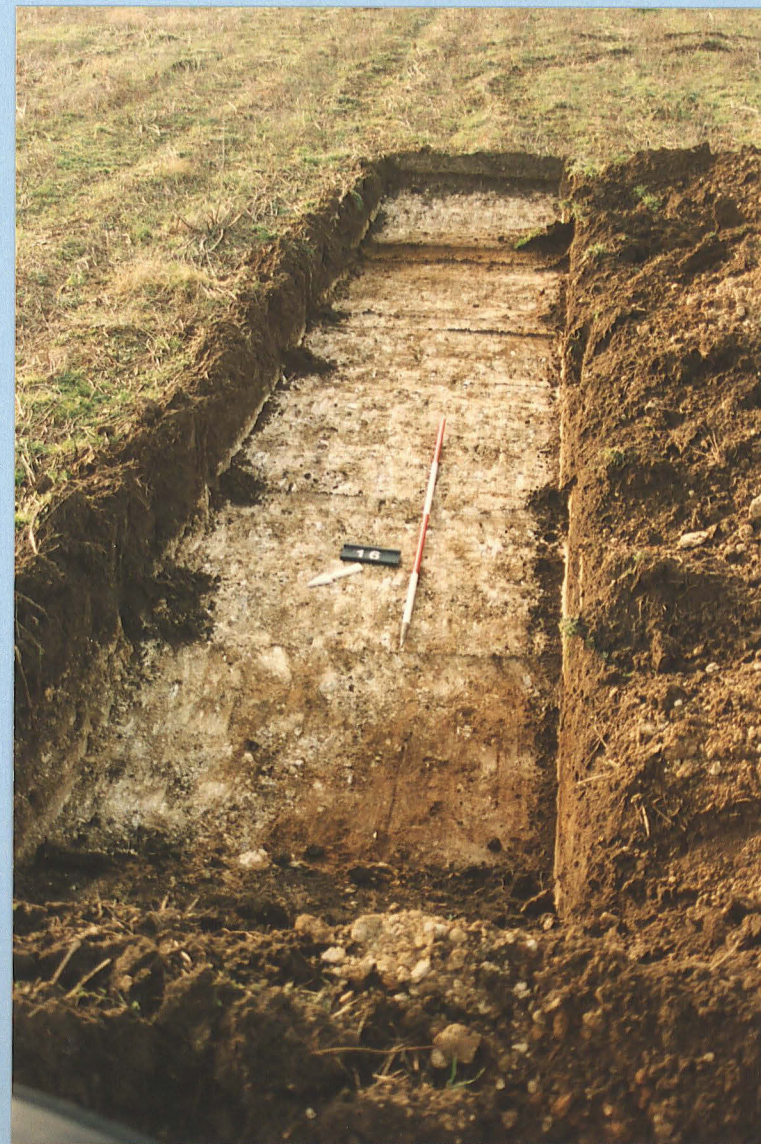
C/16

3.17	Trench 16	Ploughsoil	0.30 m.
		Subsoil	None
		Natural	Chalky rubble with clay and gravel.

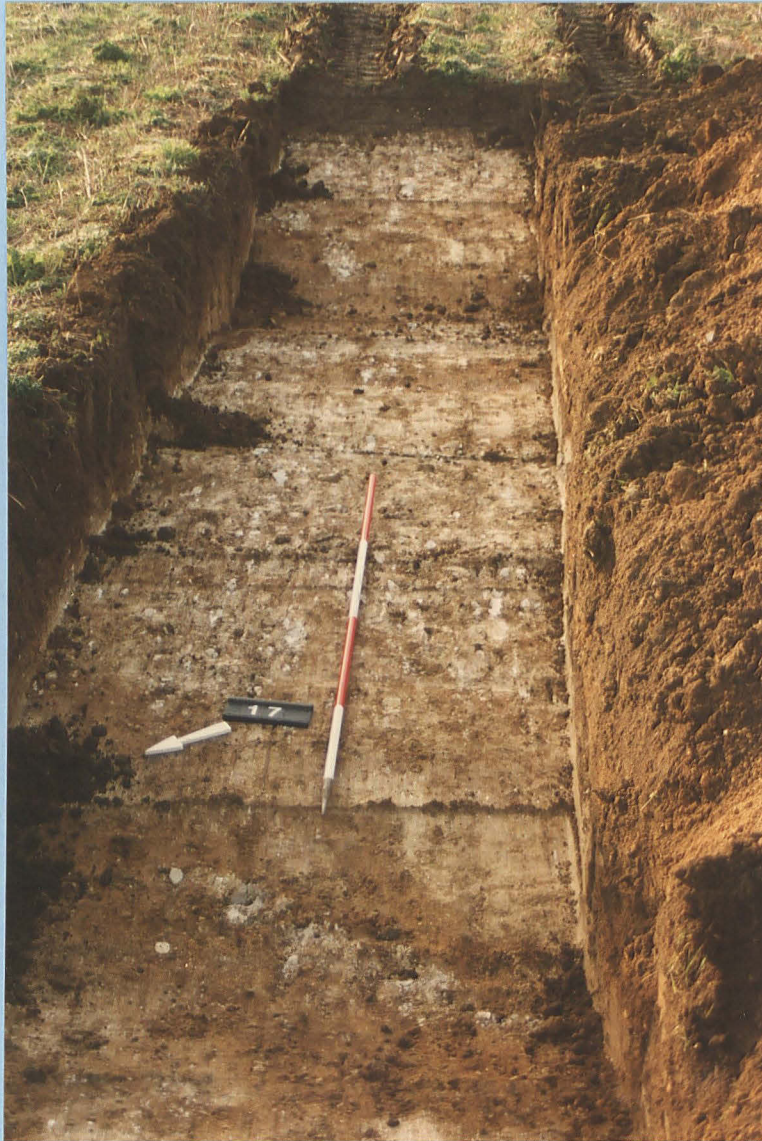
**C/17**

3.18	Trench 17	Ploughsoil	0.30 m.
		Subsoil	0.09 m.
		Natural	Chalky rubble with clay and gravel patches.

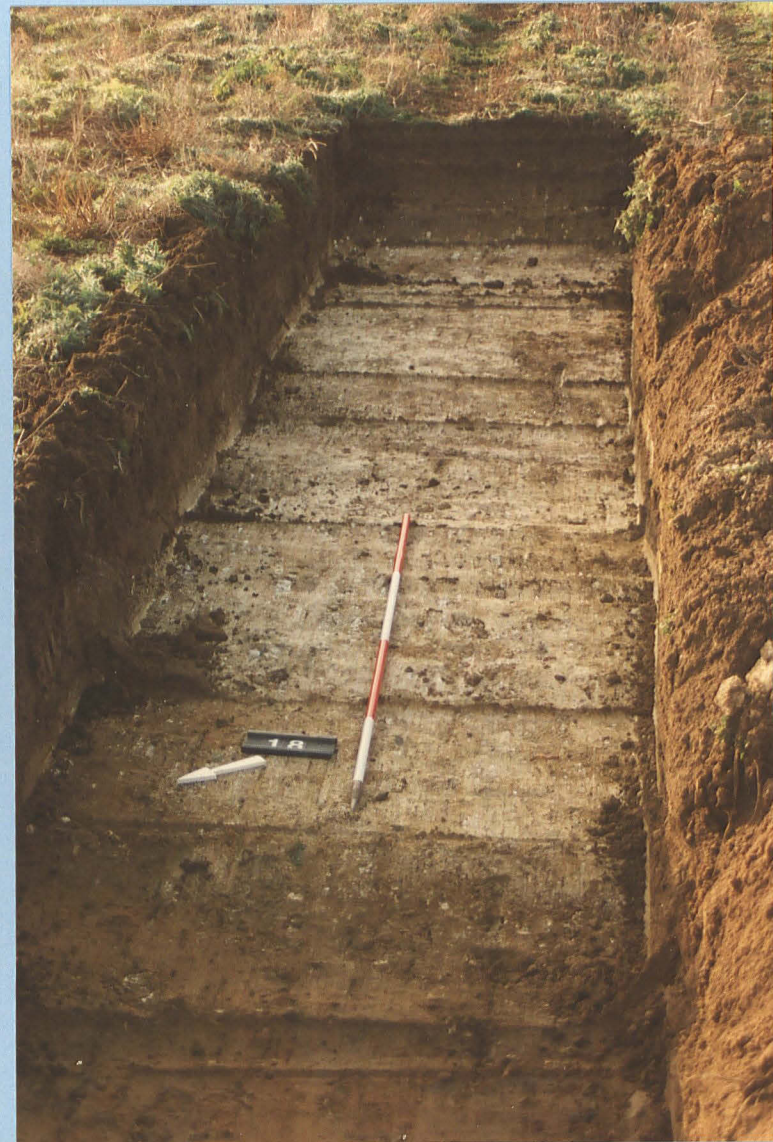
**C/18**

3.19	Trench 18	Ploughsoil	0.30 m.
		Subsoil	0.20 m.
		Natural	Chalky rubble with clay and gravel.

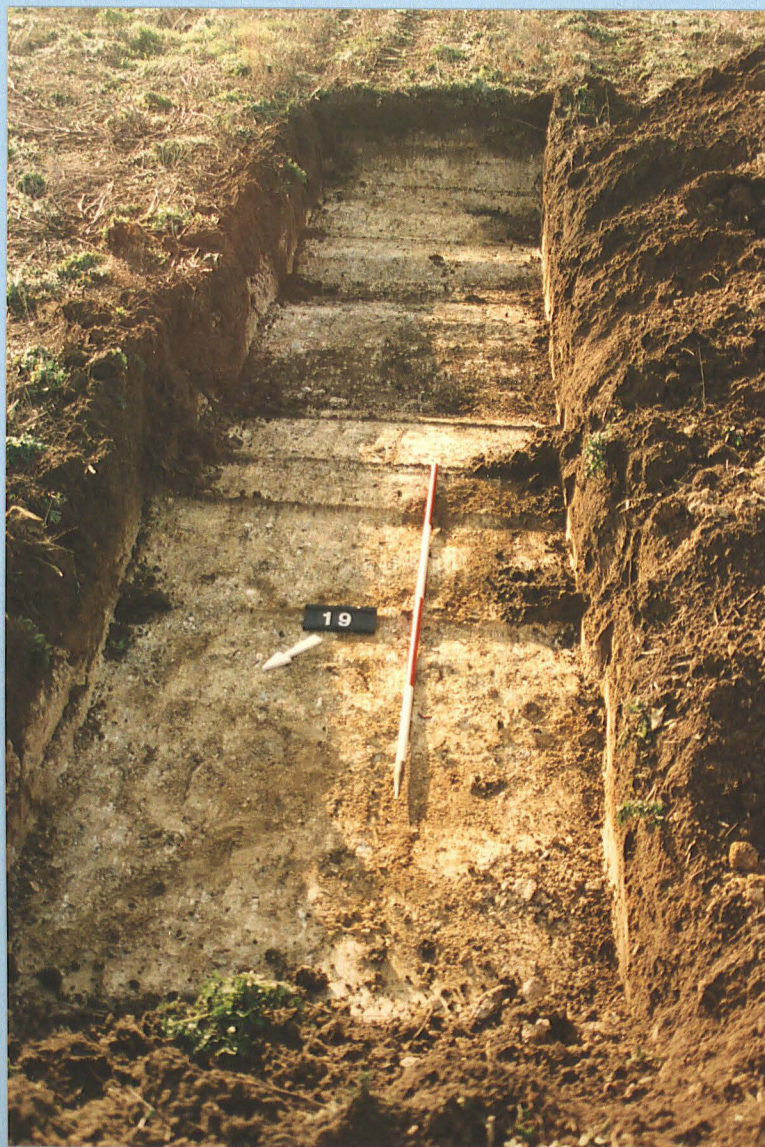
3.20	Trench 19	Ploughsoil	0.23 m.
		Subsoil	0.07 m. were it exists
		Natural	Chalky rubble with clay and gravel.
		Photograph C/19

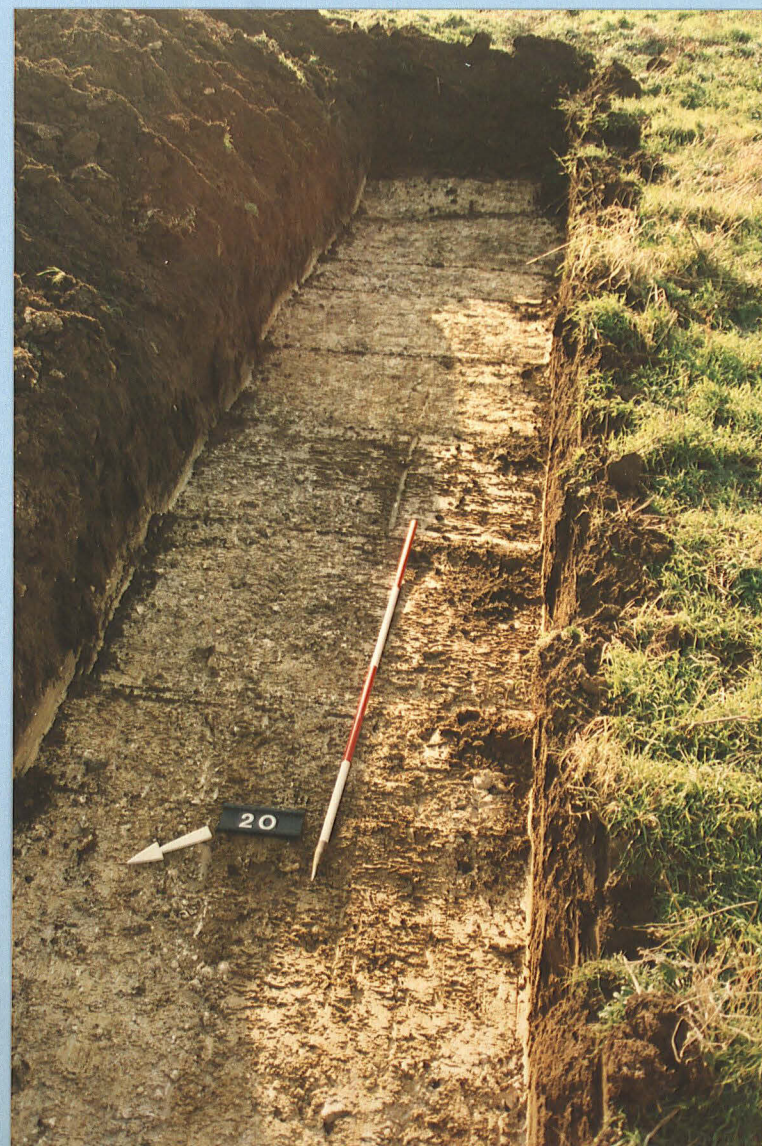
3.21	Trench 20	Ploughsoil	0.35 m.
		Subsoil	0.03 m. were it exists
		Natural	Chalky rubble with clay and gravel.
		Photograph C/20
