**ARCHAEOLOGICAL WATCHING BRIEF
ON LAND BETWEEN BRIDGE STREET
AND THE RIVER TRENT, GAINSBOROUGH,
LINCOLNSHIRE
(GNB00)**

Work Undertaken For
Environment Agency

November 2000

A.P.S. Report No. 173/00

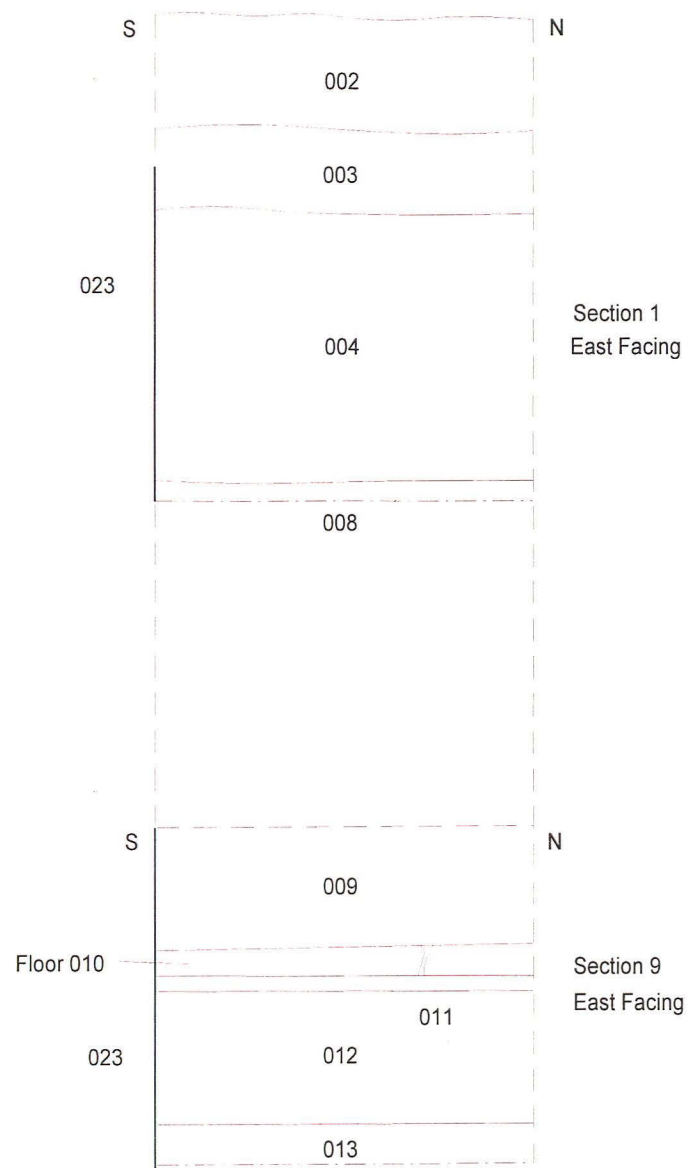
Figure 9 Soil Profile in Building 2

Within the walls, and overlying river silt (012) was a 40mm thick layer of firm, pale grey-brown mortar (011) with coarse lime inclusions (Figure 9). Seated on the mortar was a floor (010) composed of sandstone slabs, sealed below a deposit of soft, dark yellow brown silt (009) approximately 0.5m thick. Overlying this was a tip layer of firm,

In Building 2, silt deposit (004) was sealed below 0.22m of loose, very dark grey-brown sandy silt with frequent brick and limestone rubble (003) (Figure 9).

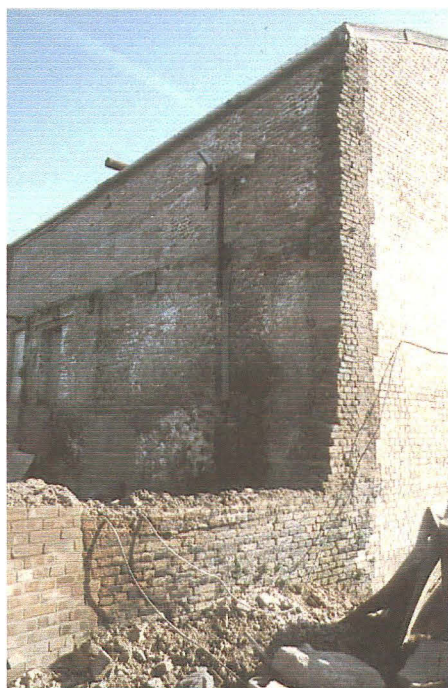
◀ Plate 2 View of Building 2 showing standing wall [014] incorporated into 3 story standing building, looking northeast

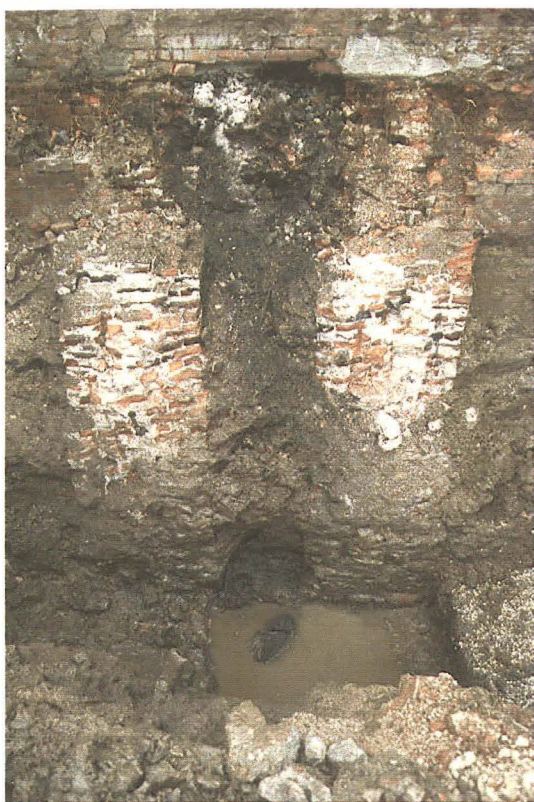
Plate 4 The separation of
Buildings 2 and 3; showing
walls [036] and [093],
looking east

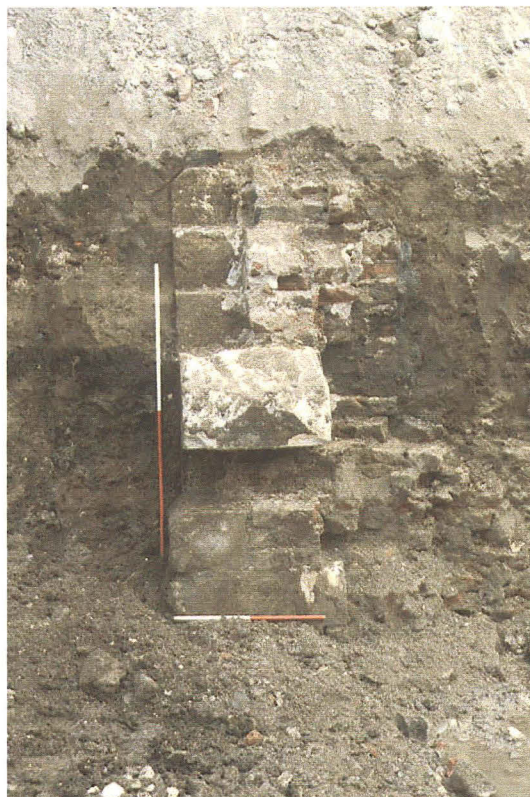
Plate 5 Section through
wall [067] in the southwestern corner of
Building 4, looking north

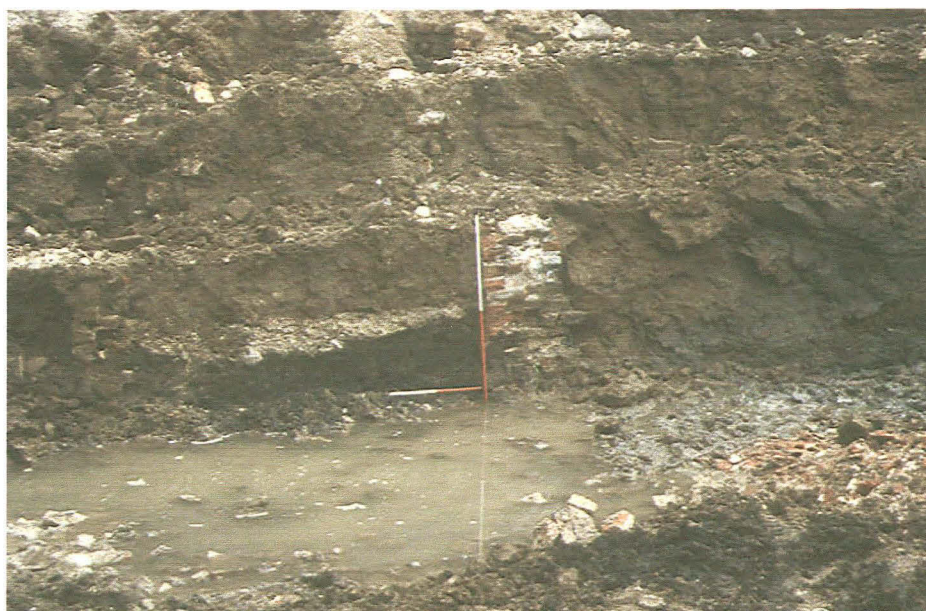
Plate 6 Section through walls [068] and [069]
showing floor deposit [083], looking east
