**St Helen's Church, Little Cawthorpe, Lincolnshire  
Archaeological Recording**

**NGR: TF 3570 8372  
Site Code: LCCB 00  
LCNCC Accn No.: 2000.9**

**LAS Report No. 535  
May 2001**

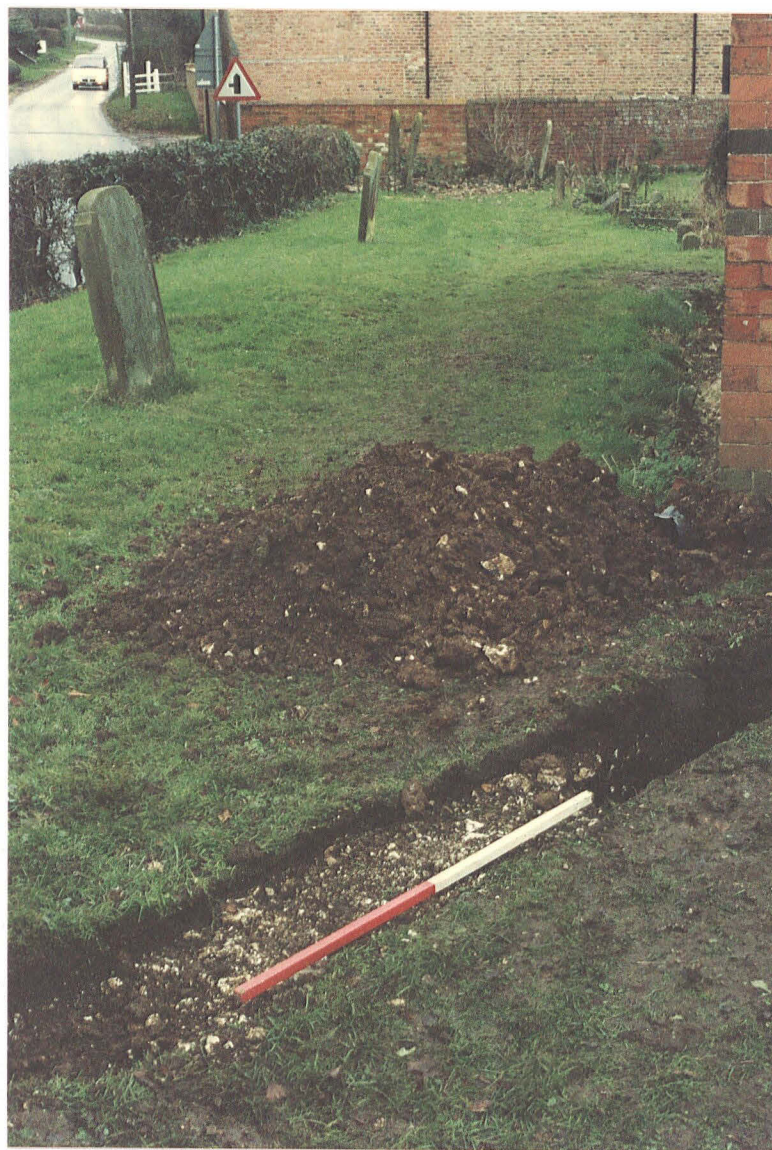
Located at the western junction of the porch and the nave, running NE-SW. This trench did not extend below the overburden although a deposit of crushed chalk c.1m wide and 0.01m deep was found approximately 2m from the church. This is possibly part of a path previously running along the western side of the nave which can be seen as a slight depression in the ground (Pl.2).

Pl. 2 Trench 1, looking north, showing crushed chalk pathway. Scale 1m.

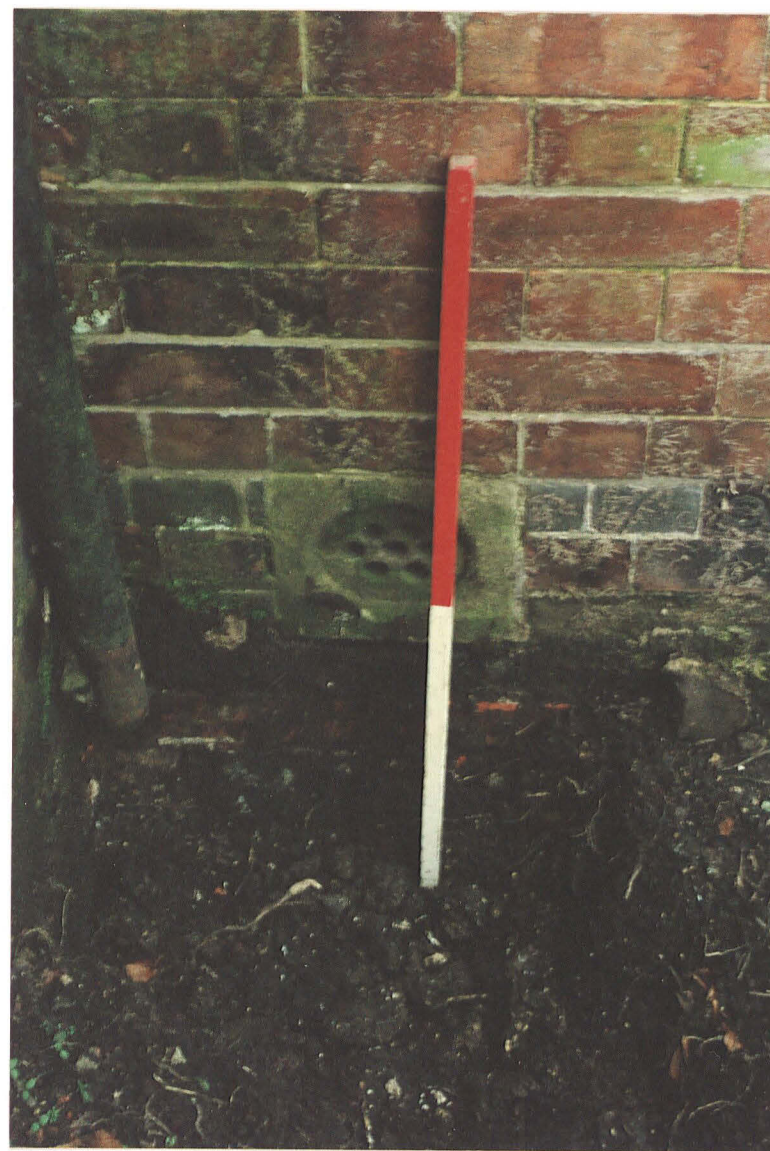
Located at the western junction of the porch and the nave. This did not extend below the modern overburden until approximately 2m from the church (Pl. 3). There were no archaeological features in the trench although the 'natural' was disturbed in areas which may have represented backfilled graves.

Pl. 3 Trench 2, looking north. Scale 1m.

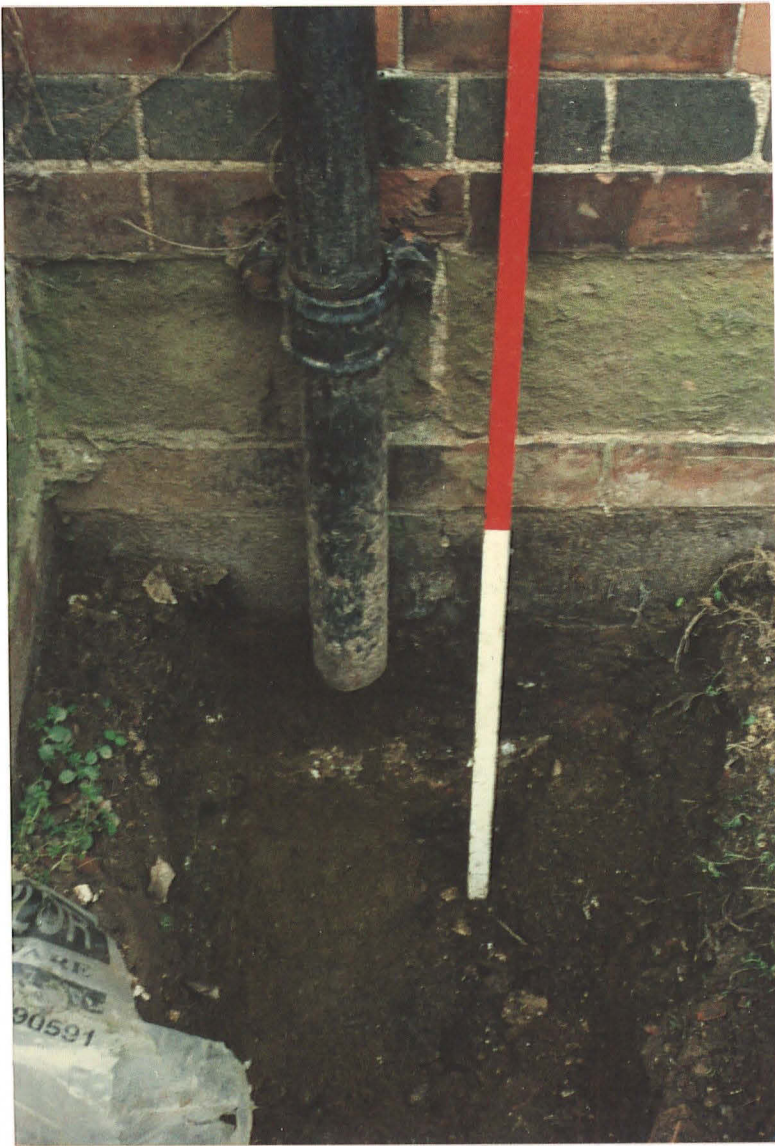
Partly located within Test Pit 6 of the 1998 investigation. Beyond this, the excavation did not extend below the overburden until approximately 3m from the church limit (Pl. 4). The 'natural' was an orange brown silty clay and often appeared mixed, probably evidence of backfilled graves.

Pl. 4 Trench 3, Looking north showing top of stepped foundations and backfilled test pit from 1998 evaluation. Scale 1m.

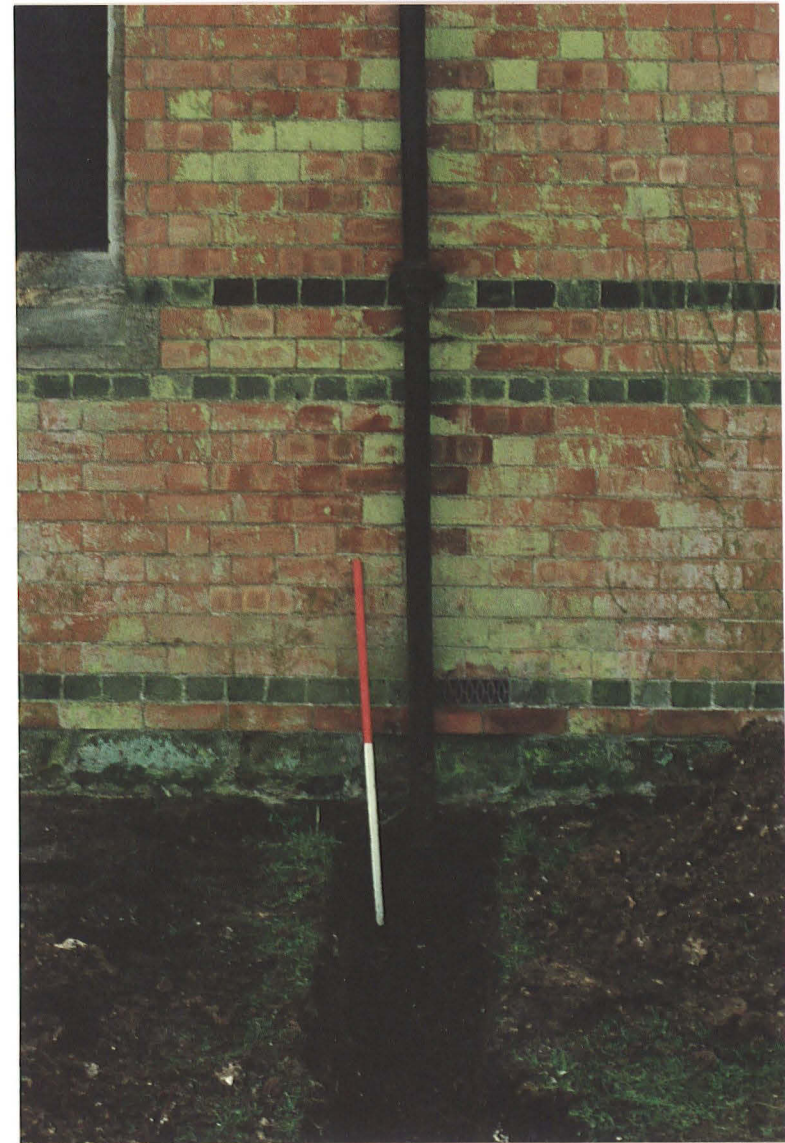
Located in the centre of the northern wall of the nave, this trench did not extend below the overburden until 3m from the church at the limit of the archaeologically excavated trench (Pl. 5).

Pl. 5 Trench 5, Looking south. Scale 1m.
