**EXTENSION TO CONCRETE PRODUCTS FACTORY
MANOR FARM, BASTON, LINCOLNSHIRE**

ARCHAEOLOGICAL WATCHING BRIEF REPORT

NAA 01/33

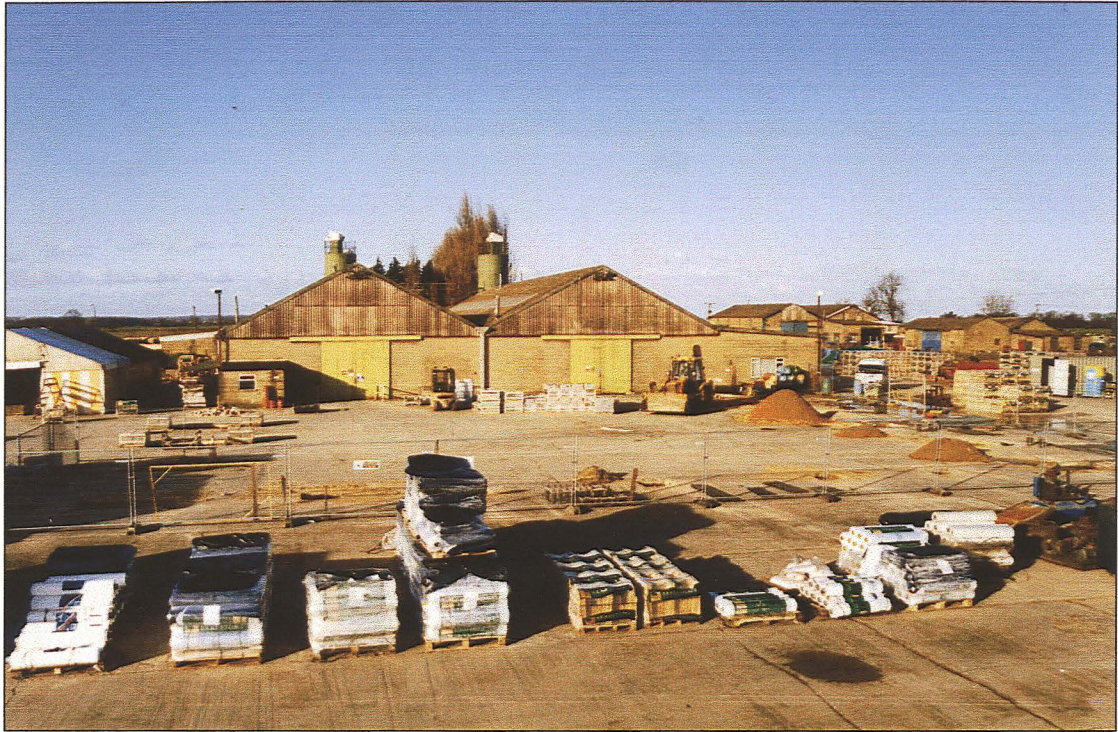
Plate 1 Site location showing excavated pits

5.1 A total of 15 pits were excavated. Ten of the pits (1 to 5 and 11 to 15) measured 2.8m by 1.8m and 1m deep and the remaining five (6 to 10) 1.5m by 1.1m and 1m deep, their locations relating to the foundation piles for the proposed factory extension (Figure 2, Plate 1).

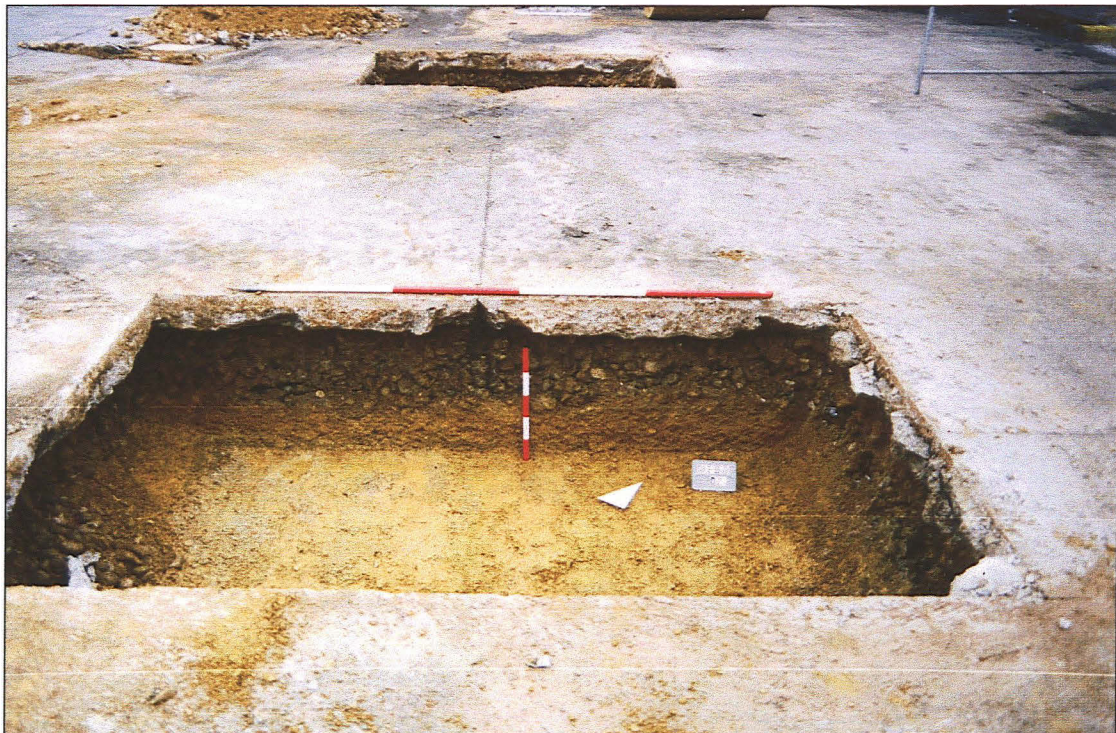
Plate 2 Foundation pit 2 showing hardcore layer overlying natural gravel

5.2 All of these foundation pits had an identical sequence of deposits with decreasing levels of hardcore the further to the south-east the pit was located. Beneath the concrete apron c.0.12m thick (1), a layer of hardcore (2) was recorded (ranging from 0.37m to 0.24m thick) consisting of rounded river pebbles, angular stone and fragments of concrete. This overlay natural gravel and sand deposits (3), which extended beyond the 1m depth that was the limit of excavation (Plate 2). The water table was encountered at a depth of c.0.65m below the ground level. No features or finds of an archaeological nature were identified.

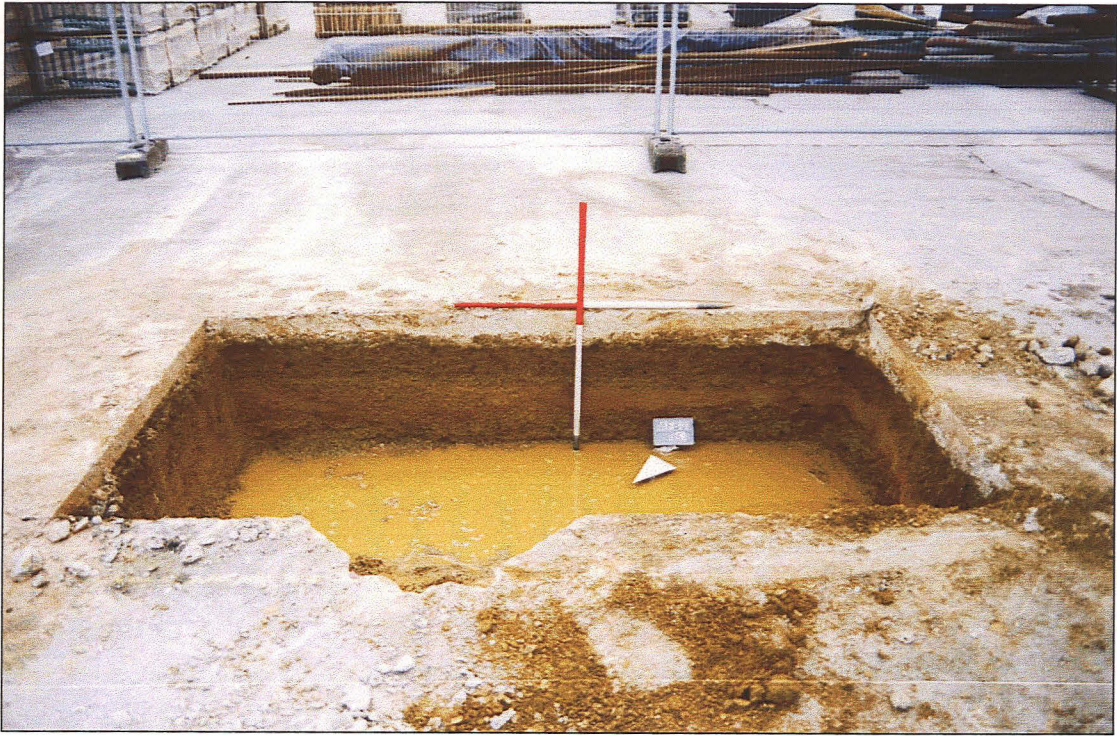
Plate 3 Foundation pit 5 showing layering of natural deposits below the concrete platform

- 5.4 No hardcore was recorded in these pits; the concrete apron instead overlay a layer of redeposited sand and gravel (4) measuring c.0.12m thick. This in turn overlay the natural sand and gravel deposits (3). The water table was encountered at a depth of c.0.65m below the ground level (Plate 3). No features or finds of an archaeological nature were identified.
