**Barrowby Road, Grantham  
New Sewage Pumping Station and Rising Main**

**Archaeological Watching Brief**

**LAS Report No. 547**

**August 2001**

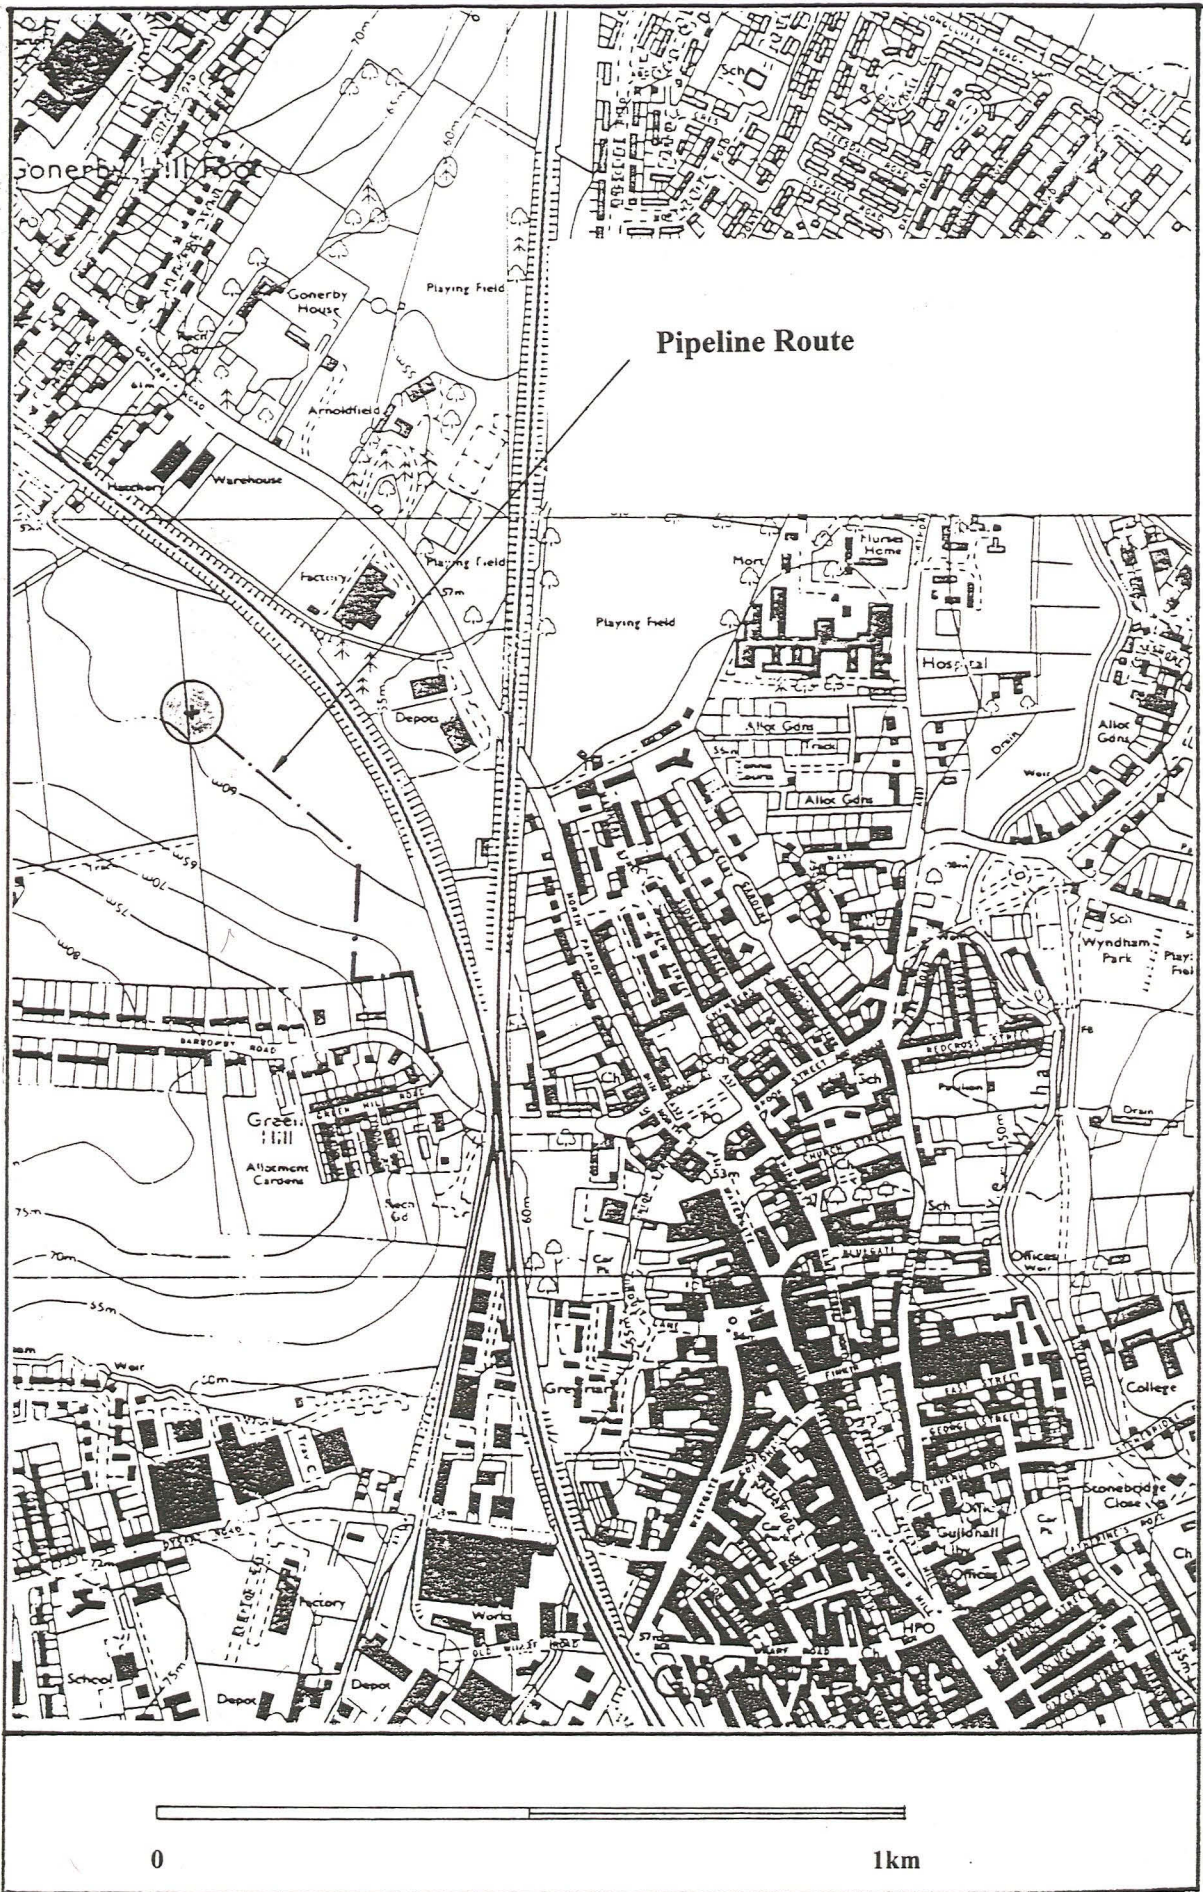
Fig. 2 Route of the monitored pipeline (based on Anglian Water Services Ltd dwg. no. SEW 00568/01. © Crown Copyright, reproduced with permission of the Controller of HMSO. LAS Licence No. AL 10002165).

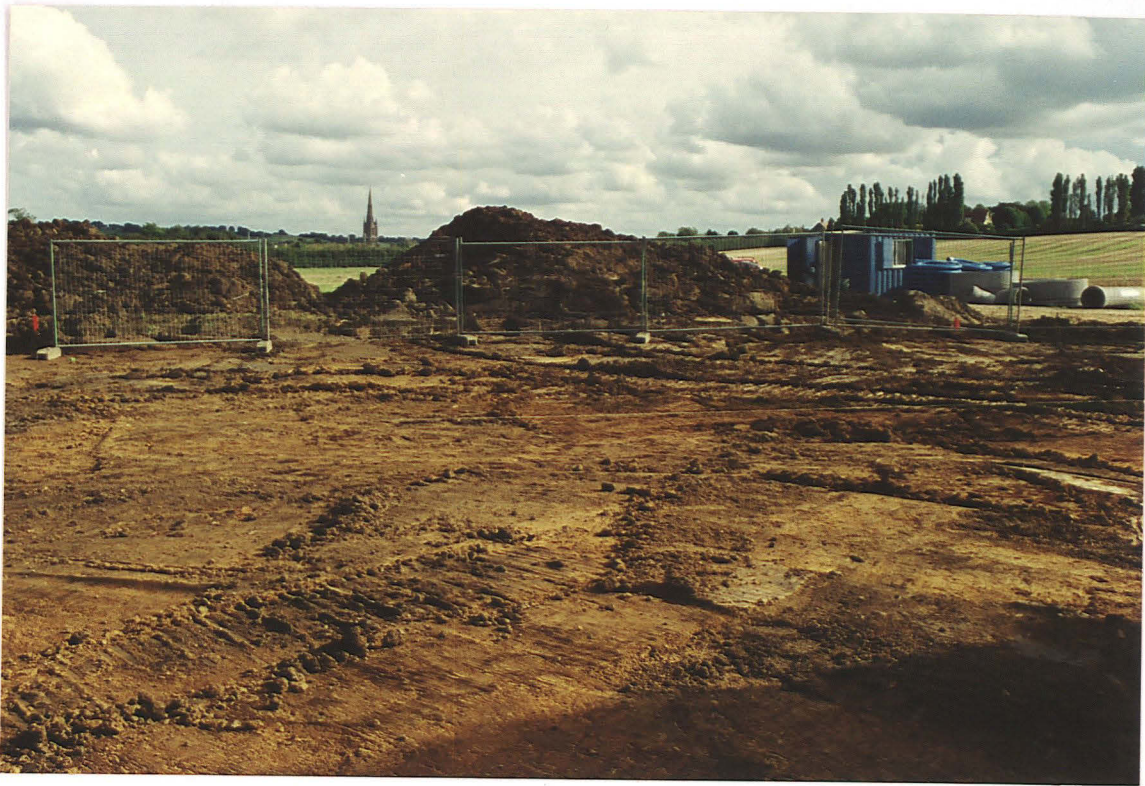
**Pl. 1** Area topsoil stripped for the new pumping station (looking SE).

The topsoil was stripped from an area measuring about 25m x 12m, using a JCB with a toothless bucket (Pl. 1). An area approximately 5m<sup>2</sup> was then excavated to a depth of 8m for a 'wet well'.

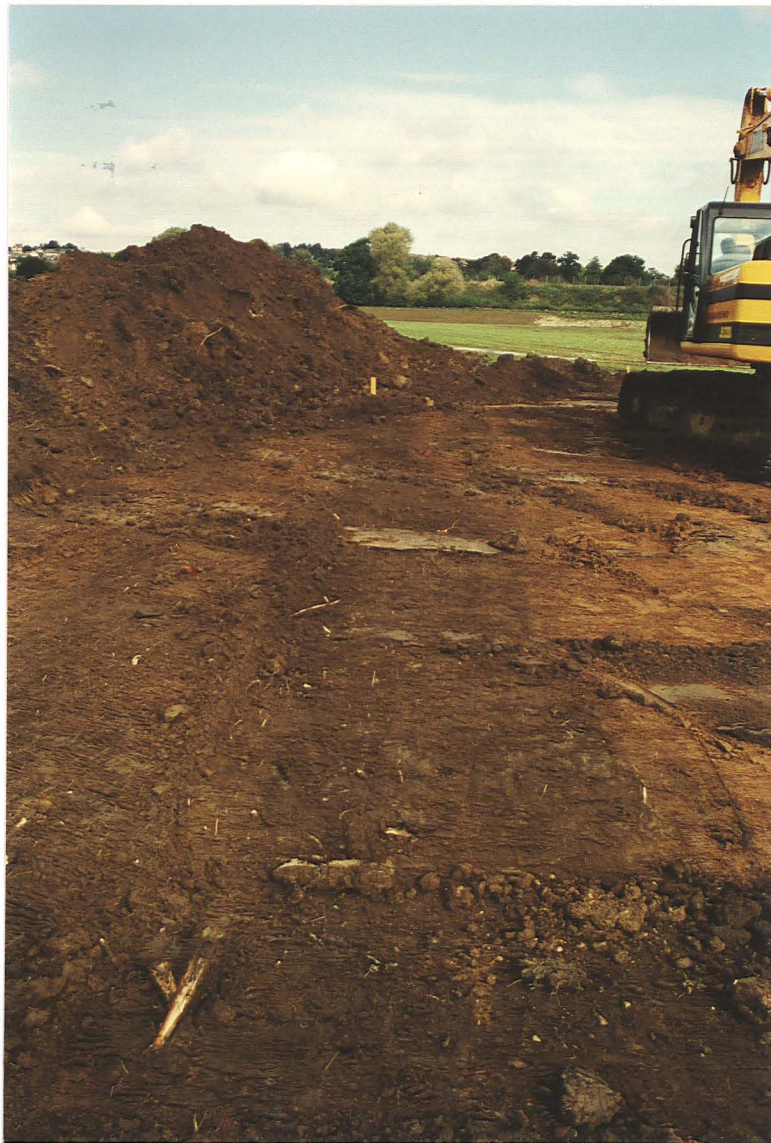
**Pl. 2** Dark backfill (centre) of post-medieval field boundary ditch crossing the pumping station site (looking north).

The 0.15m - 0.25m thick topsoil **1** was a grey/brown loam. Removal of this revealed a 0.5m - 0.6m thick yellow/brown loam subsoil **12**. Adjacent to the access road associated with the new housing development located to the SW, already installed by Wilson Homes, the ground, which had been recently disturbed for the insertion of pipes, consisted of a mixed deposit of yellow/brown loam and blue/grey clay, **13**. A backfilled field boundary ditch lay within the stripped area (Pls. 2 and 3)

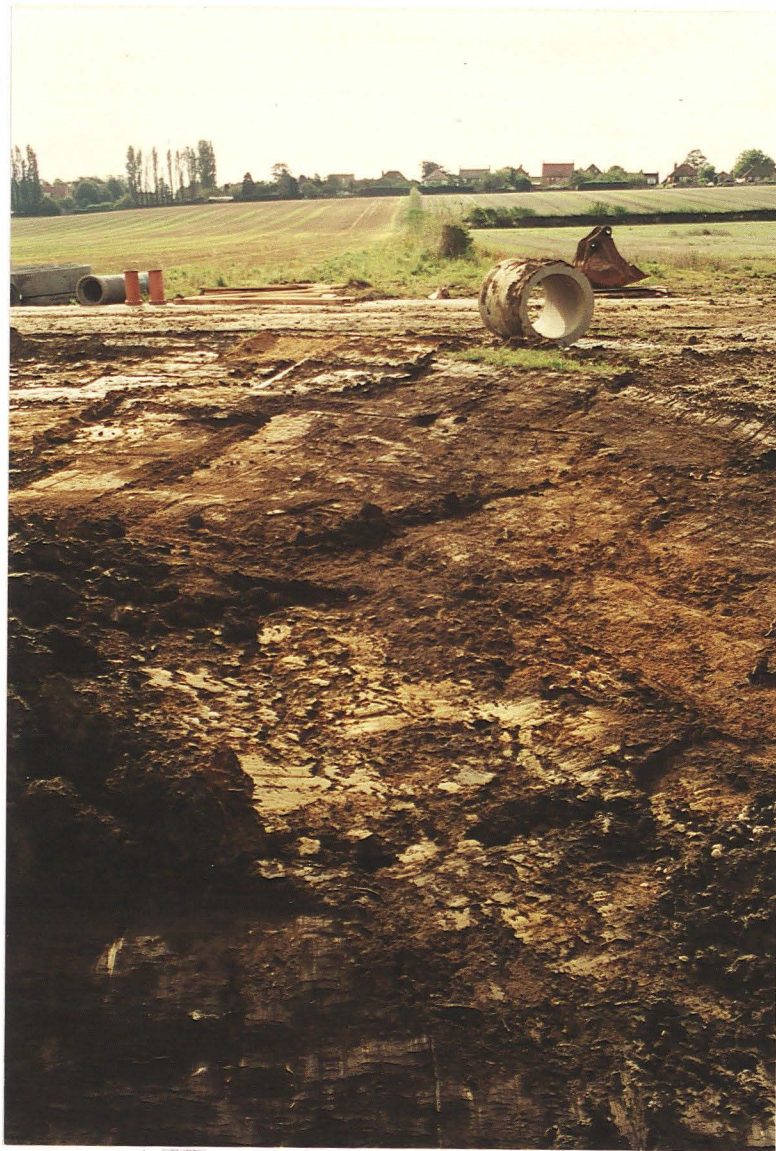
Pl. 3 Backfilled field boundary ditch (looking south along the surviving field boundary, towards Barrowby Road).

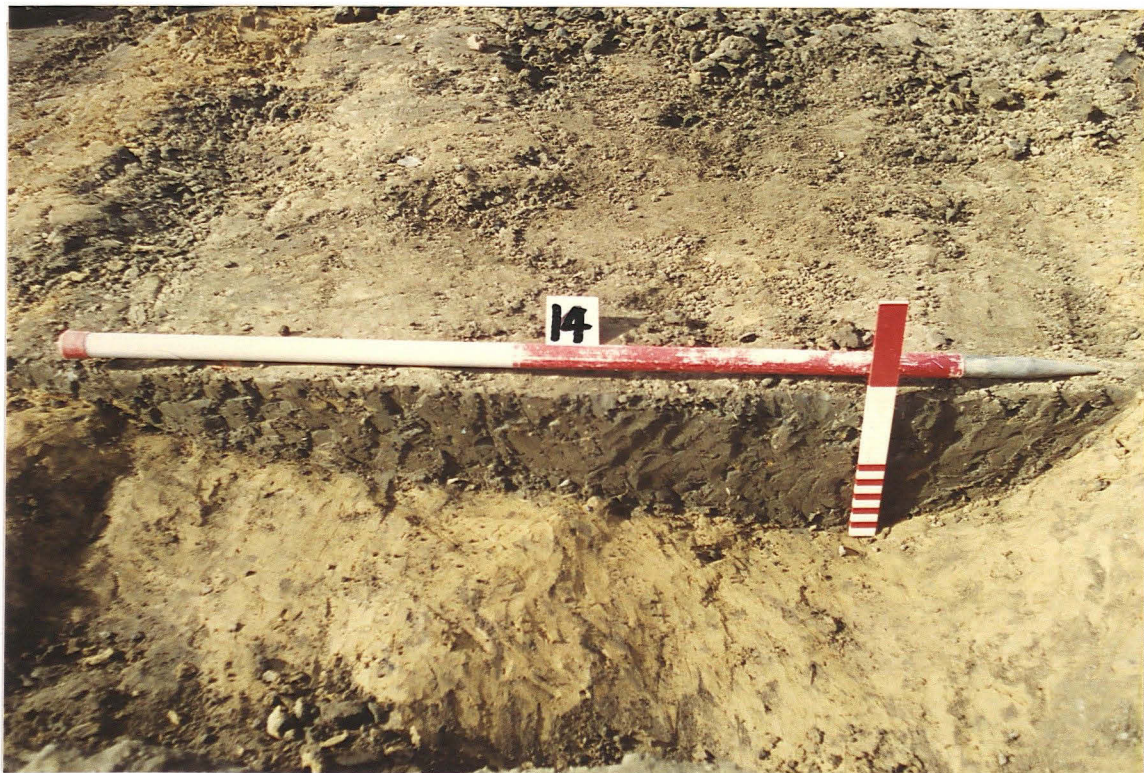
Pl. 4 Section excavated through the fill of ditch 14. Scales 0.3m and 1m.

Two parallel, curvilinear ditches (**14** and **16**) were revealed in the area stripped, cut into the subsoil. These were orientated approximately NW-SE, and extended beyond the edge of the stripped area. A 0.5m wide section excavated across ditch **14** revealed an irregular profile, sloping to a depth of 0.25m (Pl. 4). Poor weather and standing water prevented detailed investigation of ditch **16**, but the profile appeared similar to that of **14**. Nineteenth century pottery was recovered from both ditches but was not retained.

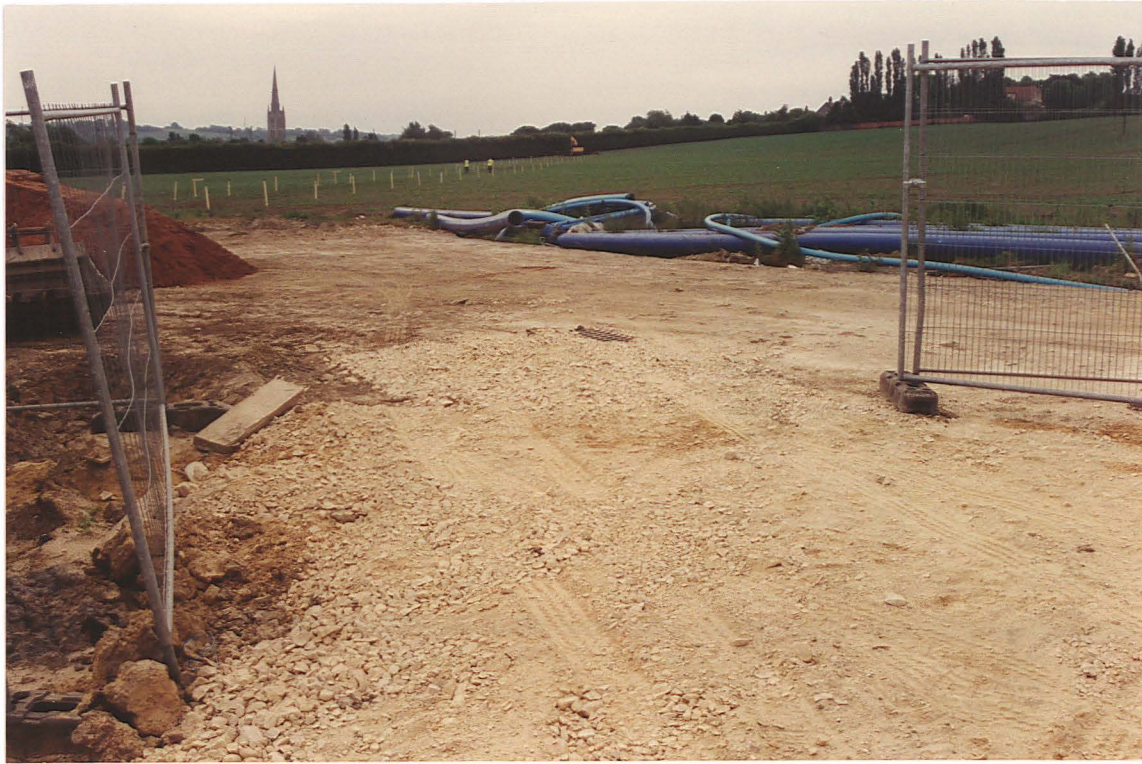
**Pl. 5** Line of the pipeline easement, extending SE from the pumping station (left foreground).

Topsoil was removed from part of a 12m wide and 280m long easement across a cultivated field between the new pumping station and the dense hawthorn hedge alongside the allotments (Pls. 5 and 6). A 0.4m wide and 0.9m deep trench was excavated along the northern edge of the stripped easement (Pl. 7). Beyond this field, the pipe was directionally drilled under the hedge, and moled along the allotment track as far as Barrowby Road.

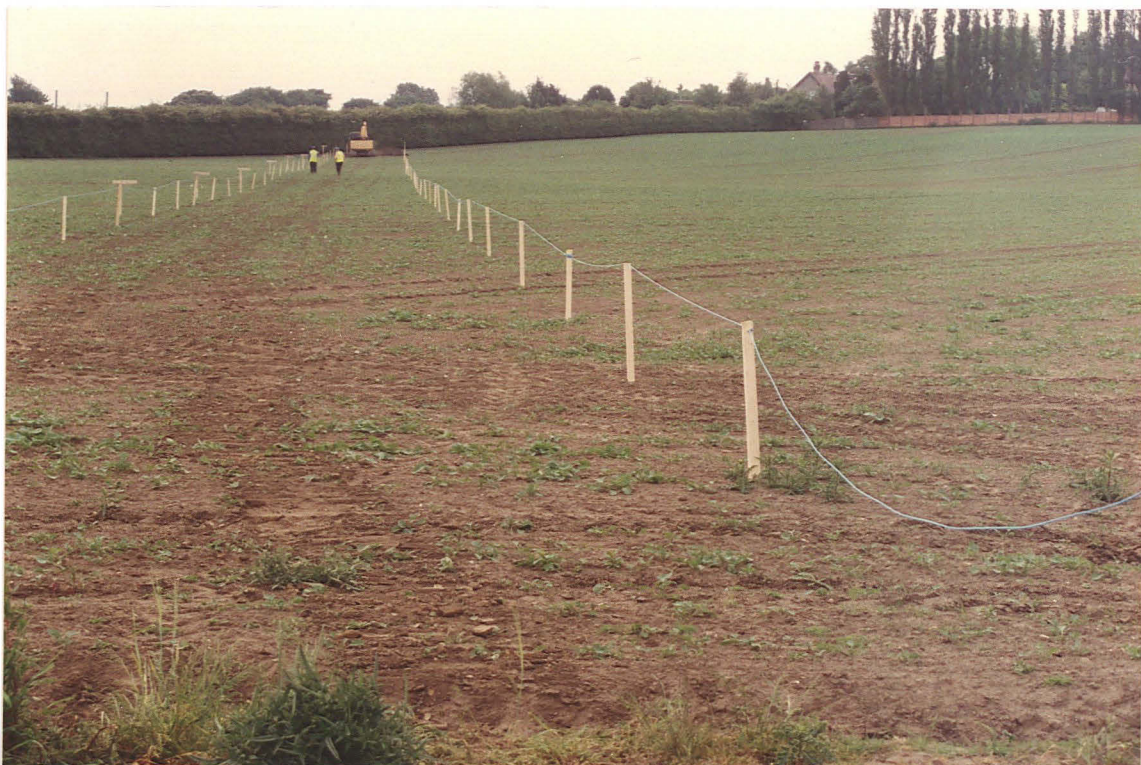
**Pl. 6** Ground conditions were good for fieldwalking prior to topsoil stripping within the fenced easement (looking SE towards the hedge, with allotment site beyond).

Archaeological examination of the route began in advance of the topsoil stripping, with a walk-over of the defined easement. Ground conditions were particularly good, with small brassica plants within a well-prepared tilth. The field surface was littered with fragments of pottery, clay tobacco pipe, glass, roof tile, and other debris of late-twelfth to early twentieth century date (Appendix 2). The apparently earlier post-medieval sherds, together with everything medieval or earlier, were collected from the plough soil as **1**.

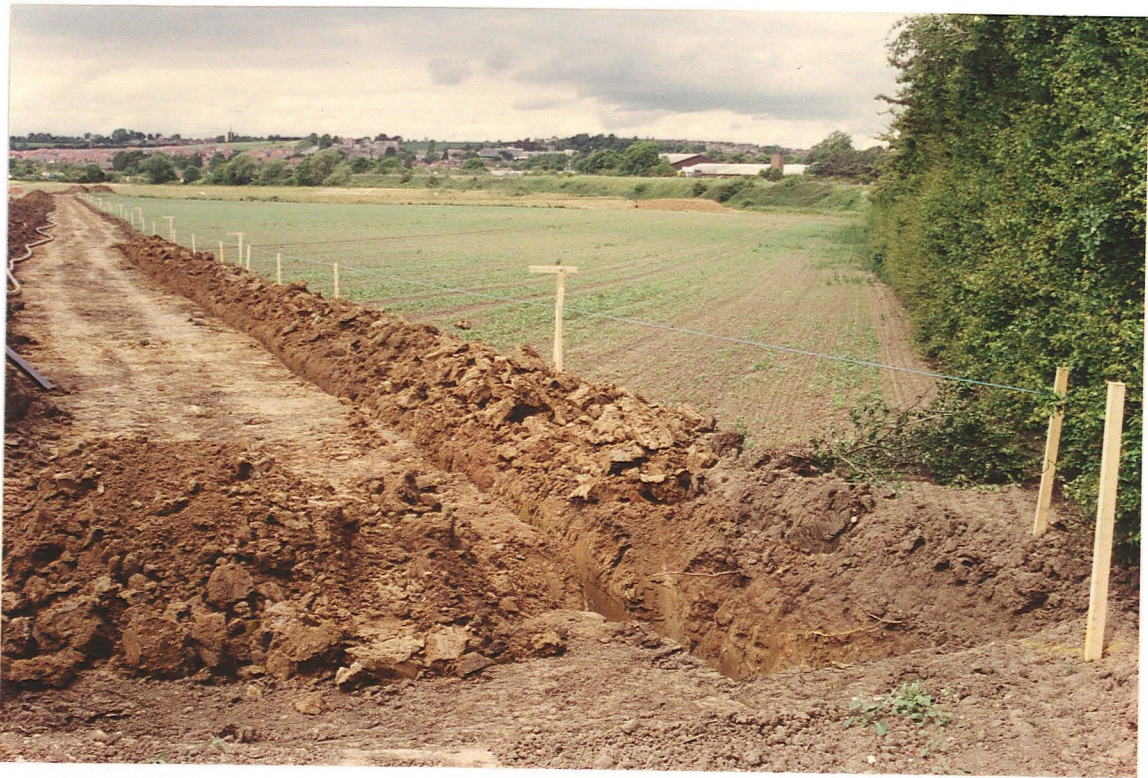
Pl. 7 The stripped easement, with part of the narrow pipe trench excavated (looking NW towards Gonerby Hill Foot).

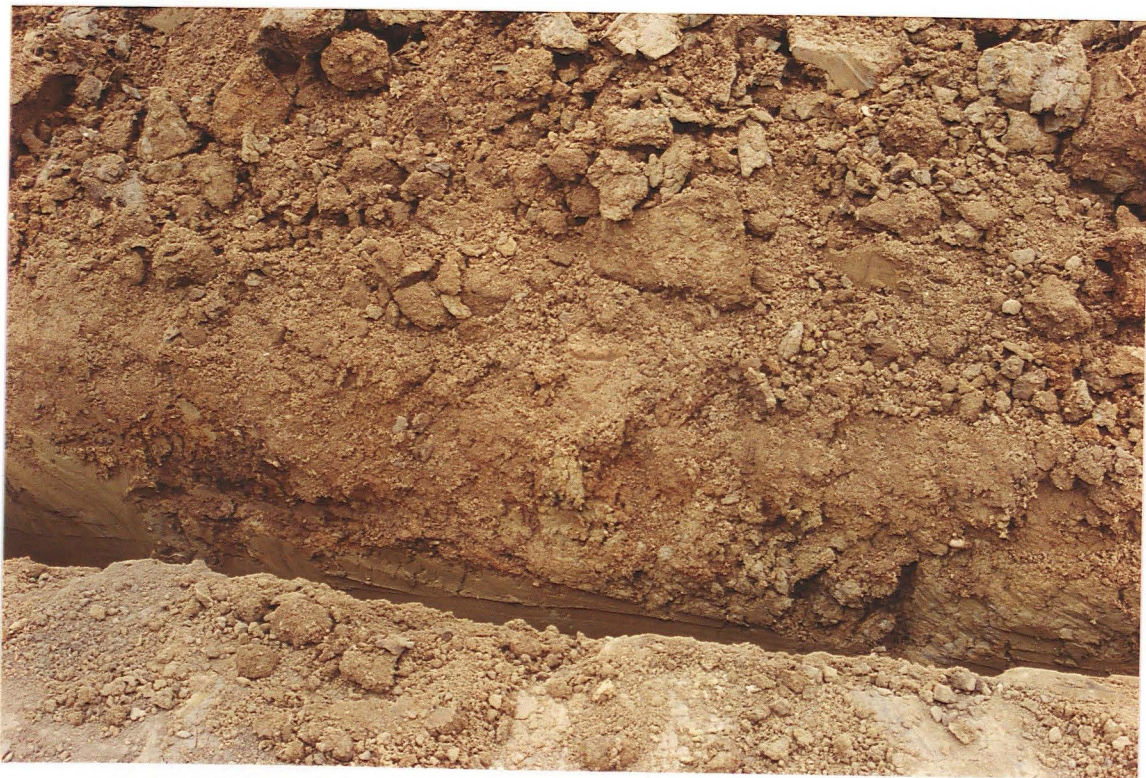
Pl. 8 Red/brown fill of plough furrow, showing in face of pipe trench.

Topsoil stripping began at the higher ground at the SE end of the easement, and a small additional number of pottery sherds were collected from the topsoil as 1. The topsoil was found to overlie yellow clay at the SE end, but this was interspersed (at intervals of about 5m) with the darker fill of NE-SW aligned plough furrows (Pl. 8). The furrow fills contained medieval, post-medieval and twentieth century material, showing that the undulations resulting from medieval or early post-medieval ploughing had been levelled relatively recently. The positions of these furrows were not planned, but pottery sherds found in their fills were allocated separate context numbers 12- 18, and the approximate position of each pottery-producing furrow was recorded. Amongst the later material, one possible prehistoric sherd (but too abraded for reliable dating) was found on the higher land at the SE side of the field.

The pipe trench revealed the furrows to have their bases about 0.55m below the field surface. No other features could be distinguished and no further finds were seen in the trench face of the excavated spoil.
