AN ARCHAEOLOGICAL WATCHING BRIEF
OF DRAINAGE WORKS AT
ST. THOMAS Á BECKET'S CHURCH,
BURTON COGGLES,
LINCOLNSHIRE
(BCC 01)

Work Undertaken For Bond and Read Chartered Architects

Report Compiled By Paul Cope-Faulkner BA (Hons) AIFA

A.P.S. Report No: 126/01

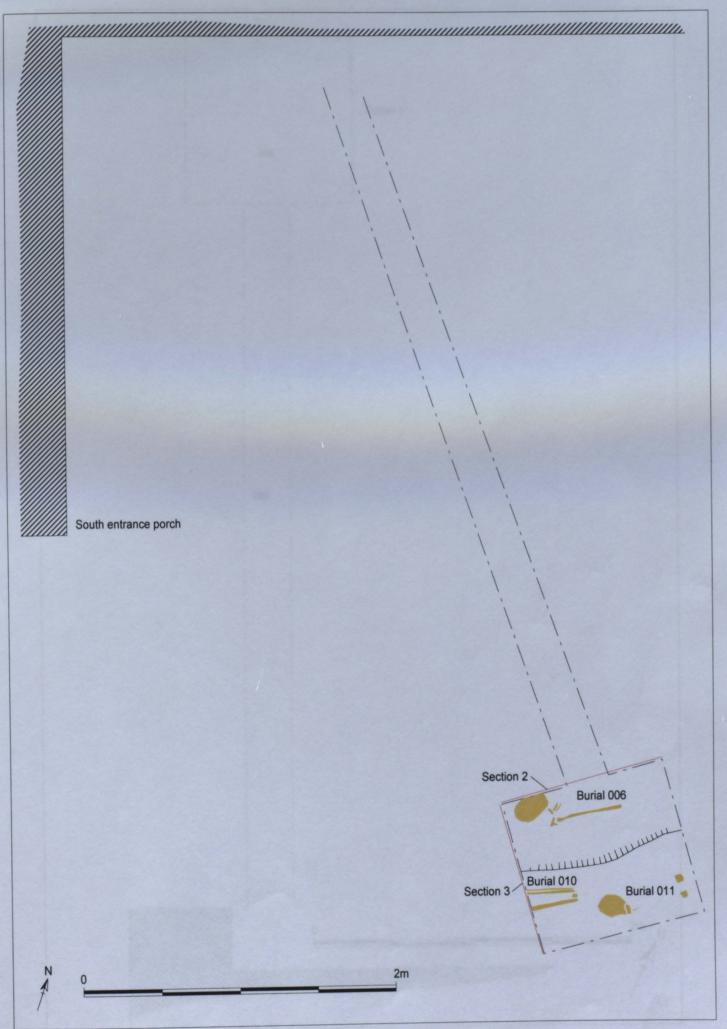
Figure 4 - Plan of the southern drainage trench

The earliest deposit in the southern trench was a greenish brown clayey silt (007 and 009) graveyard soil which was 0.35m thick. Within this deposit were three burials, one possible adult female (006) and two child burials (010 and 011). Finds retrieved from the graveyard soil included medieval and later pottery, glass, nails, burnt clay and animal bone. Sealing the graveyard soil was a modern topsoil of dark grey clayey silt (008).

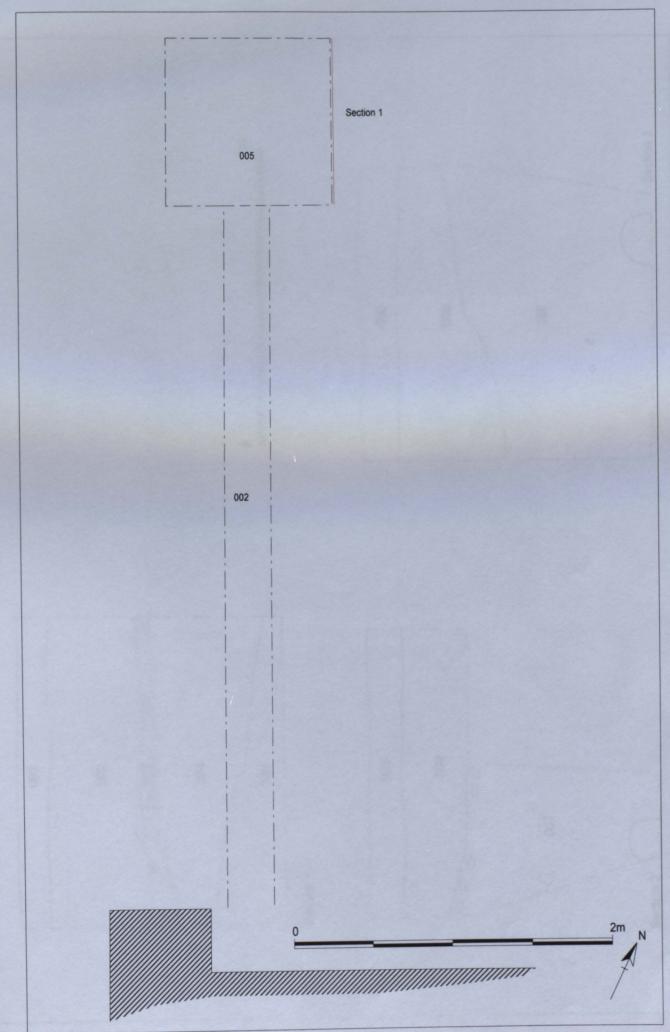
Figure 5 - Plan of the northern drainage trench

The earliest deposits encountered was in the base of the northern soakaway where a reddish brown sandy clay (005) was encountered. This was overlain by a 0.35m thick deposit of greyish brown clayey silt (004) identified as a natural subsoil.

Overlying the natural subsoil in the northern trench was a 100mm thick deposit of greyish brown limestone and clayey silt (003) identified as a construction deposit. This was overlain by greenish brown clayey silt (002) which was identified as the graveyard soil. This was 0.35m thick and contained a single sherd of 13th - 14th century pottery. The graveyard soil was in turn sealed by dark grey clayey silt (001) topsoil.

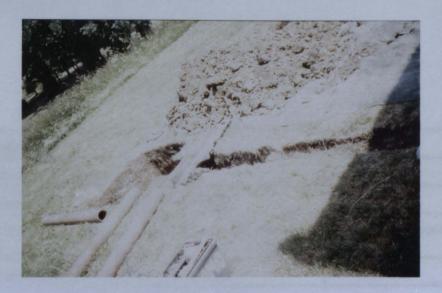
Plate 1 - General view of the northern drainage trench, looking northeast

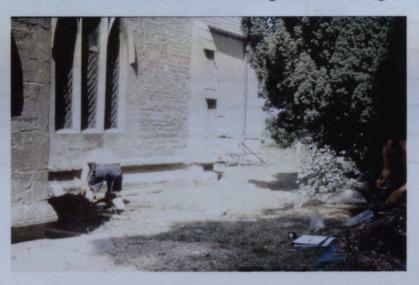
Plate 2 - General view of the southern drainage trench, looking northeast
