RAUCEBY TO SILK WILLOUGHBY LINCOLNSHIRE

An Archaeological Watching Brief
for
Anglian Water Services Limited

Pre-Construct Archaeology
January 1994

SITE CODE: SIL93

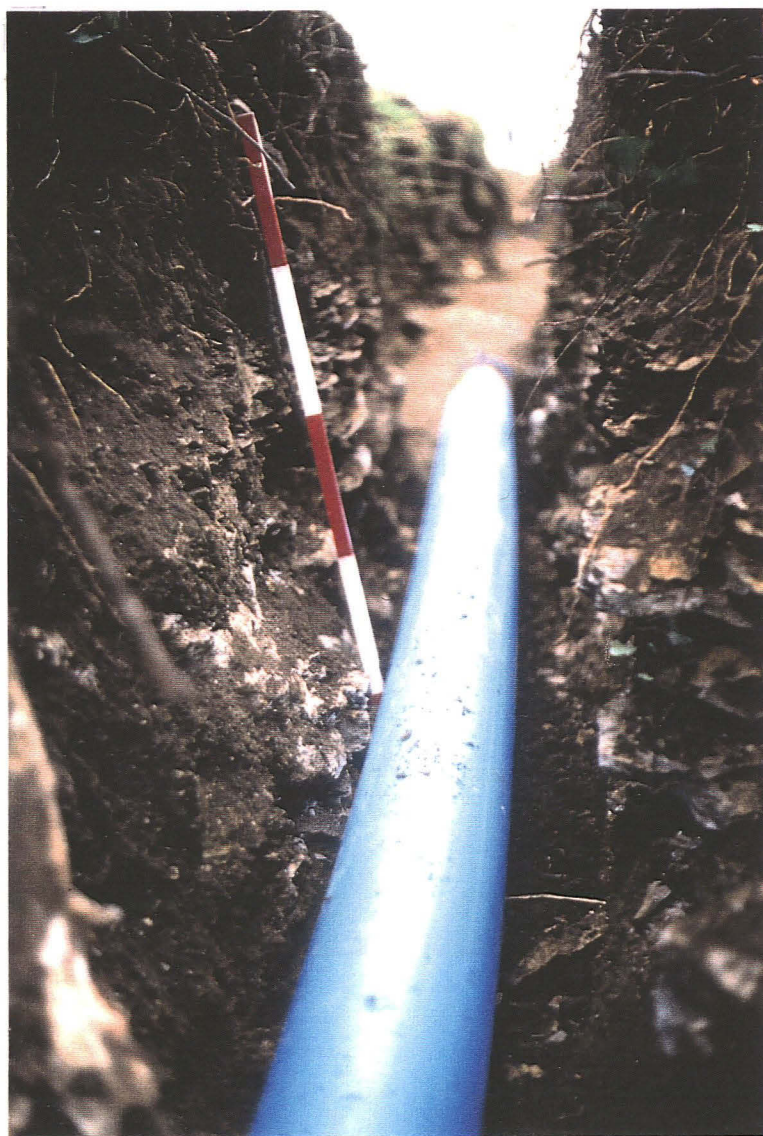
Plate 1 Silkby showing water main trench and natural limestone

At Gables Farm the water main trench veered from a westerly direction to a north-westerly one, initially through a grass field, where the best preserved remains of Silkby are located, and, secondly, through a narrow ploughed field. It was fully expected that the apparent house platforms and other upstanding features would reveal, *inter alia*, traces of buried walls. This was not the case, however, as the drawn section indicates (fig 3). In this area, laminated bed rock comes almost to the surface of the field in some places. There was no doubt that the rock was natural and had no bearing on the remains of any settlement hereabouts (see plate 1).

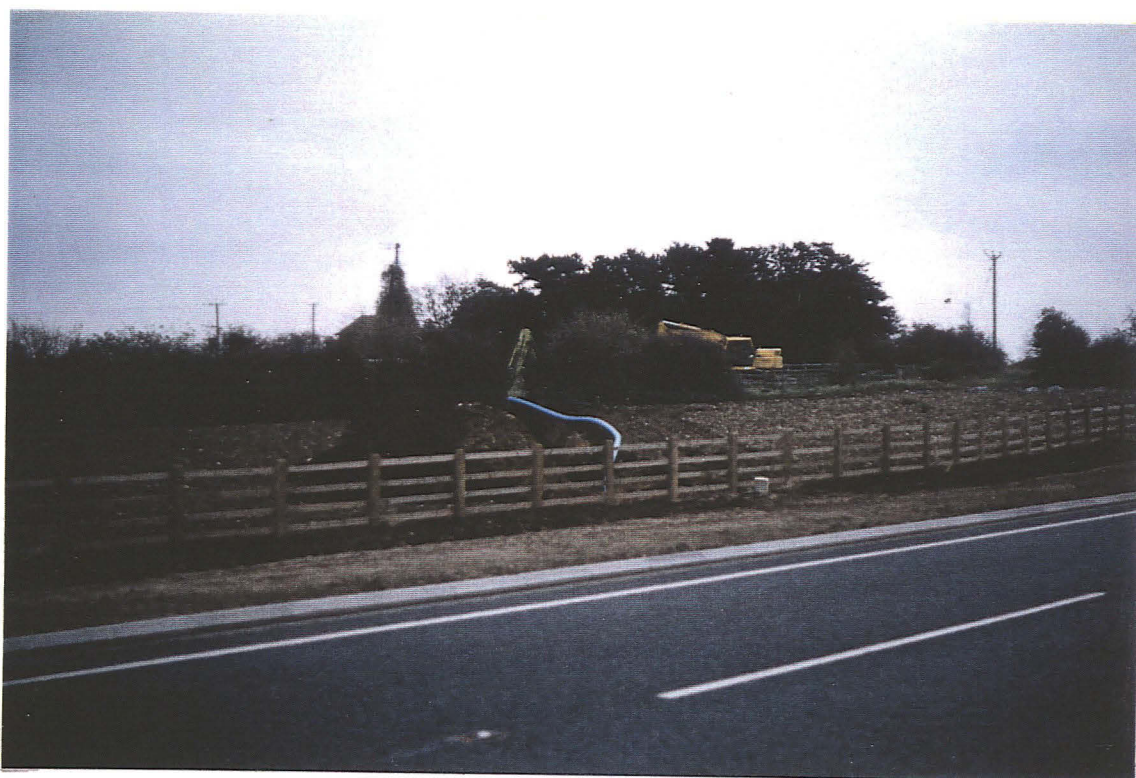
Plate 2 Saxon site seen from bypass (north is to the left)

A hedge separates the grass field from the narrow ploughed field bordering the bypass. The water main trench continued through the ploughed field but now with a cleared strip as a working space for the JCB. Immediately on the west side of the hedge a darker strip of soil was observed within a metre of the hedge and running parallel with it. Although this darker mark had the indications of a filled ditch, on sectioning it there were no clearly defined limits to it. During the archaeological fieldwork here one or two sherds of early Saxon pottery were retrieved from the strip of land running alongside the pipe trench. On further fieldwalking in the immediate area it was noticed that the small parcel of field enclosed by the pipe trench to the north, the hedge on the east, and the road and hedge on the west and south respectively, (in area less than 1 acre) was distinctly different in character from the remainder of the field. A heavy spread of limestone on the surface - almost certainly the debris from destroyed buildings - was obvious. The stone spread thinned to almost nothing to the north of the pipe trench (see plate 2). Equally, the density of early Saxon pottery associated with the stone spread was remarkable; in all 71 sherds were recovered from this small area, together with Romano-British greywares and colour coats, and medieval green glazed wares, Bourne types and one sherd of developed Stamford ware. Also within the area described were several lumps of iron slag. This part of the field is on a slight slope, which levels off beyond and to the north of the pipe trench. At the same time, the distribution of artifacts is reduced to a sparse spread north of the pipe line. (N.B. the work on the site described here is mostly beyond the

requirements of the watching brief). There were no archaeological features noticed or recorded in the sections of the water main trench. The early Saxon pottery from Silkby is similar in character to many other sites found during the past 25 years or so in this part of south Lincolnshire - Hacconby, Little Hale, Osbournby, Dowsby, etc (Simmons, 1975, 196-9), and also from 66 School Lane Silk Willoughby (Simmons, unpublished). Of the 71 sherds recovered from this new site in Silk Willoughby, only one decorated sherd was noted with five other sherds being rim sections. The site is likely to be domestic rather than funerary especially if the combination of building stone and iron slag is associated with the pottery.
