SWATON CROSSROADS EVALUATION EXCAVATION

## EVALUATION EXCAVATION ON LAND NEXT TO SWATON CROSSROADS, HORBLING, LINCOLNSHIRE

Work Undertaken For Lincolnshire County Council

Report Compiled by Mike Jarvis February 1994

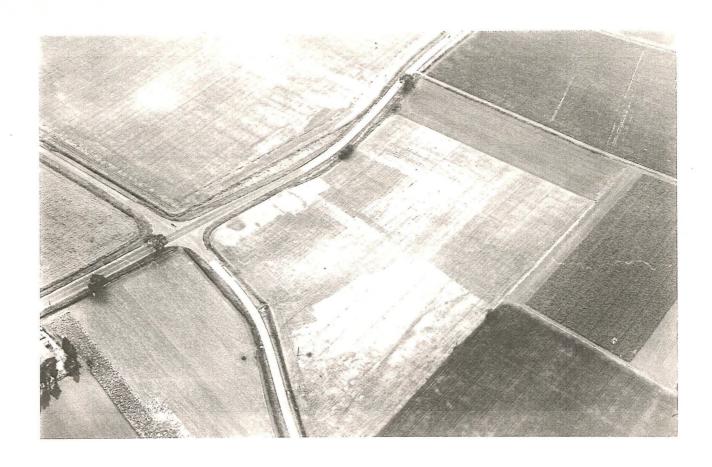
Fig. 7 Aerial View of Swaton Crossroads, looking southwest

Structures of a prehistoric date are known to exist in the general vicinity of the road junction. At least one Bronze Age barrow (NK61.11) lies in the field directly north of the site (Fig. 7). Another barrow (NK61.15) is situated 100m northeast of the investigation area. Ring ditches (NK61.13), apparently further barrows, are located c. 1km north of the crossroads.

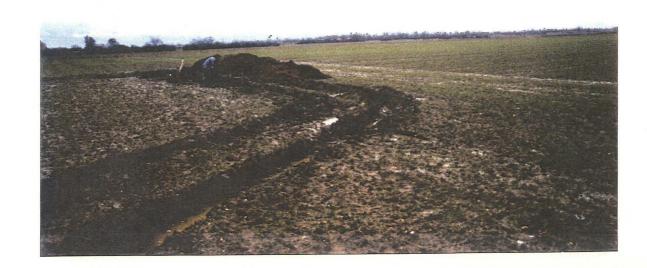
Fig. 9 Excavation in Progress: Trench C looking north

Two features cutting the natural gravels were observed in Trench C (Fig. 6). Both were large, one (030) being over 2m wide and c. 0.6m deep, the second (016) being approximately 3m wide and 0.7m deep. Both are interpreted as quarry pits (Fig. 9).

The infill deposits of these quarries are not single events but several, including recutting, this re-excavation serving an unknown function.

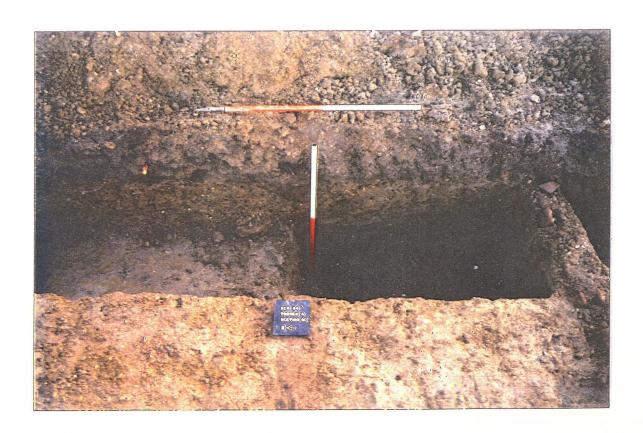
The truncated remains of a c. 2.5m wide, flat-bottomed pit (065, 078; Fig. 10) with a highly organic infill (064, 072) was recorded in Trial Trench A (Fig. 4). No pottery was recovered from these fills though a few fragments of animal bone, along with pieces of wood (species unknown) were present.

Fig. 10 Trench A. Pit 78 with organic fill (see Fig. 4, Section 9)
