**St Martin's School, Hungate (Area C), Lincoln
Archaeological Evaluation**

Report

LAS Report No: 560

December 2001

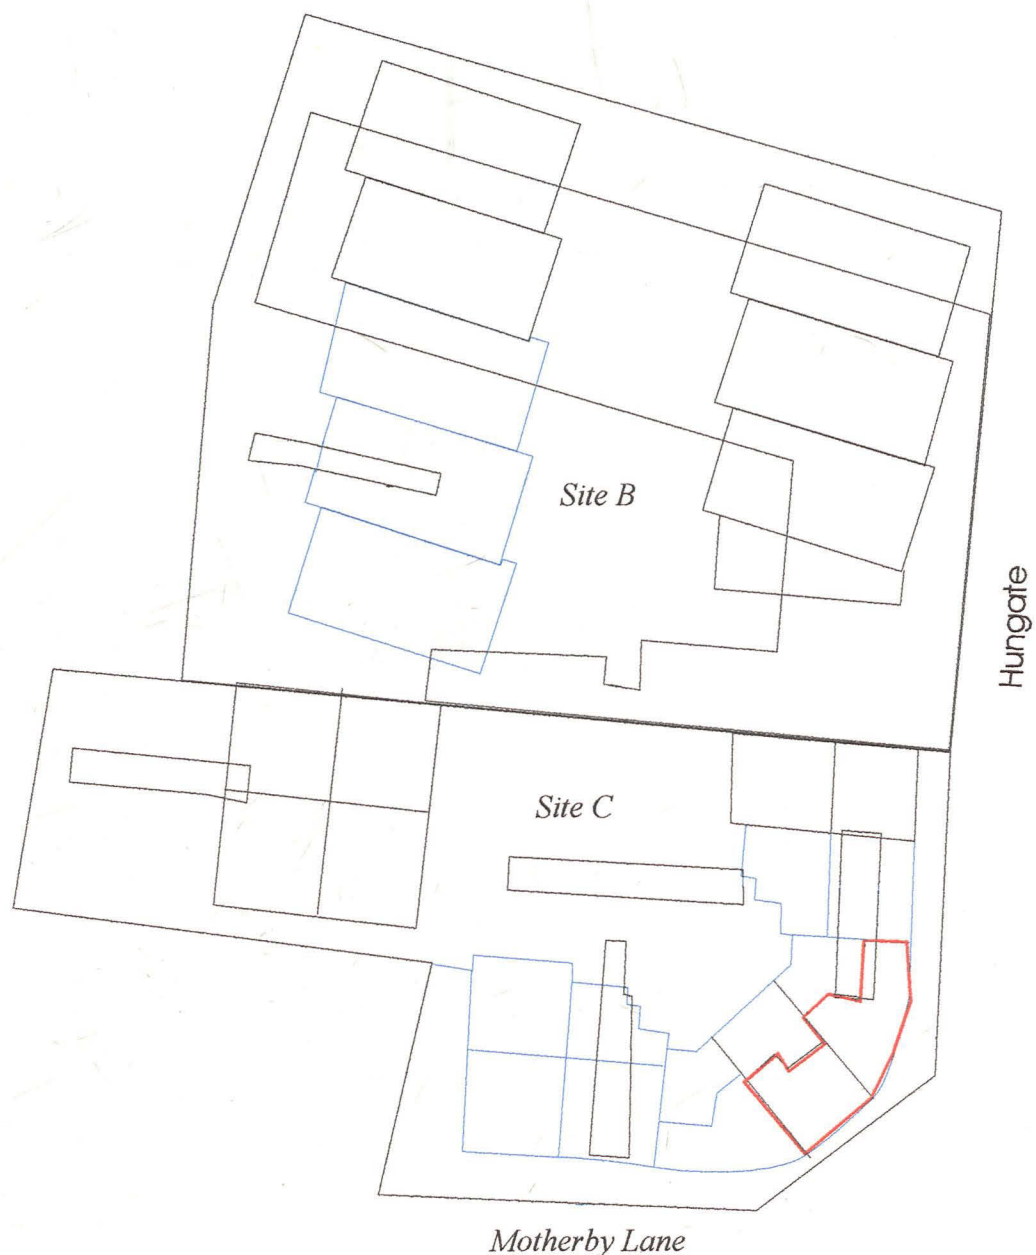
Fig. 6 Location of proposed further archaeological works

Ground beams 650mm below the finished ground level will be excavated between the piles (Fig 4). There is one area where the excavation of the ground beams will have a potential impact on the archaeological deposits (Fig 6).

The ground beam excavations on the front portions of Units 2 and 3 may penetrate sensitive archaeological deposits. Units 1 and 4 may also be affected to a lesser extent but the extrapolation of archaeological levels to the corner of Hungate and Motherby Lane is particularly difficult, given the drop in modern ground levels and it is not known where important archaeological deposits may lie.

The remainder of the site will be subject to an archaeological watching brief as follows, except where it can be demonstrated that no disturbance to archaeological deposits will occur. While the excavation described above should have dealt with all of the high potential impact areas Units 1-7 are considered to be at medium risk (Fig. 6).

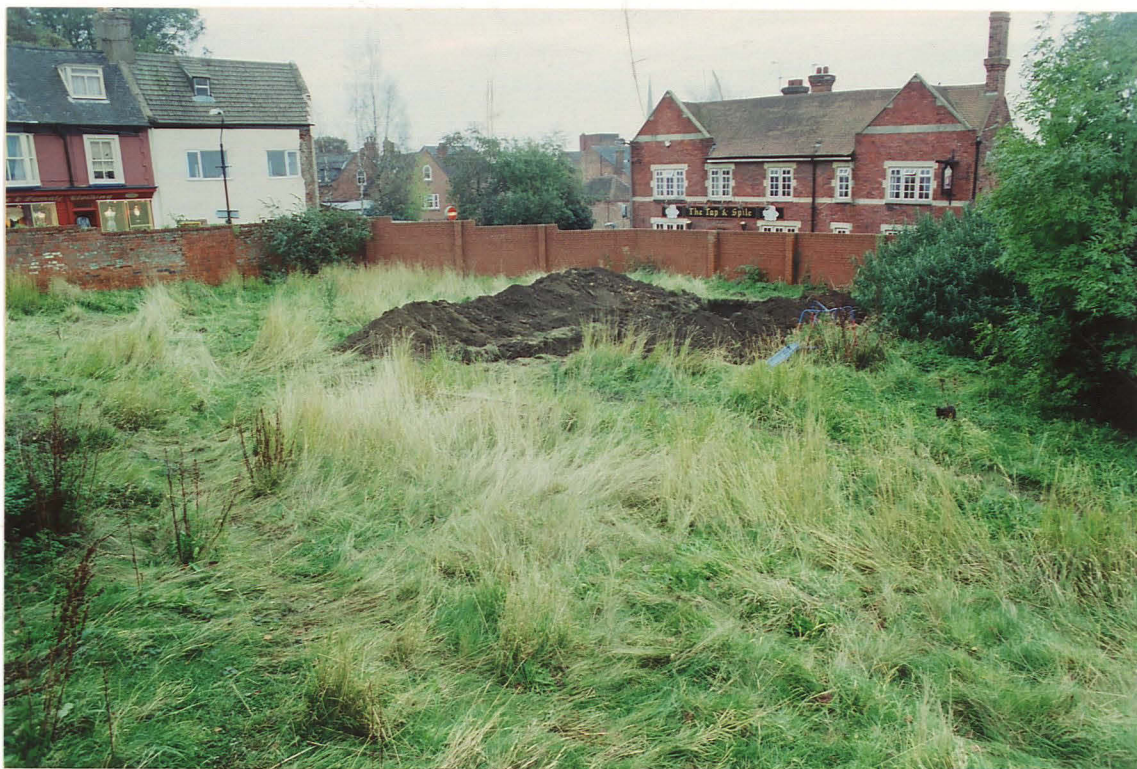
Pl. 1 General view of the site looking south-east showing Trench 1

Trench 1 (Pl. 1) was positioned in the south-eastern part of the site, perpendicular to Motherby Lane and located to investigate both the possibility of structures fronting onto Motherby Lane and whether any former line of Motherby Lane lay within the development site. It was 12m x 1.6m in area and was excavated to a depth of 1.20m at the northern end and 1.52m deep at the southern end.

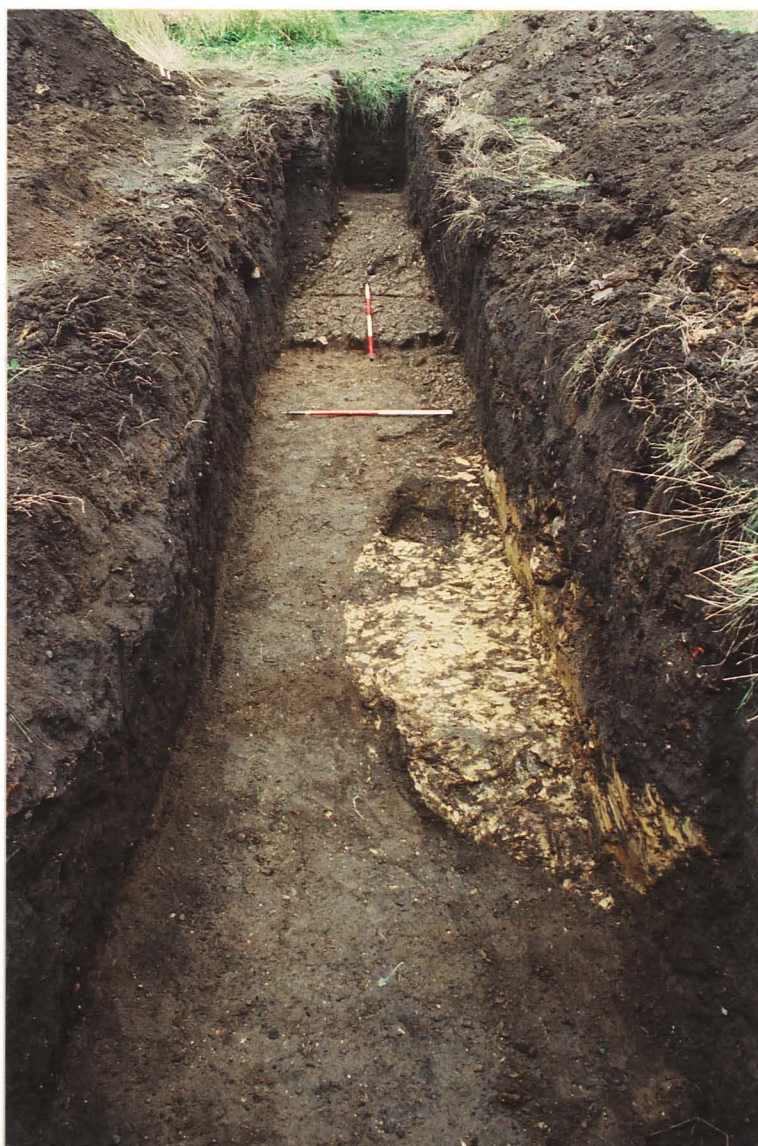
Pl. 2 Trench 1 looking north showing pit 124 in foreground

Cutting deposit **105** to the south was another large pit **124** (Pls 2 and 3). It had near vertical

sides and was filled with a stiff yellow clay **116**, which appeared to be natural. Borehole information suggests that the natural clay is at least 3.80m below the present ground surface (see Appendix 3) and it is not clear whether the clay was in fact imported from elsewhere and used to seal deposits beneath or if the pit was dug into the natural clay below because the pit could not be fully excavated. The upper part of the pit had then been dug into on at least four separate occasions. The earliest of these intrusions was **122** which contained large blocks of limestone, too jumbled to be wall foundations. This pit was cut through on its north side by **121** and to its south by **124**. The last of the pits, **120**, cut through the top of **121**. Pit **124** cut through two layers on its south side, **118**, a mid grey sandy clay with charcoal and **132** above.

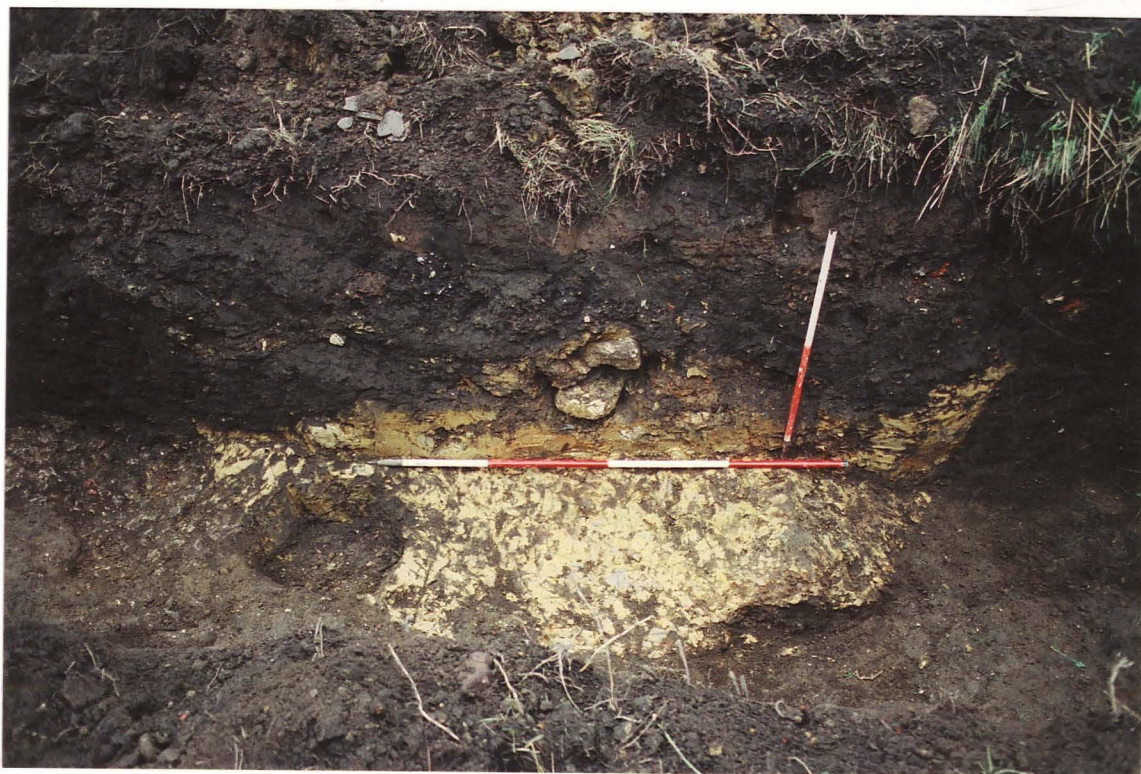
Pl. 3 Trench 1 close up of pit 124 with later pit cuts 120, 121, 122 and 123 above

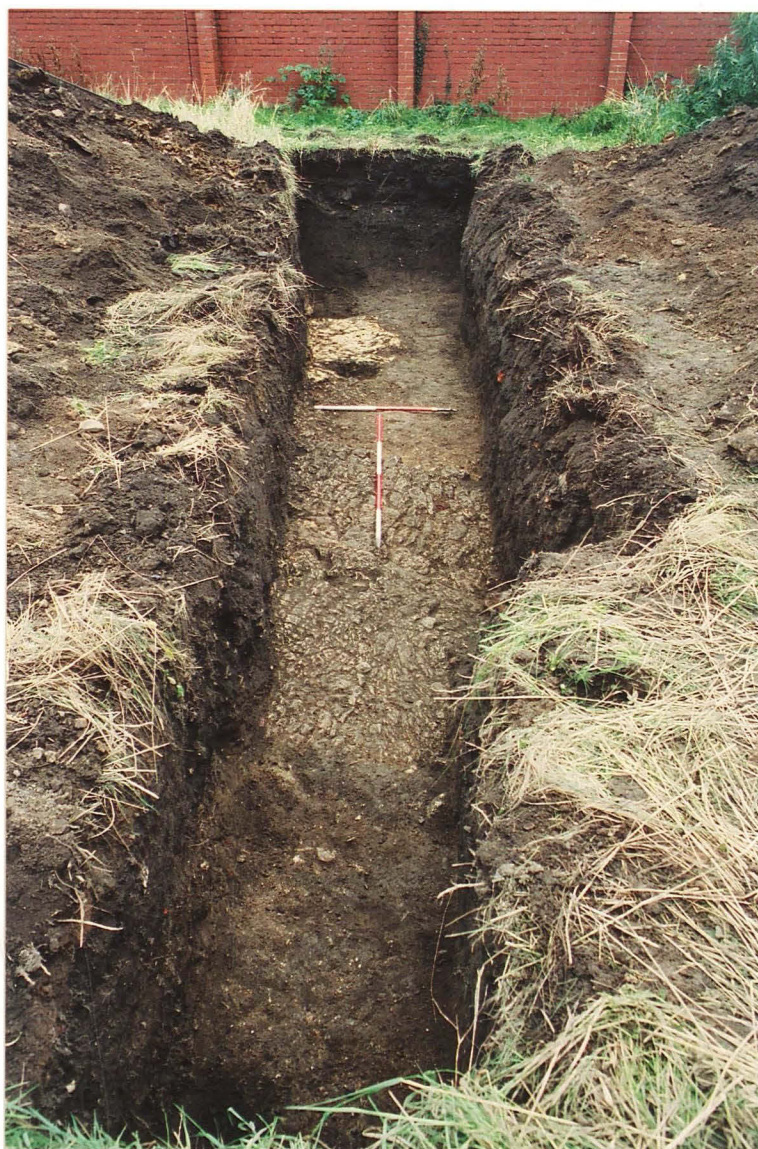
Pl. 4 Trench 1 looking south, showing cobbled surface 103

At the base of the trench near its centre was a cobbled surface **103** (Pls 4 and 5). There was a slight depression on the cobbled surface, running east-west across the full width of the trench, filled with a pale brown silt **114** (Pl. 5). A similar feature was noted on a cobbled crewyard surface found during excavations in 1985 on the opposite corner of Hungate at its junction with St Martin's St and was interpreted as a drainage feature.

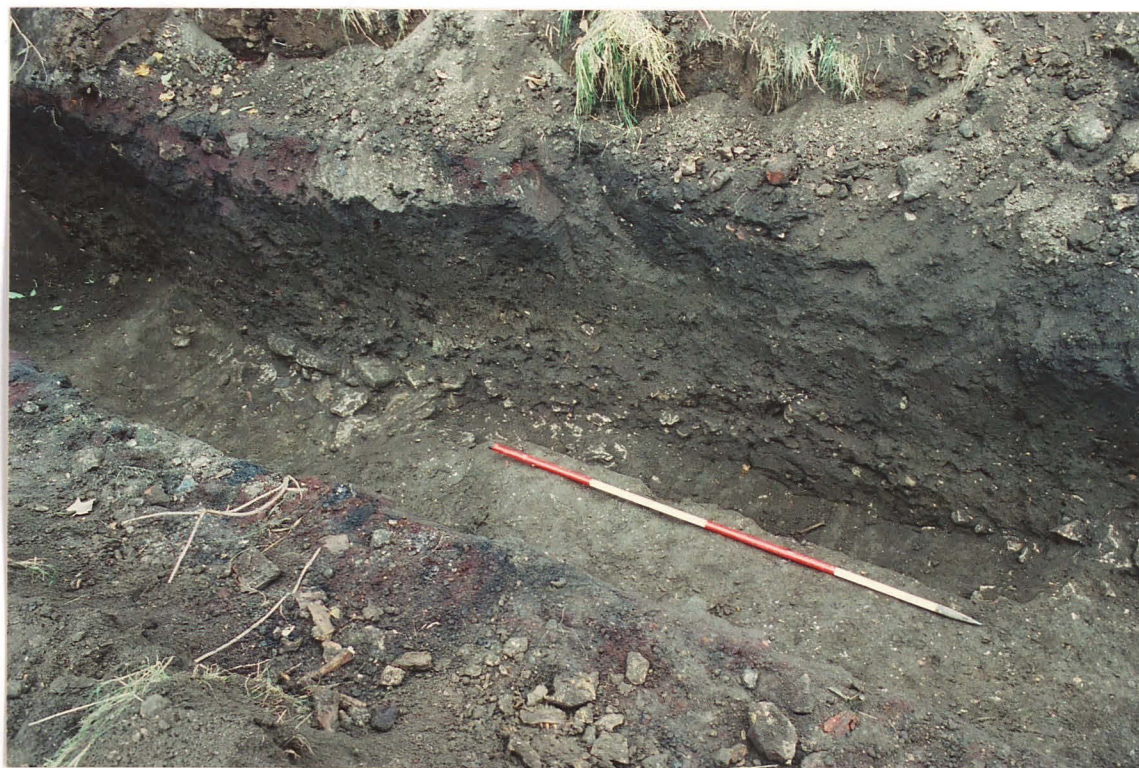
Pl. 7 Trench 2 view looking west with limestone rubble tip 208 in foreground

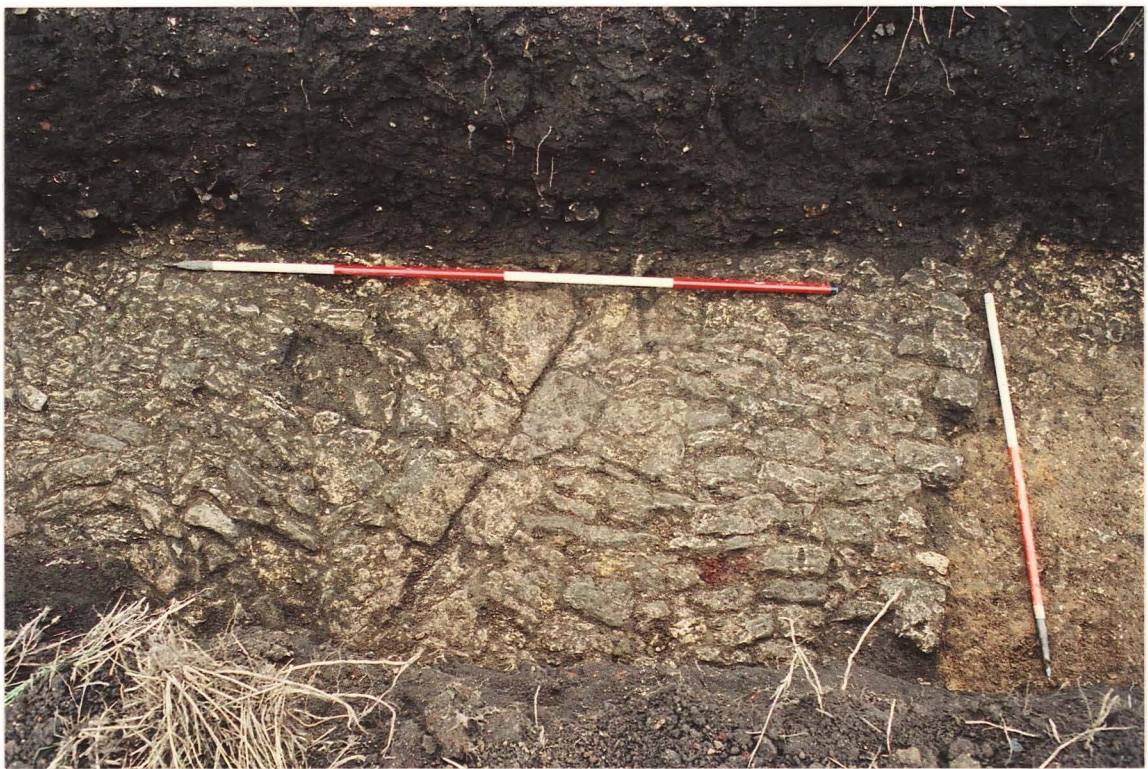
Pl. 8 Trench 2 Section at west end of trench showing tip lines running towards robbed out wall 204 (left)

To the west of wall **204** were two deposits of mid brown sandy clay **214** and **215**, quite different in character to the deposits on the east side of **204** (Pl 8). This suggests that **204** was a wall, not just a rubble dump, but whether a retaining wall for terracing or part of a building was impossible to determine within the small trench excavated. However, it is of note that **204** is almost in line with the extant terrace wall to the north.

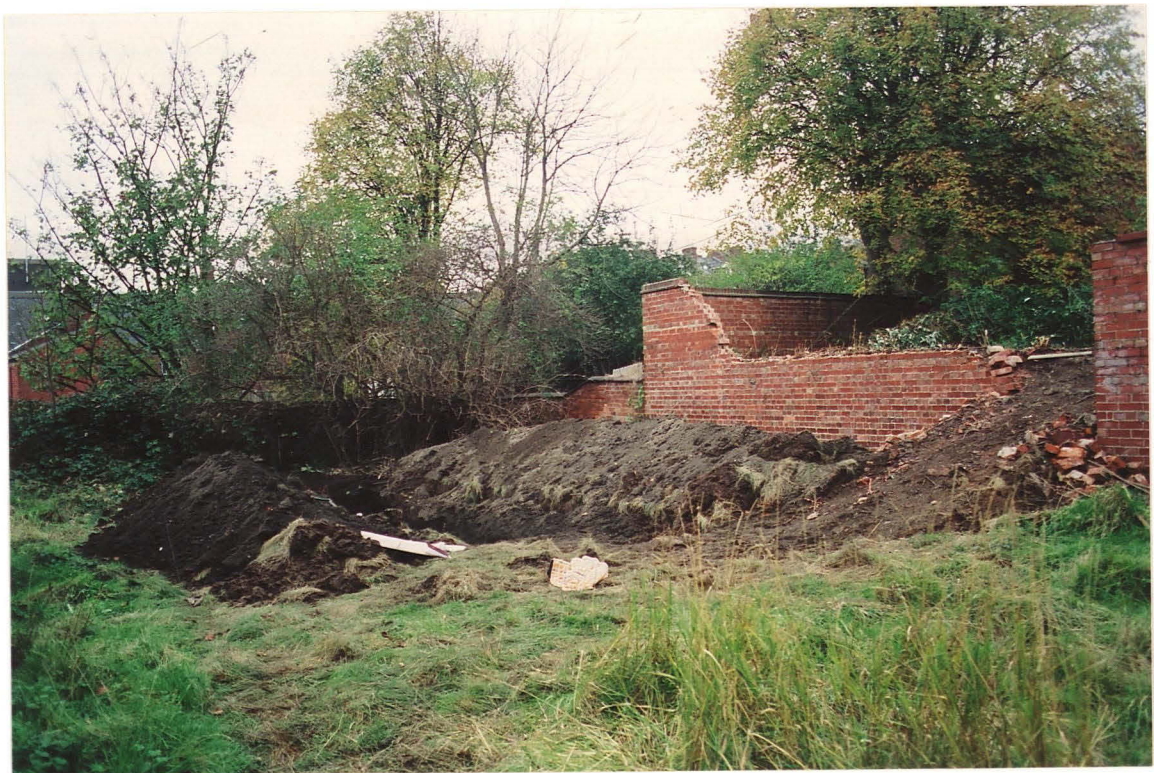
Pl. 5 Trench 1 close up view of cobbled surface 103 and drain through centre, with earlier metallised surface 130 top right

The cobbling was bedded on a thin mortar layer **129** which overlay a sandy silt **128** containing pottery of 16th -17th century date. Beneath **128**, and to the south of cobbles **103** was a rough irregular metallated surface **130**. Much of this surface had been removed by the excavation of pit **124** but a small sondage excavated south of the pit established that the cobbles **130** were present 0.30m below the base of the excavated trench and were falling with the slope of the hill towards the southern edge of the trench.
