Bicker, land off Drury Lane and Friest Lane

Archaeological Watching Brief [Plots 2, 3 and 5]

LAS Report No. 568

January 2002

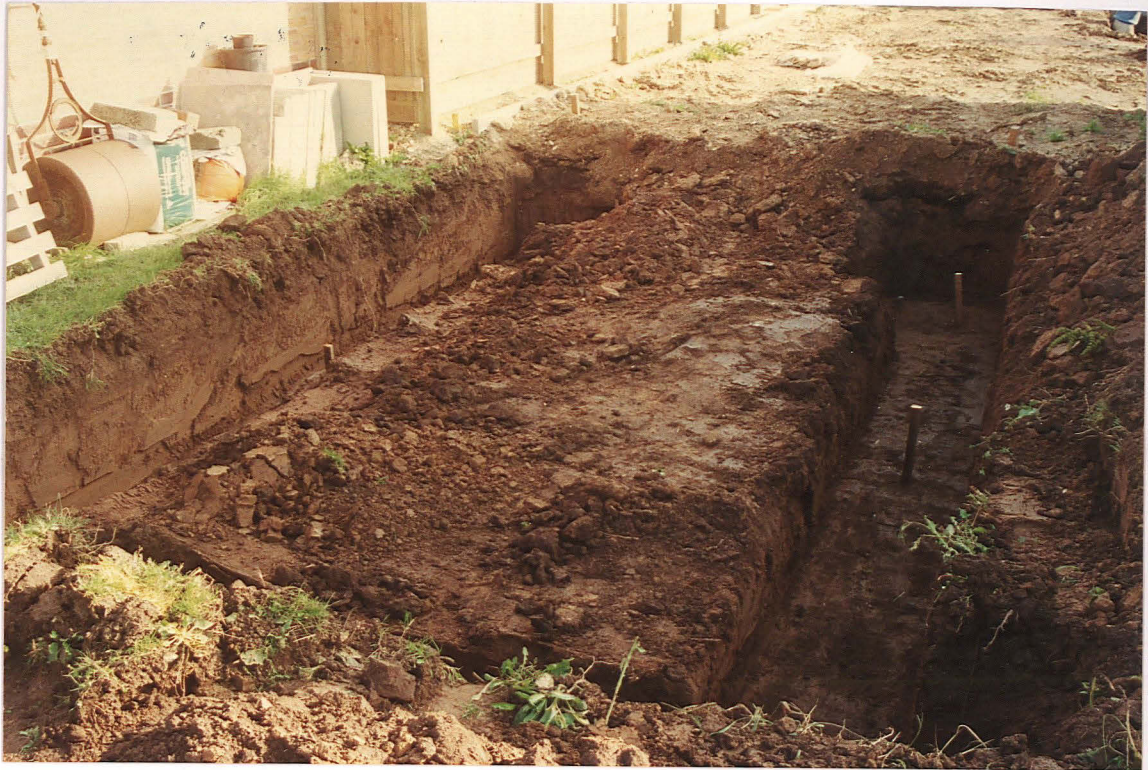
Pl. 1 Foundation trenches for the garage, Plot 5 (looking east towards Drury Lane, with the boundary of Plot 6 (formerly Plot 10) to the left).

The 0.6m wide garage foundation trenches cut through the 0.25m thick topsoil **70** and the underlying 0.35m thick layer of light brown silt **71**. Beneath this was a 0.1m thick discontinuous layer **72** of wood ash fragments mixed with silt, similar to a deposit seen elsewhere on the development site. Below this was a further thick deposit of light brown silt **73**, extending below the base of the 0.75m deep trench.

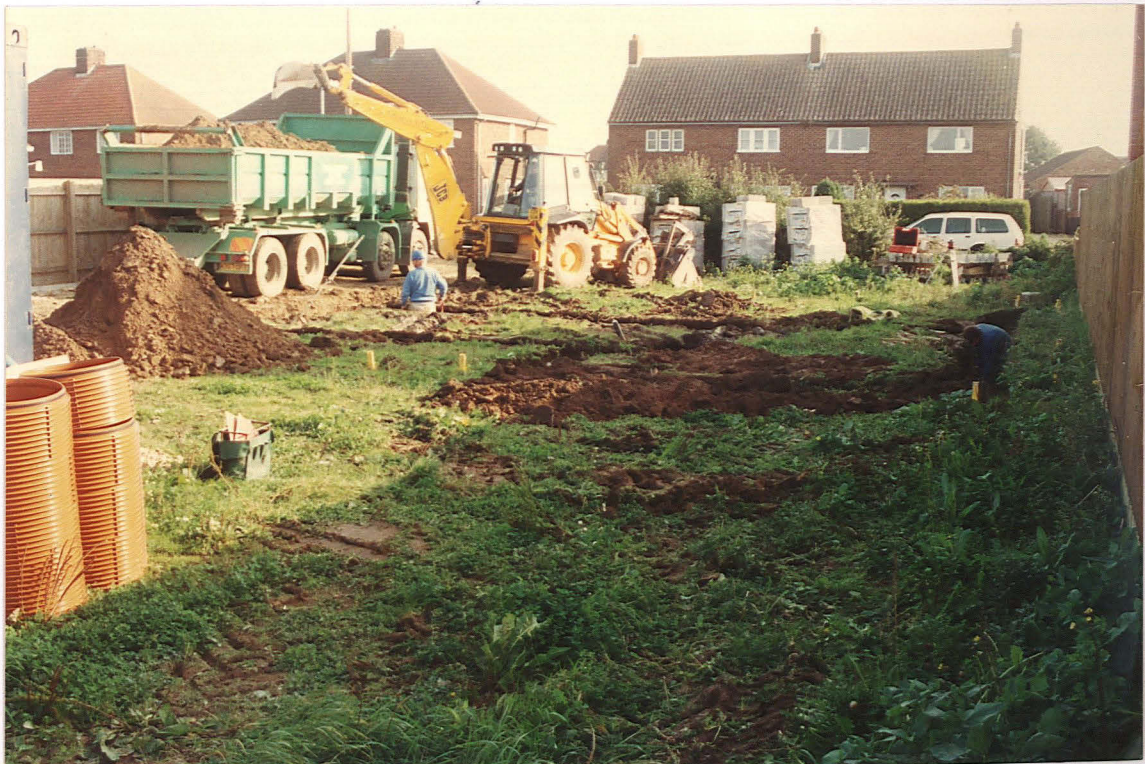
Pl. 2 Excavation of foundation trenches for Plot 5 (looking east to Drury Lane)
