OSBOURNBY THE DROVE WB

**ARCHAEOLOGICAL WATCHING BRIEF  
OF A WATER PIPELINE AT  
THE DROVE,  
OSBOURNBY,  
LINCOLNSHIRE**

Work Undertaken For  
Anglian Water Services Ltd.,

March 1994

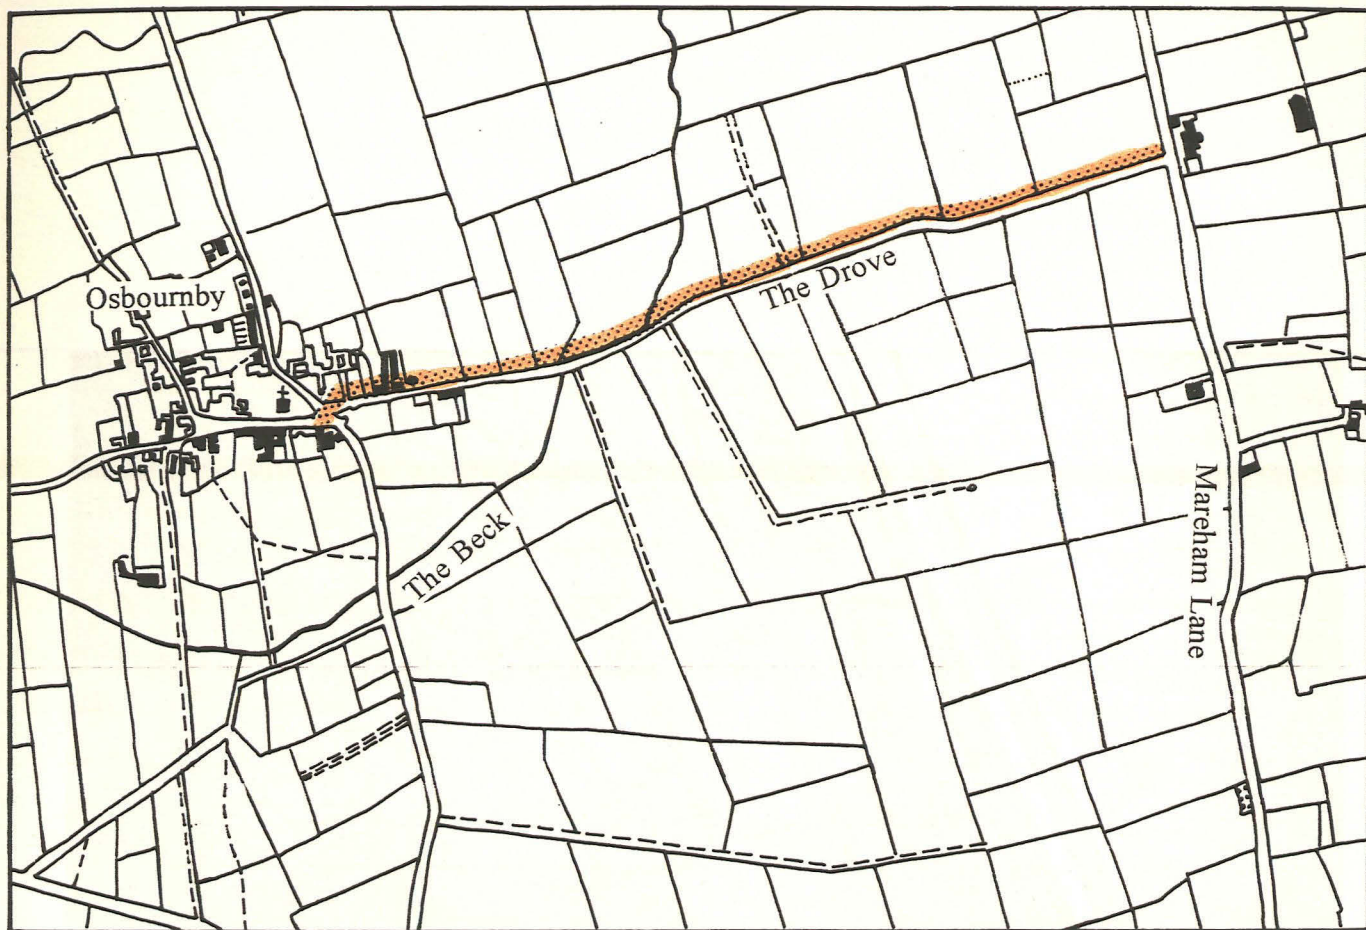
Fig. 3 CROPMARKS CROSSED BY THE DROVE, OSBOURNBY

Towards the eastern end of The Drove, aerial photographs record cropmarks that represent enclosure complexes (Fig. 3). On morphological grounds, these enclosures could be late prehistoric or Romano-British. However, the later date is suggested by finds of Roman artefacts, including a brooch and pottery (SMR) from the general location of the cropmarks. Mareham Lane, which provides the terminus of the pipeline, preserves the line of a Roman road.

*The watching brief identified The Drove as a probable causeway road, built up above the surrounding countryside. Soil layers, interpreted as road make-up, were found to be uniform along the length of the pipeline and no archaeological deposits were recognised, nor artefacts recovered. The pipetrench did not extend through the full depth of the embankment. Consequently, archaeological remains, including the enclosures recorded on aerial photographs, were neither seen in, nor affected by, the pipeline excavation.*

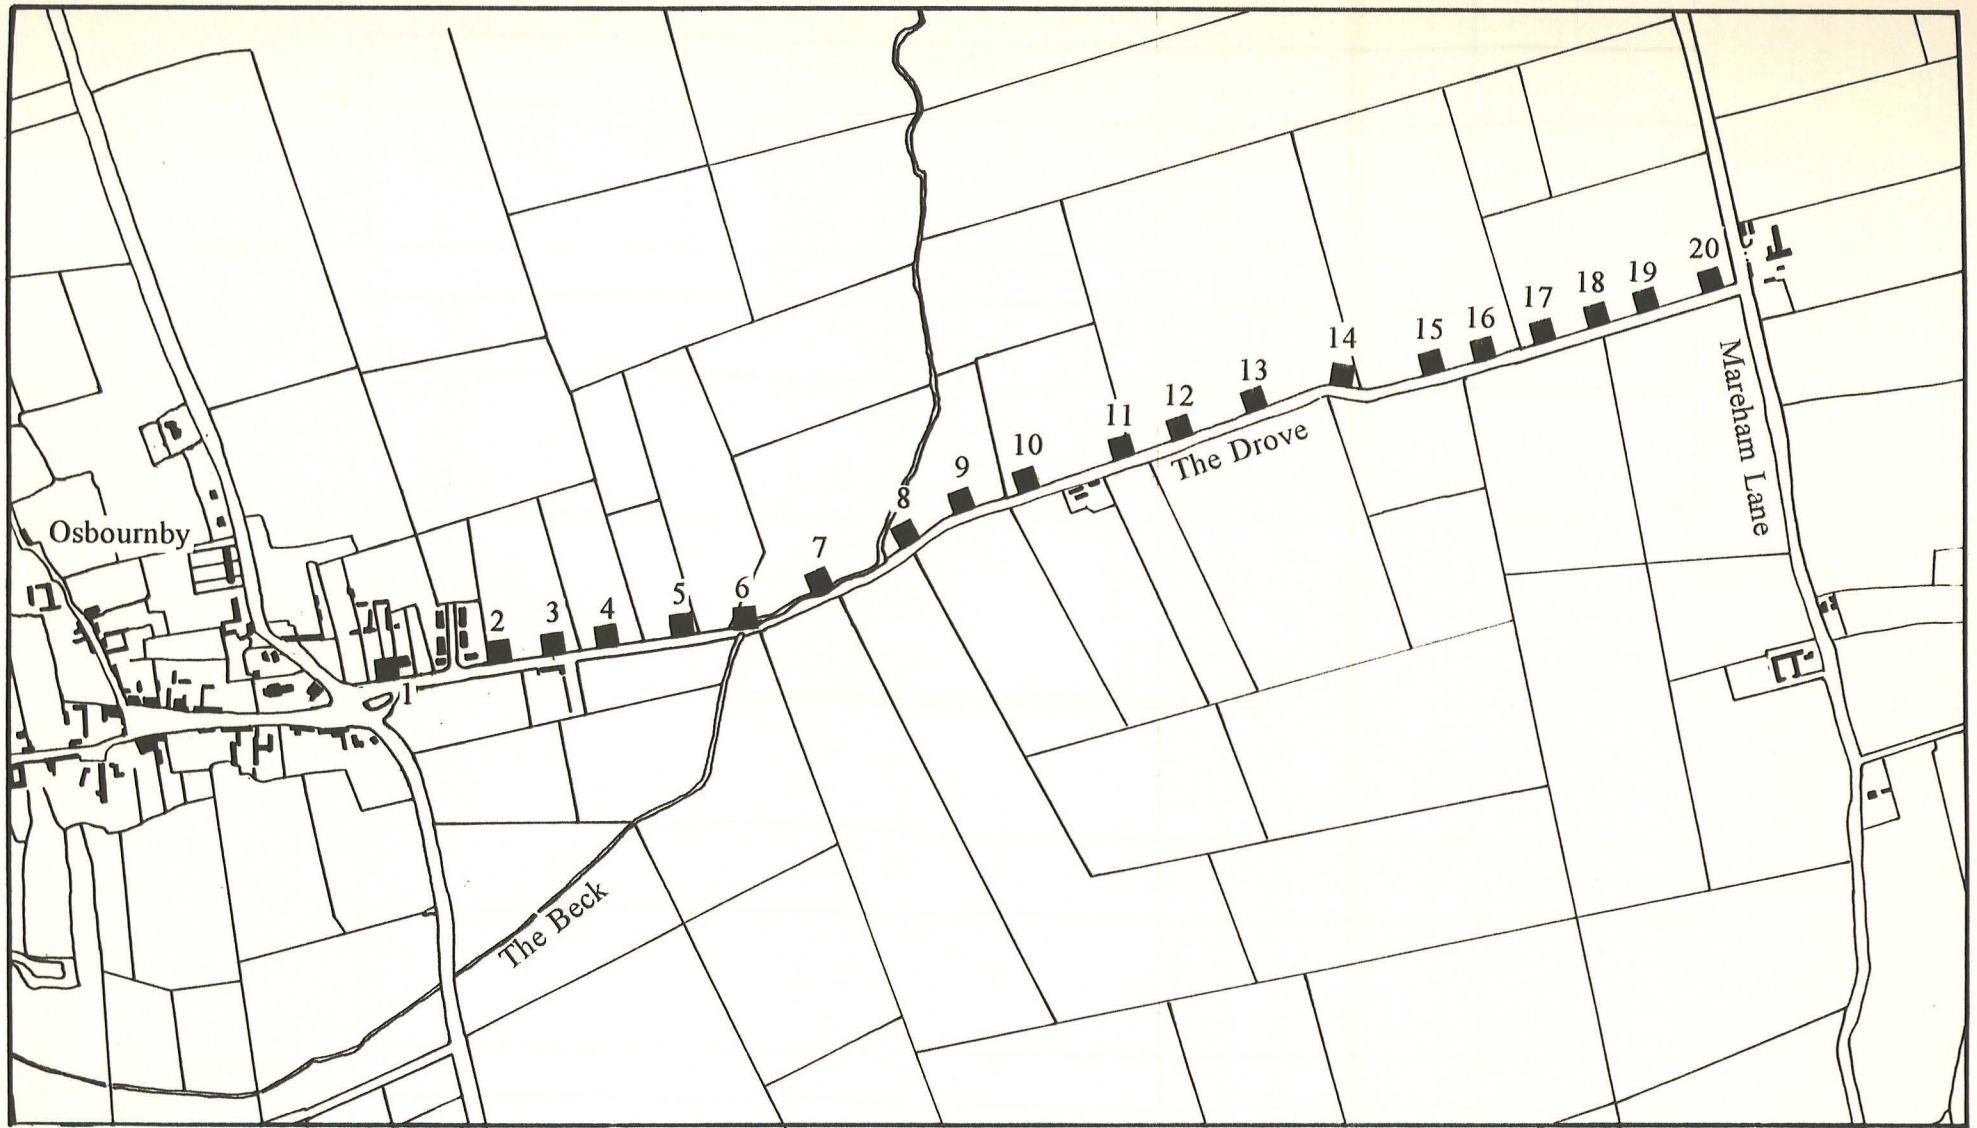
Fig. 4 LOCATION OF RECORDED SECTIONS

■ LOCATION OF RECORDED SECTIONS  
(not to scale)

measured 0.60m wide, 0.90 deep and approximately 1.9km in length. See Fig. 4 for the location of the recorded sections.
