ARCHAEOLOGICAL WATCHING BRIEF REPORT; PLOT 3, LEGSBY ROAD, MARKET RASEN, LINCOLNSHIRE

> NGR: TF 1136 8846 SITE CODE: LGMR01 LCNCC ACC. NO: 2001.445

> > Report prepared for Leen Valley Designs by Chris Clay December 2001

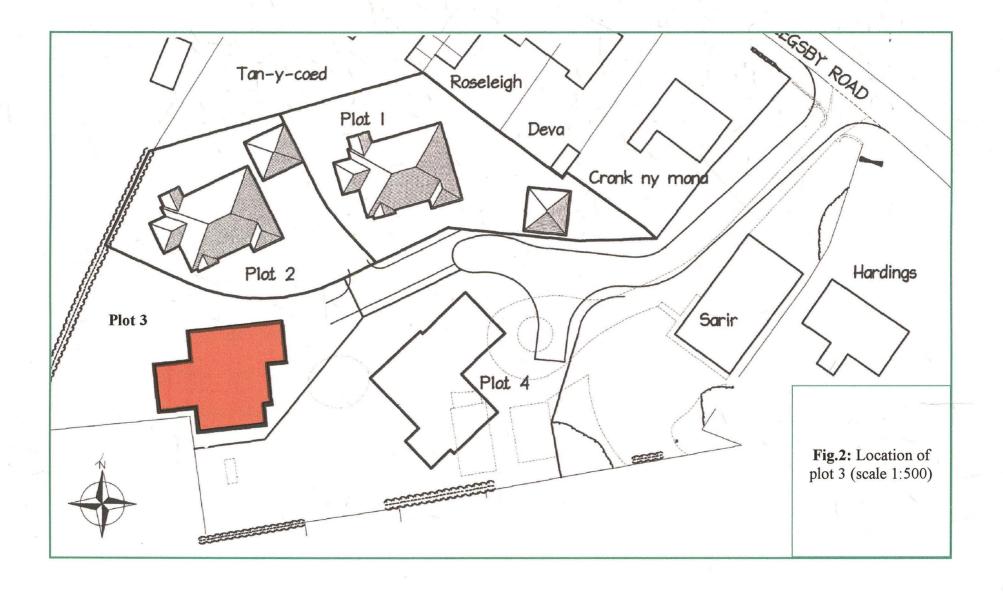
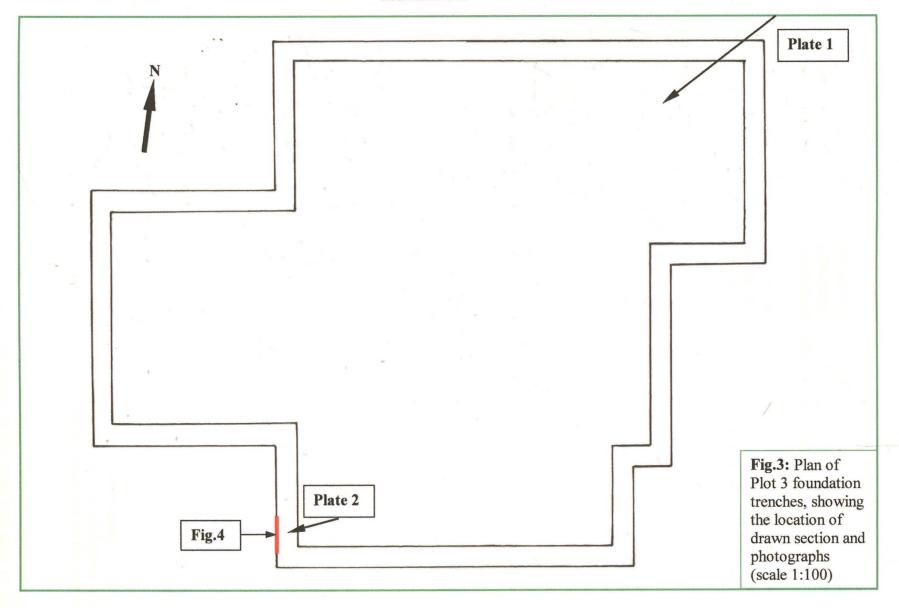
- Fig 1: Site location (scale 1:25,000)
- Fig.2: Location of Plot 3, (scale 1:500)
- **Fig.3:** Plan of Plot 3 foundation trenches, showing the location of drawn sections and photographs (scale 1:100)
- Fig.4: Representative section drawing of stratigraphic sequence (scale 1:20)

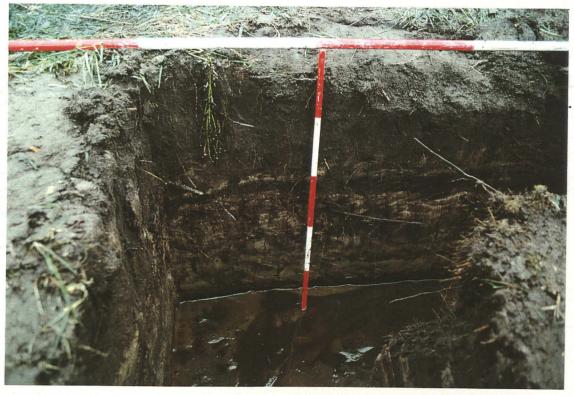
Plate 2: Representative shot of stratigraphic sequence, looking west-south-west

The stratigraphy was uniform throughout the plot. The uppermost deposit was a dark grey/brown topsoil, (001), with abundant root disturbance (resulting from the former orchard). This deposit had a maximum depth of 0.35m, and sealed a 0.2m thick yellow/brown sandy silt subsoil deposit, (002). This also exhibited considerable root disturbance.

Beneath (002) was a dark grey/brown sandy silt, (003), which was approximately 0.25m deep and was interpreted as a former topsoil. This sealed (004), a yellow/brown buried subsoil deposit, which in turn sealed (005), a natural wind blown sand that is common to this area. No dating evidence was retrieved from any of the exposed deposits.
