Horncastle, Pentecostal Church Archaeological Watching Brief

Horncastle Pentecostal Church

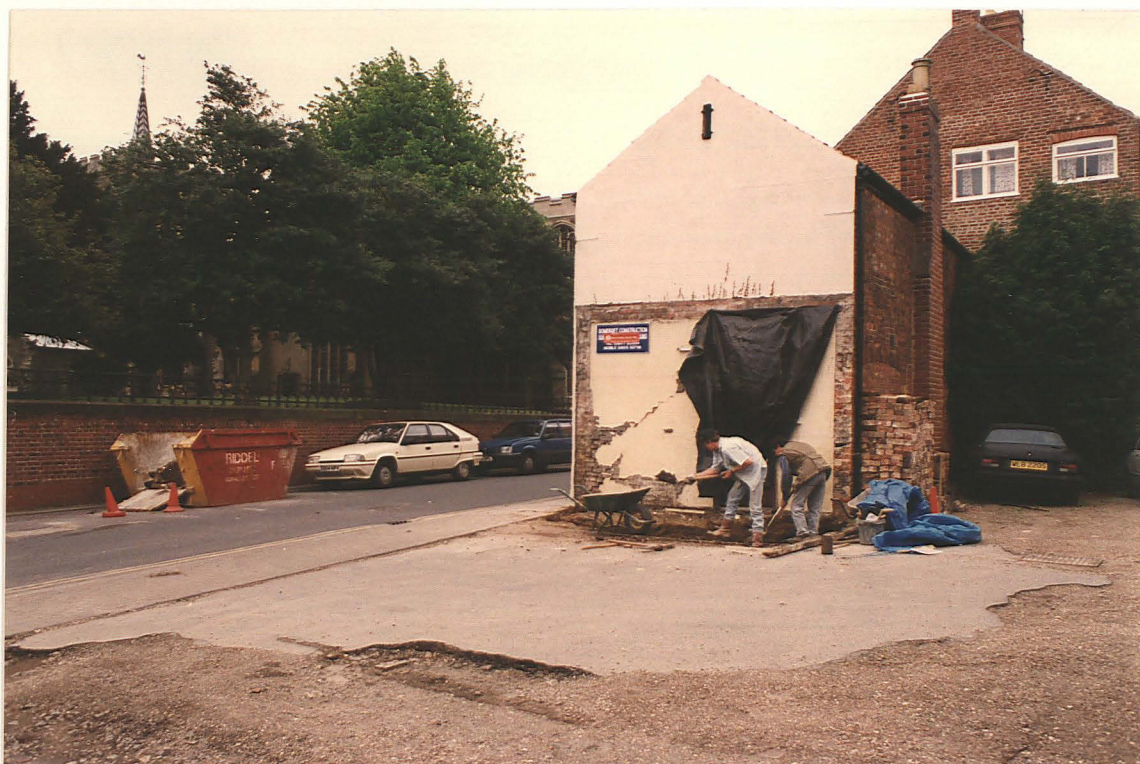
Pl. 1 7 Church Lane, Horncastle. Looking north-west showing parish church and churchyard in background

The Assembly of God, 7 Church Lane, lies opposite the parish church and the churchyard (Pls. 1 and 2). The site is situated inside the area of the Roman defences and when the churchyard wall was replaced in 1985 disturbed remains of an internal rampart were recorded (Fig. 1). It was anticipated that further evidence of the rampart might be found during construction of the extension to the Pentecostal church.

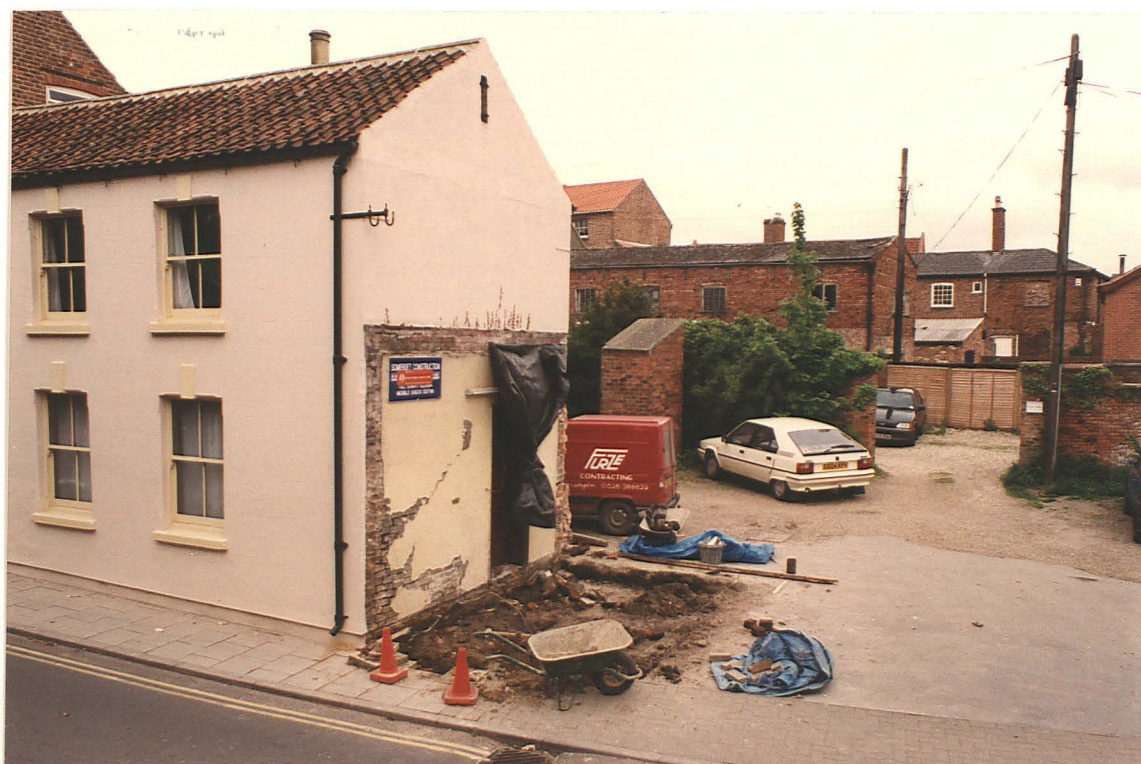
Pl. 2 7 Church Lane, Horncastle. View east

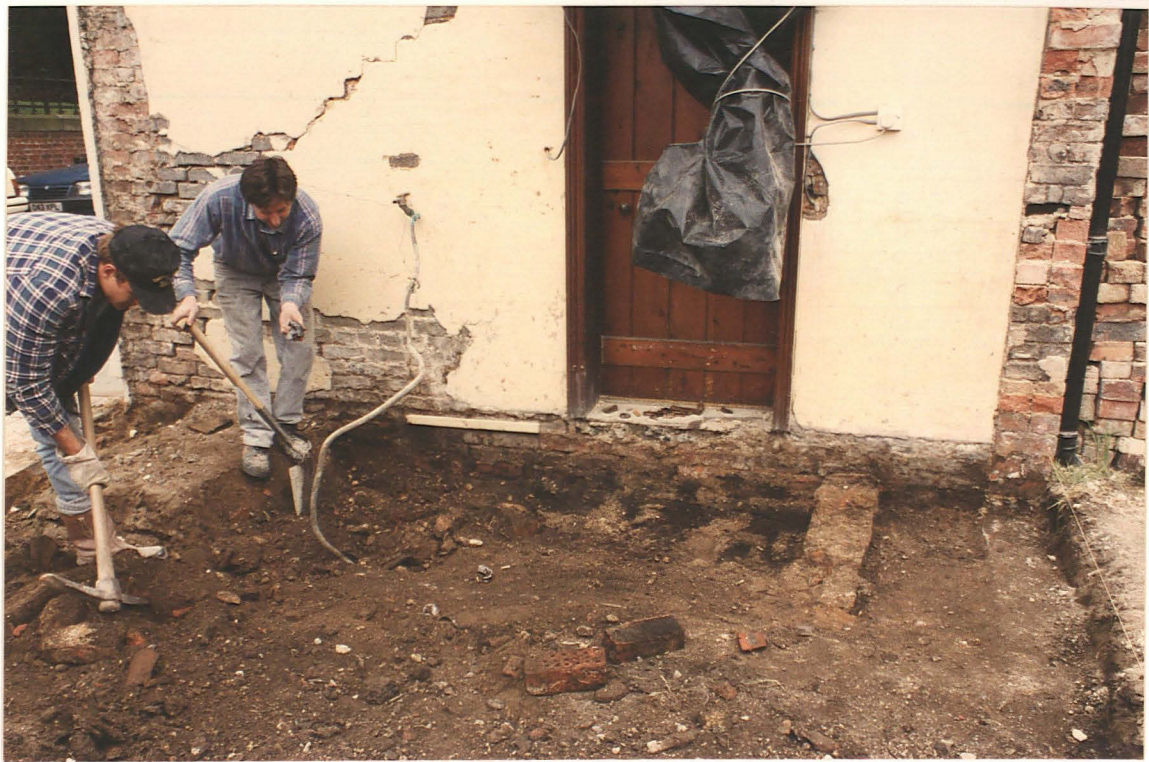
Demolition of the lean-to and removal of its concrete floor took place prior to the site visit. Preparation of the site comprised clearance of the ground to a depth of 0.2 m below present ground surface before digging out foundation trenches 0.6 metres wide by 0.6 metres deep. Inside the former lean-to the top 0.2m comprised a loose brick rubble base for the concrete floor. In the 1 metre wide strip beyond the limit of the lean-to the ground surface comprised tarmac with cinder make-up beneath. Clearance of this material revealed the brick footings of a former chimney stack butting the south gable wall of the standing building. Within this area which measured 1.37m deep and 2m wide, was a black sooty fill, containing clay pipe stems, animal bones and Victorian bottle glass and pottery (Fig. 2, Pl. 3).

Pl. 3 Clearance of the area to a depth of 0.20m, showing chimney footings.

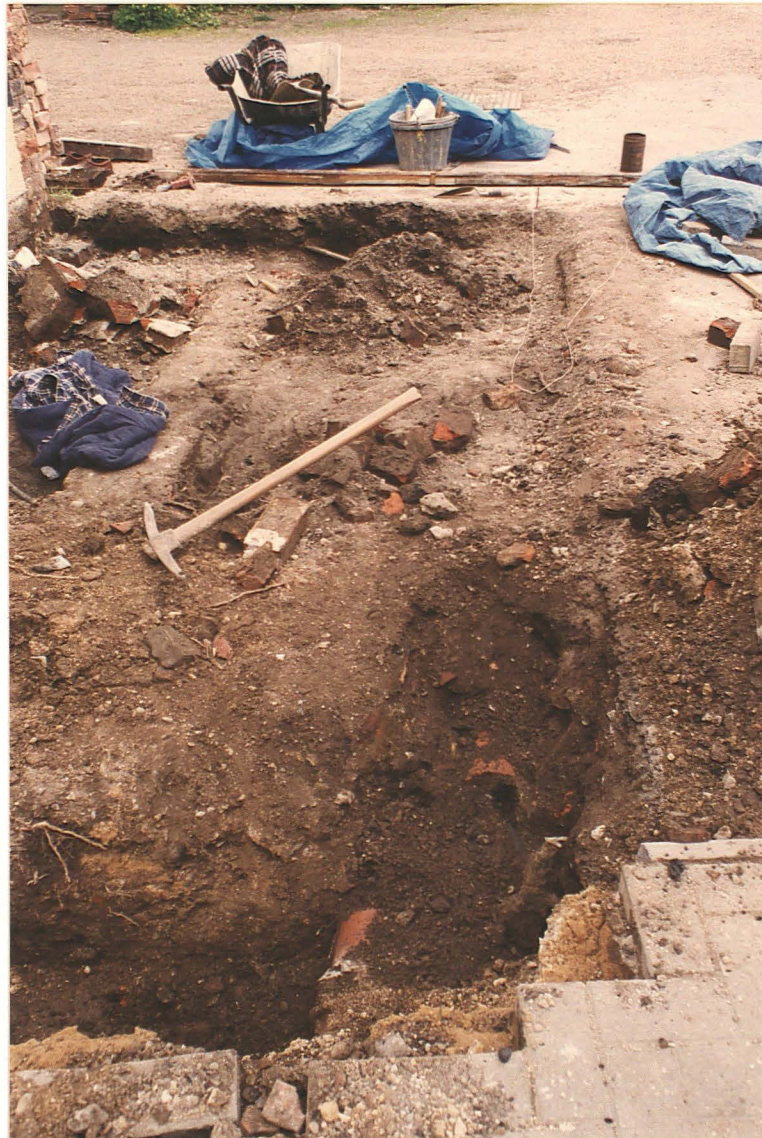
The south foundation trench was found to run along the line of a modern, ceramic pipe, drain. An electric cable was found running parallel to the pipe so all ground was previously disturbed (Pl. 4).

Pl. 4 South foundation, looking east showing drainpipe in foreground which connects to the manhole cover behind the bucket at top of the photo.

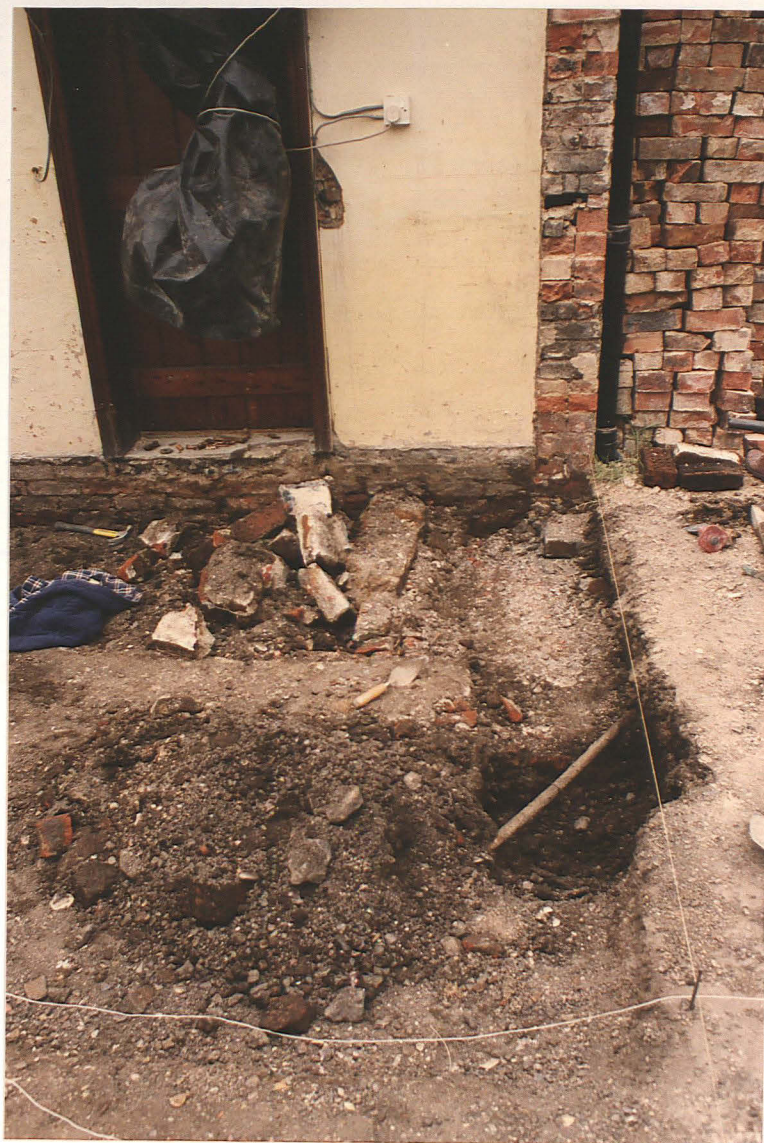
The east foundation trench was also disturbed at the north end by the brick foundations of the outshut. A former gas pipe crossed the south-east corner of the trench (Pl. 5).

Pl. 5 East foundation, looking north, showing gas pipe crossing the trench.
