**ARCHAEOLOGICAL WATCHING BRIEF
AT
LINCOLN ROAD,
LEASINGHAM,
LINCOLNSHIRE**

Work Undertaken For
Anglian Water Services Ltd.

Report Compiled By
Paul Cope-Faulkner

June 1994

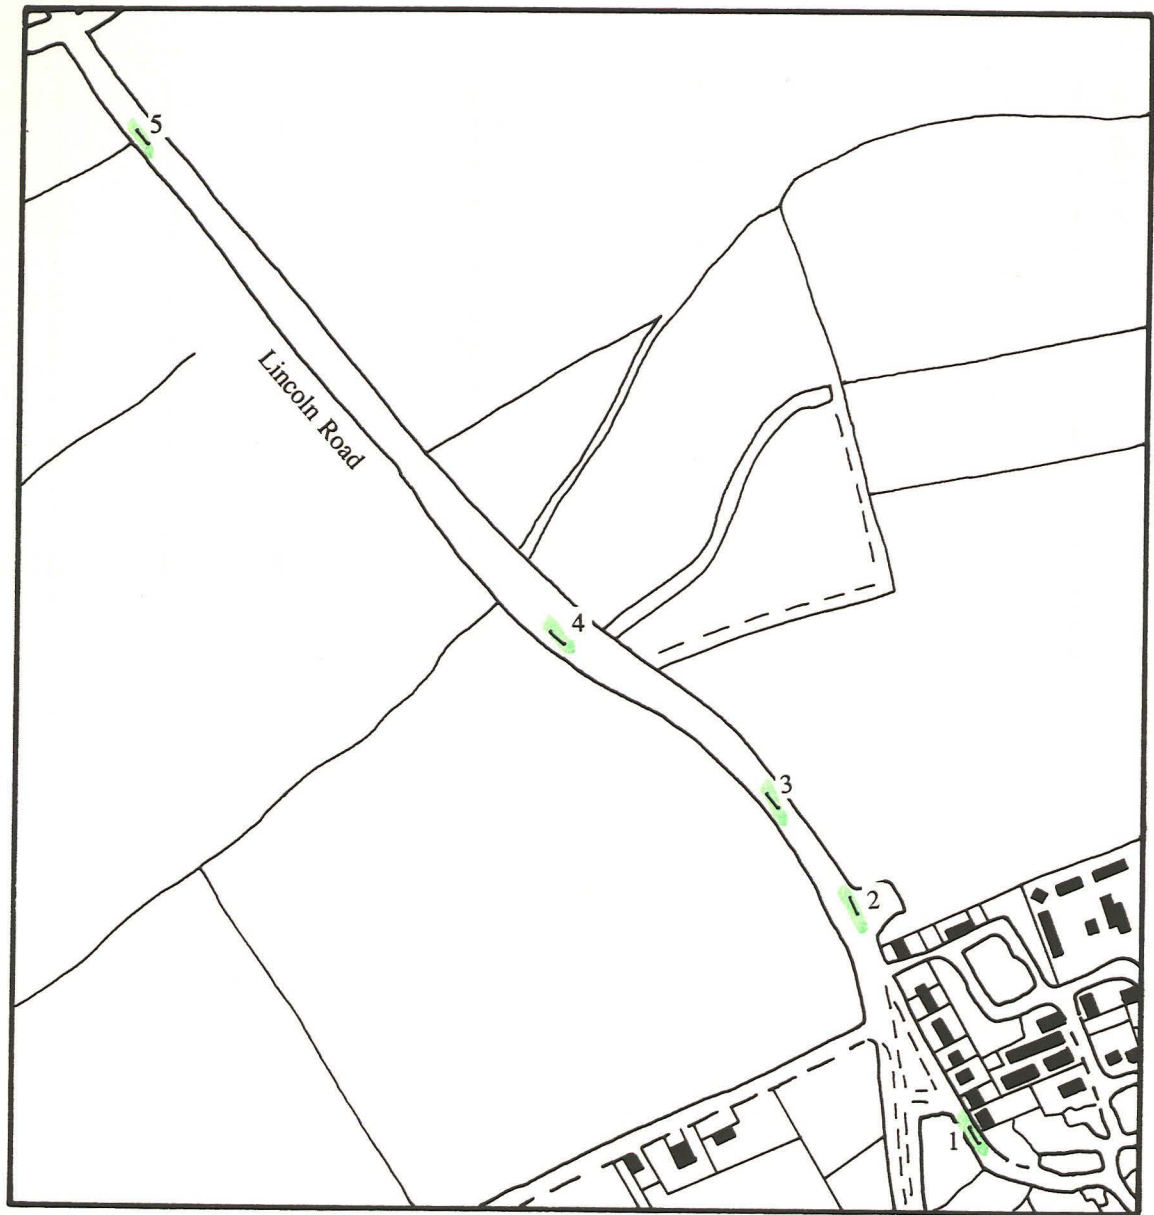
Fig. 3 Location of Recorded Sections

A mechanical excavator was used in the construction of the pipe line trench, which measured 0.6m wide and averaged 1.1m in depth. See Fig. 3 for the location of the recorded sections. The sides of the trench were cleaned by hand and inspected for archaeological remains prior to recording the sections. Each archaeological deposit or feature was allocated a unique reference number with an individual written description. A photographic record was compiled and sections were drawn at scale 1:20. Additionally, the natural geology was recorded.
