**St. Martin's Church, Welton le Wold, Lincs.**

**Archaeological Watching Brief**

**Report**

**LAS Report No. 579**

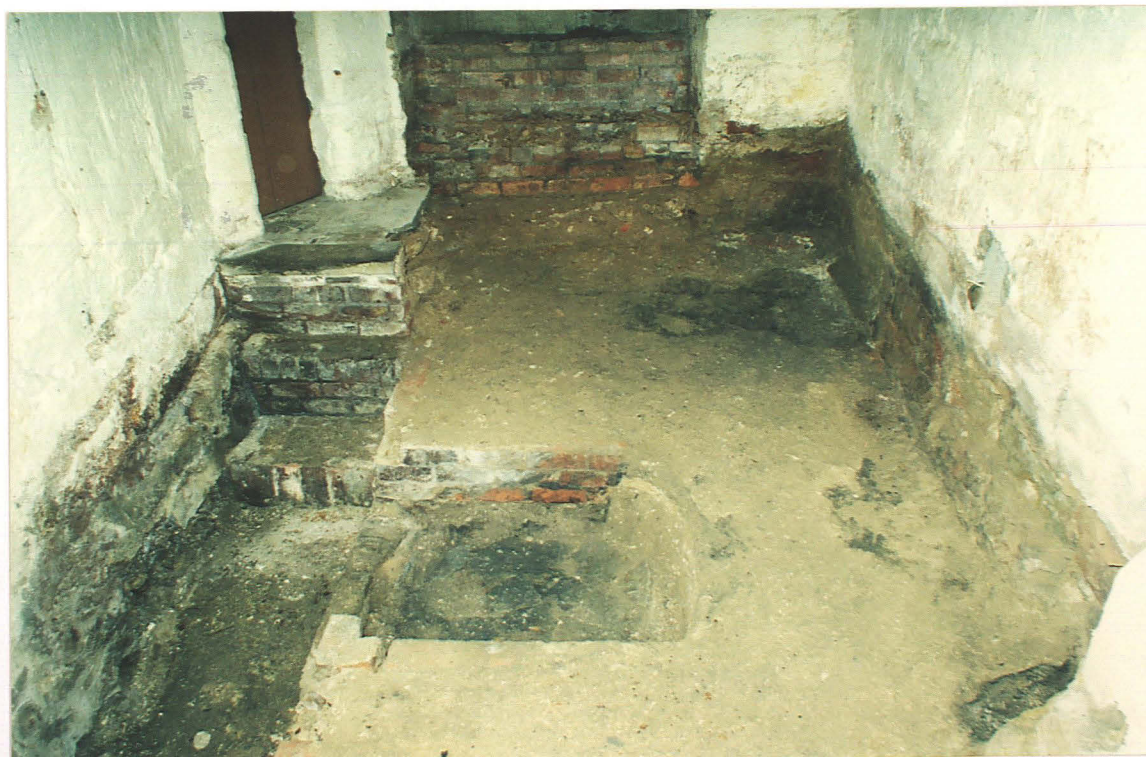
LAS had been advised that only the nineteenth century floorboards would have been lifted before the first monitoring visit was made. In practice, the area inside the tower had been lowered by about 0.7m, which was described as having been loose material below the removed floor (Pl. 2). The builders reported that the floor had been supported on joists, laid irregularly on the loose fill which incorporated mortar and brick fragments. Pieces of window glass of post-medieval date were also present.

Pl. 2 Tower interior after removal of rubble beneath floorboards, looking west. Note brick steps leading to boiler, left and coal bunker in centre of floor. Area of burning in top corner may indicate position of stove.

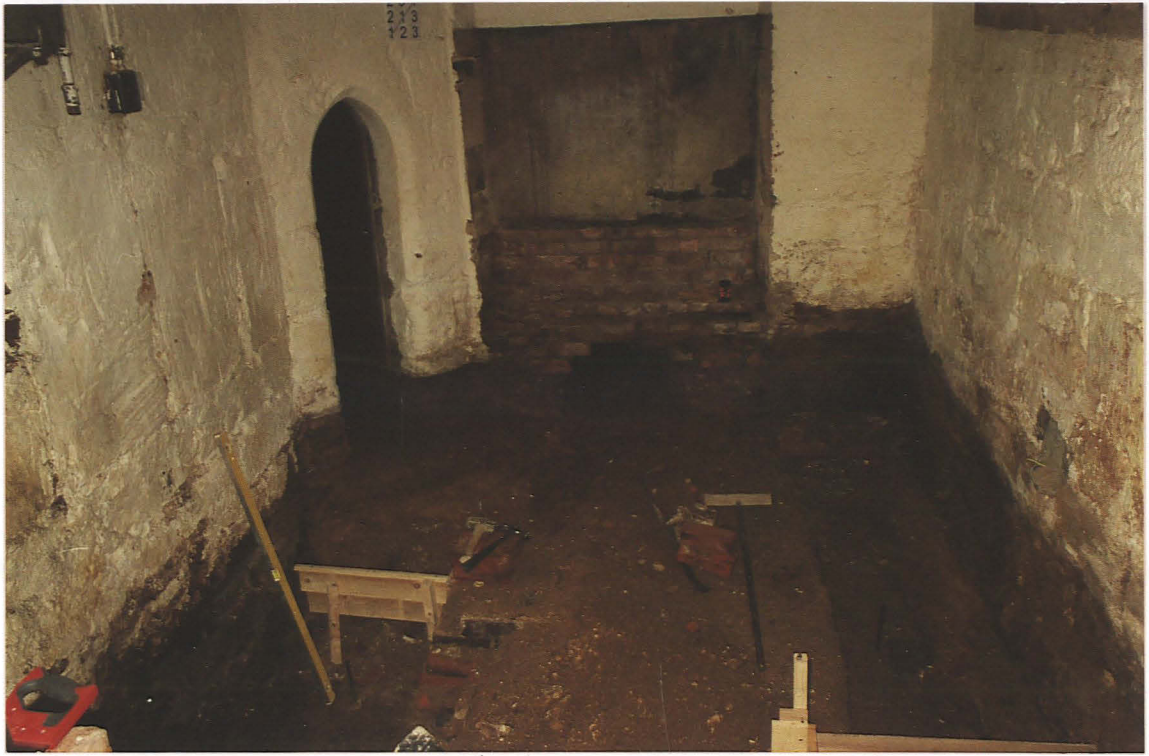
Removal of the loose deposit below the tower floorboards revealed the offset foundation for the north wall of the tower which rose in height towards the east end of the wall (Pls 3 and 5). At the SW angle of the tower, the wall foundation respects the stair turret (Pl. 4). The edge of the foundation trench for the north and west walls of the tower was 0.30m wide. The foundations at the tower arch are of one build with the tower (Pl. 6).

Pl. 3 Tower interior after removal of brick steps, revealing original threshold to tower stairs, looking west. Trench for services has been dug out along north wall (right).

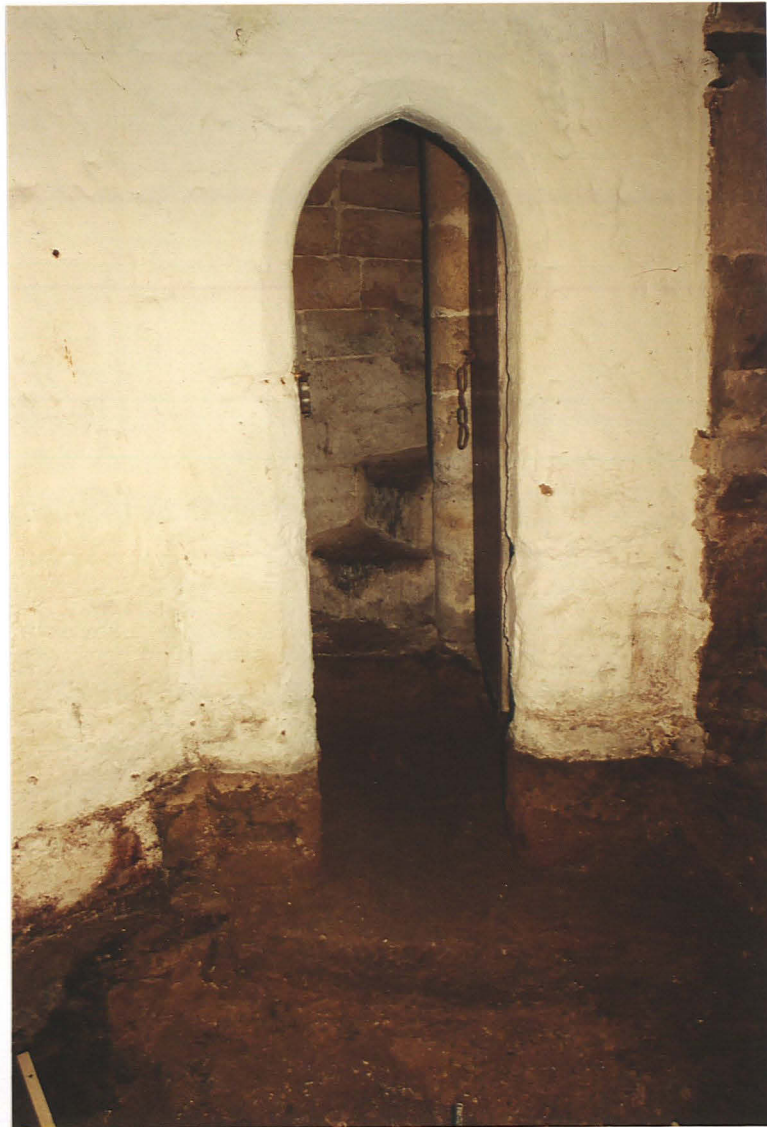
Pl. 4 Doorway and threshold to stair turret after removal of boiler house steps.

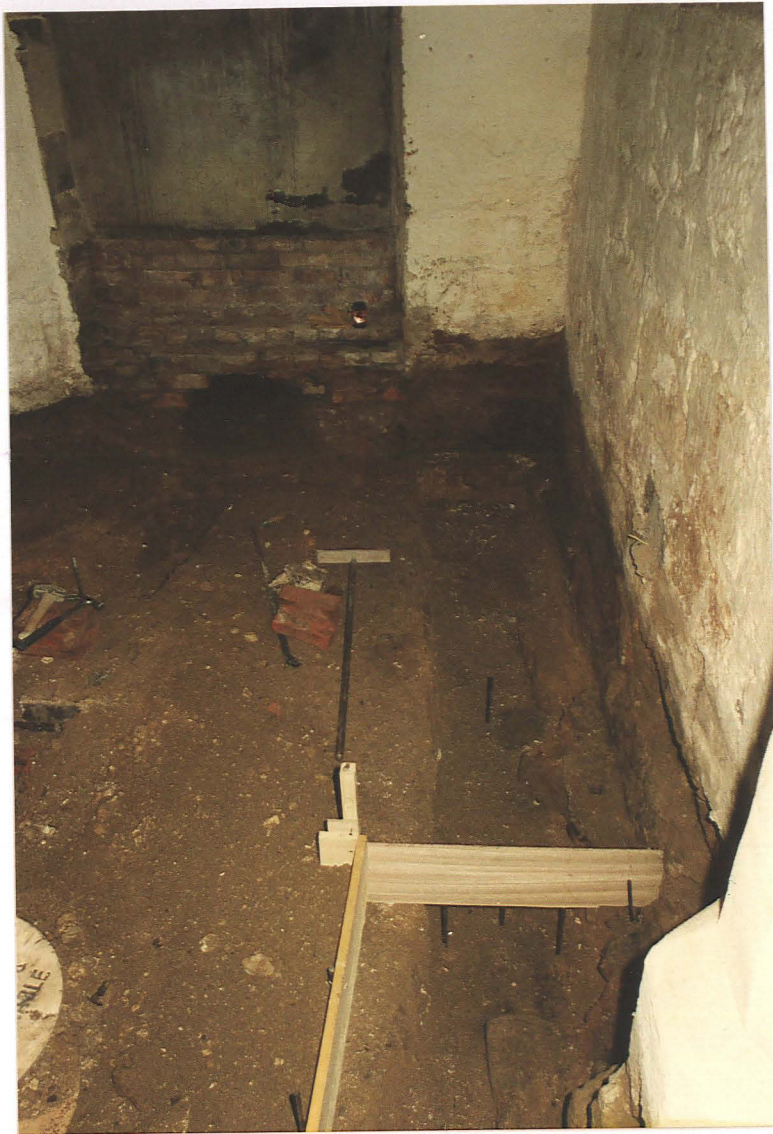
Pl. 5 Service trench dug along tower north wall, looking west.

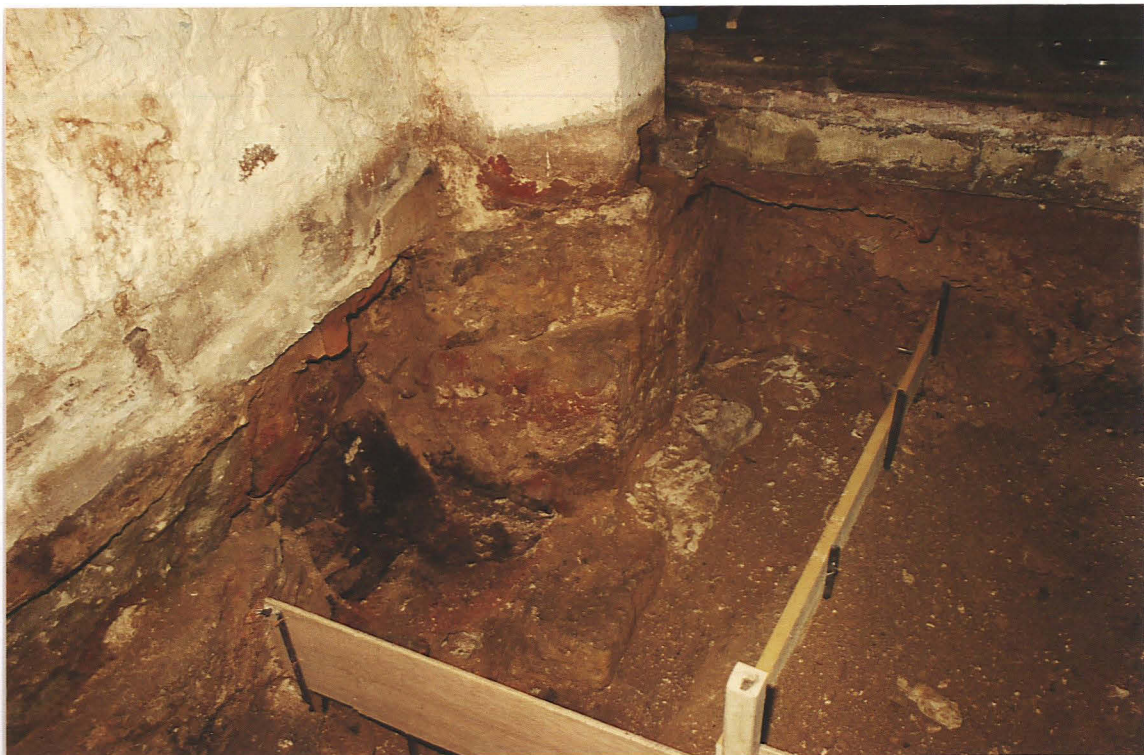
Pl. 6 Polygonal base of tower arch (north side) resting on foundations for tower north wall.

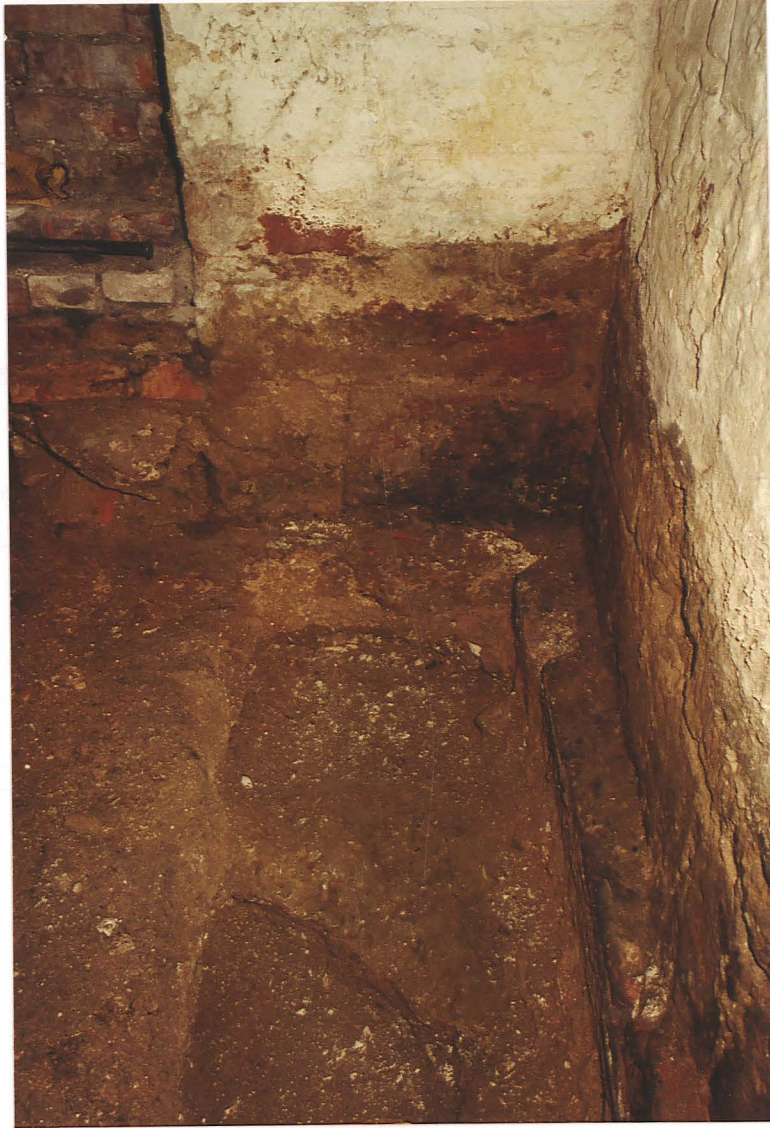
Areas of burning were seen adjacent to and along the north wall, and these may have been the sites of early stoves (Pls 7 and 8).

PI. 7 Offset footings along tower north wall. Note burnt stonework, looking west.

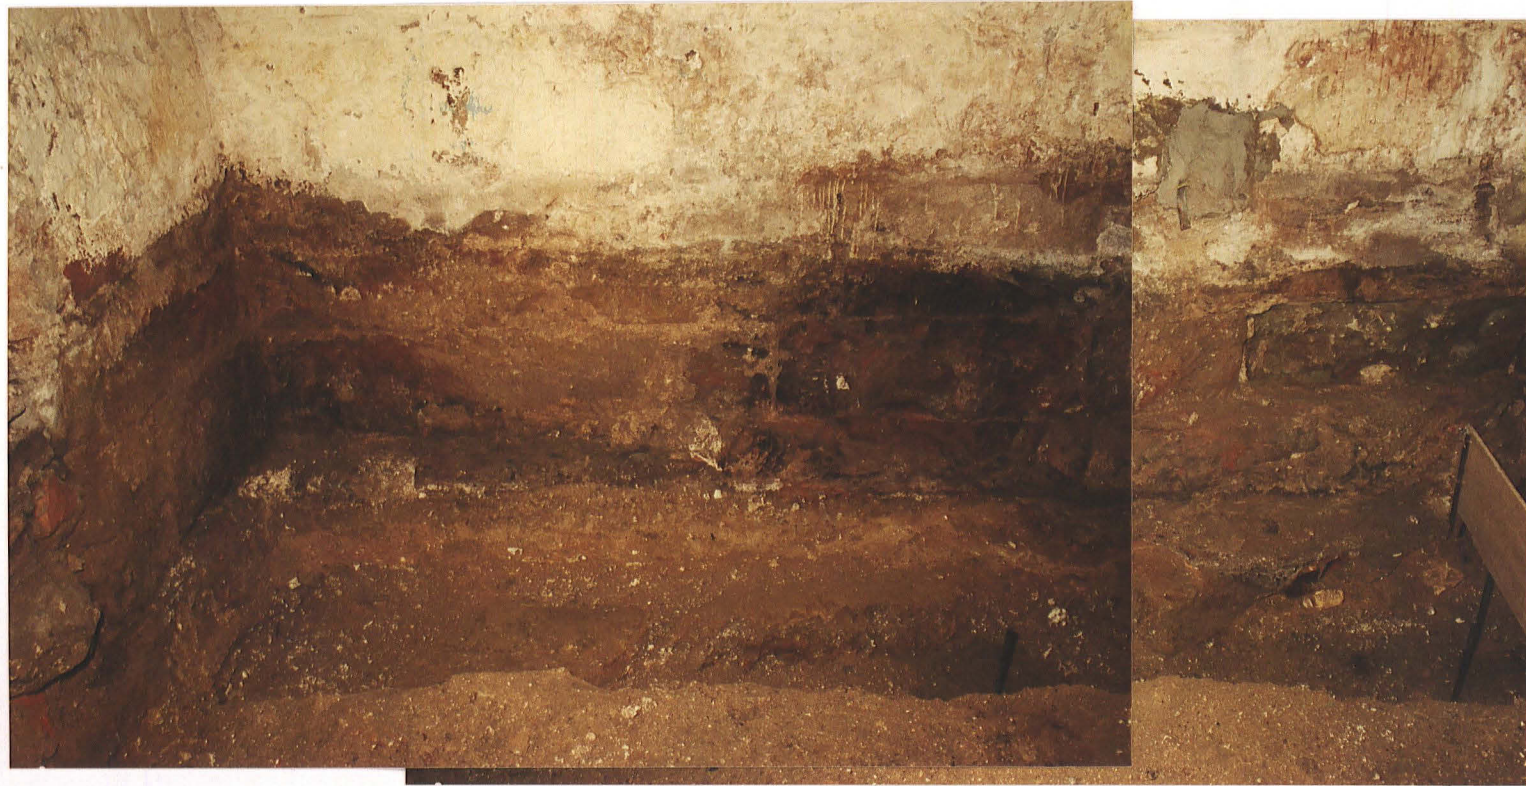
Pl. 8 Tower north wall, showing burning below plasterwork, looking north.

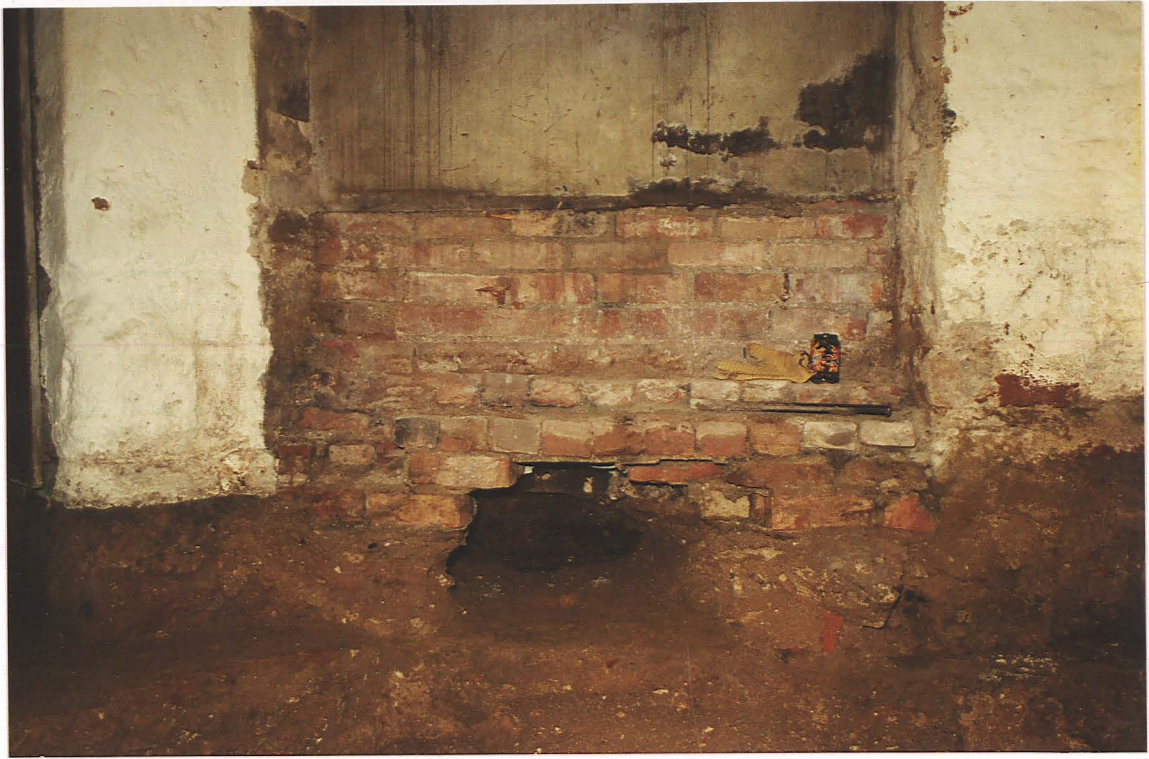
The tower west door was blocked internally with brick above its original threshold and the door retained outside (Pls 9 and 10). The external door jambs had been replaced at a lower level, probably during the mid-nineteenth century, but the associated threshold looked to be of greater age. The door has two large and elaborate hinges, the upper of which looked oldest and the lower one may have been a copy. The timber door is probably of nineteenth century date. Against the threshold was what appeared to be an overturned and cracked tapered grave slab, but upon lifting was found to be the top of a 'table' tomb (Pls 10-12). The tomb lid was lifted to enable a hole to be

Pl. 9 Blocked tower west door, with hole for services. Base of hole is original threshold level for the door.

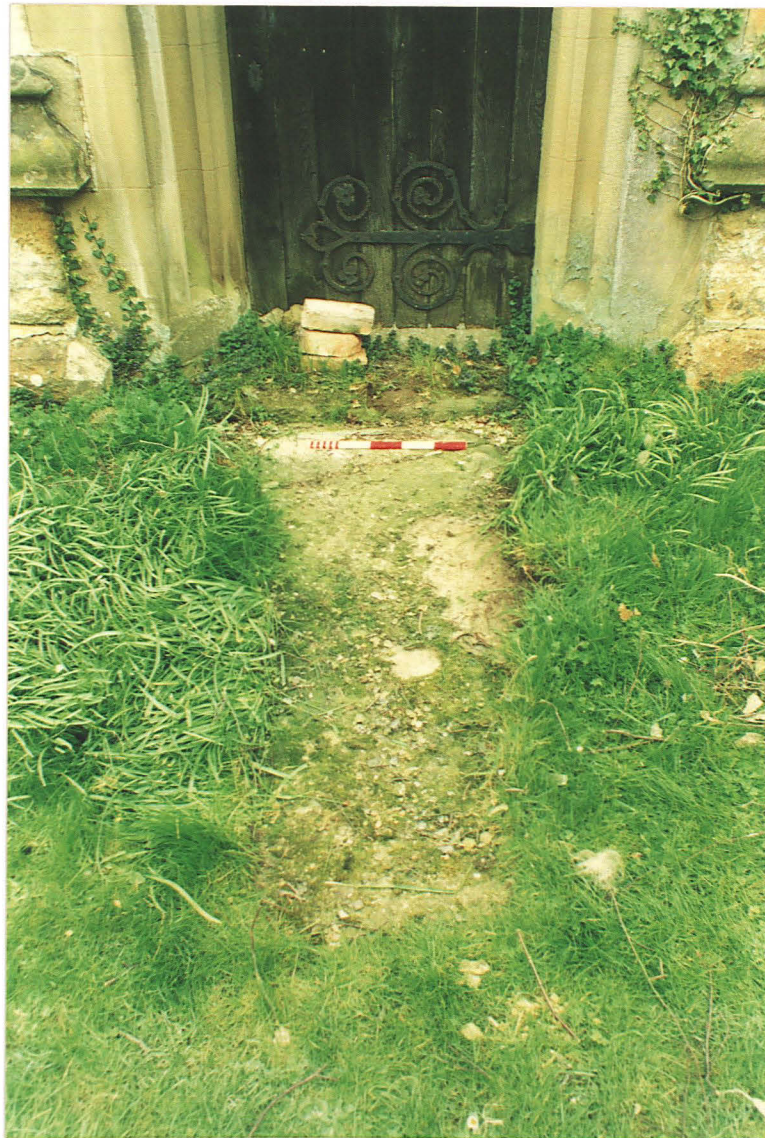
Pl. 10 Tower west door with table-top tomb lid in front. Scale 0.50m.

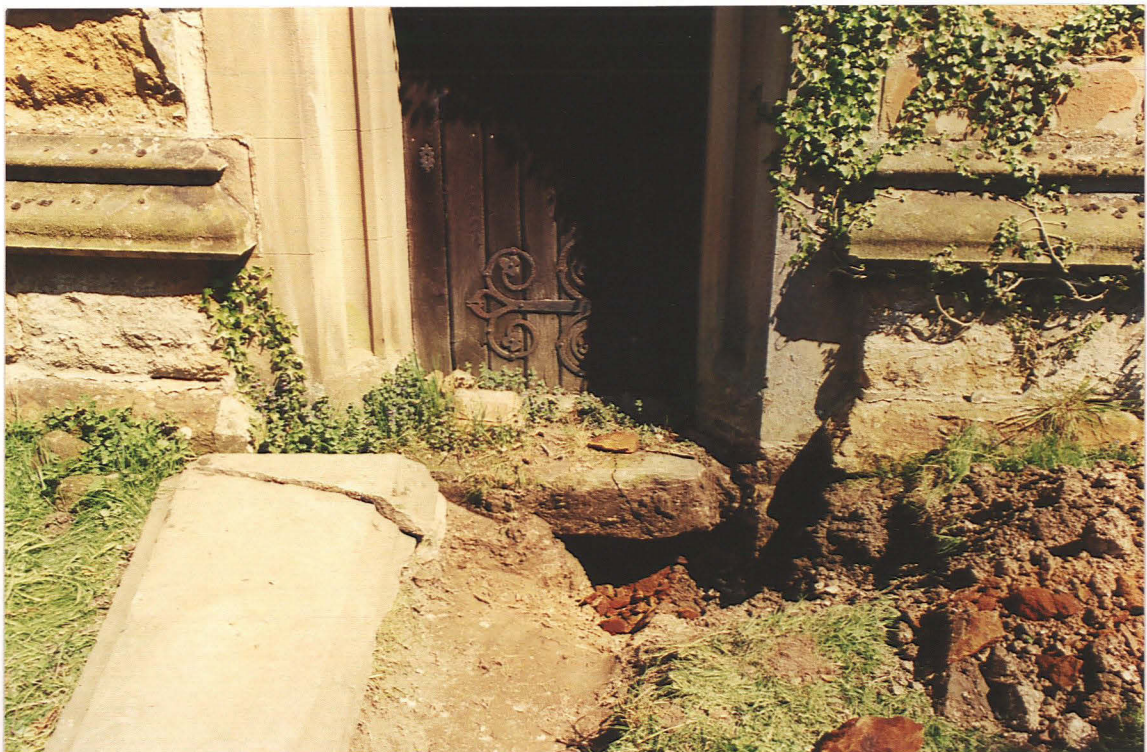
dug through the wall for the service pipes leading from the facilities inside the tower to the septic tank in the footpath to the west of the tower (PIs 9 and 12).

Pl. 12 Tower west door after excavation for services. Note iron hinge, copy of older hinge above.

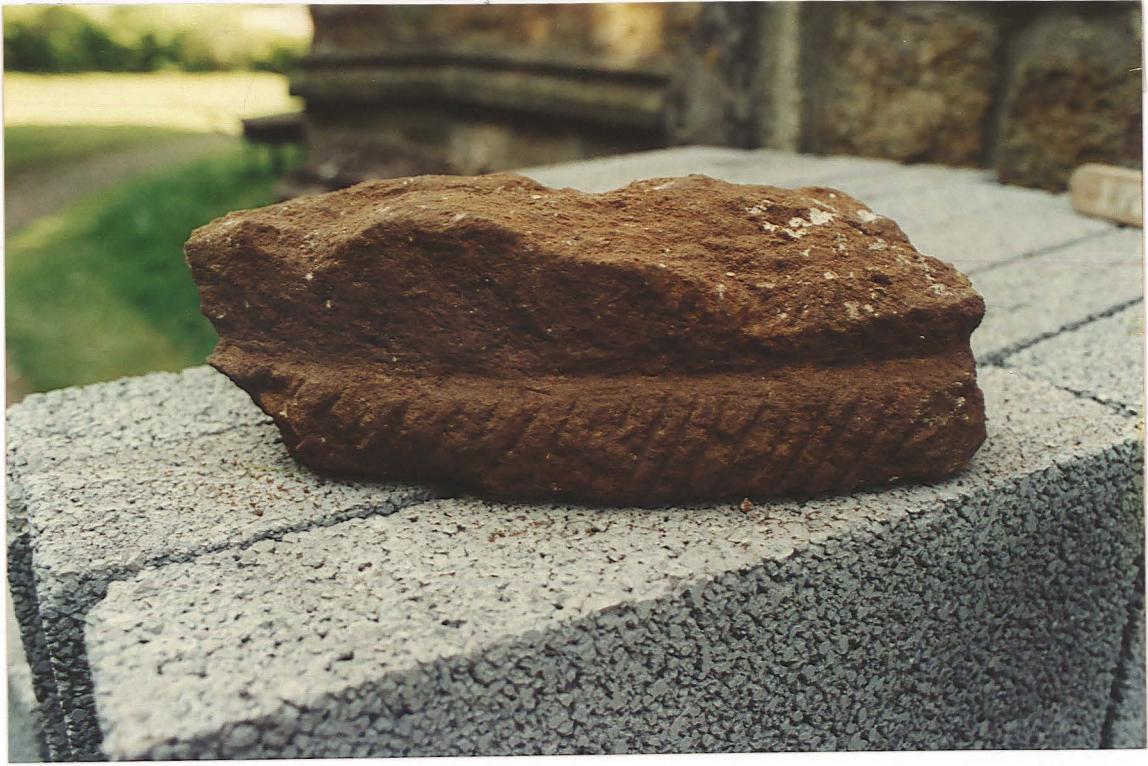
Two pieces of stonework were retrieved from the excavation of the tower. One piece was as column fragment with a crude rope decoration of probable Norman date (PI. 13). A piece of window tracery was also recovered (PI. 14).

Pl. 13 Column fragment found in tower.

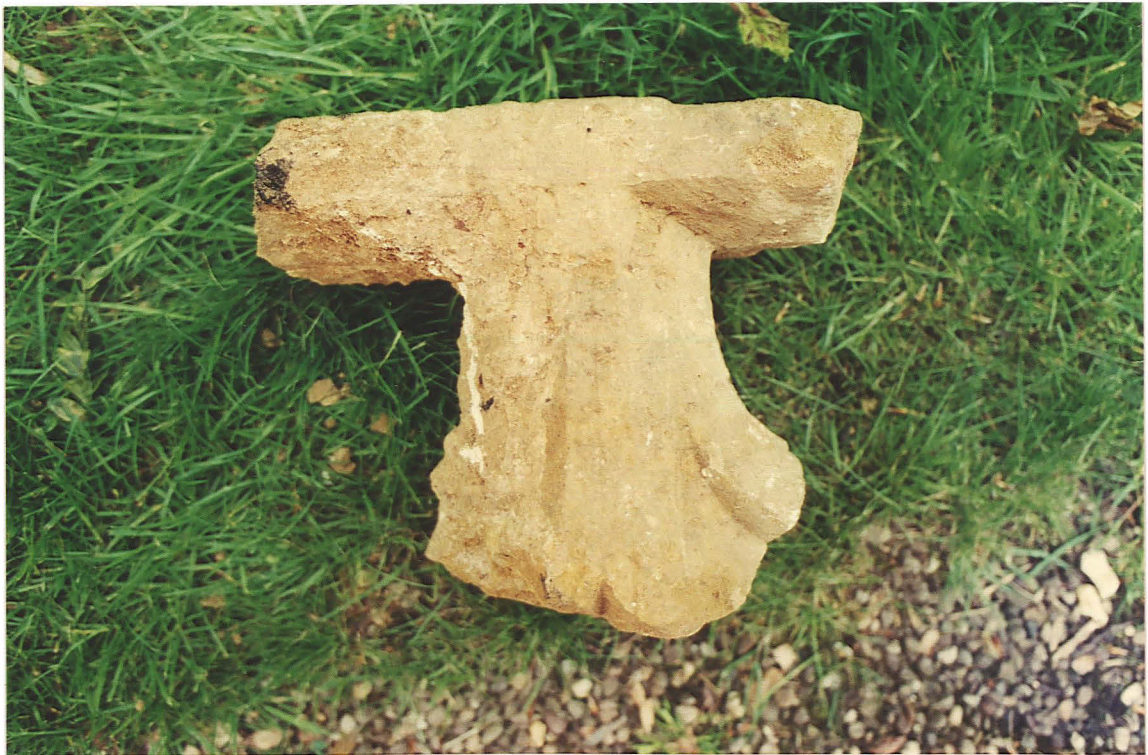
Pl. 14 Window tracery fragment found in tower.

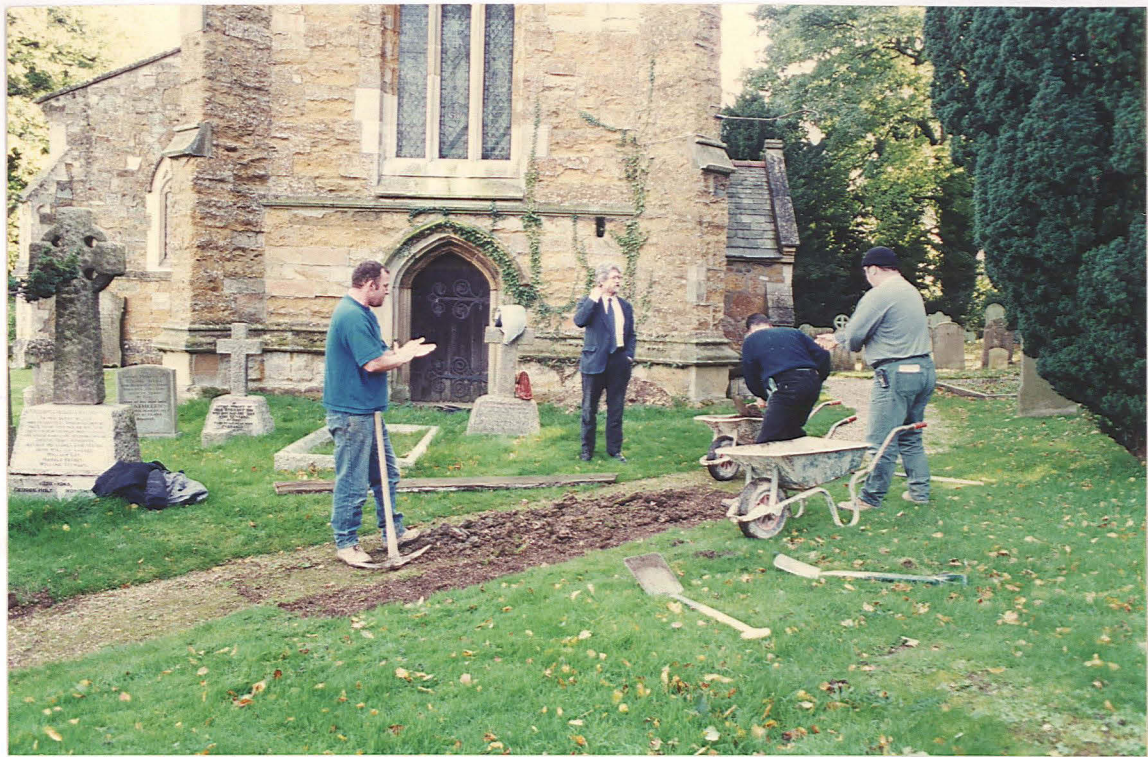
A trench was dug linking the toilet in the tower to a septic tank with a sump under the footpath, immediately west of the tower. The area excavated was 4m x 1.5m wide (PI. 15). The southern section was dug to a depth of 0.70m, the remaining two thirds being 1.50m deep. Rapid excavation of the trench allowed only the most basic of cleaning and recording to be carried out. The trench was dug out by the builders and when human remains were encountered they were cleaned and recorded by the author, prior to lifting for reburial by the incumbent.

Pl. 15 Location of cess pit west of tower on line of footpath, looking east.

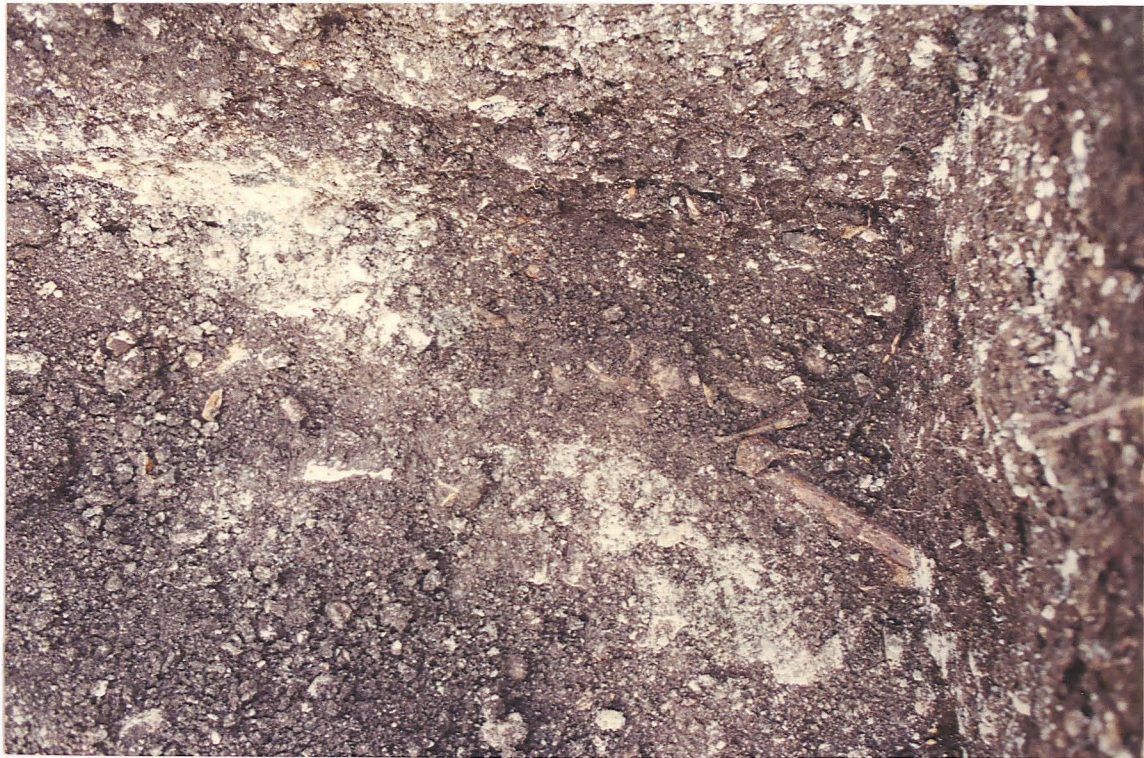
All the burials were orientated west-east with their heads to the west. They were neatly laid out but not aligned in precise rows. Burial 8 was in the south-west corner of the trench and only partially exposed. It appeared to contain only a jumble of bones comprising pelvis and vertebrae on top of leg bones (PI. 16). Evidence for more than one layer of burials, eg. Burial 1, just north of Burial 8 cut though the right side of Burial 2 (PIs 17 and 18). Next to Burial 2, with heads almost aligned,

Pl. 16 'Burial' 8 at south end of trench containing jumble of bones.

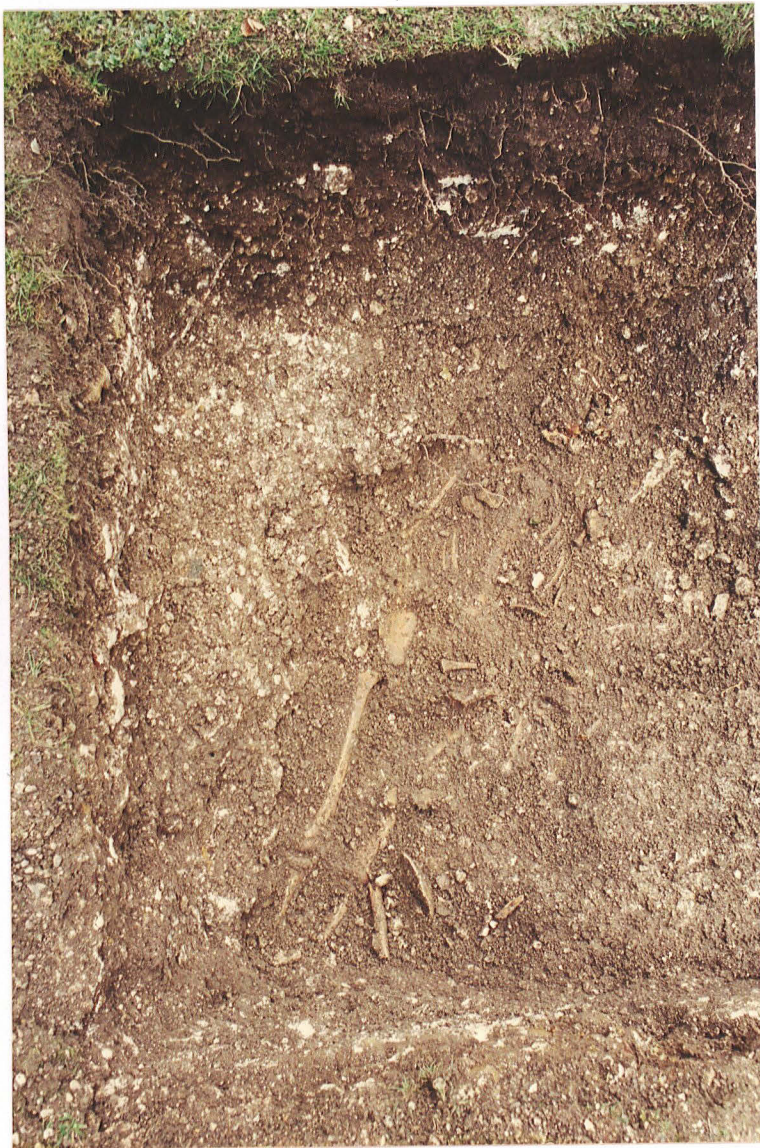
Pl. 17 Burial 1 with burial 2 to right.

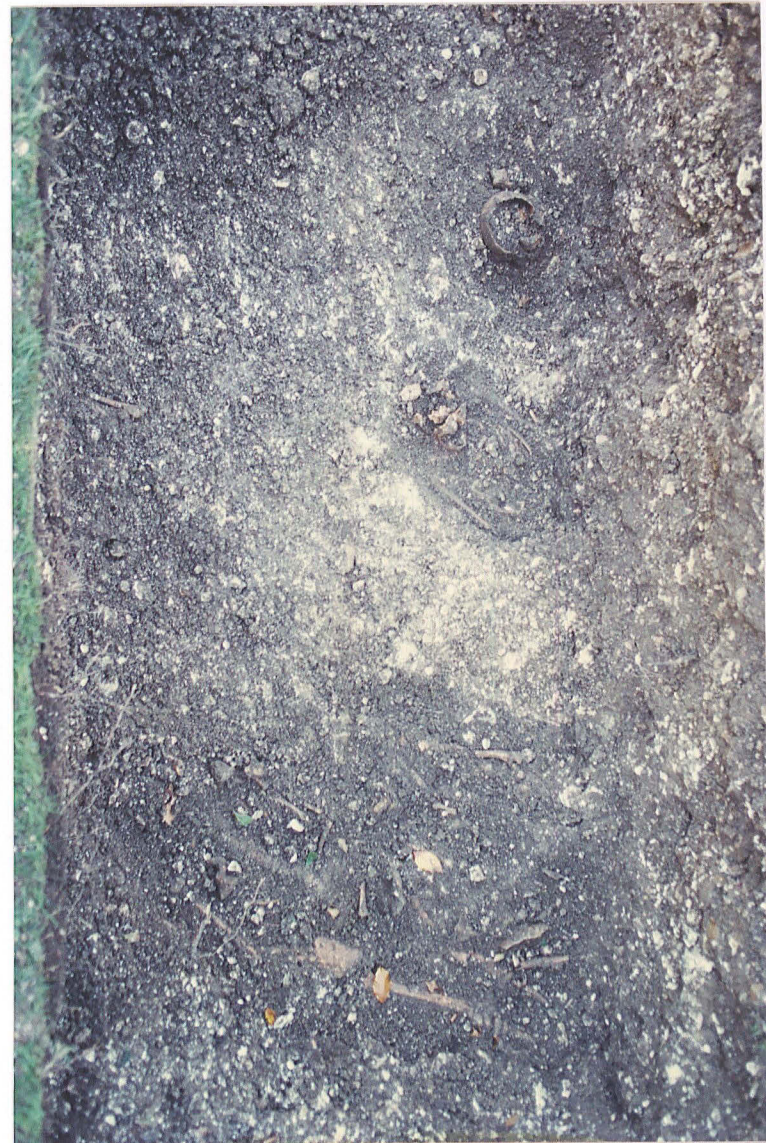
were Burials 4 and 5 which ran beneath the eastern edge of the trench (Pl. 18 and 19). Burial 7 cut through the feet of Burial 10. The feet of Burial 11 were found near the right shoulder of Burial 9. Burial 6 at the north end of the trench (Pl. 20).

Pl. 18 Burials 1 and 2 (left) and Burials 4 and 5 (right).

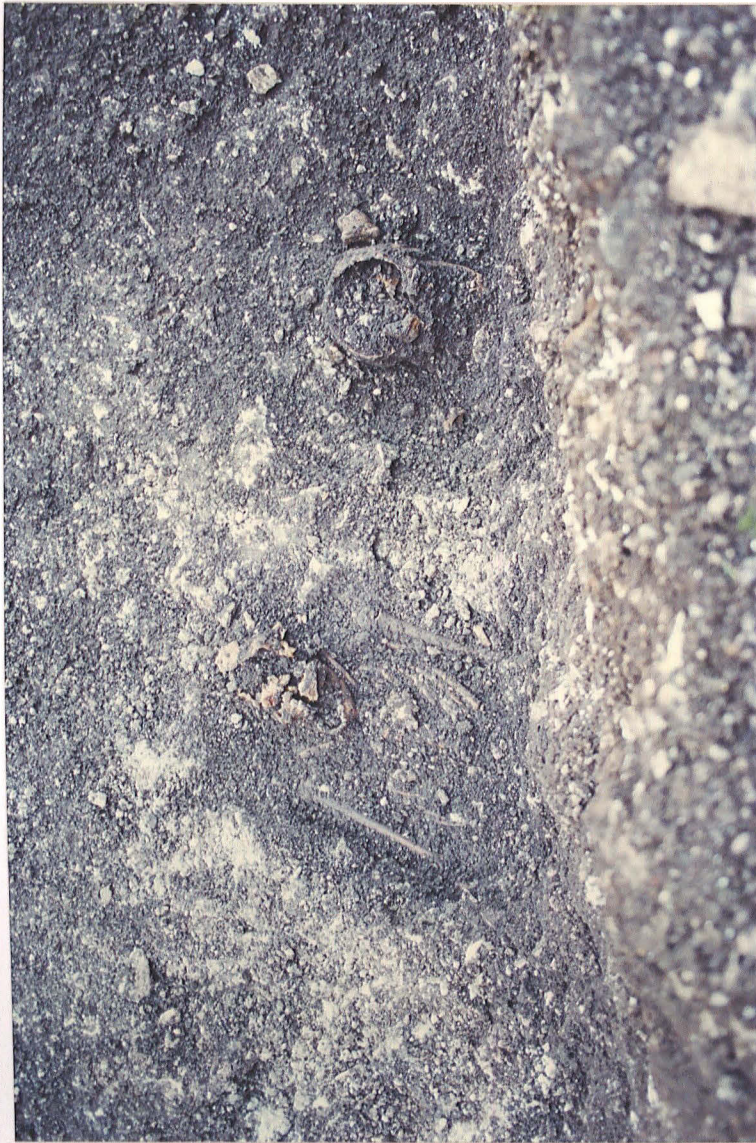
PI. 19 Burials 4 and 5

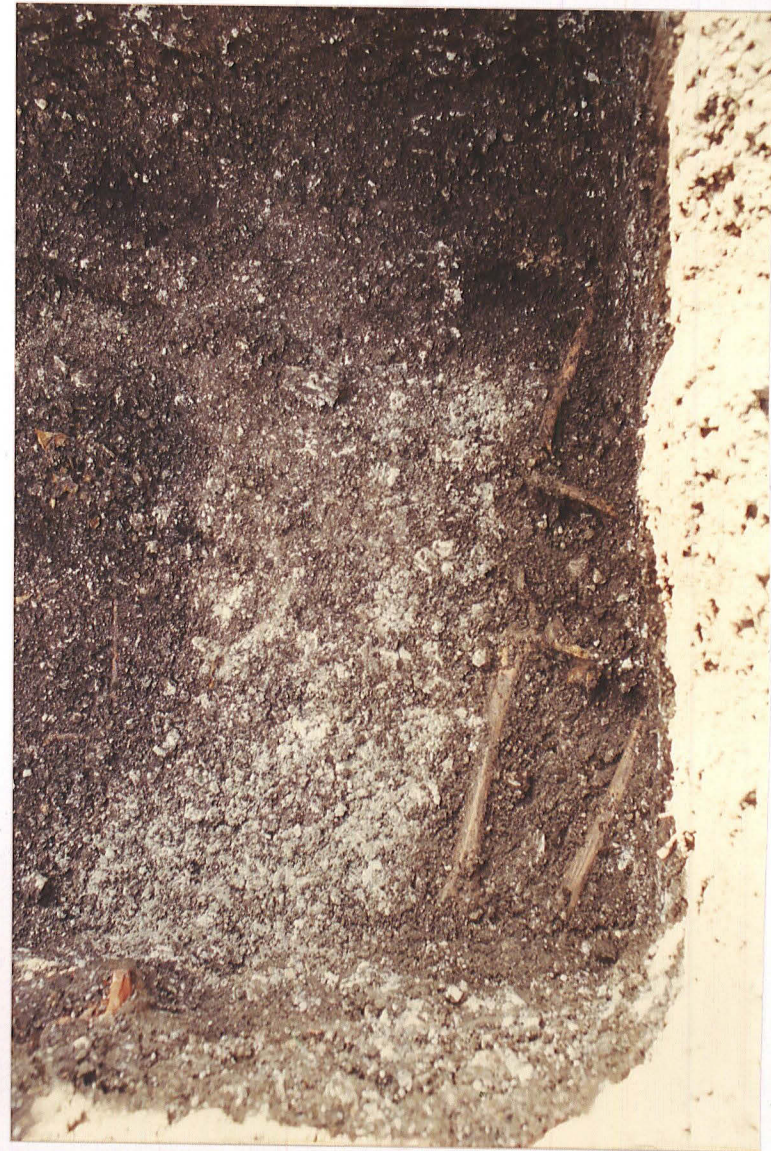
PI. 20 Burial 6
