**University of Lincoln, Riseholme Campus,
Lincs.
Equine/Animal Facility
Archaeological Evaluation**

**NGR: SK 9850 7572
Site code: RPEC 02
LCNCC Museum Accn. No.: 2002.130
West Lindsey District Planning Application No.: M02/P/0111**

**LAS Report No. 582
April 2002**

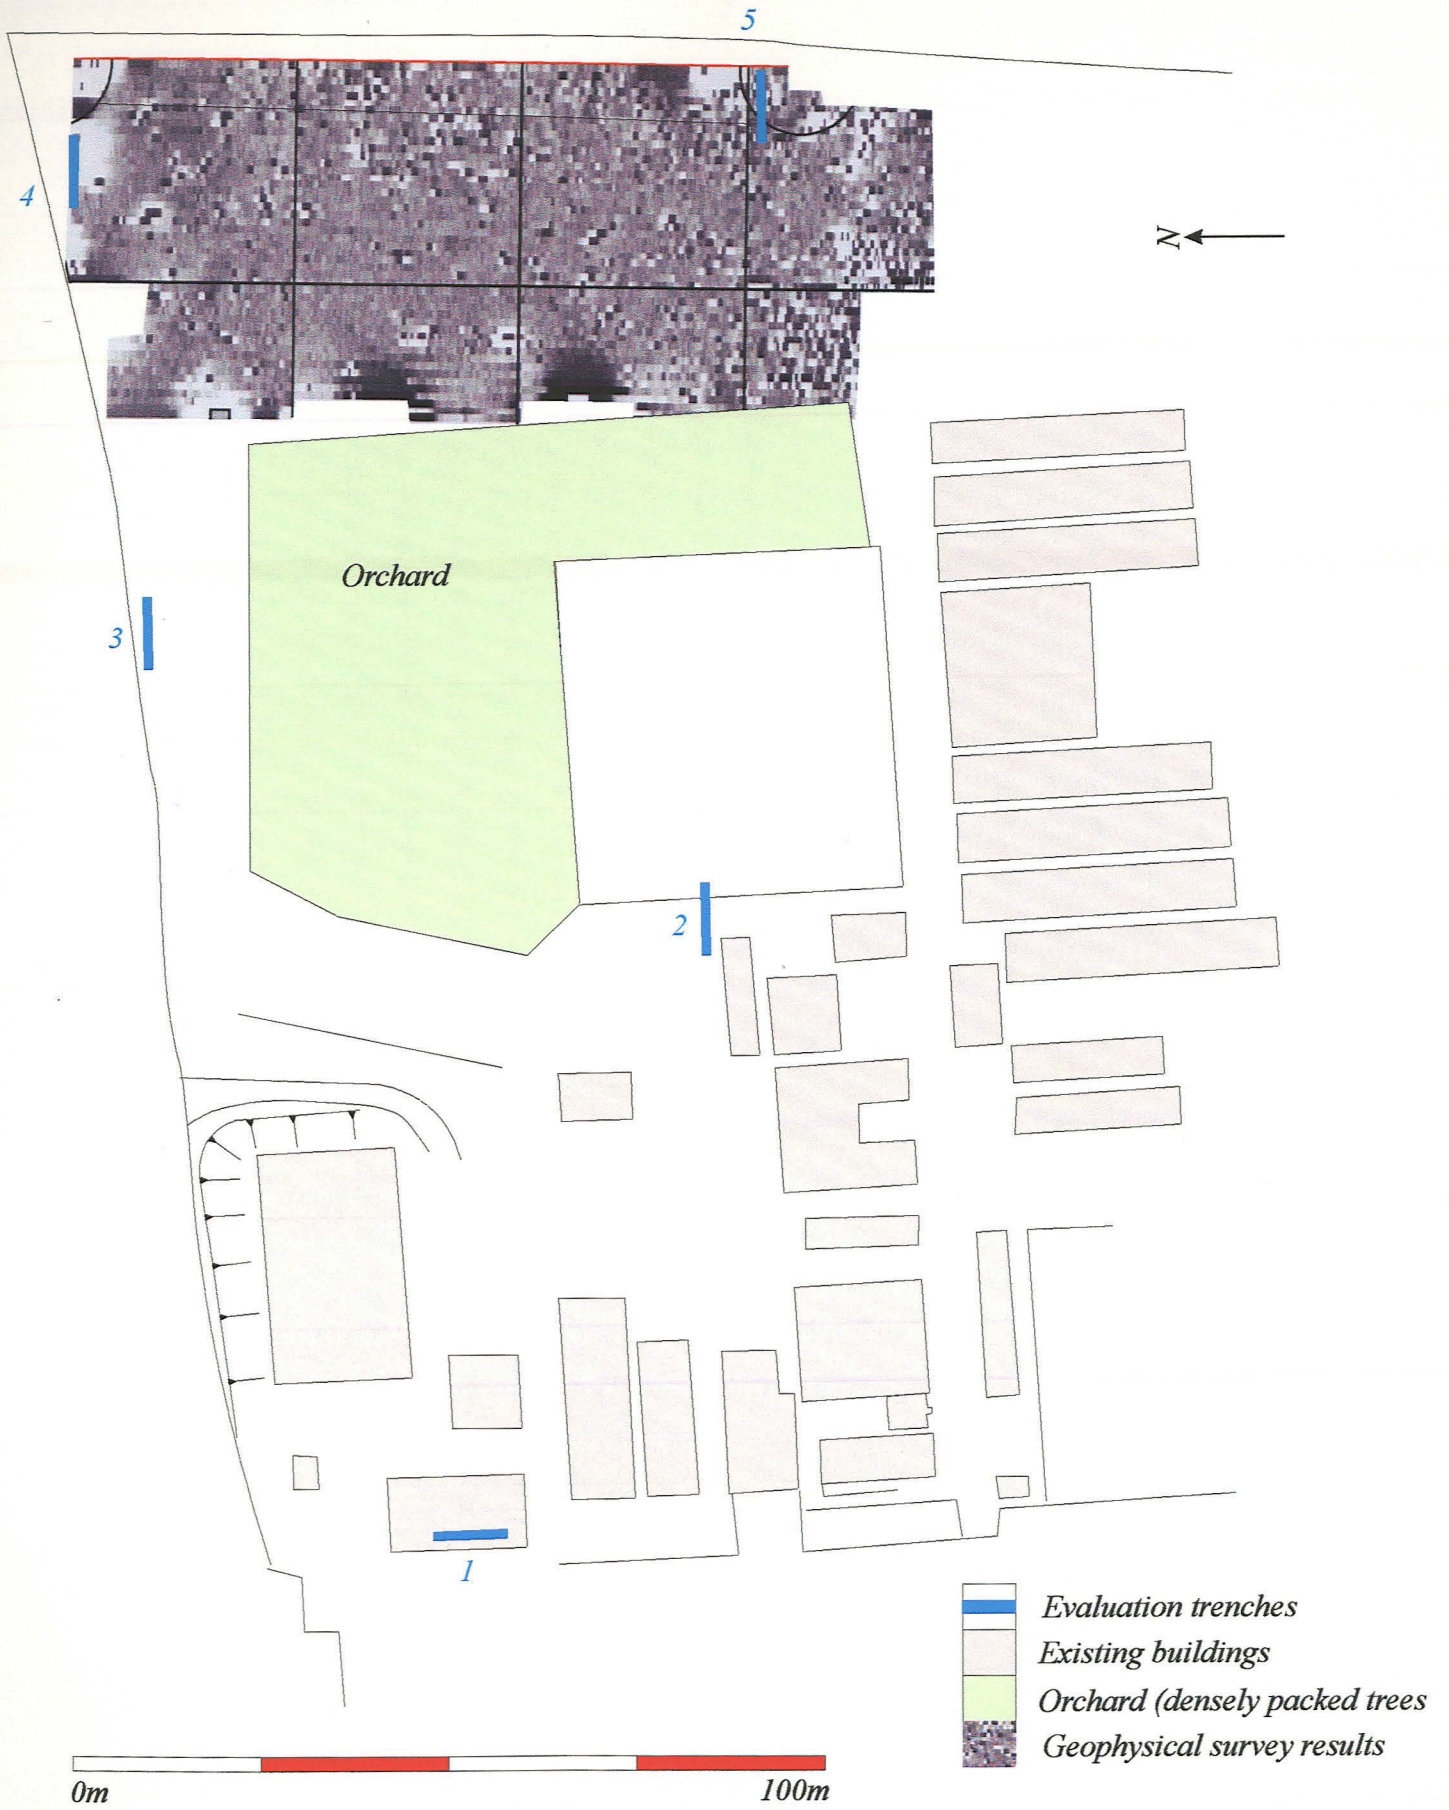
Fig. 2: University of Lincoln Campus, Riseholme
Trench Location and geophysical survey
results

The trenches were excavated according to the plan on Fig. 2. Topsoil removal had already taken place over much of the site which meant that the orientation of Trench 5 had to be altered from north-south to east-west.

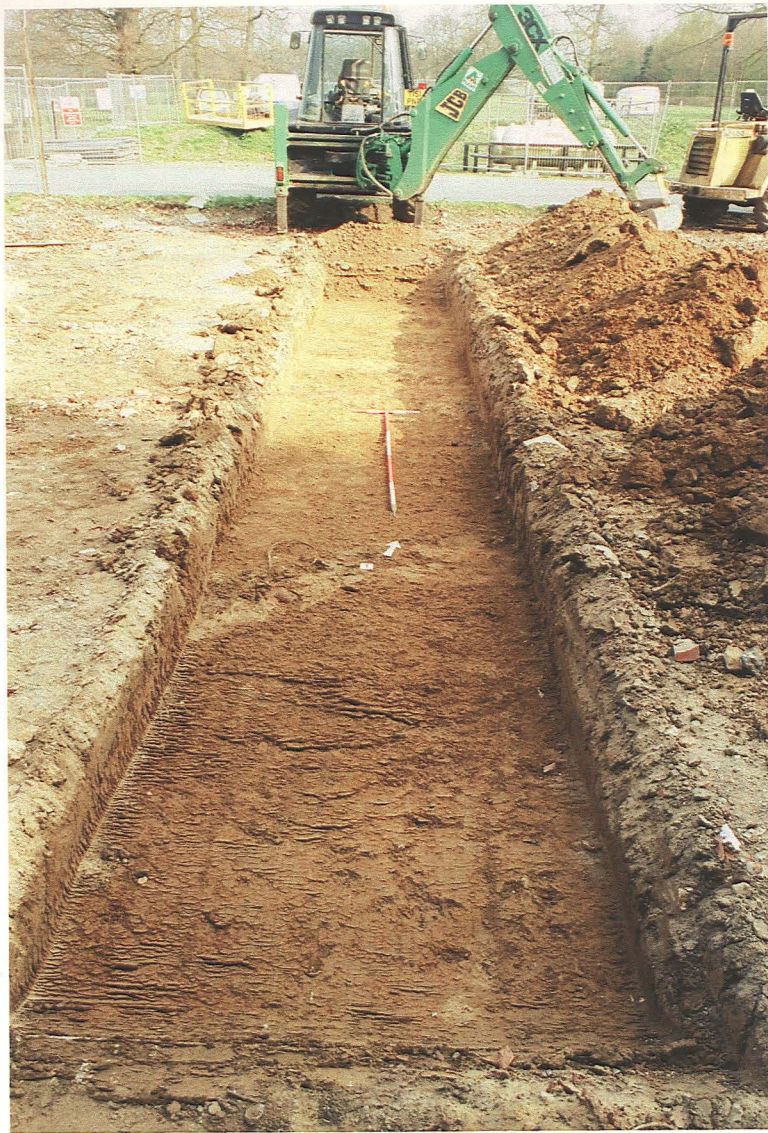
*Pl. 3 Trench 1 (right) scales
0.50m and 2m*

Located in the western part of the site, this trench was closest to the deserted medieval village and the supposed location of the previous church. The previous use of the site was for temporary buildings which had been placed directly on the subsoil after removal of the topsoil. The remaining subsoil was a brown slightly sandy clay (100) approximately 0.18m deep, overlying a mid brown sandy clay (102). The only feature in the site was a relatively recent ceramic field drain (101).

No archaeological features or artefacts were found in this trench.

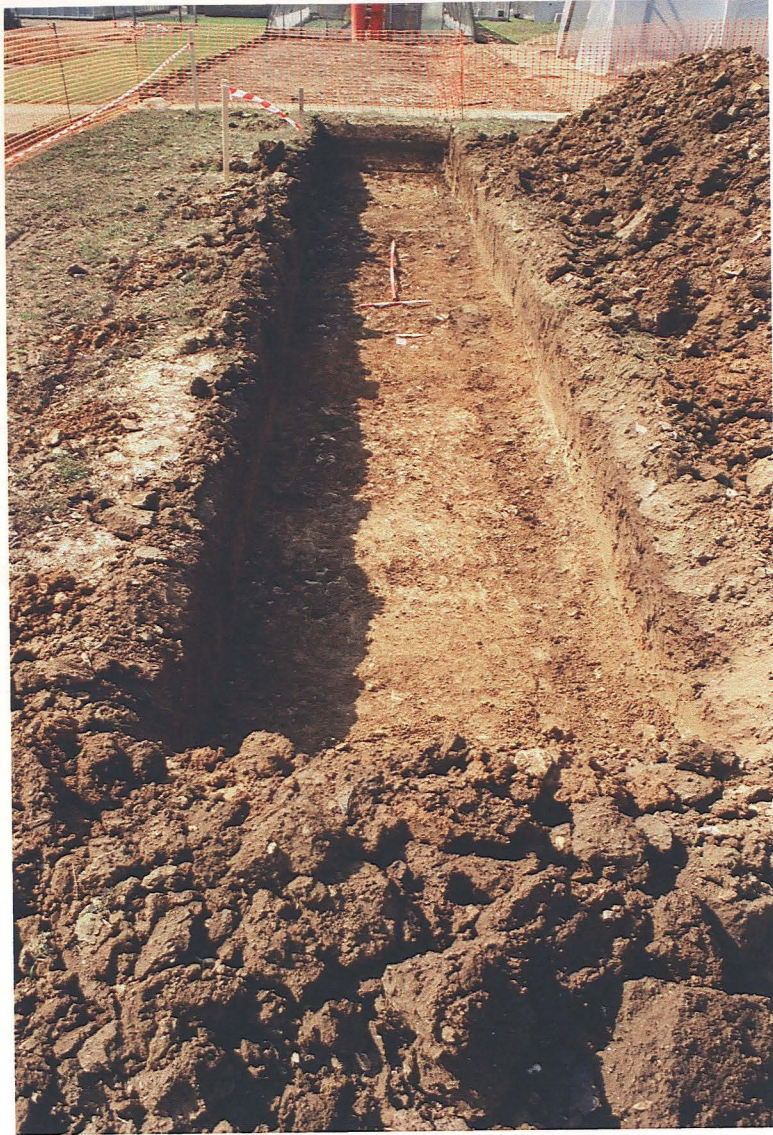
*Pl. 5 Trench 2 (right) scales
0.50m and 2m*

Trench 2 was located in the south/central part of the development over an area previously used by the horticulture unit for cultivating plants. The topsoil was a very clayey silt up to 0.30m deep (200), overlying a brown sandy silt clay, 0.20m deep (202). This deposit overlay a mixed clay with limestone fragments. There was a small water pipe, 201, cut into the natural, running the length of the trench, which was part of a former irrigation system.

No archaeological features or artefacts were found in this trench.

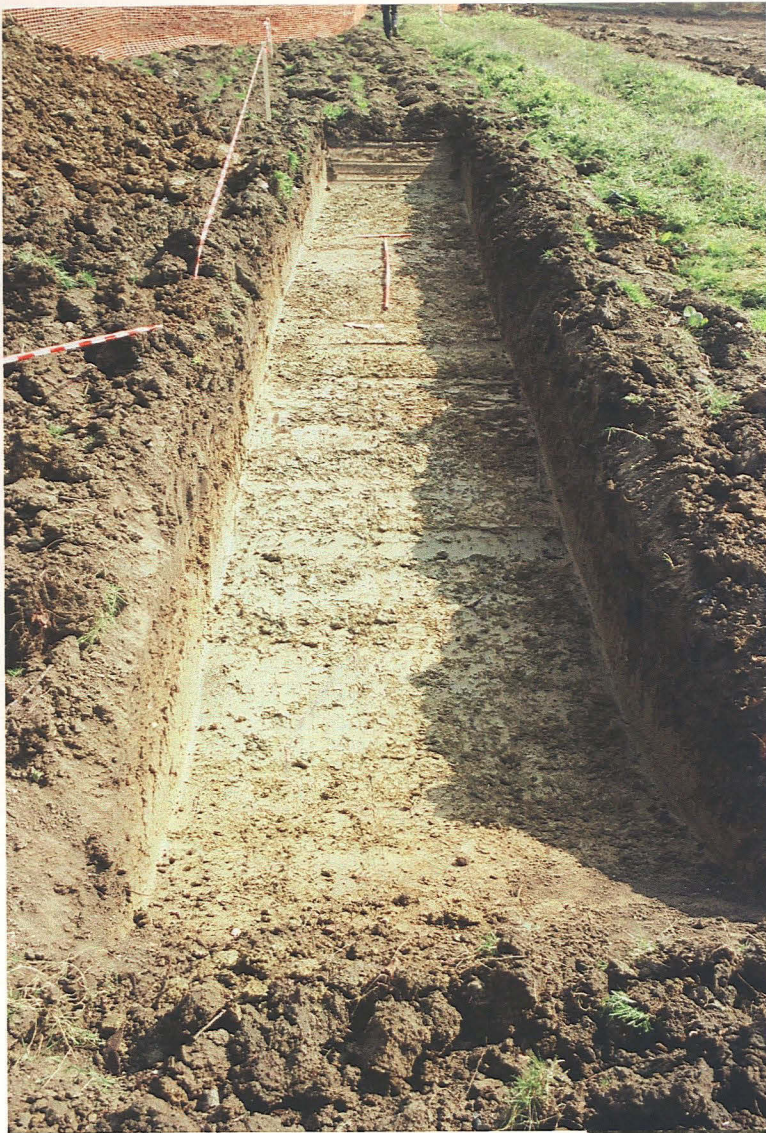
Pl.7 Trench 3 (right), scales 0.50m and 2m

Located in the north central part of the site, Trench 3 was excavated through 0.30m of dark brown clay silt topsoil (300), 0.30m of a brown silty clay subsoil (301), onto a firm brown/blue green clay (303). A deeper section was excavated in the west end of the trench to provide a deeper profile which showed a grading into mixed blue green clays at a depth of 0.90m.

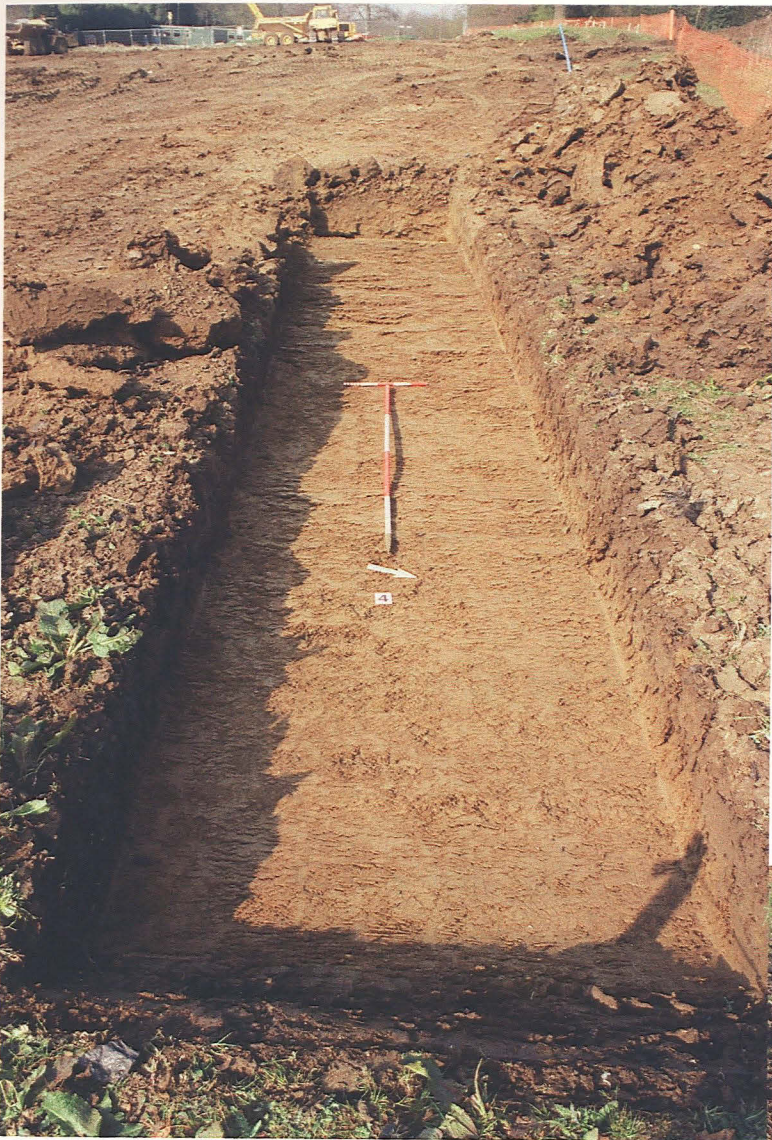
Pl. 9 Trench 4 (left), scales 0.50m and 2m

Trench 4 was excavated through 0.35m of silty clay topsoil, 400, onto a brown slightly sandy clay, 401, 0.60m deep onto mixed natural clays, 402. A deeper section was excavated in the western side shown the clay continued but with increasing amount of gravel.

There was no features or artefacts identified in this trench.

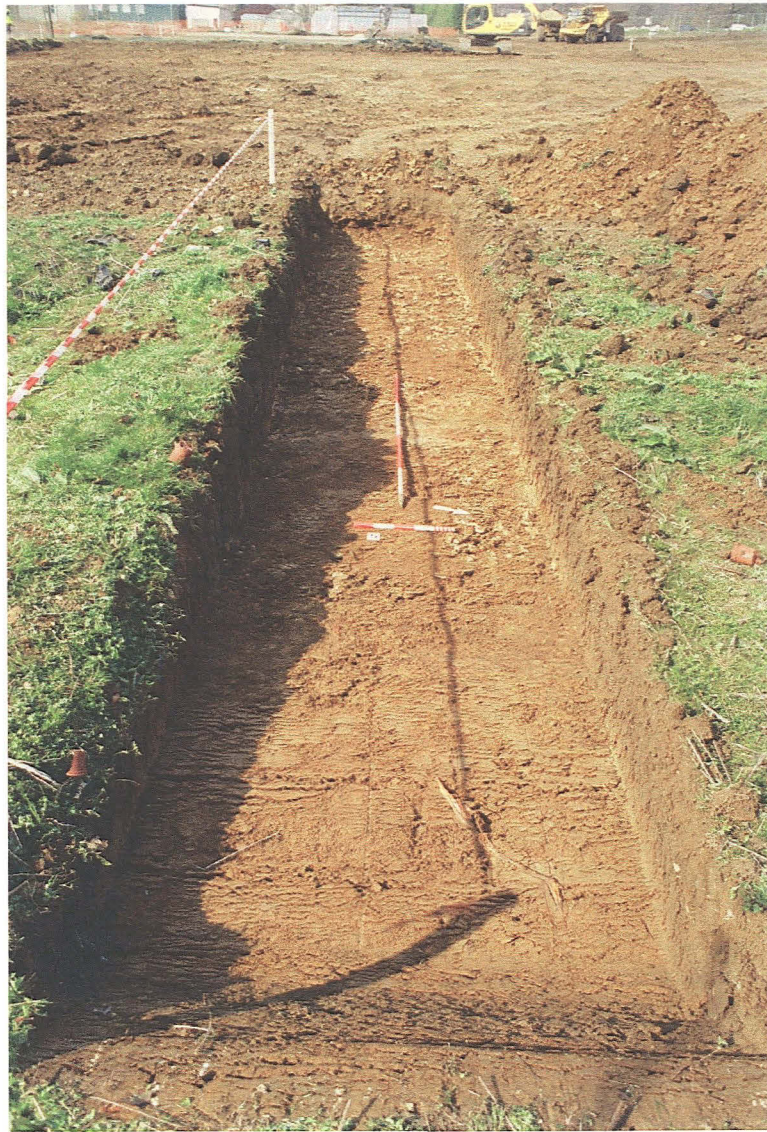
Pl.11 Trench 5 scales 0.50m and 2m

Trench 5 was located at the eastern boundary (which also forms the parish boundary between Riseholme and Nettleham). This trench was excavated through (0.46m) of topsoil 500, onto a brown clay subsoil, 501(0.15m deep), onto a natural light blue clay with frequent limestone fragments, 502.

No archaeological features or artefacts were found from this trench.
