**PLOTS 1 - 2, CHURCH FARM,
NEWTON BY TOFT,
MARKET RASEN, LINCOLNSHIRE**

**ARCHAEOLOGICAL WATCHING
BRIEF REPORT**

Site code	CFNT 02
NGR:	TF 0500 8738
LCCM Acc No:	2002.142

Report prepared for Mr M Brown
by S.A. Savage

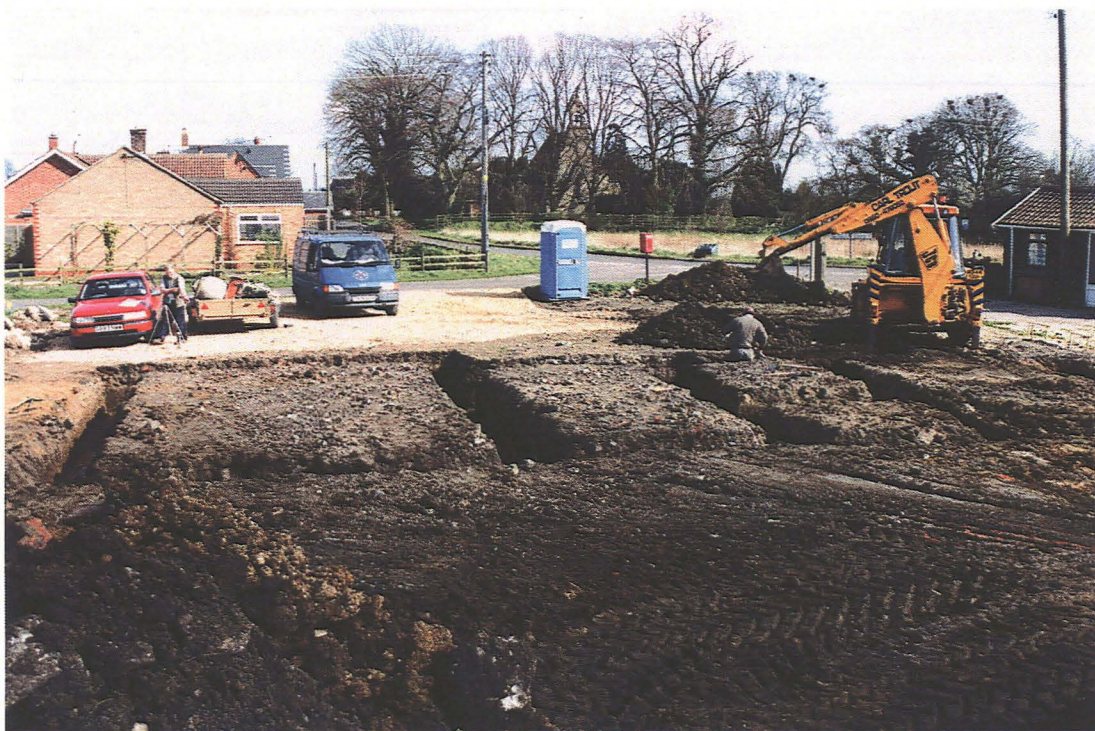
Plate 1: General view of the site during machining, looking SE. The parish church can be seen amongst the trees in the background.

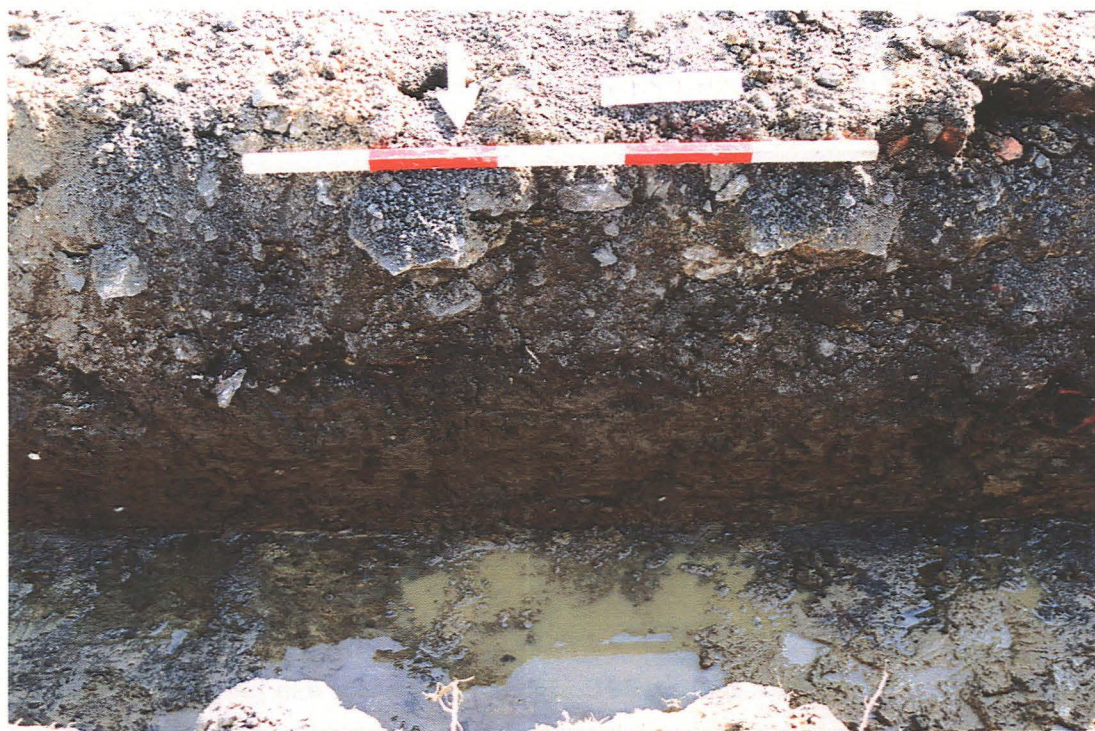
Plate 2: North facing section showing the typical sequence of layers (see fig. 5).

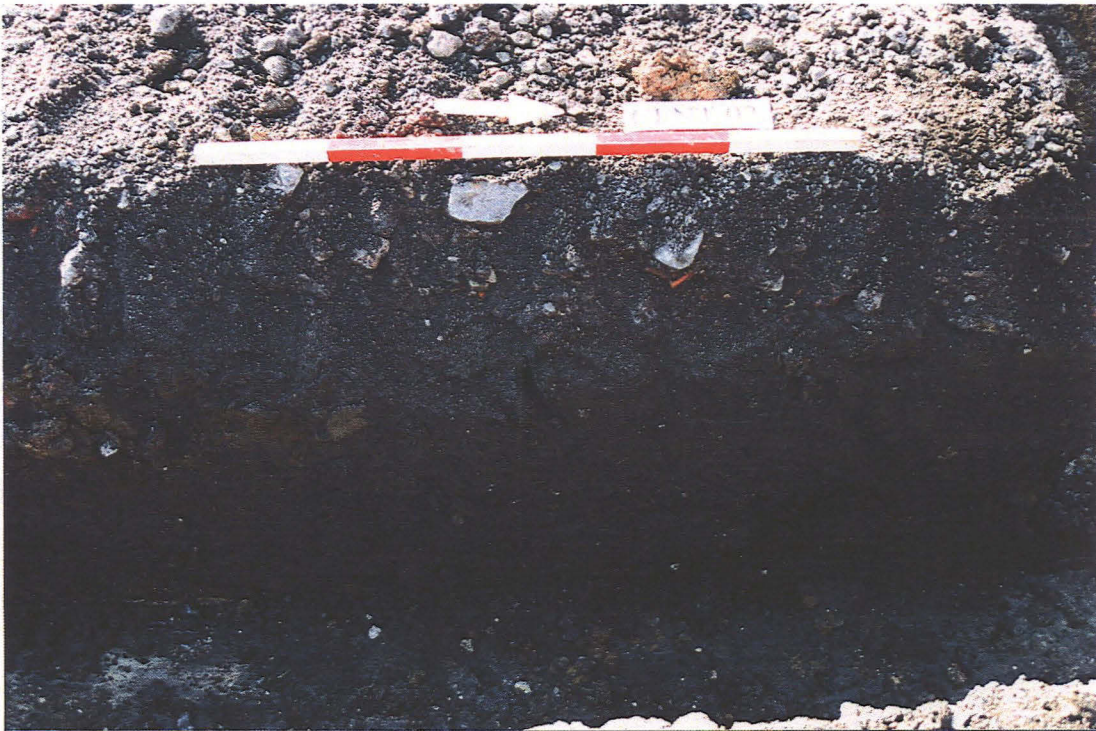
Plate 3: East facing section showing layer 005 (see fig. 6).

In the middle of the site, below 001, lay a very dark greenish brown sandy clay (005), which oxidised to a very dark greyish brown after c20 minutes exposure to the air. 005 was very irregular in plan and the boundary between it and 003/004 was also irregular. This material was, in all respects except colour, similar to 003 and was interpreted as material which had become discoloured by the leaching of effluent from the farmyard above (see fig.6).

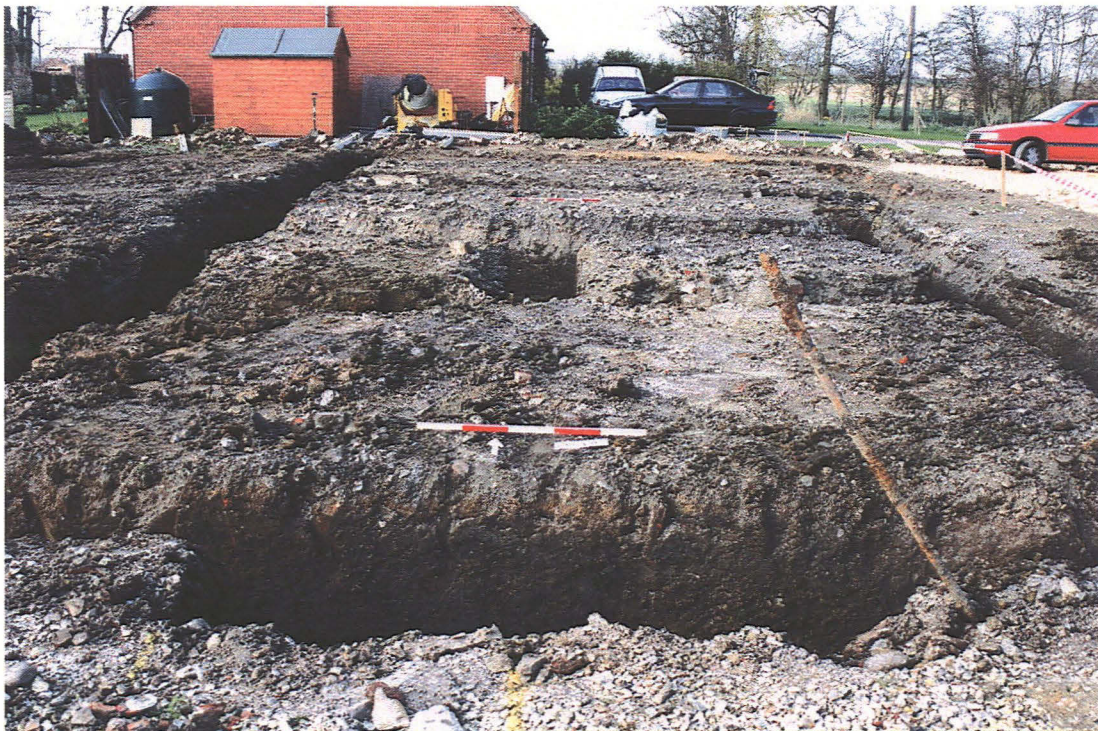
Plate 4: General view of the foundation trenches, looking north. The barn foundations [006] can be seen in the middle distance.

In the SW part of the site, the foundations of the former barn were seen (006), these were built of handmade bricks (230mm x 115mm x 80mm in size), the lower two courses of which (foundation) were laid in two rows on end as headers, with a double row of stretchers above representing the lowest course of the walls. The brickwork was laid in a straight-sided, flat-bottomed trench, 0.48m wide and 0.3m deep (see fig. 4).
