**DALBY HALL, MAIN ROAD, SPILSBY, DALBY
LINCOLNSHIRE**

**ARCHAEOLOGICAL
WATCHING BRIEF REPORT**

Prepared by
NETWORK ARCHAEOLOGY LTD.
on behalf of
CgMs Consulting

**Report 173
February 2002**

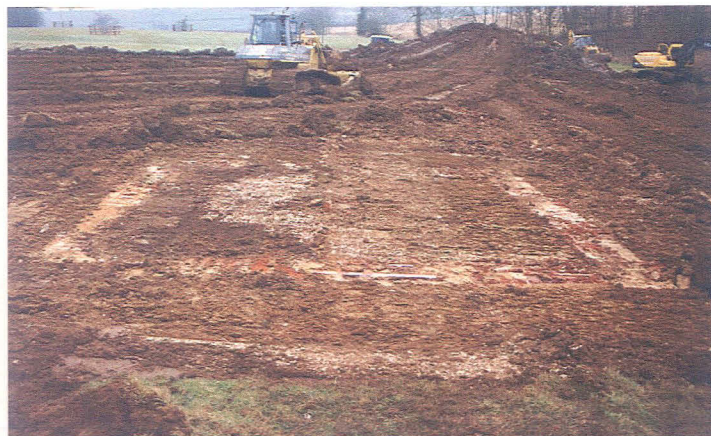
Plate 3: Building group 0017 (looking east)

The foundations (0013) for a small square structure were recorded in Area 1 (see Figure 3). They were exposed after the removal of topsoil (0001). The structure measured 5.60m by 5.50m, and was located approximately 34m ENE of the existing lake. Up to two courses of continuous brick foundation (0013) remained. The foundations were 0.50m wide (the length of two end to end mortared bricks) and were up to 0.12m deep.

The bricks were bonded by a compact light yellowish-brown lime mortar. Each brick measured 0.23m in length, 0.11m wide and 0.06m deep. The foundations showed signs of having been burnt *in-situ* (see Appendix E). They appeared to have been laid into a trench [0015] just wide enough to accommodate them, as the edges of this trench were not visible in plan.

A 0.07m thick compact deposit (0014) containing frequent fragments of chalk was visible in the northern half of the structure.

Only part of the foundations (0013) and the chalk layer (0014) remained. The brickwork was continuous around the perimeter of the foundations, with no evidence for an entrance into the structure.

Context (0014) appeared to be a deliberately laid make-up layer, and may have originally supported a floor that had been removed along with the upstanding structure.

Some hand-made bricks recovered from foundations (0013) have been dated to the 17th or 18th centuries (see Appendix E). The bricks and some mortar retained from foundations showed signs of having been burnt in-situ. Similar burning had taken place on bricks retained from demolition deposit (0016) situated 40m WNW of Structure (0017). It is possible that Structure (0017) was destroyed by fire, and that (0016) originated from the burnt remains of the up-standing building. Another possibility is that the bricks used in foundations (0013) had been recovered from elsewhere and re-used.

The position of these foundations suggests that they may have originally supported a small summer house or ornamental building in the parkland surrounding Dalby Hall, with evidence for its destruction by fire preserved in the discoloration of the bricks. Alternatively, the building may have been used for an industrial purpose.
