**Savoy Cinema (Former Co-operative Society Store)
West Street, Boston**

Archaeological Watching Brief

**Report for Northern Building Design Associates Ltd
(on behalf of Savoy Cinemas)**

**LAS Report No. 584
March 2002**

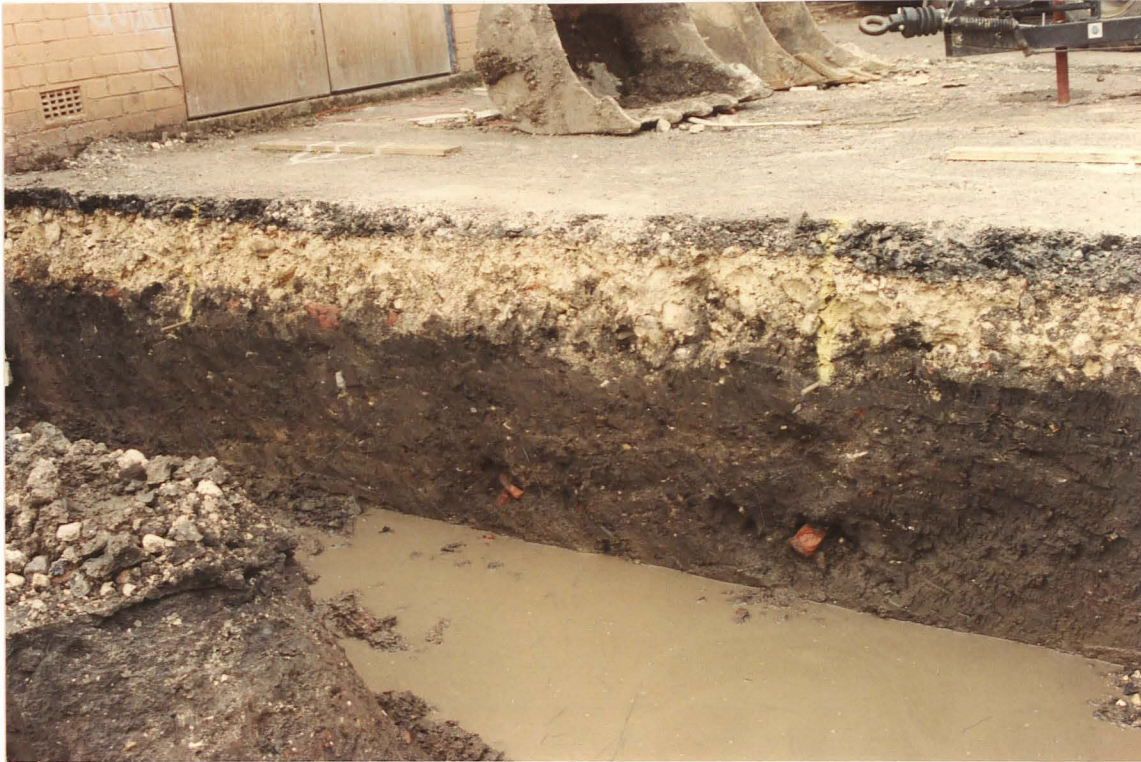
Pl. 1 Northern face of Trench 1 (looking NW).

The most northerly west-east aligned trench keyed into a projection of the existing building, and was therefore shorter (4.5m long). A former tarmac surface, bedded on crushed limestone, remained around the exterior of the new extension but had been removed from within it. This may have been laid after construction of the existing building.

The crushed stone bedding for the tarmac yard lay directly over several features, which had probably been truncated when the surface was laid. It was observed that no earlier yard surface, such as cobbling, was present; neither was there a homogenous soil layer that would have suggested cultivation. The latest buried feature was a small post-hole **166**, 0.2m diameter and 0.2m deep. A deeper post-hole **168** was positioned 0.25m to its west, extending over 0.7m to below the new foundation trench. Both these features may have been contemporary with the existing building or its late nineteenth century bakery predecessor, possibly acting as scaffolding supports.

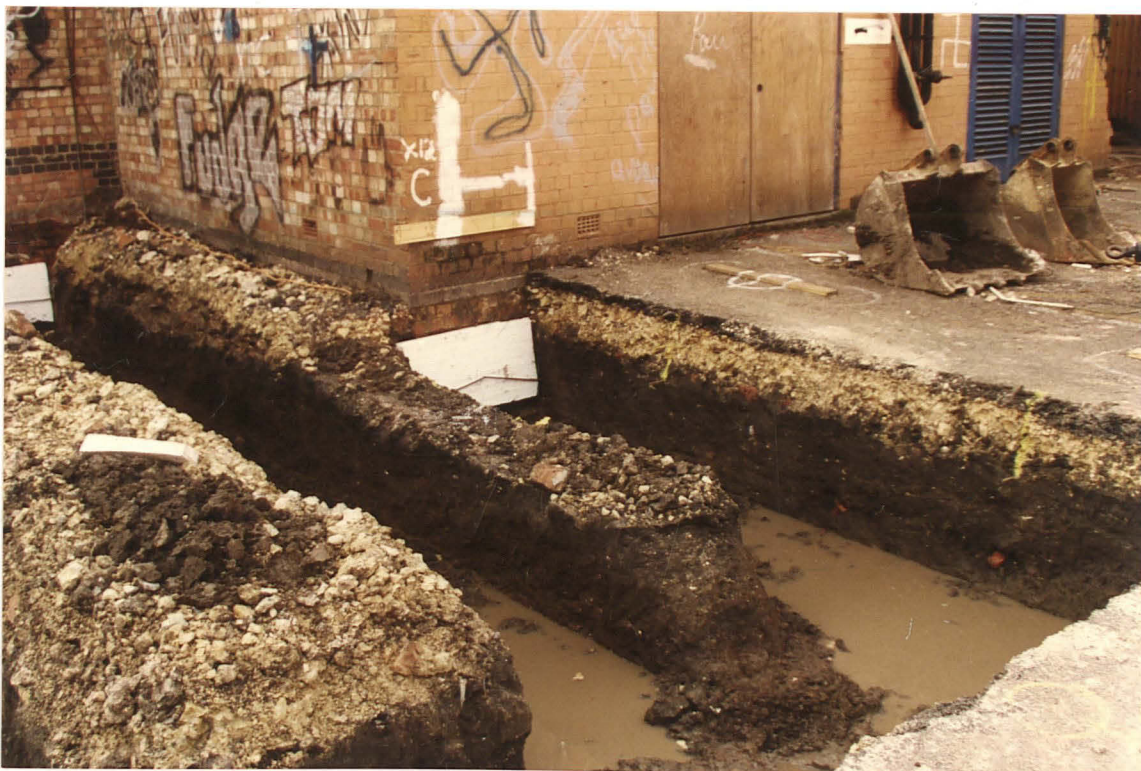
Pl. 2 Location of Trench 1 (short trench) and Trench 2 (extending to main building). Looking NW.

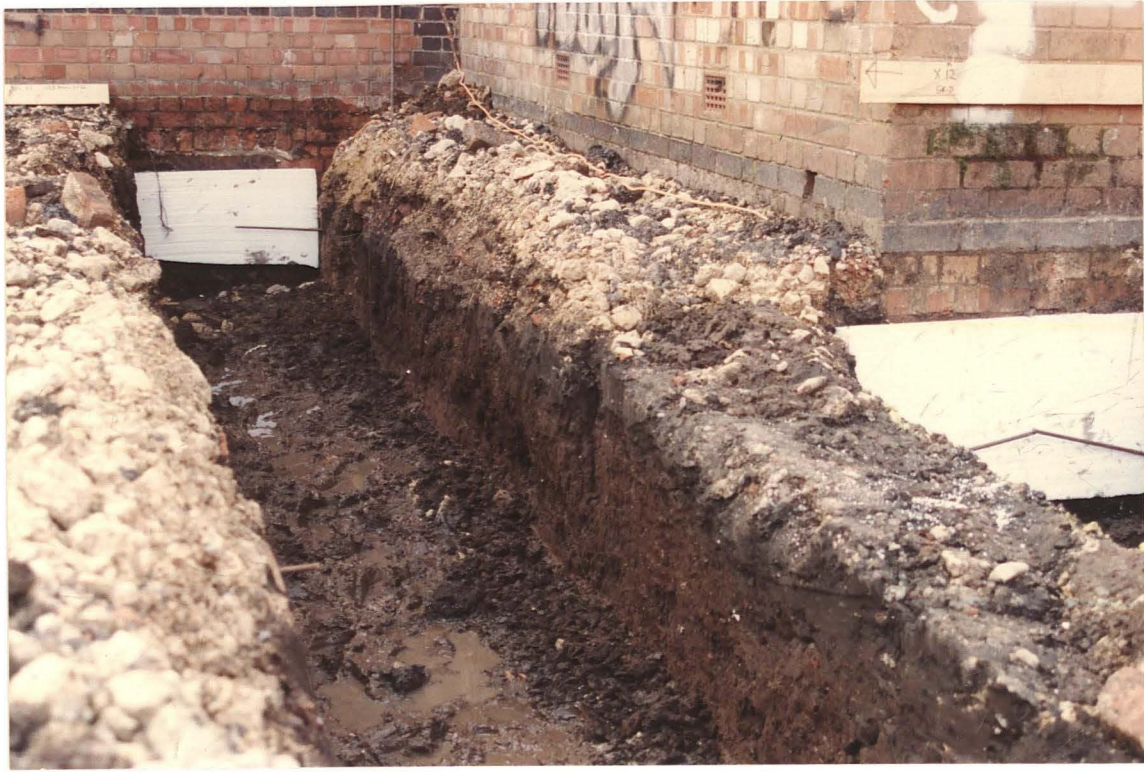
Pl. 3 Deposits visible in northern face of Trench 2 (looking west).

of the existing building. The northern trench face exhibited a similar sequence to that of Trench 1. Brick rubble survived below the crushed stone bedding **101** only as far east as the adjacent projection, suggesting that it had been a restricted deposit. It was unclear whether its extent related to the area beside the existing building, or if the coincidence was fortuitous.

Below **101** was the dark grey-black silt layer **102**, between 0.1m and 0.25m thick. Close to the western end it had been removed by a 0.8m wide and 0.35m deep pit or other intrusion **124** (which produced a fragment of slag and a piece of an iron knife blade). At the eastern end was another disturbance **125**, with a dark brown/black silt fill **126**. This had cut into the upper part of layer **103**, but, because of the colour similarity, it was unclear whether it had been dug through the overlying silt. Elsewhere, layer **102** covered the light brown silt with tile inclusions **103**, with up to 0.15m of the clean brown silt **104** visible at the base of the trench face.

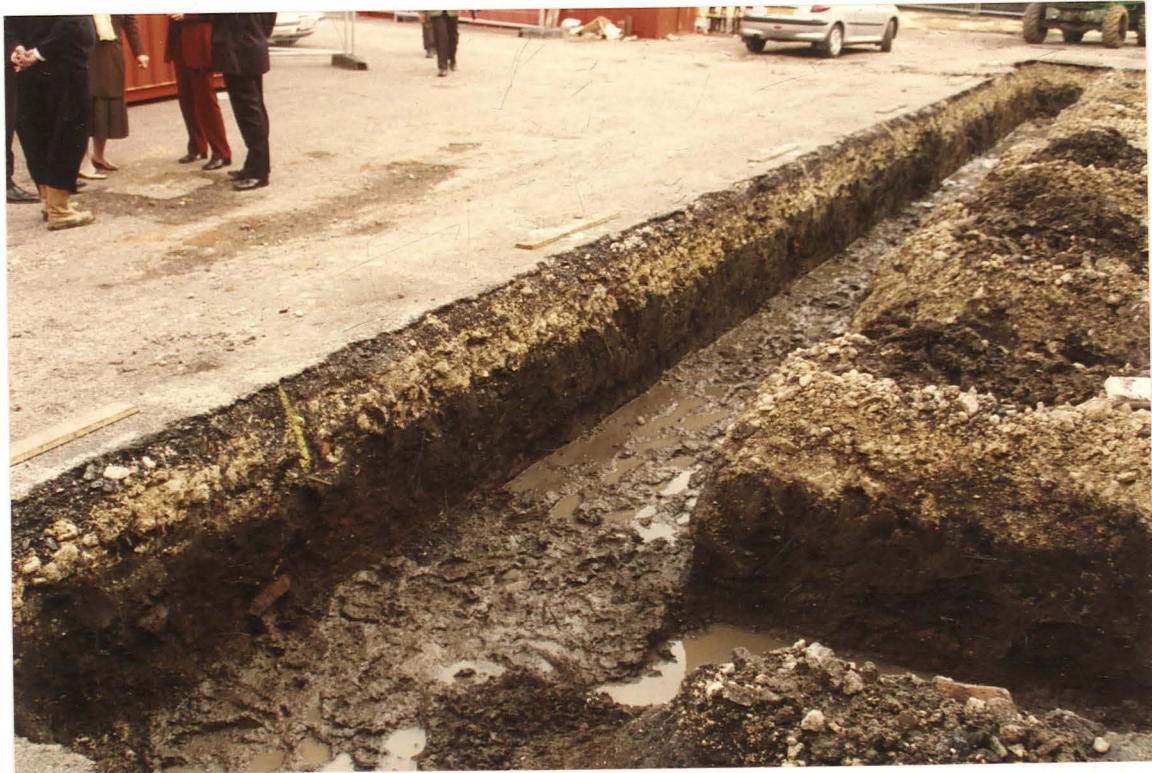
Pl. 4 Brick cover of tile drain visible to east of Trench 2 in the eastern face of Trench 8 (looking SE).

A tile-lined drain **127** was exposed crossing the base of the eastern end of Trench 2 and the northern end of Trench 8 on a SW-NE alignment (Pl. 4). The tiles were roof tile fragments, but none were collected. This drain is thought to have been post-medieval.

The eastern face of the trench revealed the fills of late twentieth century disturbances, occupying much of its length. This prevented further examination of the features at the southern corner. A 3m length of less disturbed deposits survived at the northern end, and here it was possible to identify the deposits seen in the NE corner. The NE-SW aligned crude brick drain seen at the base of Trench 2 survived in the trench face, cut through layer **104**, but was indistinguishable in the higher silt layer **103**.

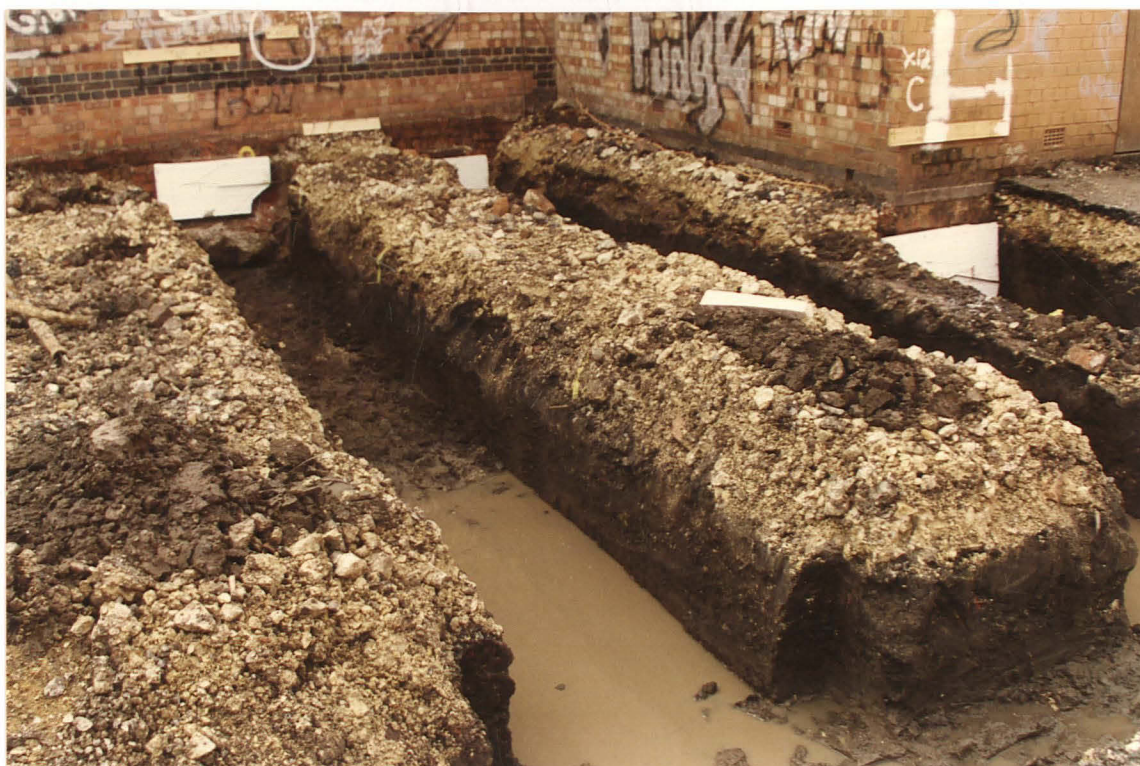
Pl. 5 Trenches 1-3, showing deposits in northern face of Trench 3 (looking NW).

This trench was 1.3m south of Trench 2. Rapid examination of the northern trench face identified the sequence of **102** over **103** with **104** at the base, as seen in Trenches 1 and 2. A 0.65m wide pit **130** was seen 2.5m east of the existing building, cut through **102** to below the trench base.

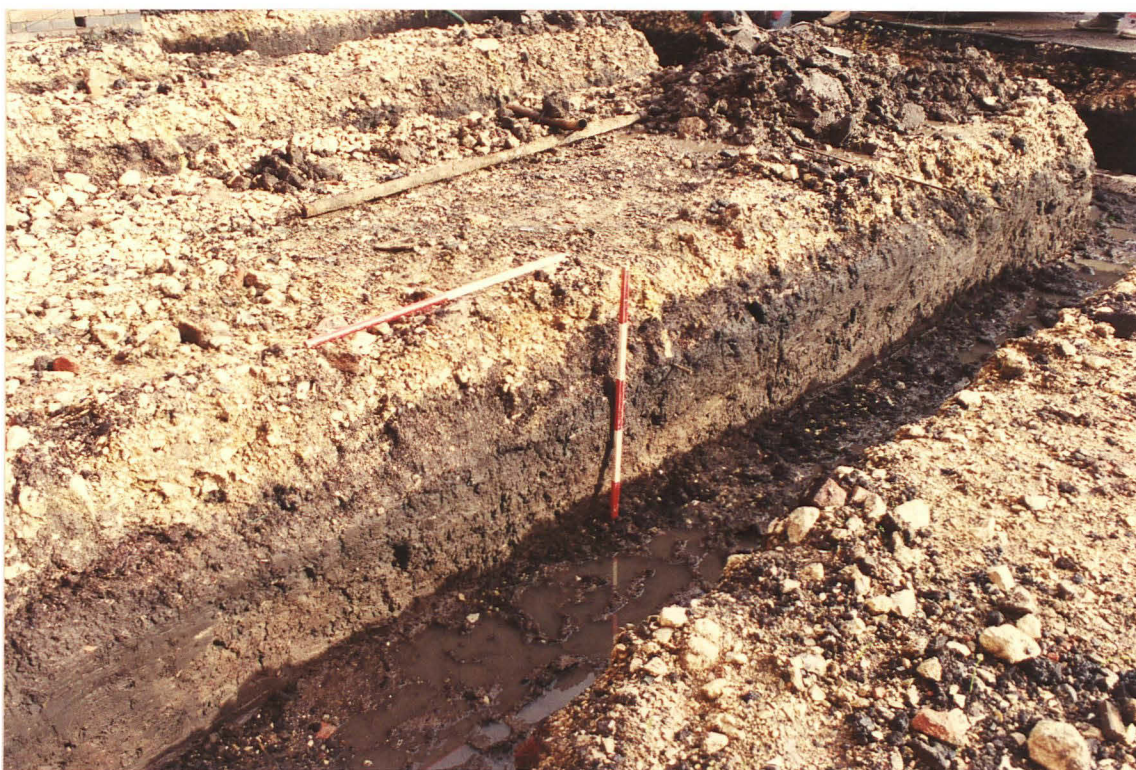
Pl. 6 Deposits visible in the northern face of Trench 4 (looking NE).

Interpretation of this trench, 2.6m south of Trench 3, was hampered by a series of similar deposits interspersed with clearly different material, some of which exhibited sloping tip lines. Deposits similar to those visible in Trench 1 were recorded, suggesting that the sequence in that trench may form part of an extensive feature across this part of the site.

In Trench 4, the clearest stratigraphy was at the eastern end, with **101** sealing the black silt layer **102**. Here there is a suggestion that layer **102** represents a continuing process, possibly of cultivation. Pit **112**, a 2.5m diameter feature, at least 0.4m deep with sloping sides, was sealed by black silt, but also cut an almost identical deposit **115**. The pit fill **113** was a dark silt with brick fragments and charcoal inclusions.

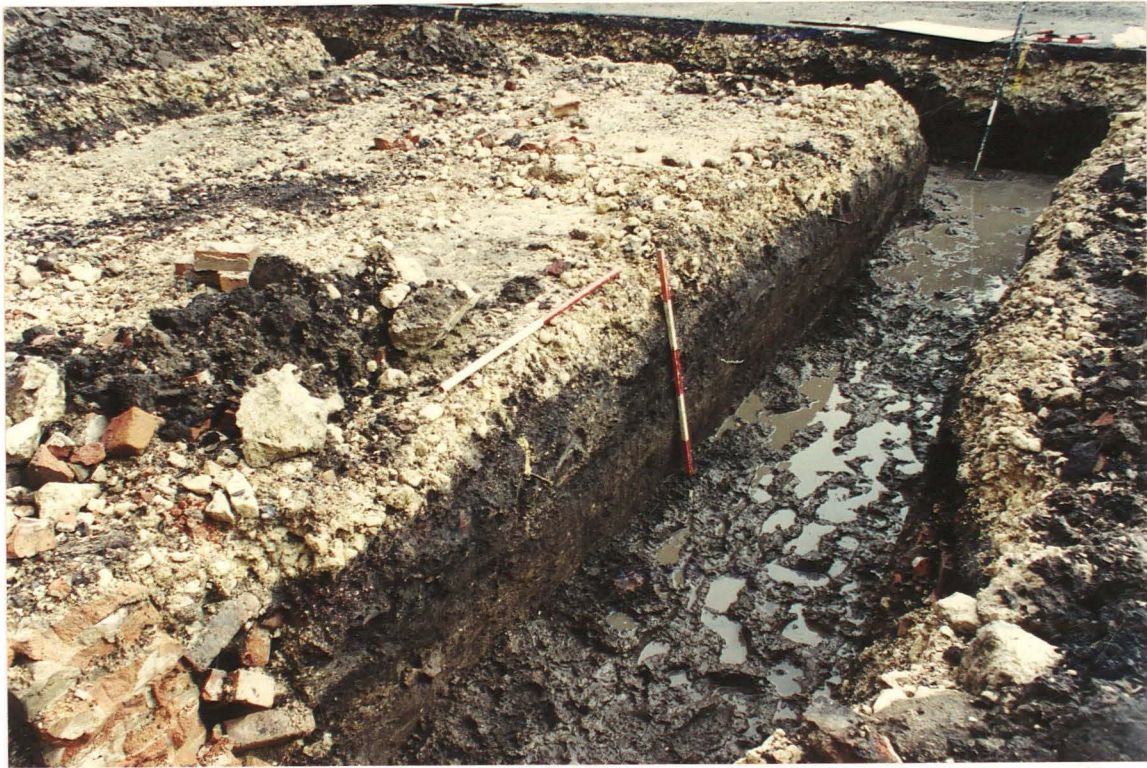
Pl. 7 Northern face of Trench 5 (looking NE).

This was positioned 4m south of Trench 4. Despite much of the western part of the trench being disturbed by previous foundations and backfilled foundation trenches, it was possible to see similar deposits as in that trench. The ash and cinders deposit **108** was restricted to a 3.5m wide depression 0.2m deep, centred about 3m east of the existing building. Below the black silt **102** was a 3.5m wide thin layer of light brown silty clay **120**, interpreted as a spread of the fill from a 0.7m wide vertical-sided post-hole or pit **119**. The fill contained a very abraded sherd of pottery which may have been Roman or medieval. It is possible that the material was actually a separate deposit (stratigraphically and visually similar to **114/170**).

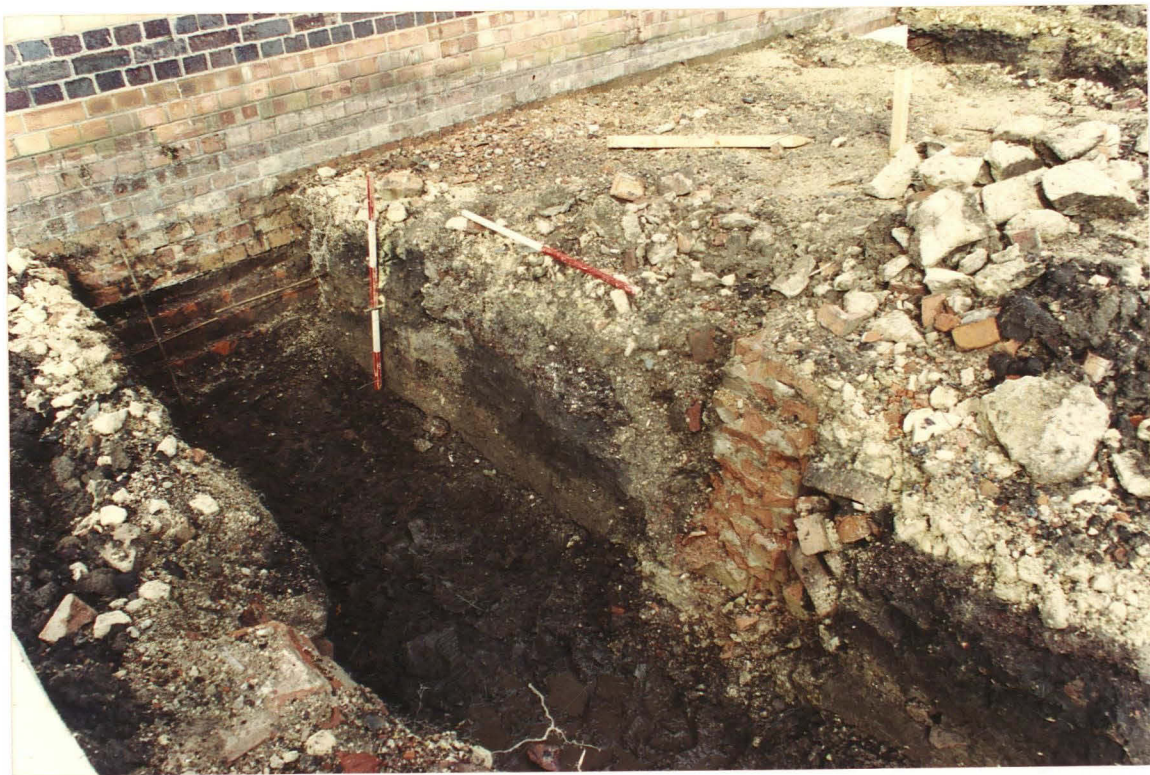
Pl. 8 Silts deposits at the western end of the northern face of Trench 5 (looking NW).

The brown silt with tile inclusions **103** was darker than seen further to the north, and produced shell fragments. At the eastern end of the trench face it sloped downwards to the west, over a black silt deposit **165** which contained preserved twigs.

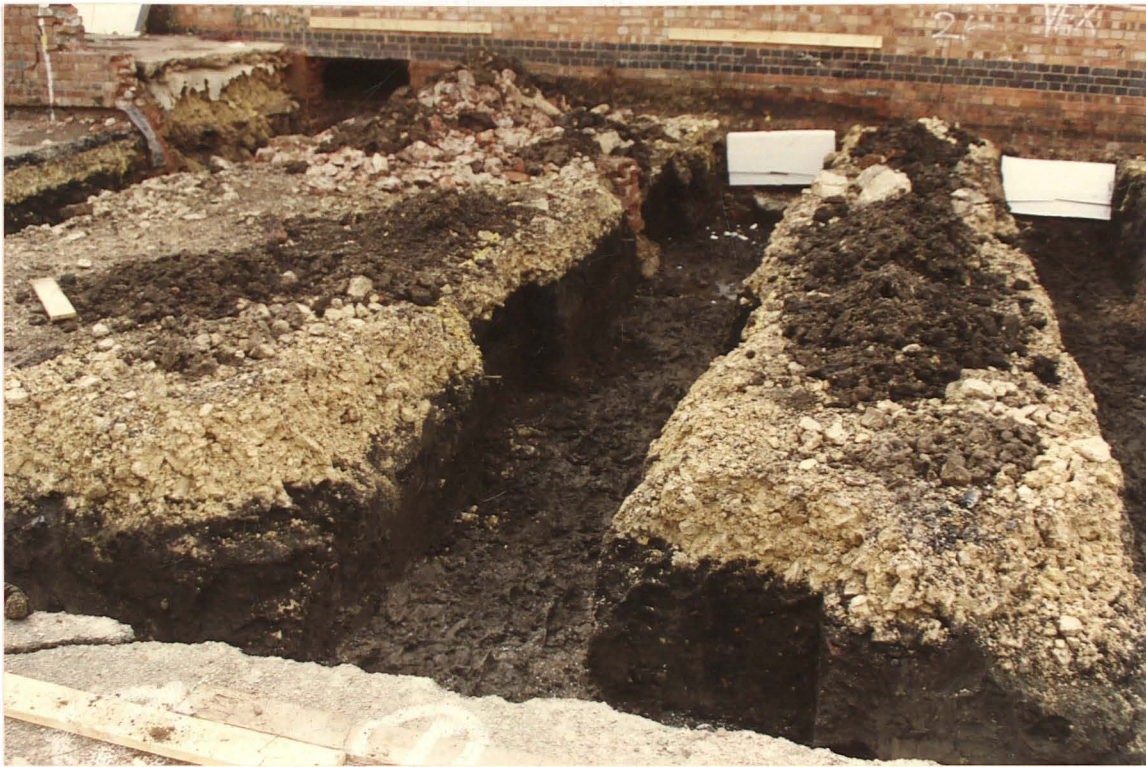
Pl. 9 Trenches 5 (right), 6, and 7 (left). Looking west.

A rapid inspection of the trench face identified no obvious significant features and the same sequence of deposits as in Trench 5, 1.7m to the north.

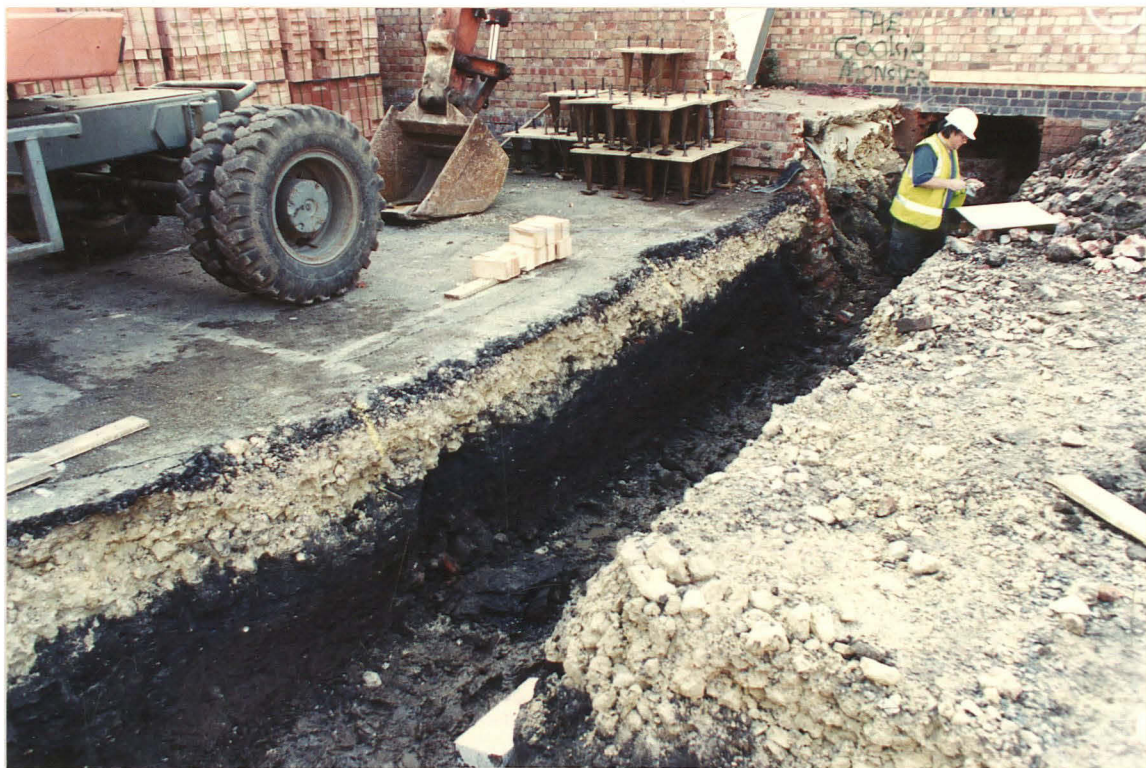
Pl. 10 Southern face of Trench 7, at the southern end of the main extension (looking SW).

The southern foundation trench of the new extension cut through a zone of twentieth century disturbance within 3m of the existing building. This included foundations for the former Co-operative Society building's ramp, but also slightly earlier structures. Within this zone, it was unclear whether any of the surviving soil deposits remained *in-situ* or whether they had been redeposited as part of foundation construction.

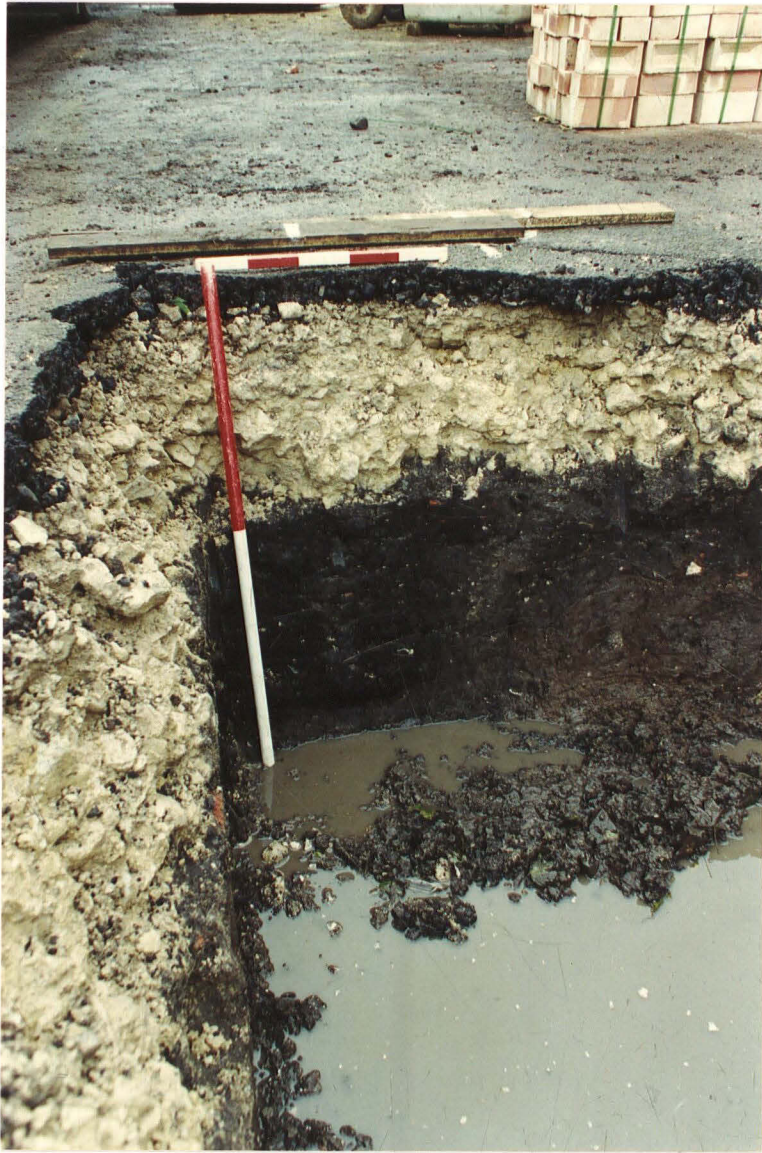
Pl. 11 Dark silt fills of pits 157 and 158 (looking south at the SE corner of Trench 7).

At the eastern end of the trench, in the SE corner of the extension, was the western edge of a 0.7m wide, and 0.5m deep feature **157** (Pl. 11). The side of the feature was almost vertical, other than a slight lip; it had a flat base. Its lowest fill was a 0.02m thick lens of peat **139**, suggesting a period of vegetation growth in waterlogged conditions (although redeposition of peat is also possible in this context). Above the peat, the fill **136** was a black silt with brick flecks (darker than **135**, but probably derived from it as it cut through that layer). Immediately below this feature was the very similar **158**, about 0.2m wider, and sealed by **135**. Its fill, **140**, was a dark grey silt with very few inclusions. The similarity of these two features suggested that one had replaced the other, either as ditches or as post-holes; the steep profile seemed more suited to a post-hole or pit, than to a ditch cut through the local silts.

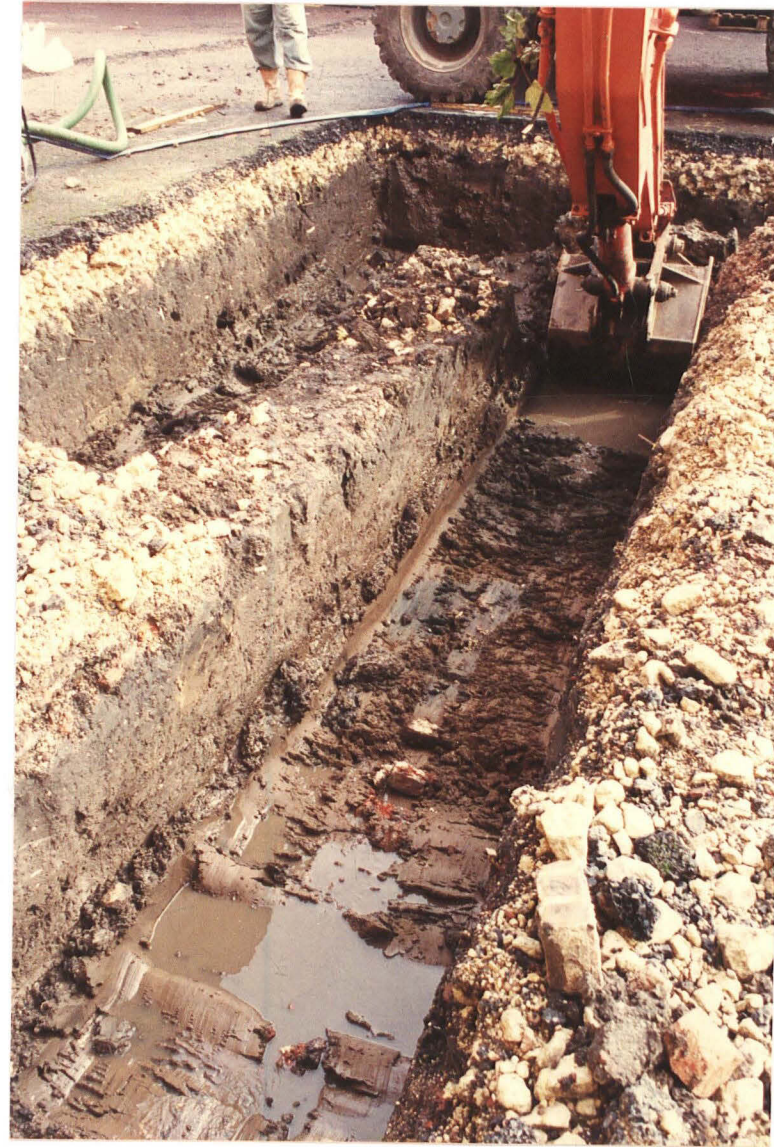
Pl. 12 Darker silt visible at the eastern end of the Eastern Extension trenches immediately after machining (Trench 2, looking east).

Interpretation of the deposits seen in the extension area was thwarted by the inability to identify reasons for the discontinuity of layers. Monitoring of the excavation of these trenches would have assisted in this. An attempt was made by the contractors to clean the trench bases with a machine bucket, under archaeological observation. This failed as the soil was already waterlogged by a combination of heavy rainfall and high local water table, and where the ground was successfully cleaned without smearing, it was rapidly covered in a thin layer of water insufficient for removal by pumping. During this process, a marked difference was seen in the colour of the silts at the trench bases, and this abrupt change was plotted (Pl. 12). The incompletely revealed division formed an

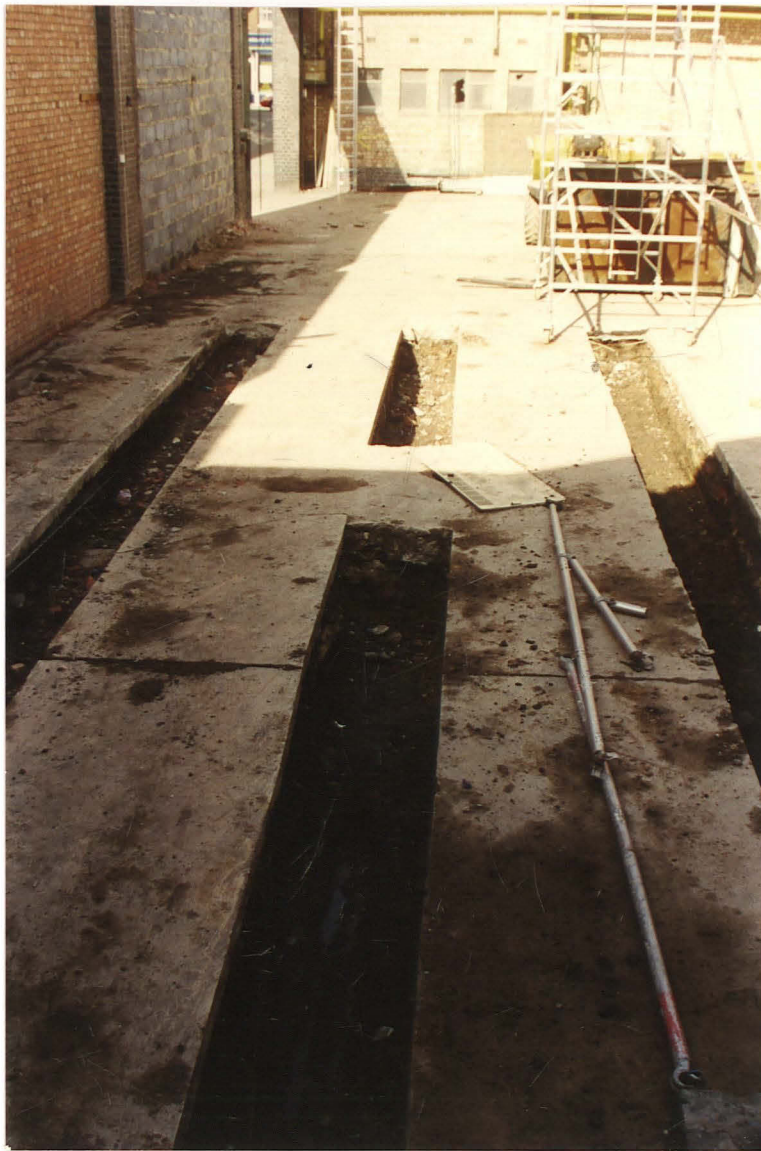
Pl. 13 Position of the three narrow slot trenches in Cinema 1 (looking north).

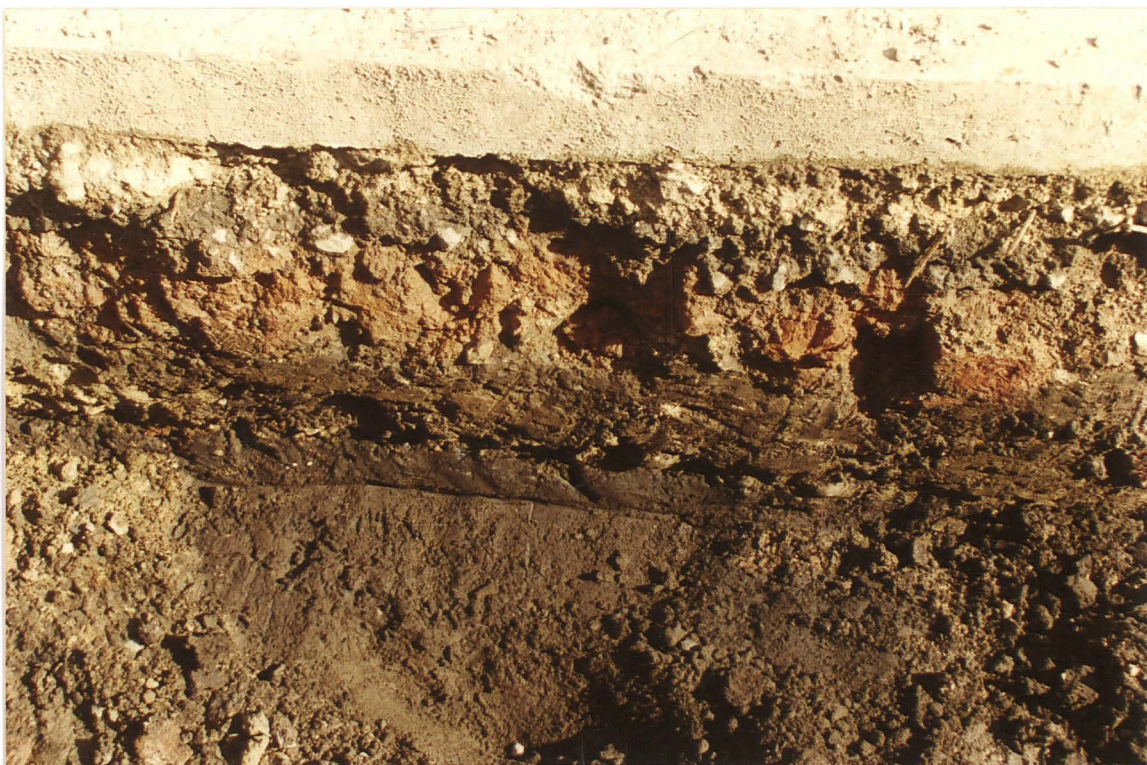
Pl. 14 Brick rubble and underlying silt deposits seen in the eastern slot trench in Cinema 1 (looking east).

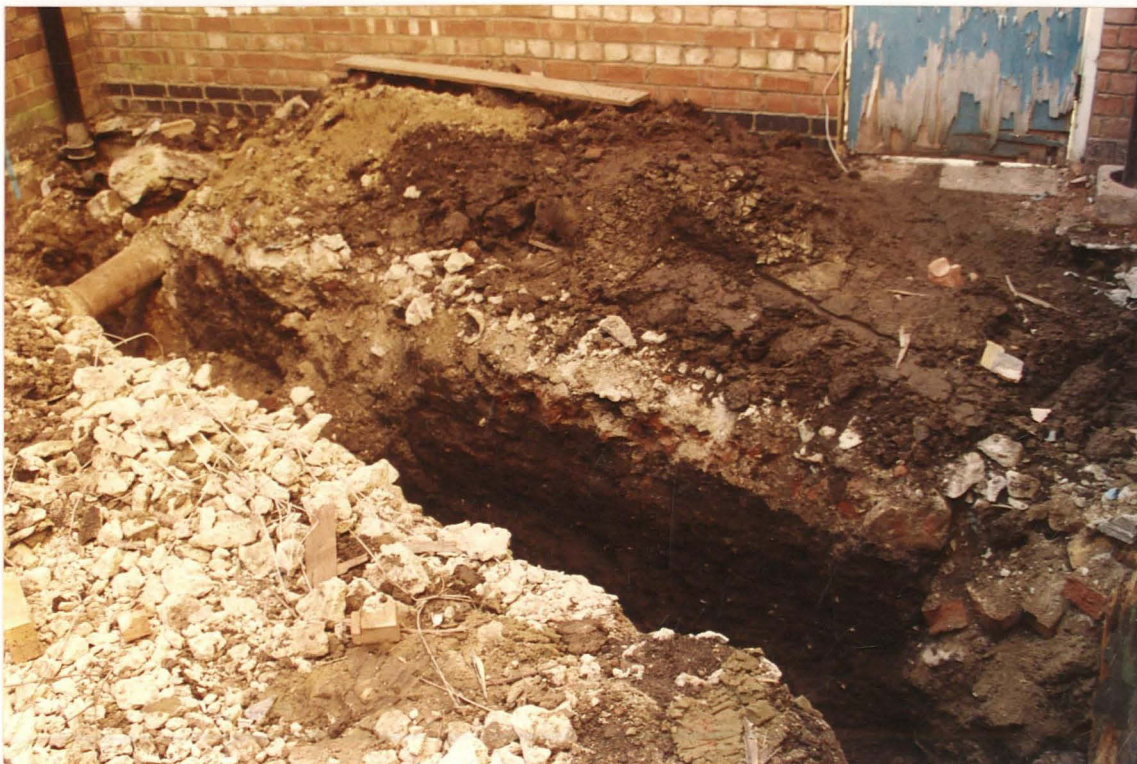
Pl. 15 Trench excavated at the western side of the Central Access Area (looking west).

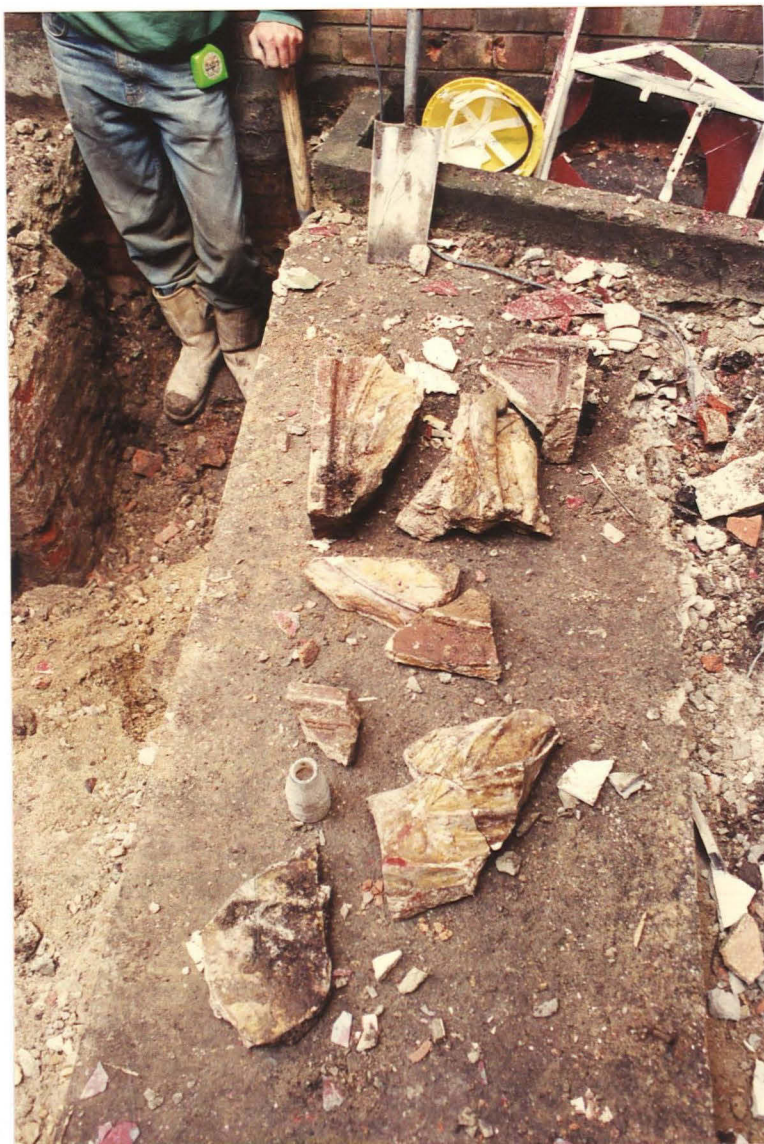
Pl. 16 Fragments of plaster decoration found re-used as backfill below the floor at the NE corner of the Central Access Area (looking north).

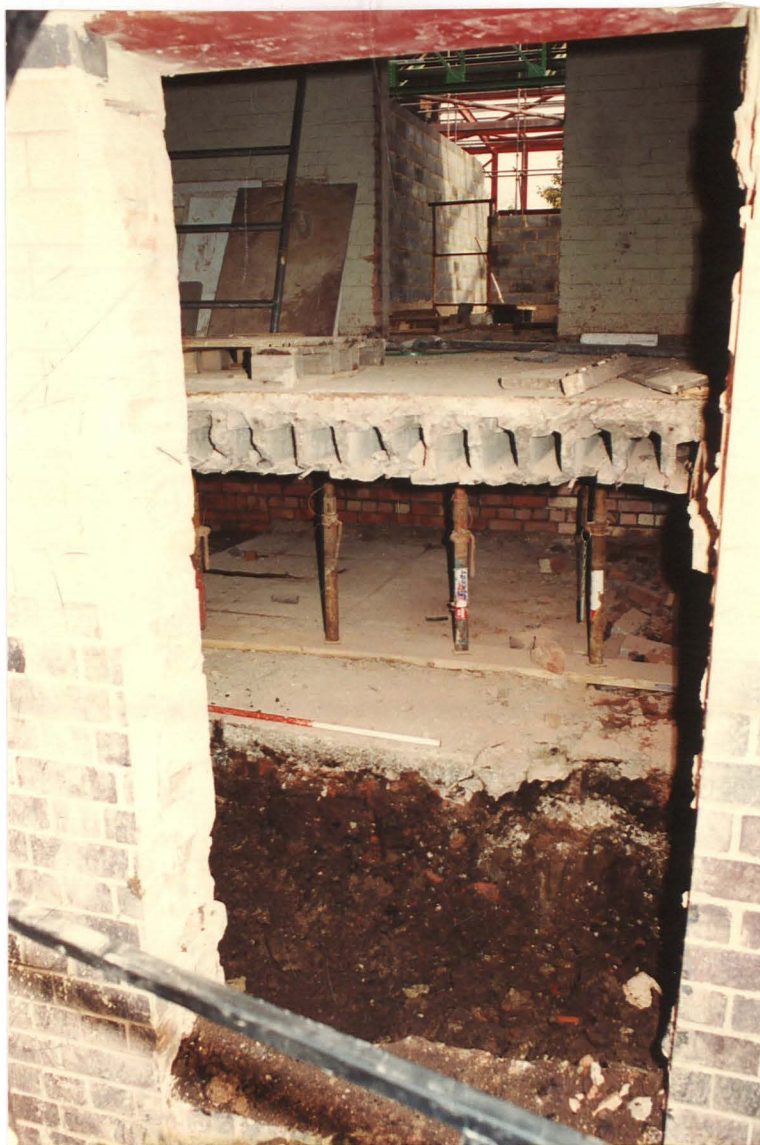
Pl. 17 Brick rubble and soil below the suspended floor in the position of the new SW Stair Access (looking west).

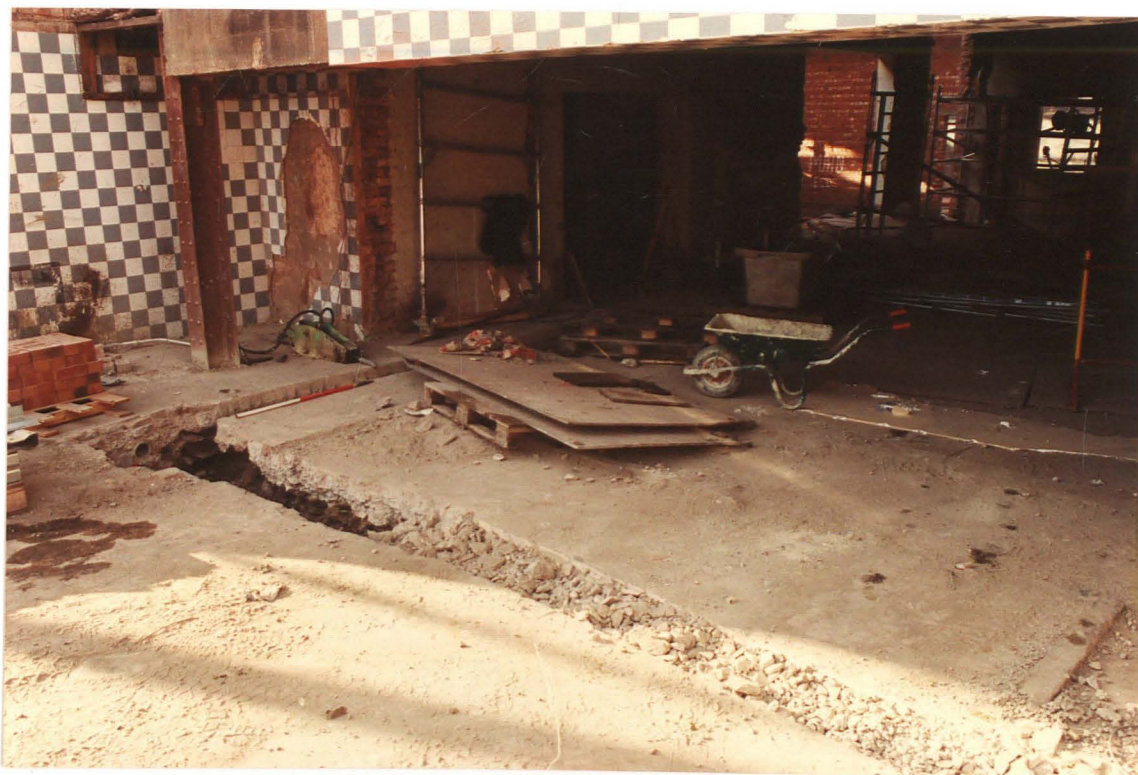
Pl. 18 Position of trenches inspected in the position of the new NE Access (looking SW to the Central Access Area).

After demolition of an existing extension on the eastern side of the building, new foundation trenches were excavated to a width of 0.45m and depth of 0.6m through the concrete slab floor (PI. 18). These disturbed nothing other than brick rubble, leaving soil deposits intact below.

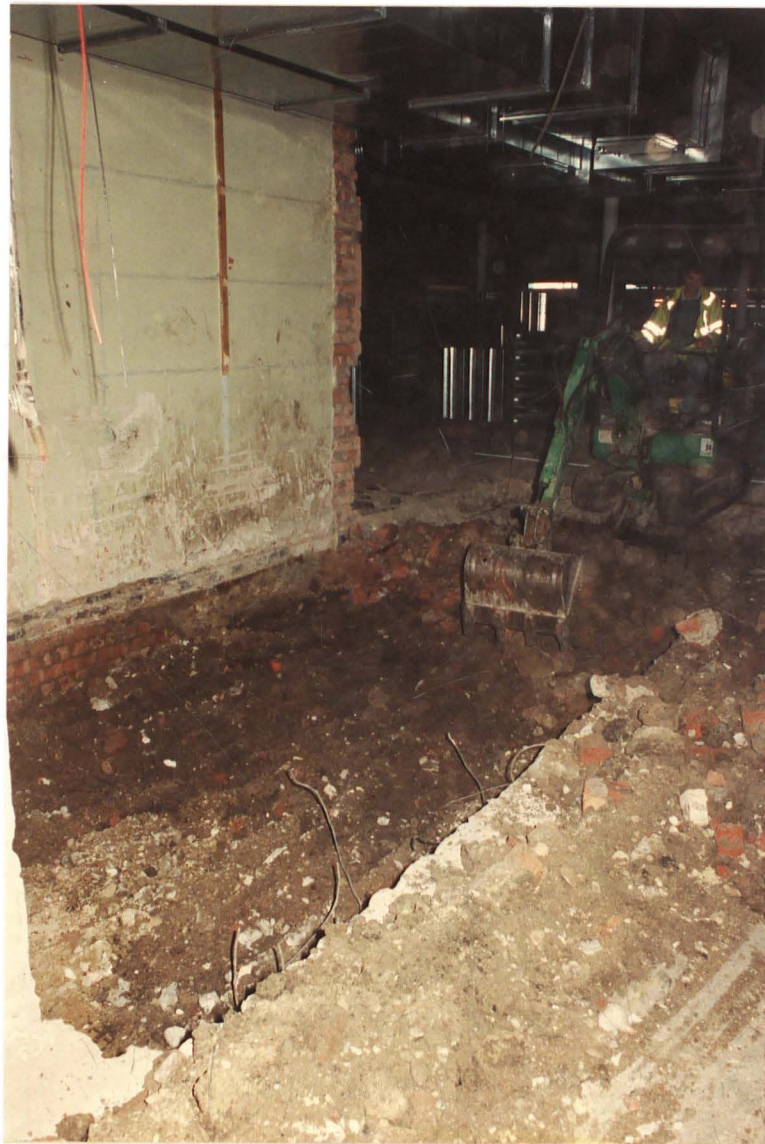
Pl. 19 Trench through brick rubble north of the former lift shaft, in the position of the new Fire Escape/Wheelchair Route (looking west).

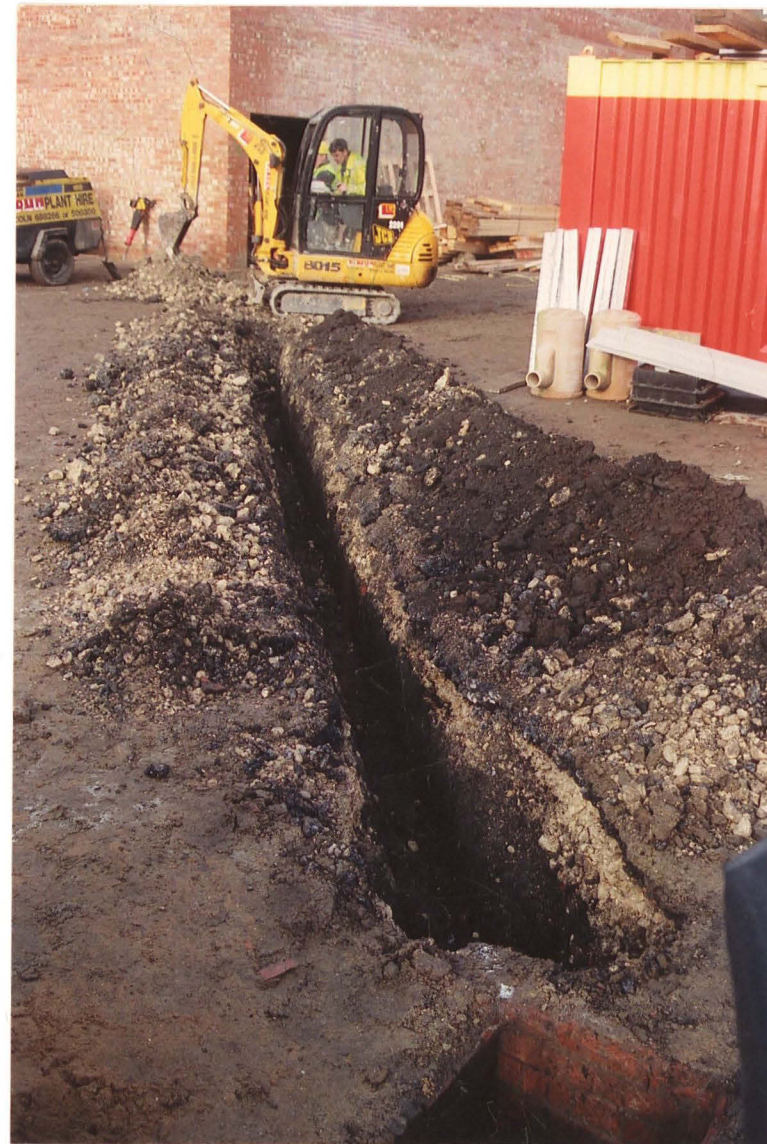
Pl. 20 Drain connection trench, excavated from the new extension towards the SE corner of the yard (looking NW).

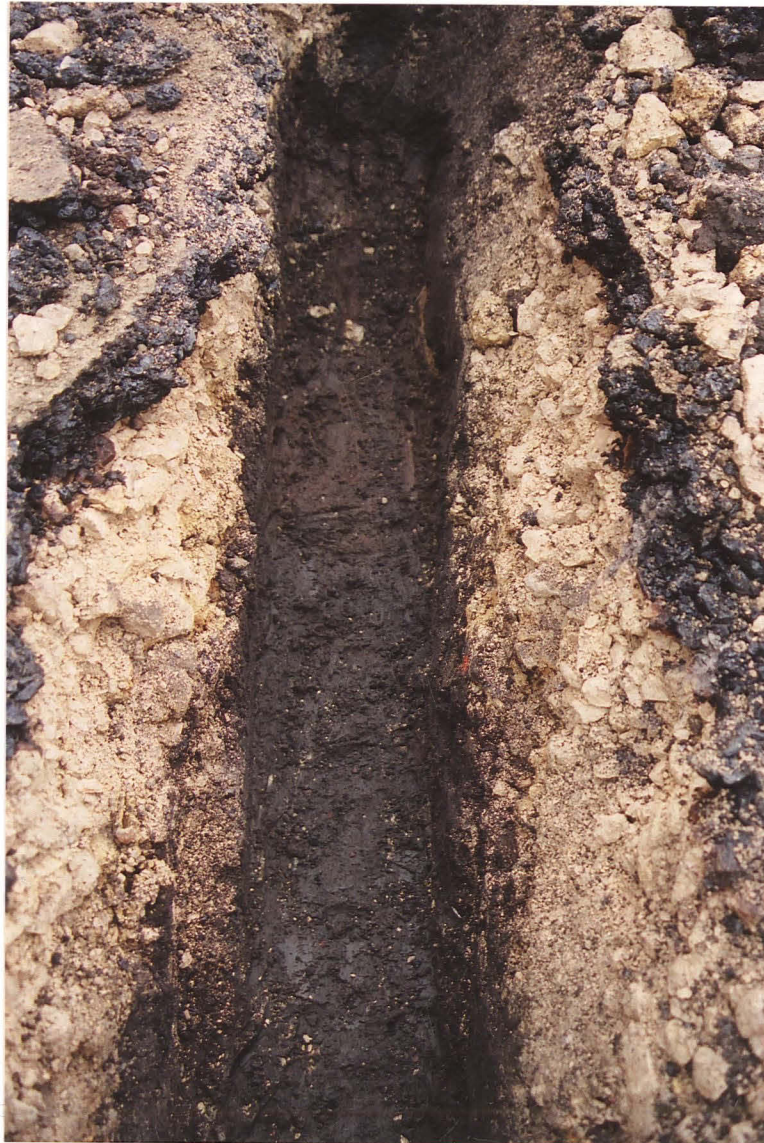
Pl. 21 Junction between black silt layer 183 and the underlying brown silt 182 (background) seen in the drain connection trench (looking SE).

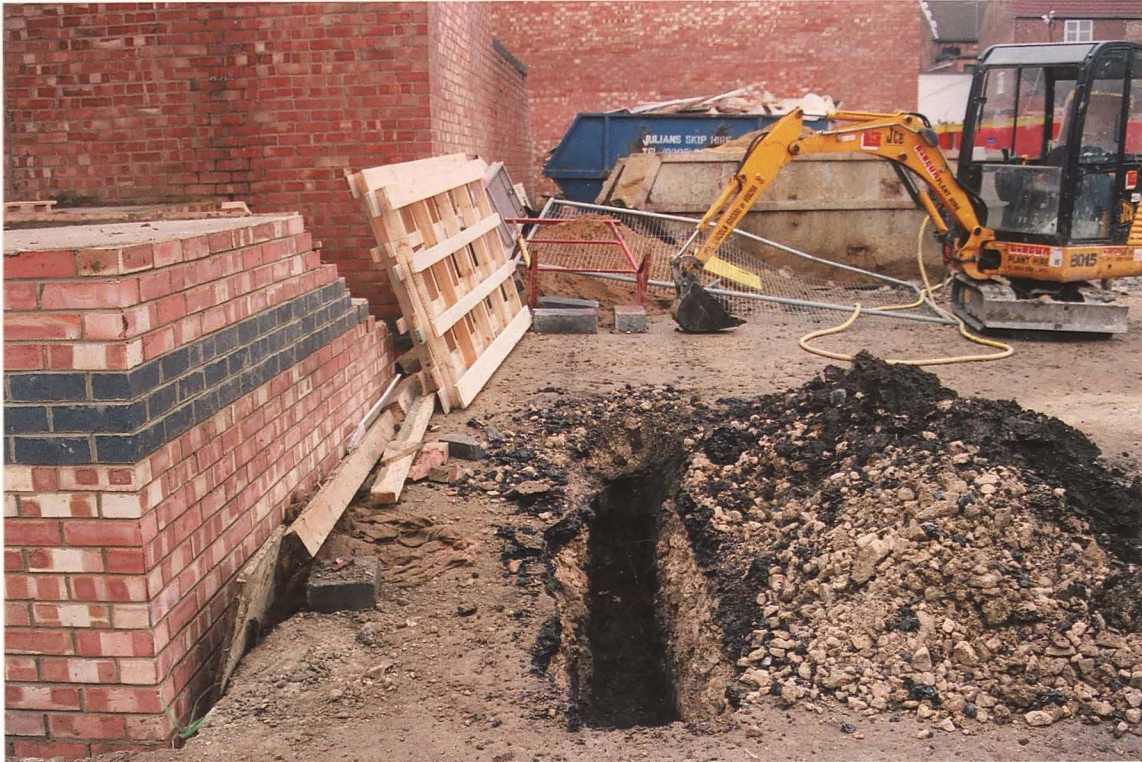
Pl. 22 Short trench excavated beside the new SE Exit (looking north towards the new extension).

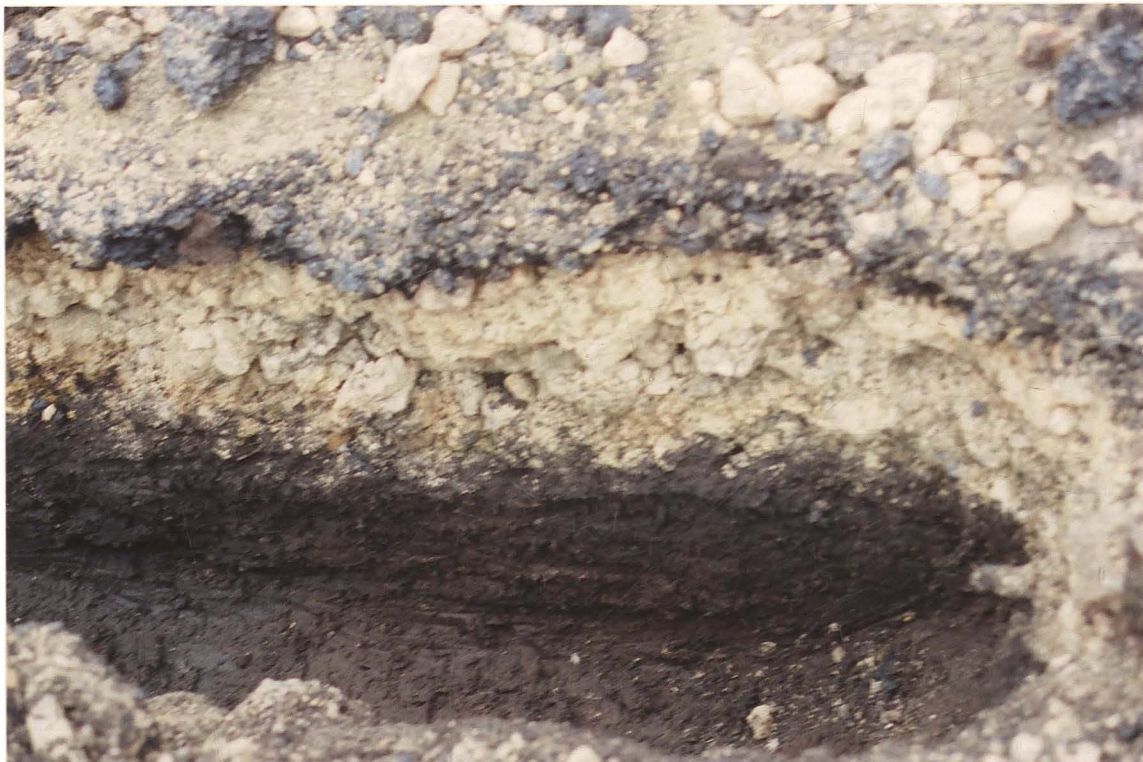
Pl. 23 Silt deposits in the trench beside the SE Exit, with thicker black silt (left) possibly marking the position of a backfilled boundary ditch (looking west).
