**Savoy Cinema (Former Co-operative Society Store)
West Street, Boston**

Archaeological Watching Brief

**Report for Northern Building Design Associates Ltd
(on behalf of Savoy Cinemas)**

**LAS Report No. 584
March 2002**

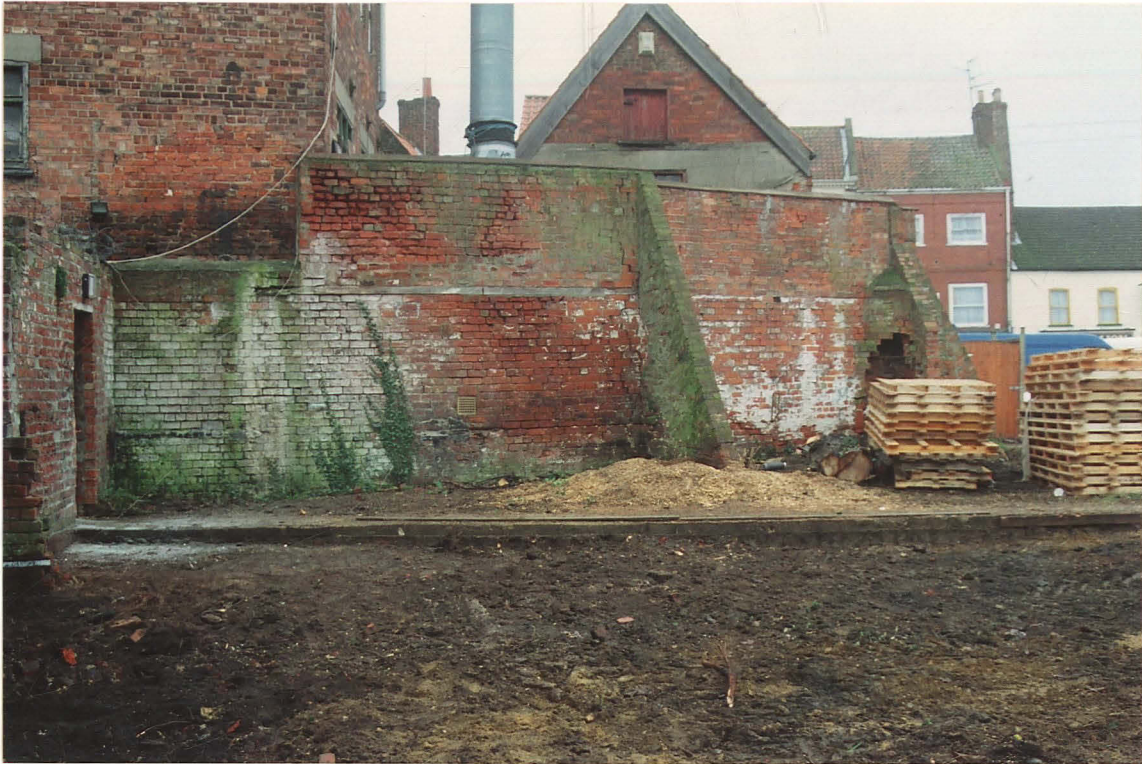
Pl. 24 A laid brick surface was exposed beside the entrance through the wall at the northern side of the car park area closer to High Street (looking east).

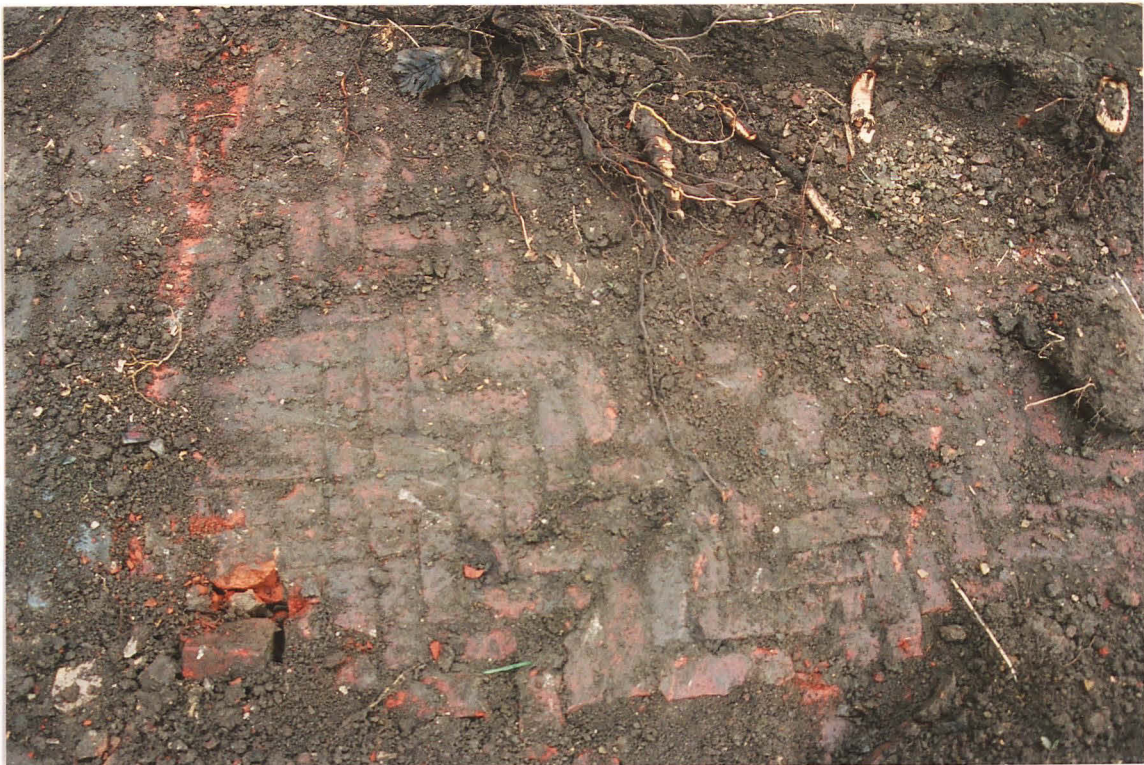
Pl. 25 Position of the entrance with laid brick surface (left foreground), to the east of the cinema development site (looking NE).
