Land NW of St Peter's Road, Scotter Archaeological Evaluation

NGR: SE 88466 00784
Site Code: SSPR 02
LCNCC Museum Accn No.: 2002.139
W. Lindsey District Council Planning Application No. M01/P/1180

LAS Report No. 592 June 2002 Conservation Services

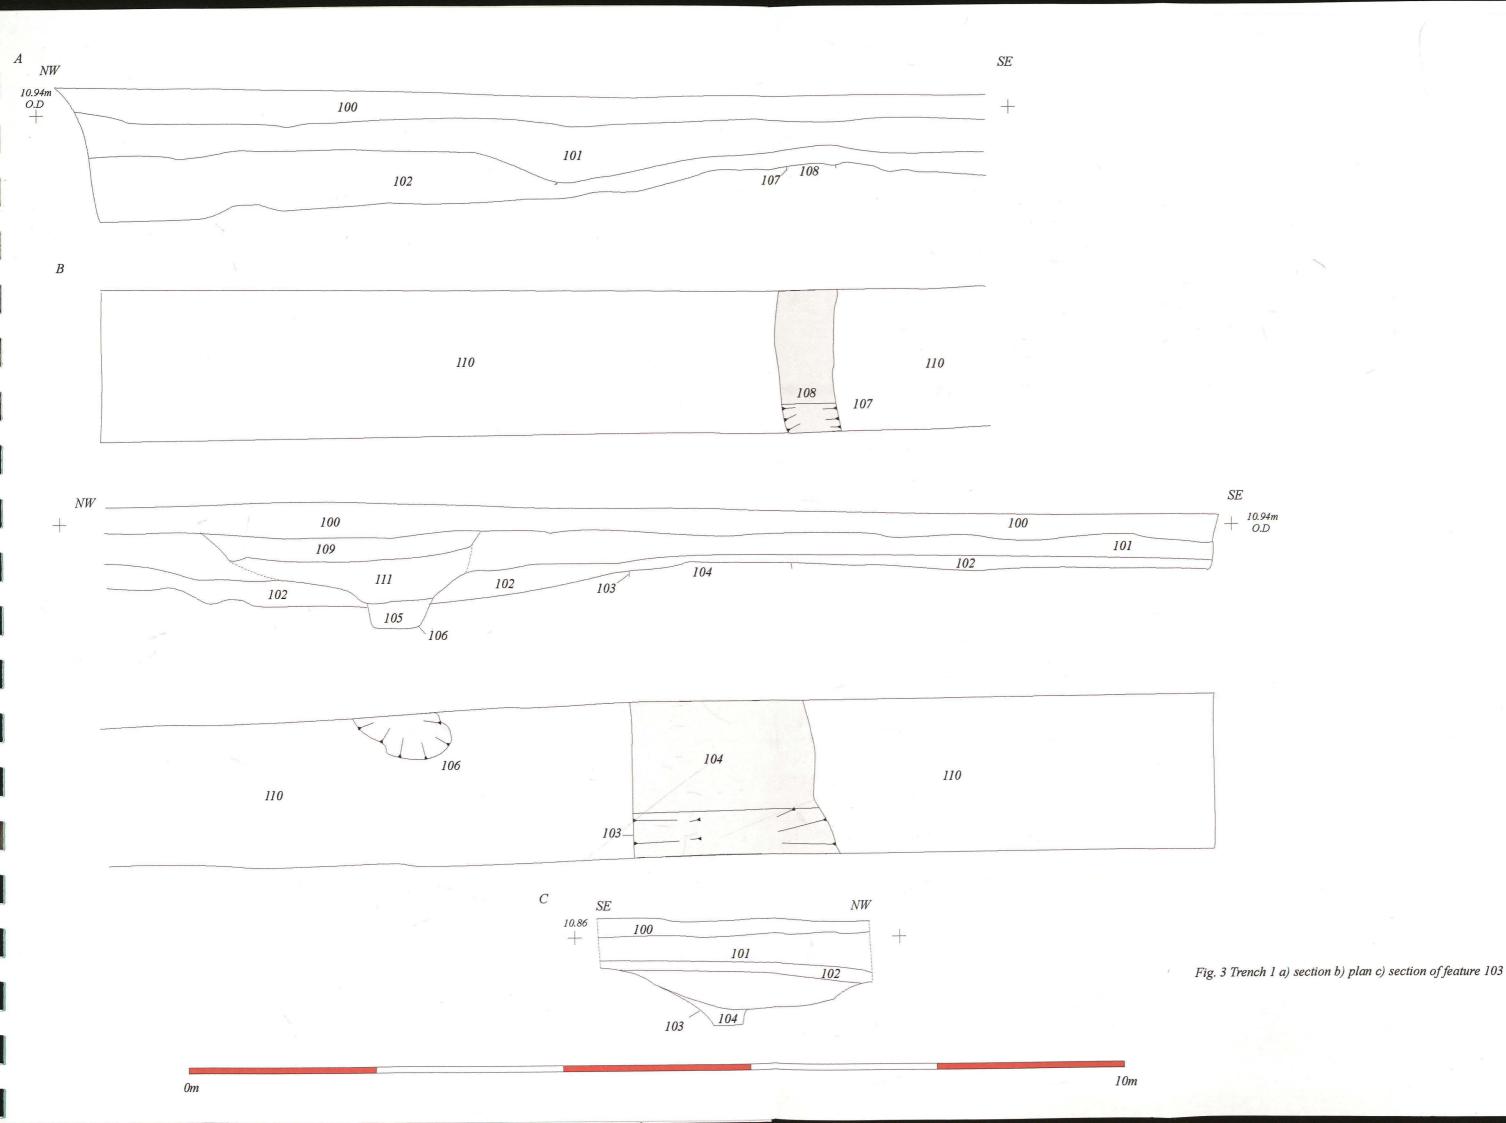
Fig. 3 Trench 1 a) section b) plan c) section of feature 103.

Three features were identified in Trench 1. Ditch 103, at the south east end of the trench, was 1.1m below the ground surface and appeared to be sealed by layer 102 but ground conditions were very disturbed by tree roots. It was had a rounded profile but with a narrow slot in the base and contained 19th/20th century pottery. A narrow gully 107 was recorded towards the north west end of the trench. It was c.0.55m wide and 0.20m deep and also sealed by 102, and had a rounded profile. It also contained 19th/20th century pottery.

Immediately north-west of ditch 103 was a small pit, 106. It contained animal bone and medium sized stones. It contained no datable finds but was dug from a higher level than the two ditches so is assumed to be even later in date.

The very late finds from the features 103 and 107, apparently sealed by 102 suggest that layers 102 and 101 are dumped deposits of very recent date. The undulating surface of the natural 110 may indicate the vestiges of levelled ridge and furrow. The two high points in the trench were approximately 9m apart, which is similar in spacing and orientation to the anomalies identified as ridge and furrow during the geophysical survey.

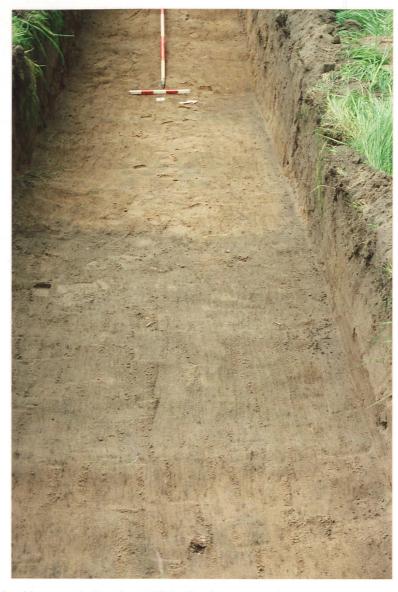
PI.1 Trench 1 looking west showing 103 in the foreground.

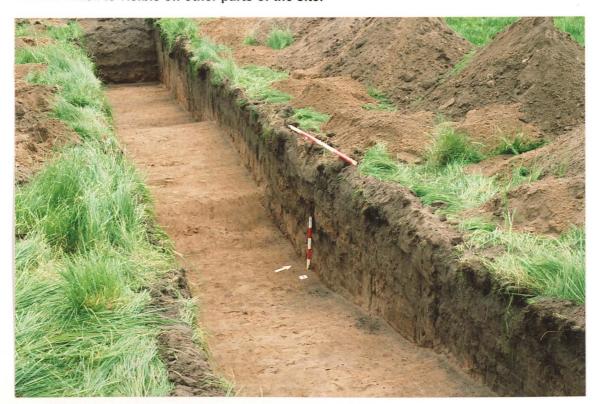
Trench 1 was orientated approximately north-west south-east and was excavated to a depth of between 0.5m to1.20m. A dark brown silty sand topsoil, **100**, approximately 0.30m deep, sealed **101**, a loose greyish brown silty sand which varied in depth across the trench between 0.35m and 0.60m. Below this was **102** which possibly represents an earlier subsoil which overlay an undulating natural surface **110** of firm orange brown silty sand.

PI.2 Trench 1 section. Undulations in the base of the trench may relate to ridge and furrow which is visible on other parts of the site.

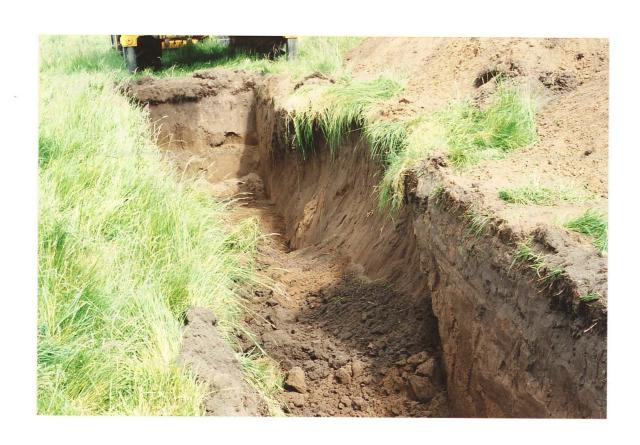
Trench 2 was excavated to the north-east of Trench 1. The topsoil was 0.20m deep but a further 1.20m of overburden, that was very similar to the topsoil was recorded. This reinforces the interpretation that much of the soil on the site has been deposited recently. The natural 110 was reached at a depth of 1.40m and there was no evidence of archaeological features. The trench edges were highly unstable and collapsed, which made it impossible to closely examine the trench.

Pl. 3 Trench 2 after the sides of the trench collapsed.
